2022

PERIODIC REVIEW REPORT

**240 – 260 LAKEFRONT BOULEVARD SITE
240 LAKEFRONT BOULEVARD
NYSDEC SITE #C915340
CITY OF BUFFALO, ERIE COUNTY, NEW YORK**

JUNE 15, 2020 TO DECEMBER 4, 2021

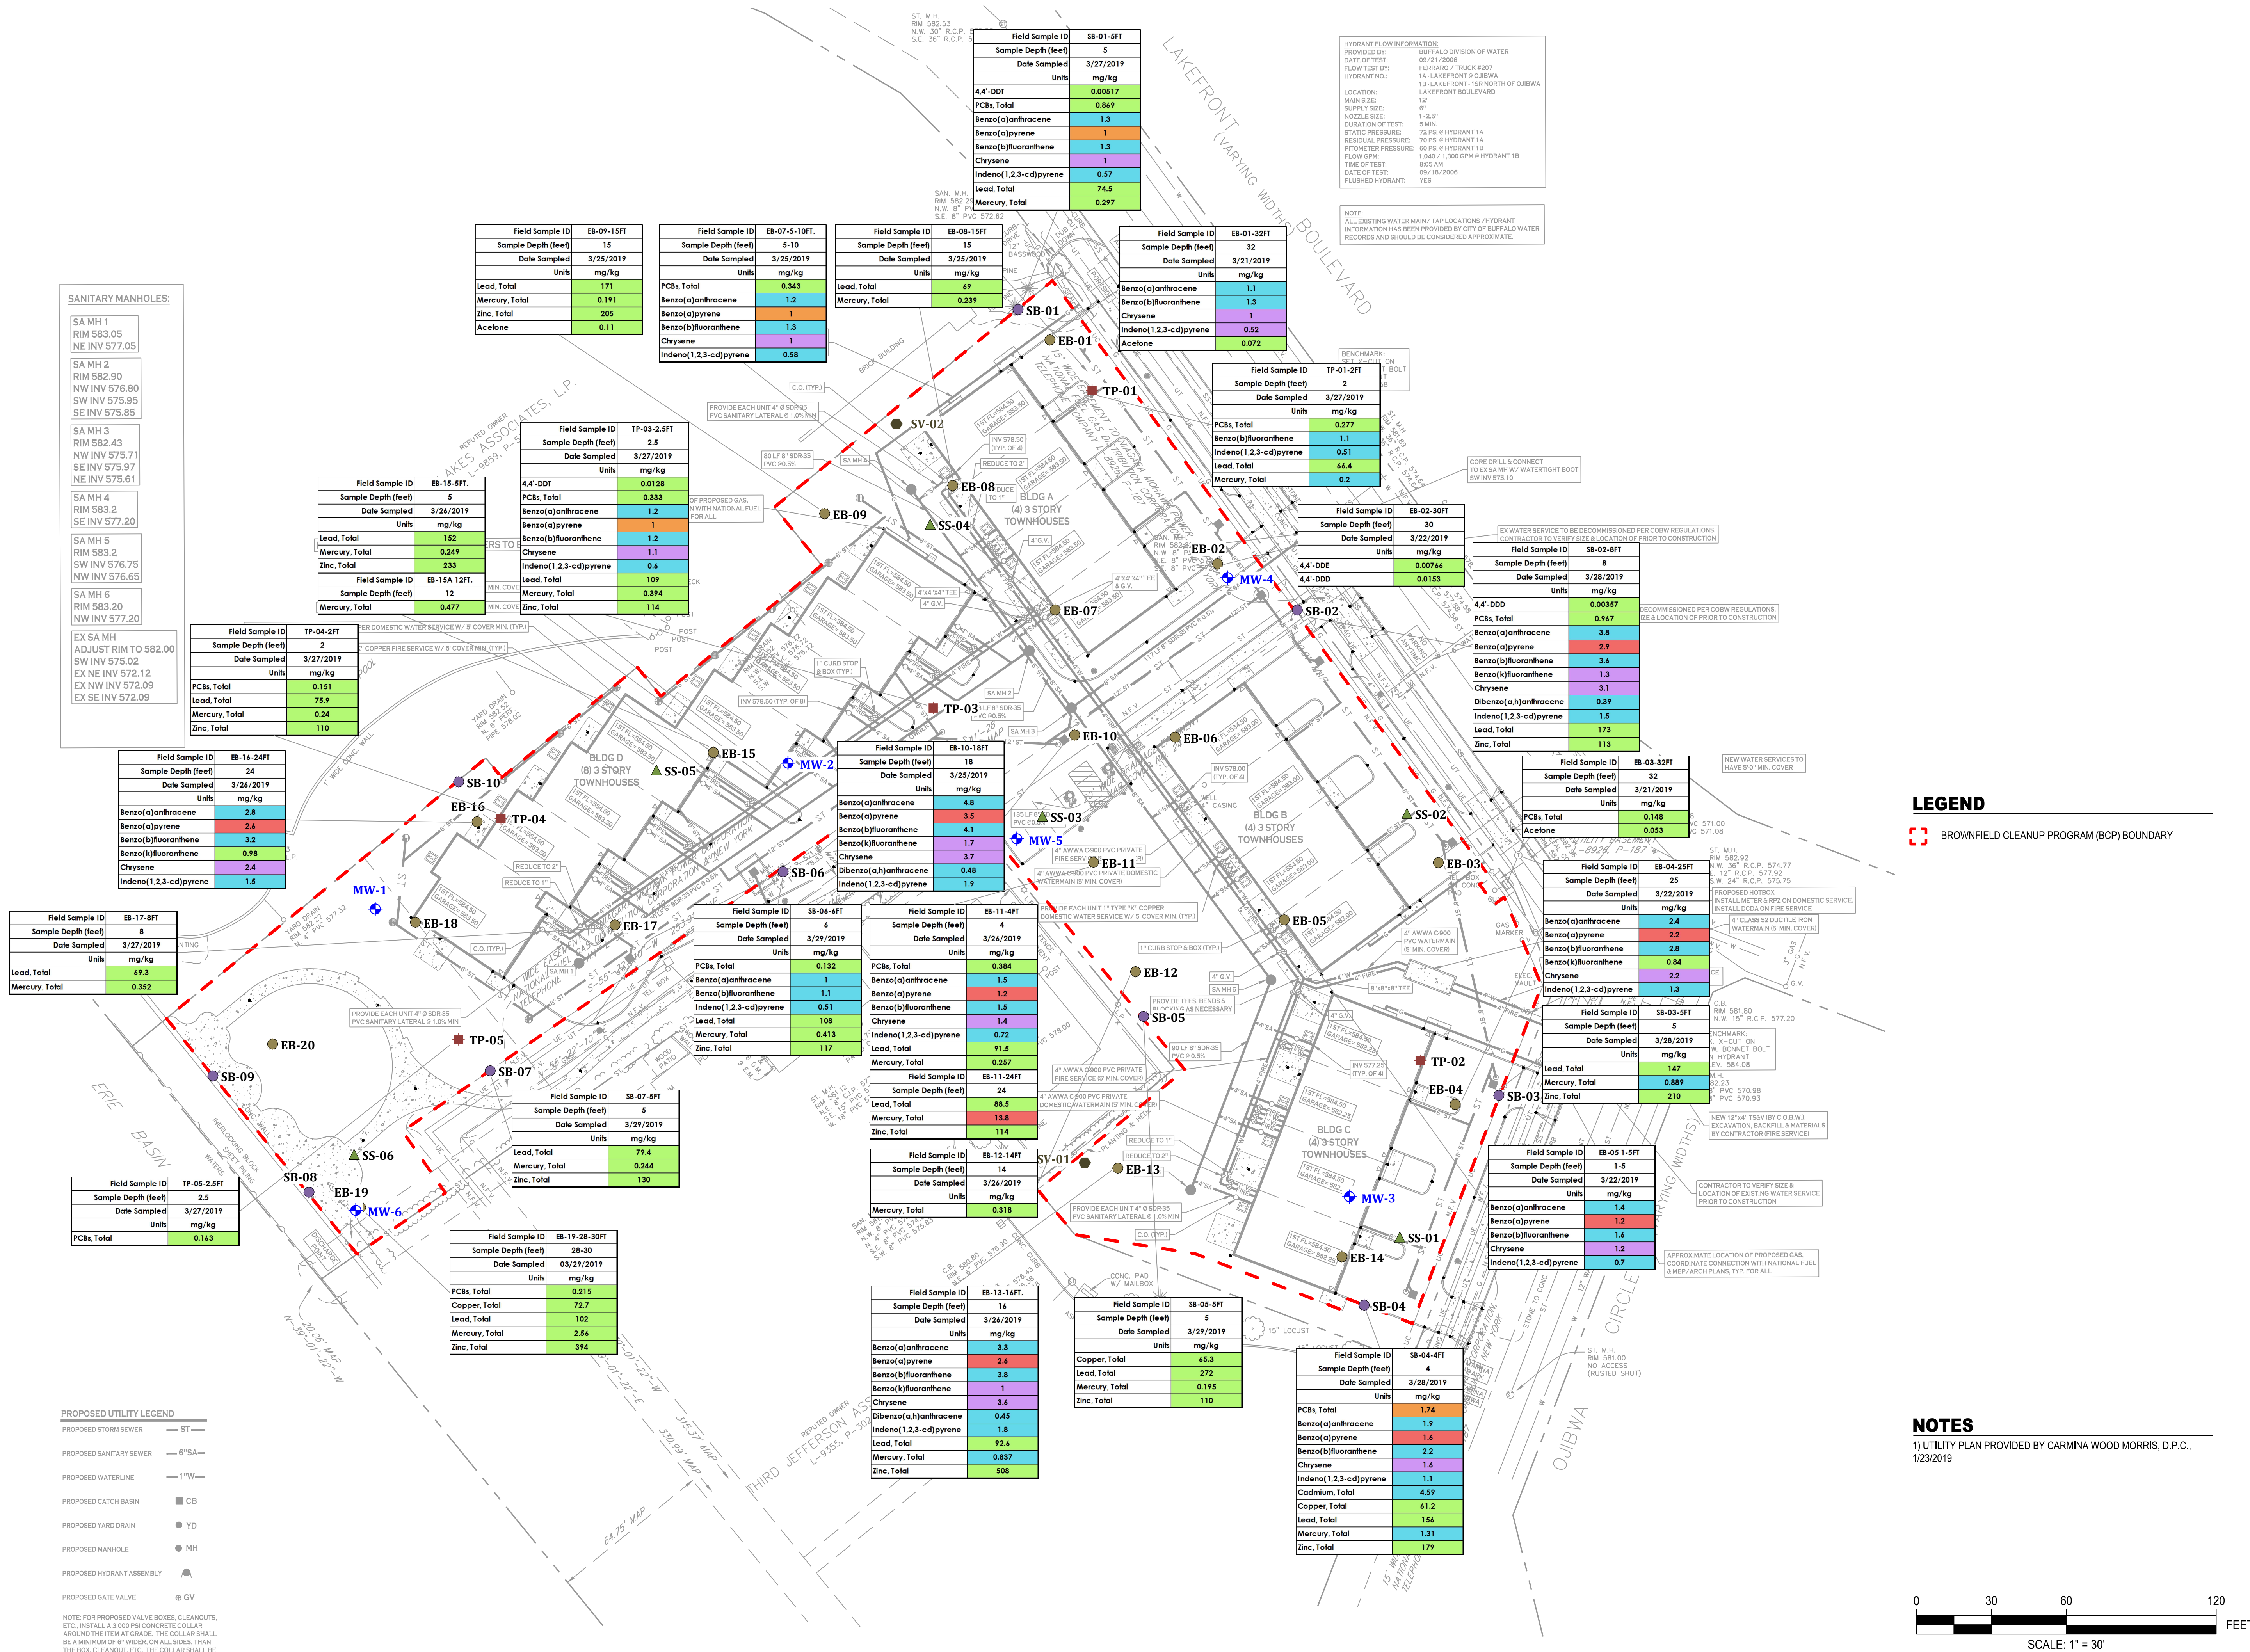
FIGURE 2

Sample locations documenting remaining contamination is presented in **Figure 2**.

REMAINING SOIL CONTAMINATION

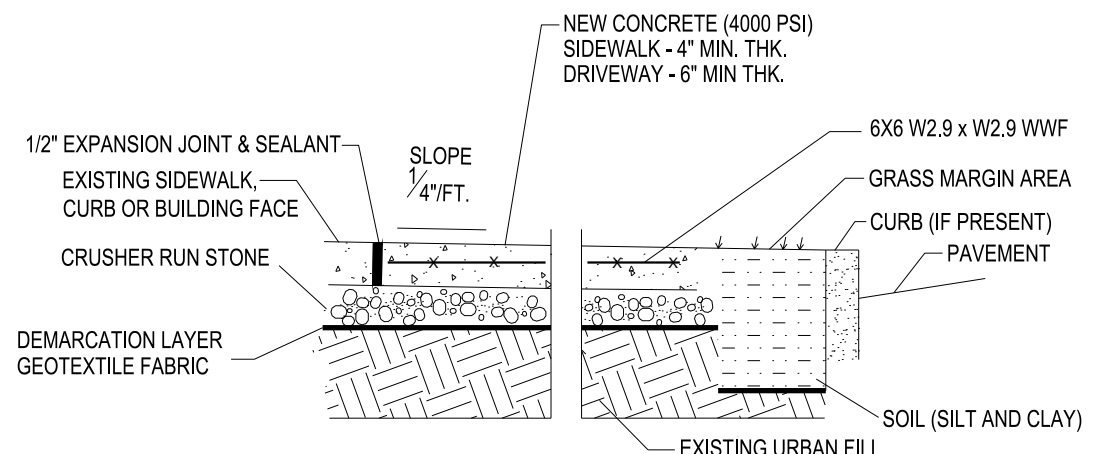
CONCRETE SIDEWALK
N.T.S.

- SOIL COVER TYPE A
- HARDSCAPE (CONCRETE AND ASPHALT) AND SUB-BASE MATERIAL
 - SEE SITE PLAN DETAILS
 - TOTAL AREA = 57,207 SQUARE FEET

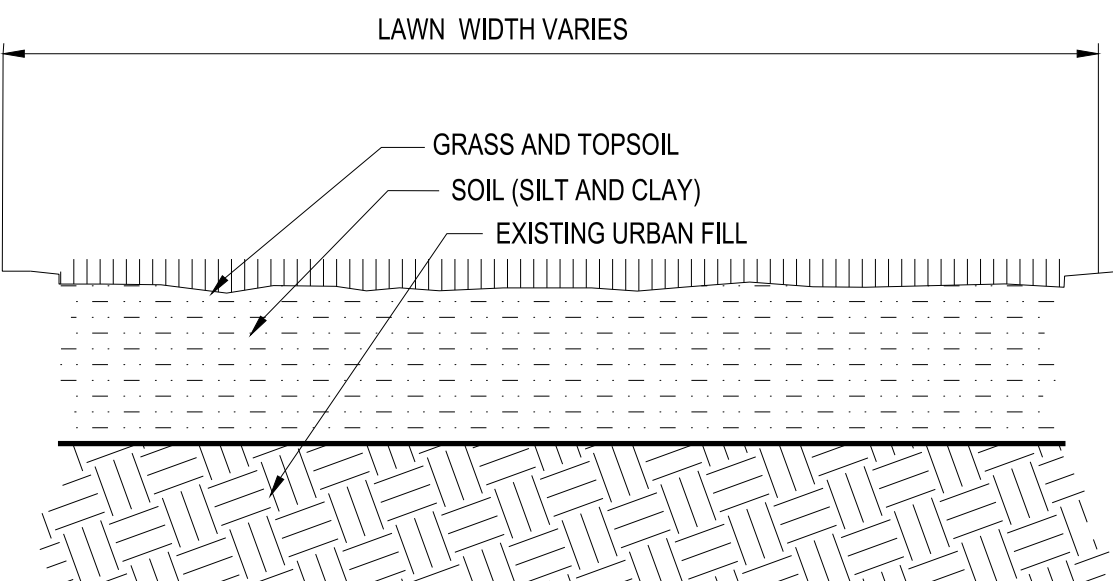
LAWN SECTION
N.T.S.

- SOIL COVER TYPE B
- AREAS NOT COVERED BY HARDSCAPE REQUIRE AT LEAST 2 FEET OF NYSDEC APPROVED MATERIAL ABOVE CONTAMINATED FILL MATERIAL
 - SEE SITE PLAN DETAILS
 - TOTAL AREA = 33,809 SQUARE FEET

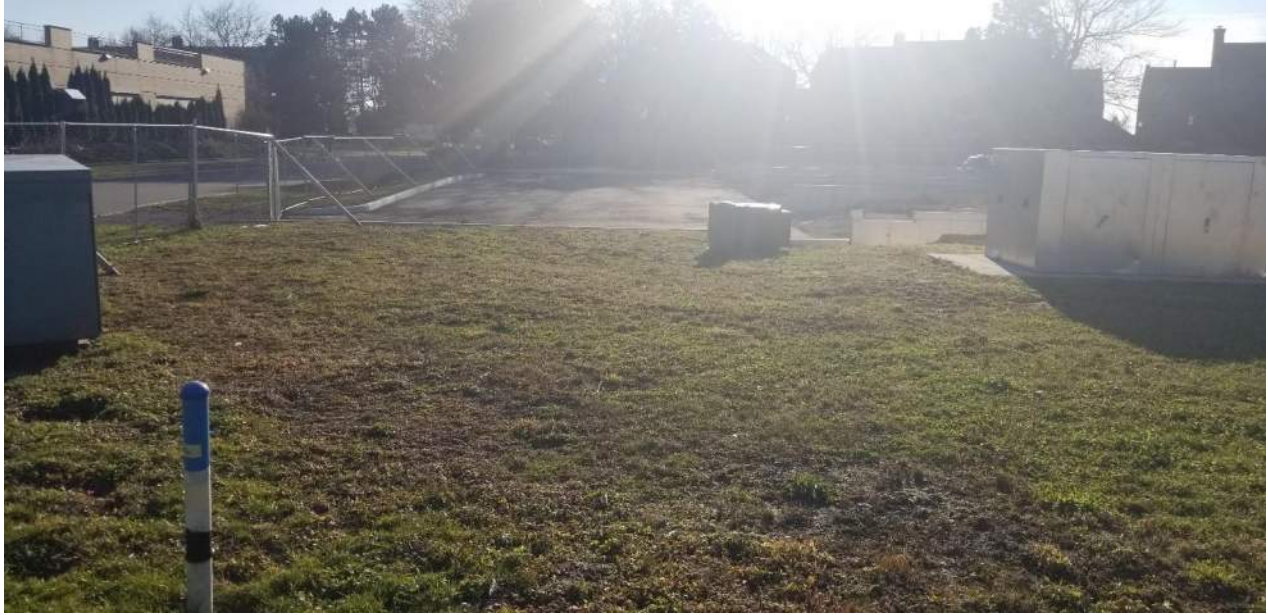
View of Track 4 cover system adjacent to Ojibwa Circle. Showing Soil Cover Type A (hardscape) and Soil Cover Type B (landscape).

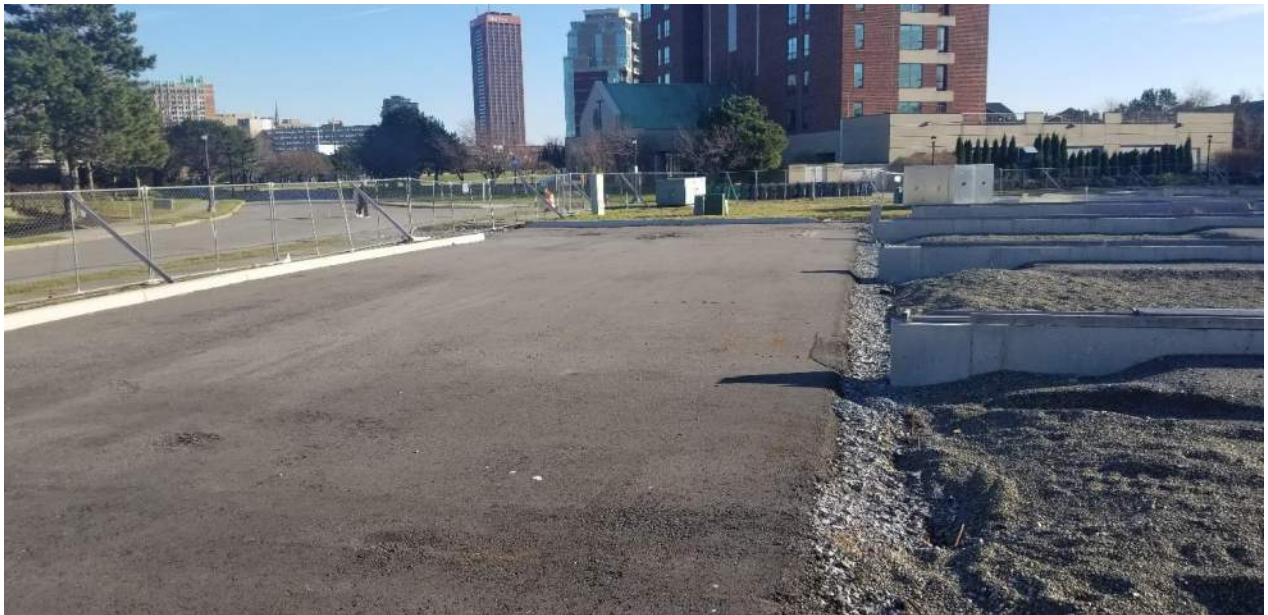
View of Track 4 cover system looking at the corner of Lakefront Boulevard and Ojibwa Circle. Soil Cover Type A and foundations for two future townhome structures.

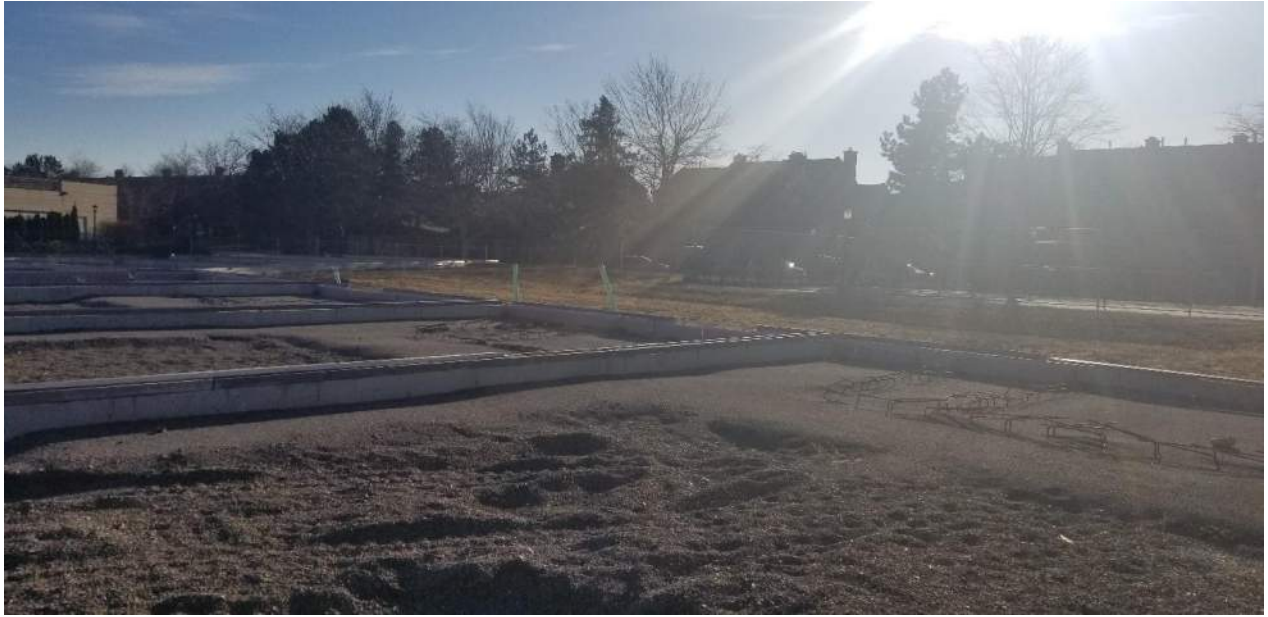
View of the Track 4 cover and foundations for future townhomes.

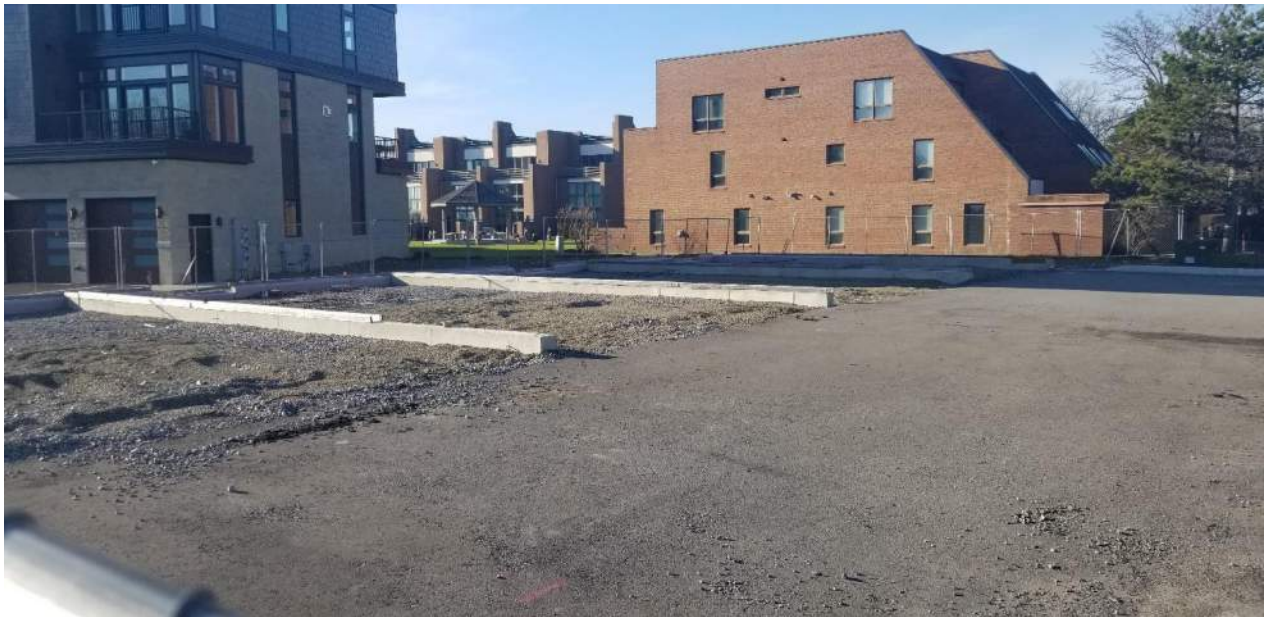
View of the Track 4 cover and foundations for future townhome adjacent to the completed townhome complex (Soil Cover Type A).

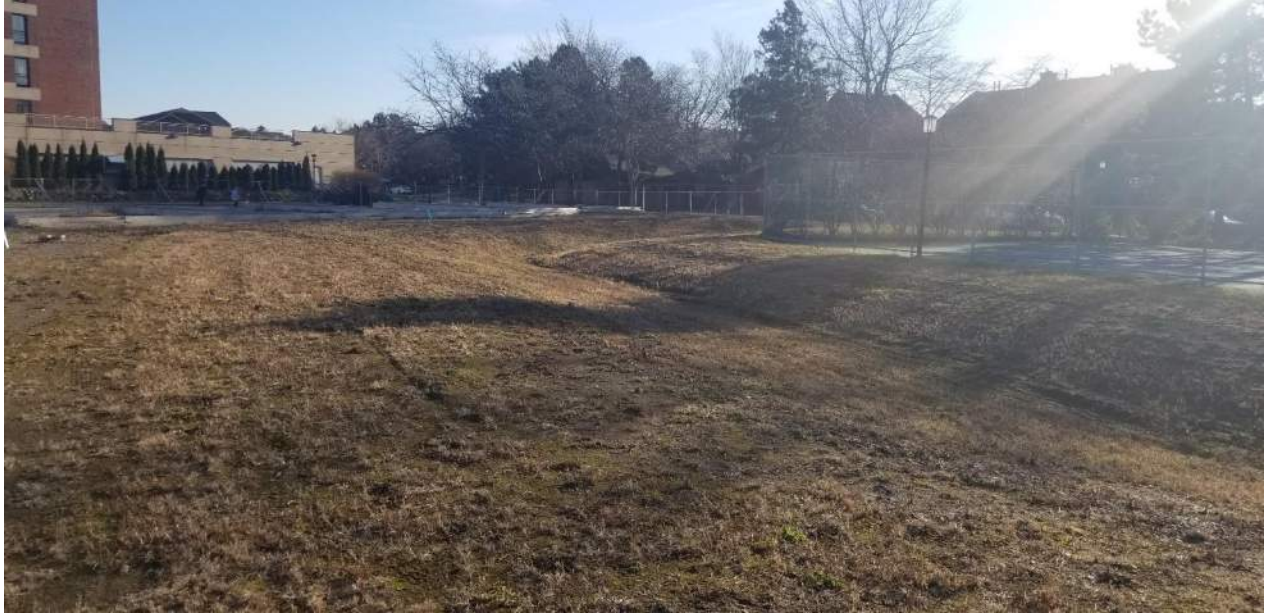
View of the Track 4 Soil Cover Type B along the southwest border. Note existing tennis courts in background.

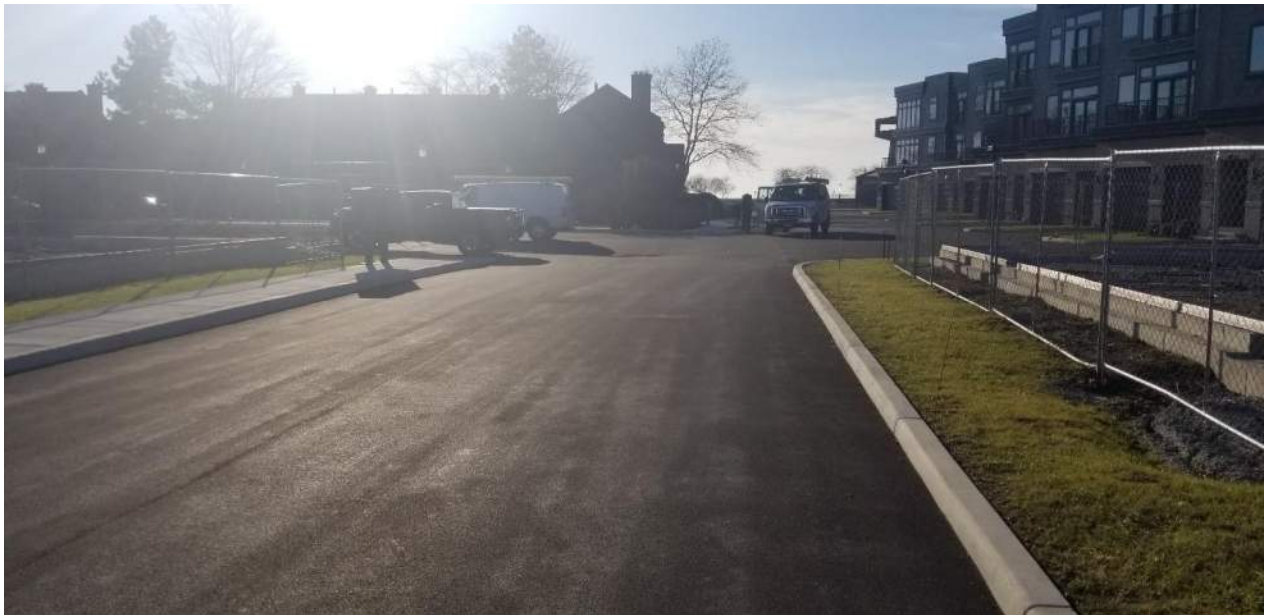
View of the Track 4 cover – driveway (Soil Cover Type A) and landscape areas (Soil Cover Type B).

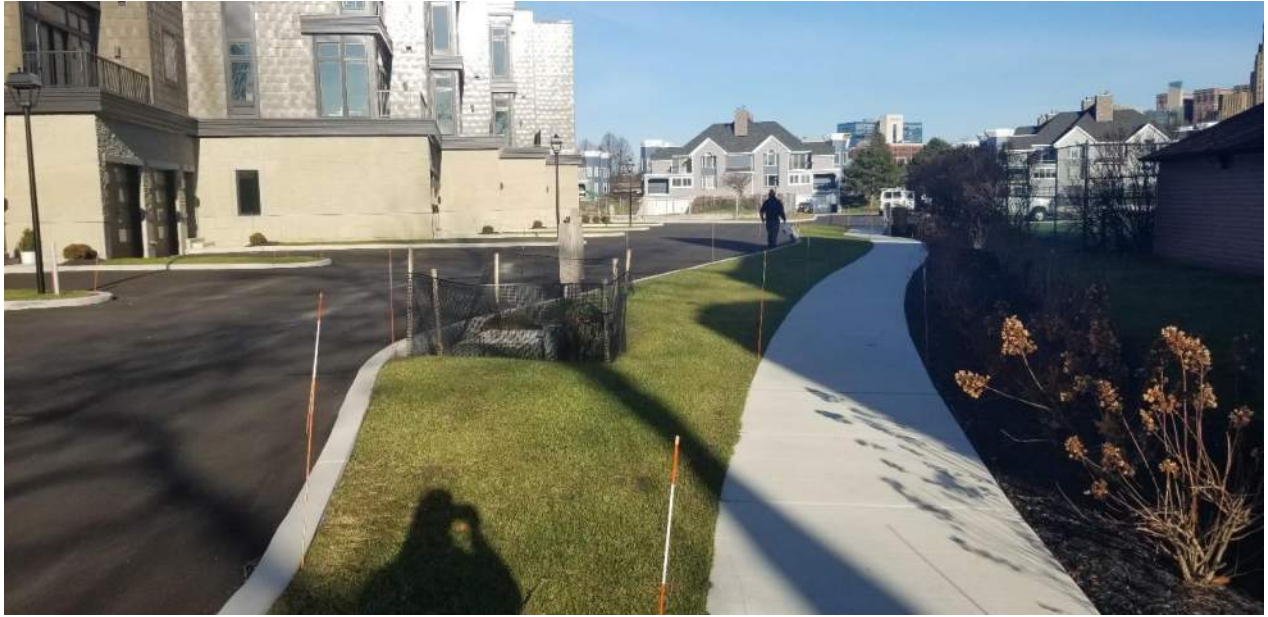
View of the Track 4 cover – driveway (Soil Cover Type A) and landscape areas (Soil Cover Type B).

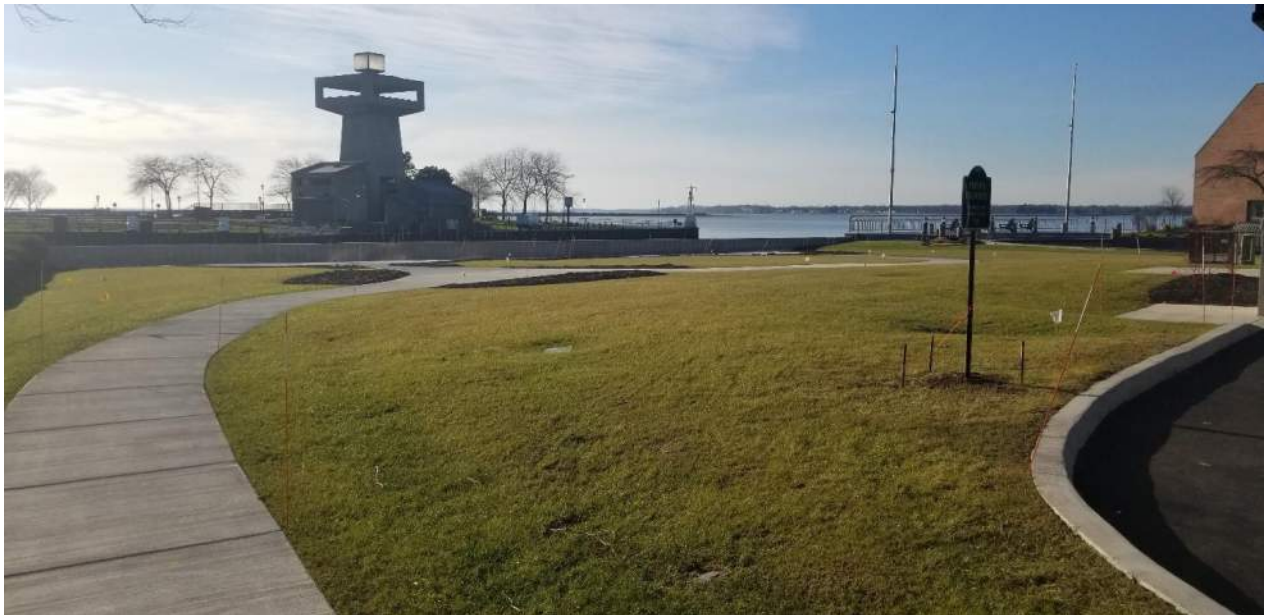
View of the Track 4 cover – driveway (Soil Cover Type A) and landscape areas (Soil Cover Type B).

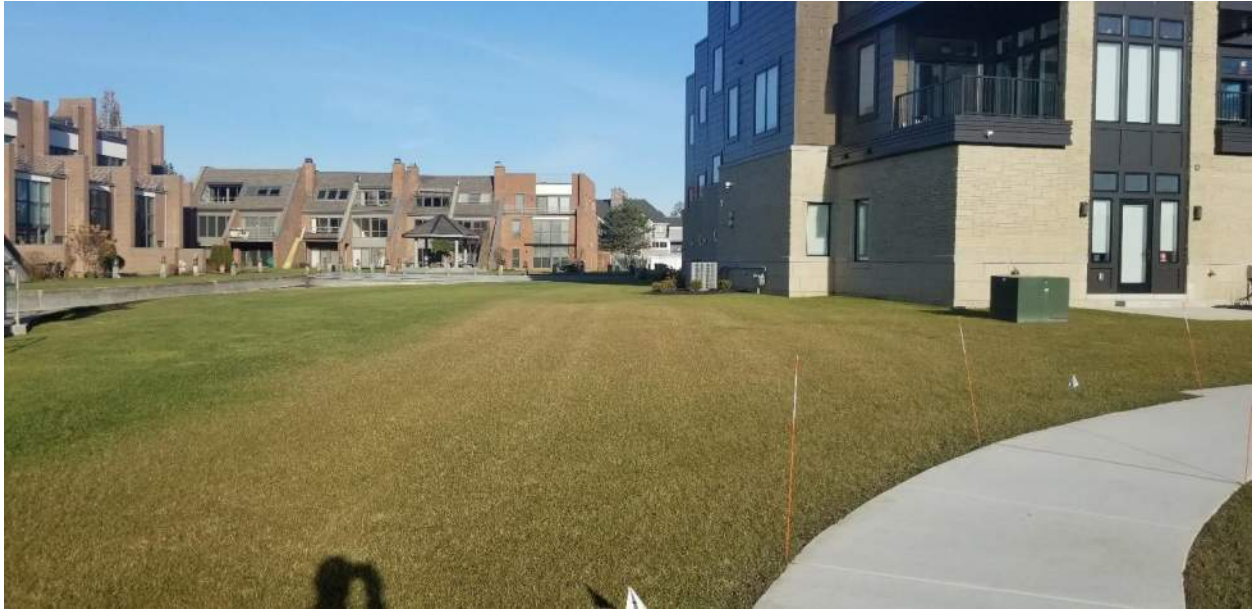
View of the Track 4 cover – driveway (Soil Cover Type A) and landscape areas (Soil Cover Type B).

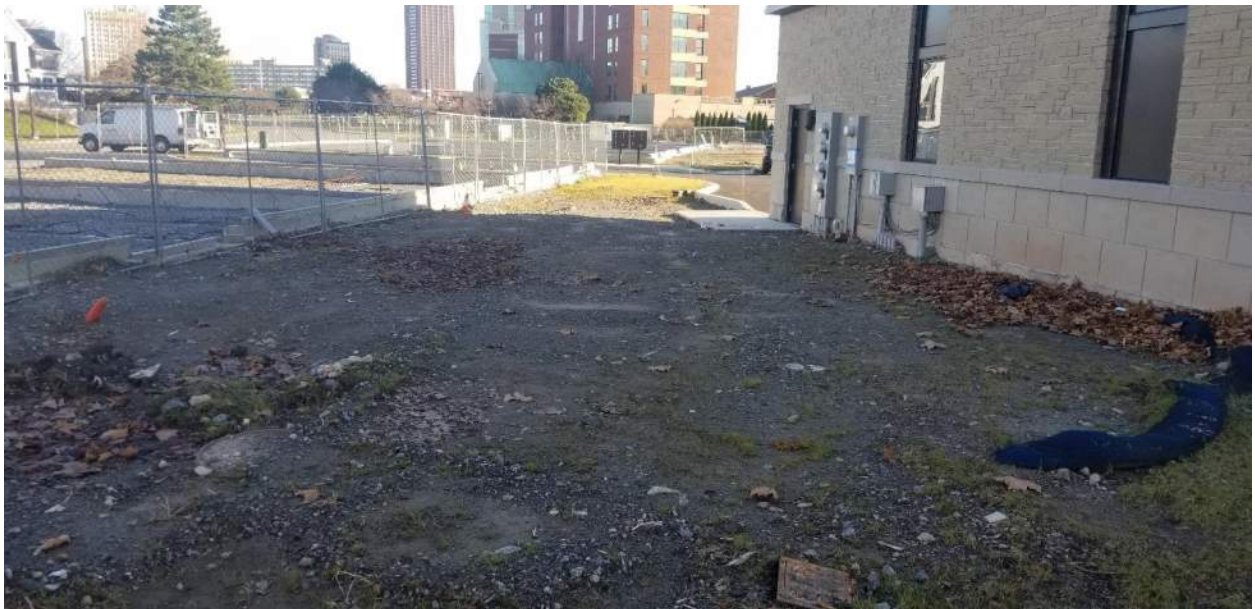
View of the Track 4 cover –landscape areas (Soil Cover Type B) on the east side of the building. Poor grass growth.

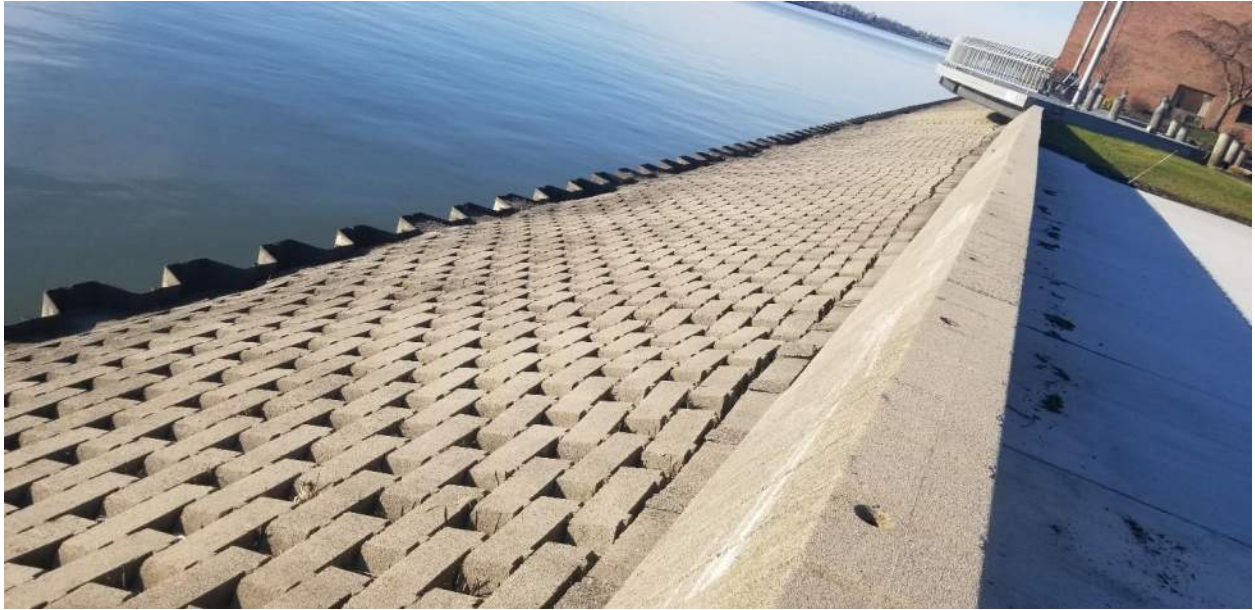
Comments: No. The shoring wall appears to be in good condition.
Inspector's Signature: _____

View of the shoring wall looking north.

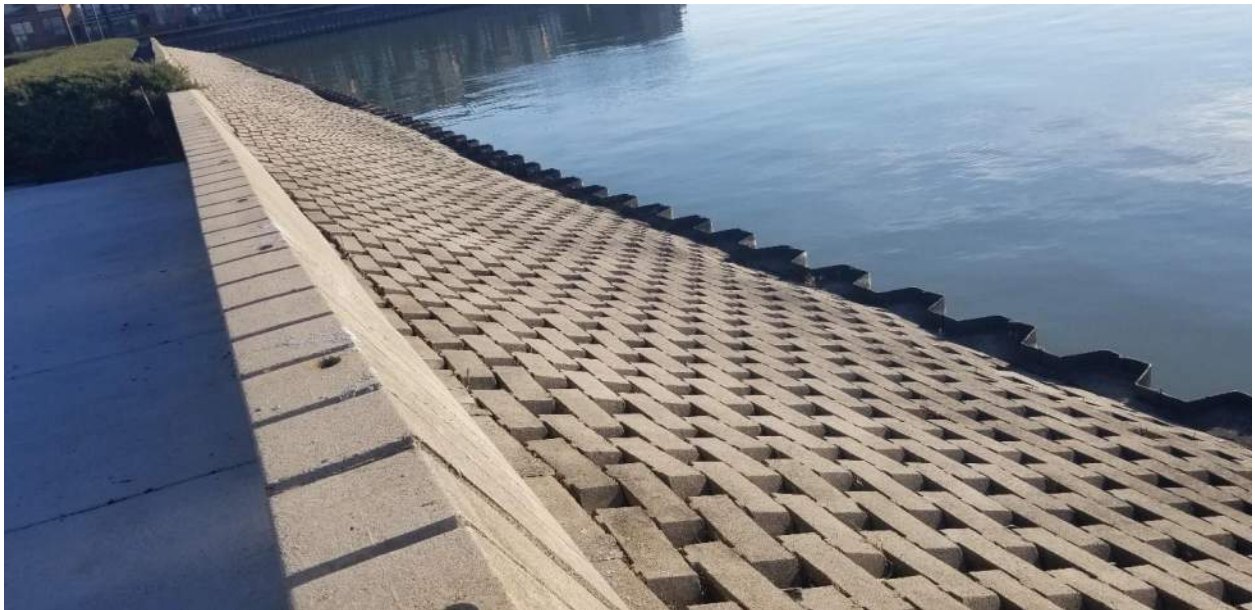
View of the shoring wall looking south.

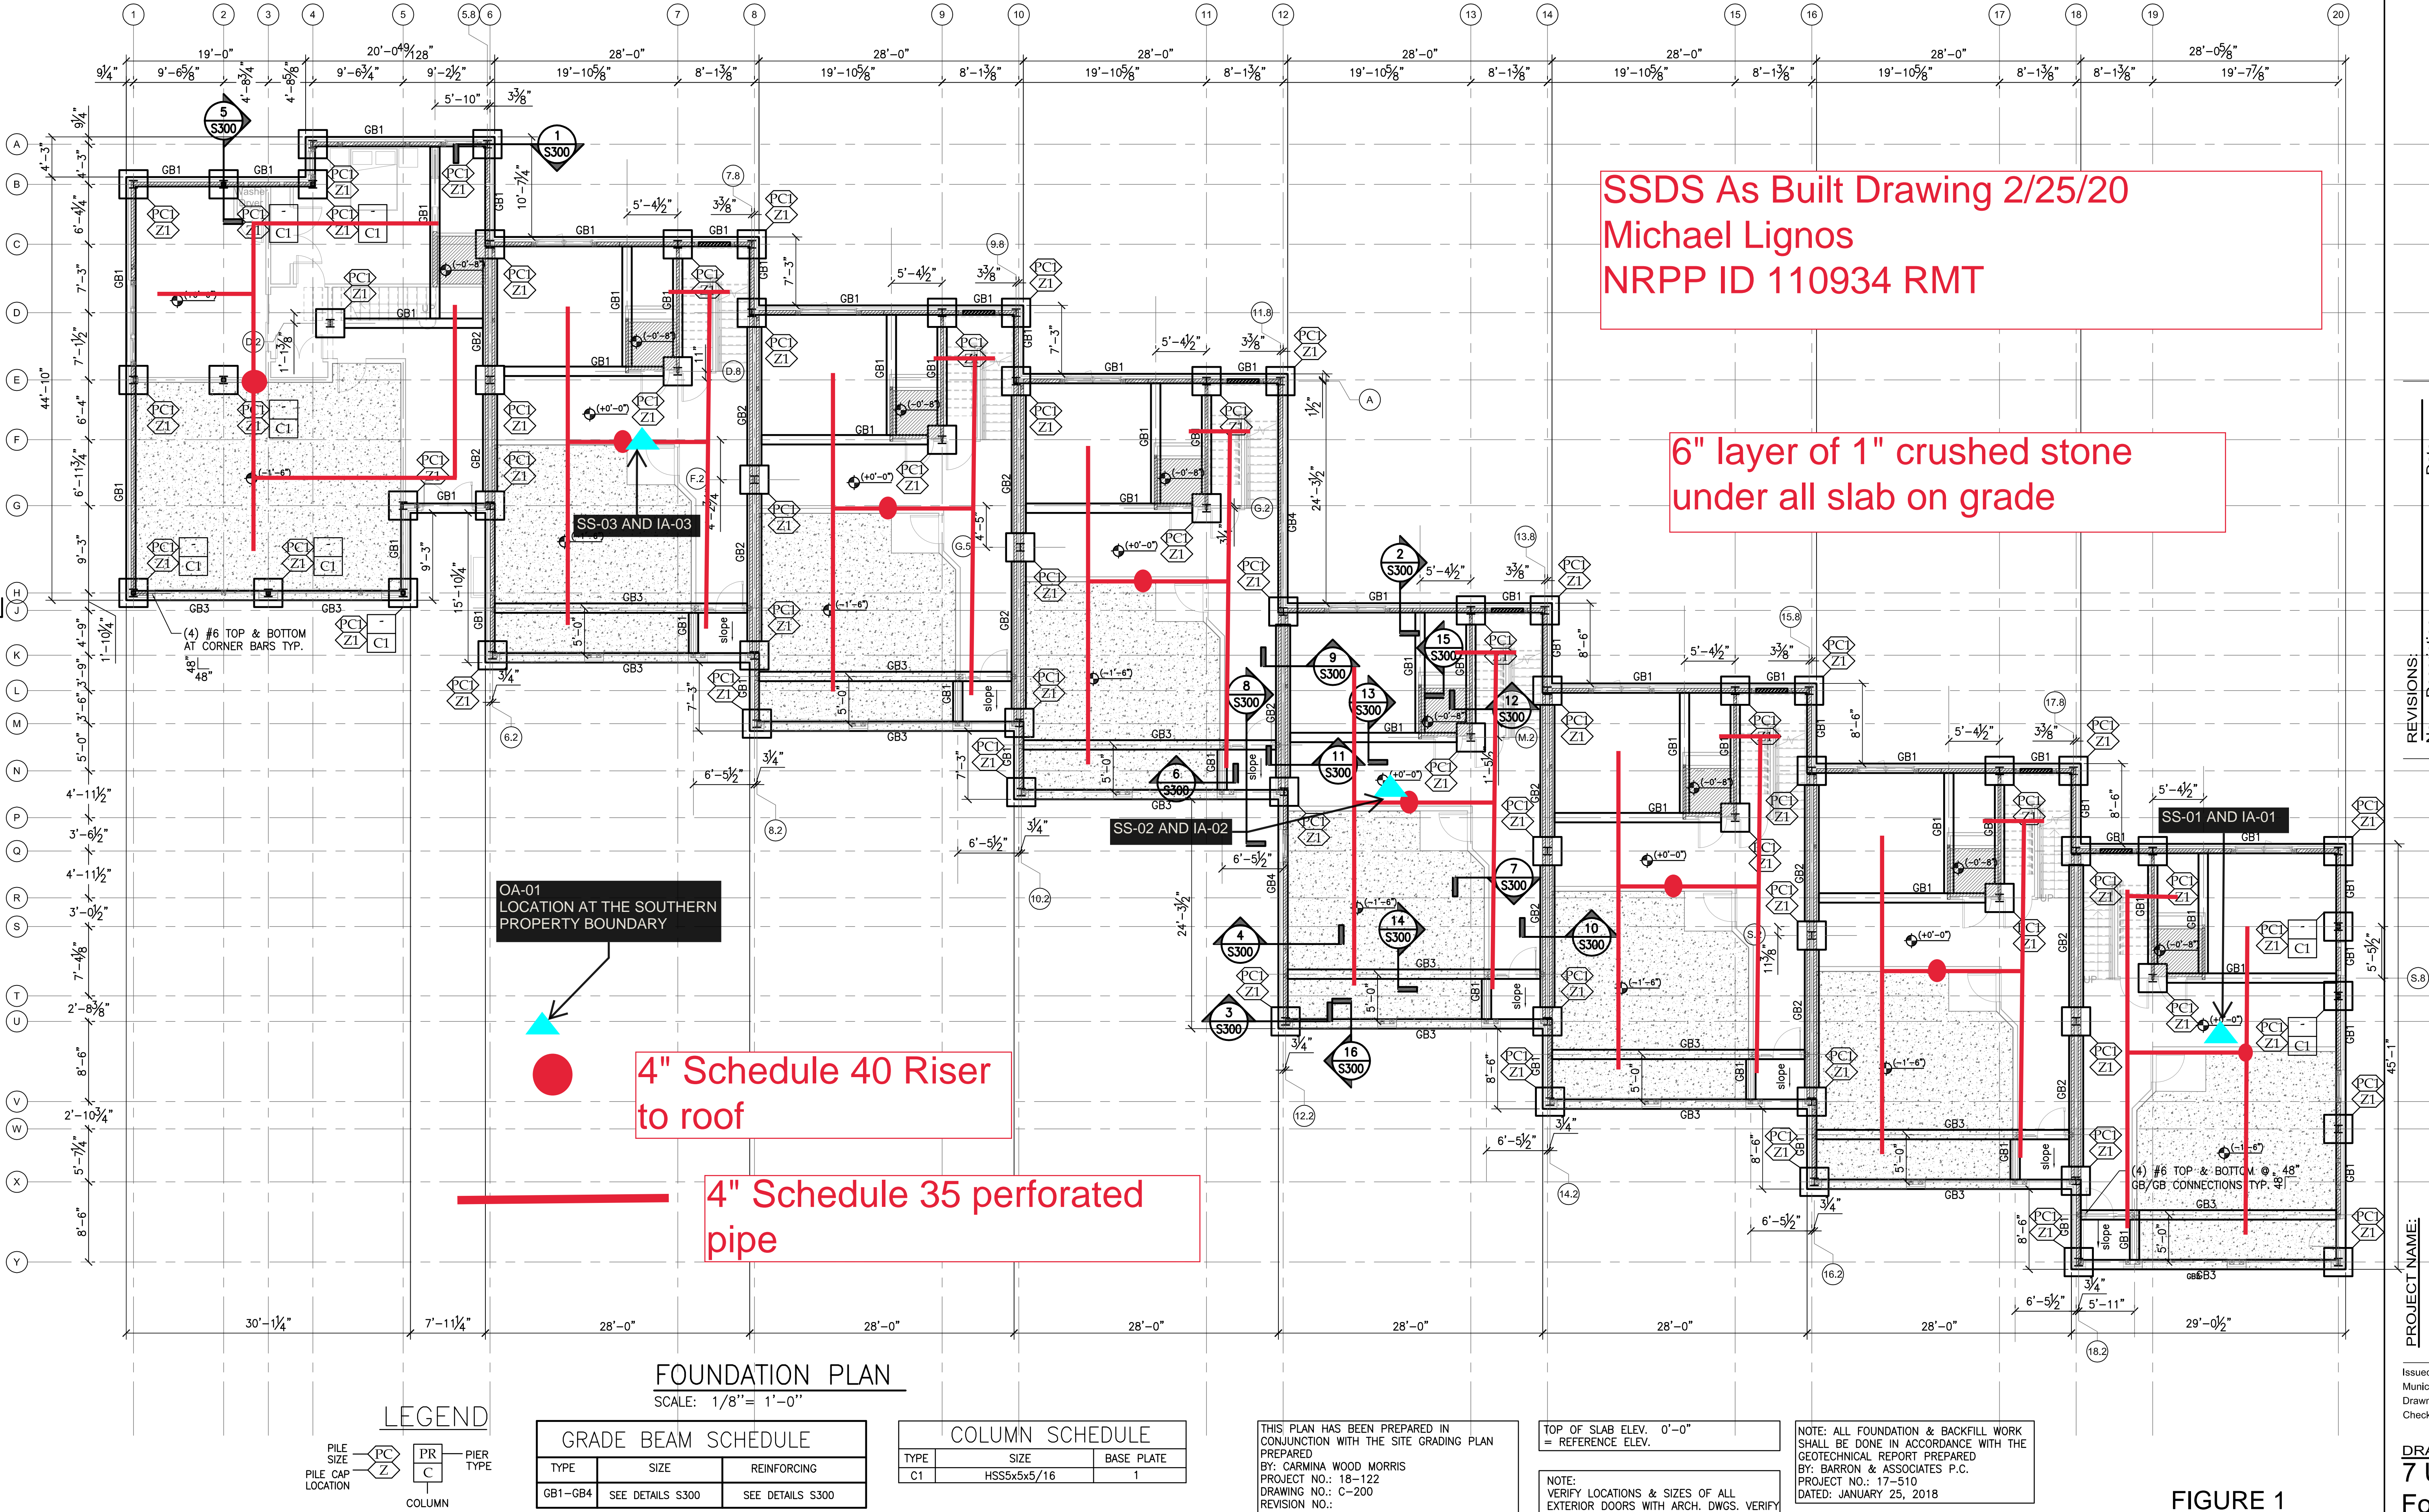
FOUNDATION PLAN
SCALE: 1/8" = 1'-0"

NOTE: ALL FOUNDATION & BACKFILL WORK SHALL BE DONE IN ACCORDANCE WITH THE GEOTECHNICAL REPORT PREPARED BY: BARRON & ASSOCIATES P.C. PROJECT NO.: 17-510 DATED: JANUARY 25, 2018
