Remedial Investigation/Interim Remedial Measures/Alternatives Analysis Work Plan

1155 Main Street Site
Buffalo, New York

January 2019

0481-019-001

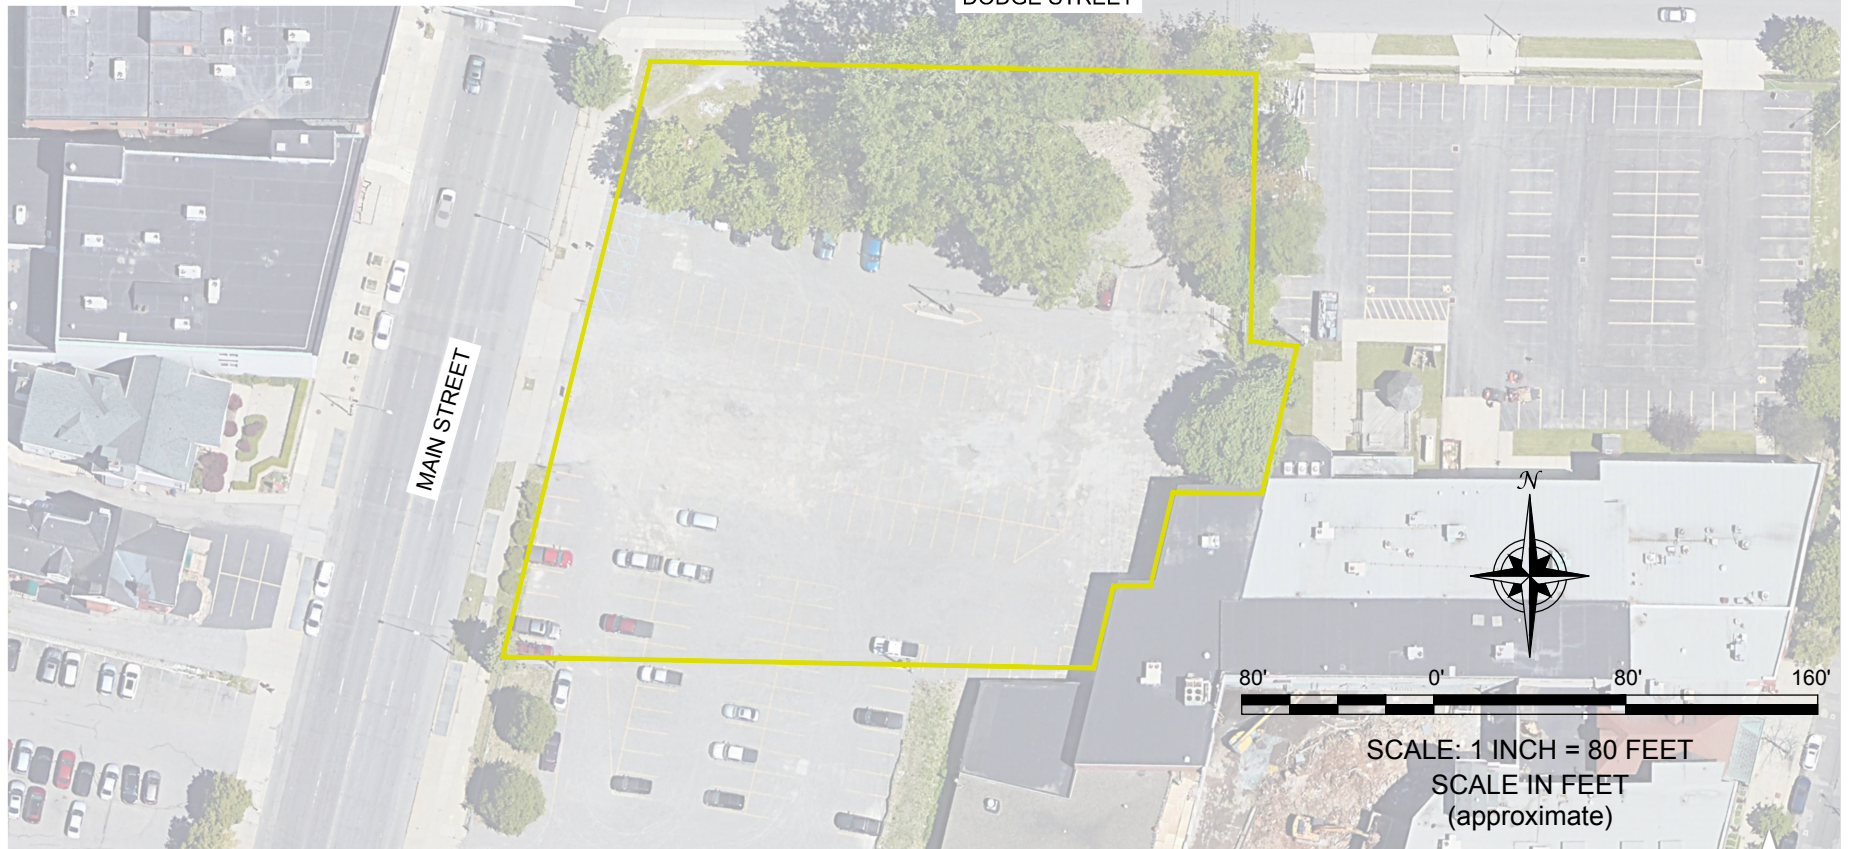
SITE PLAN (AERIAL)

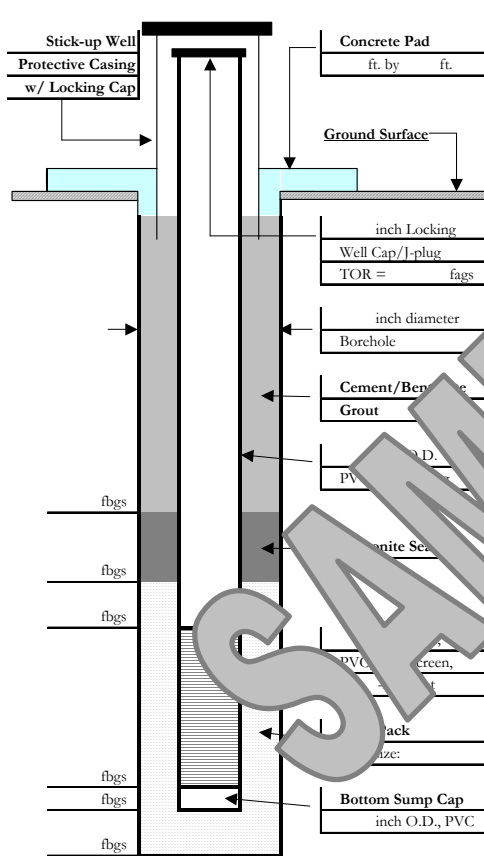
STICK-UP WELL/PIEZOMETER COMPLETION DETAIL

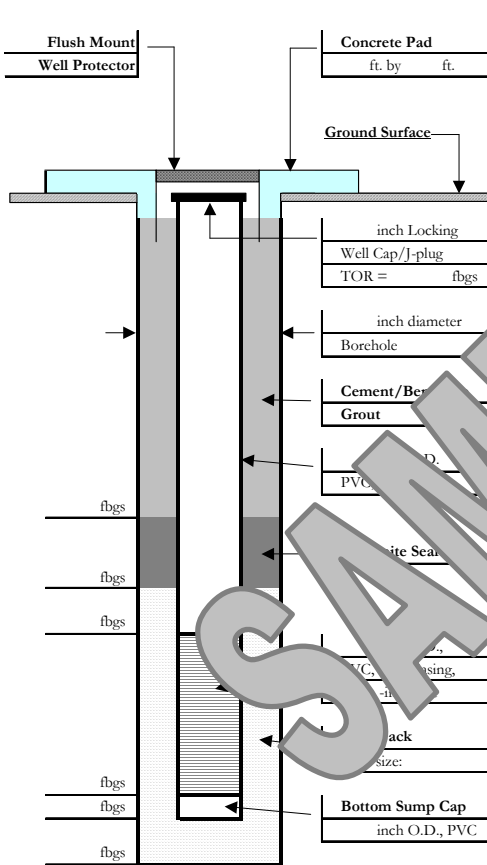
FLUSHMOUNT WELL/PIEZOMETER
COMPLETION DETAIL

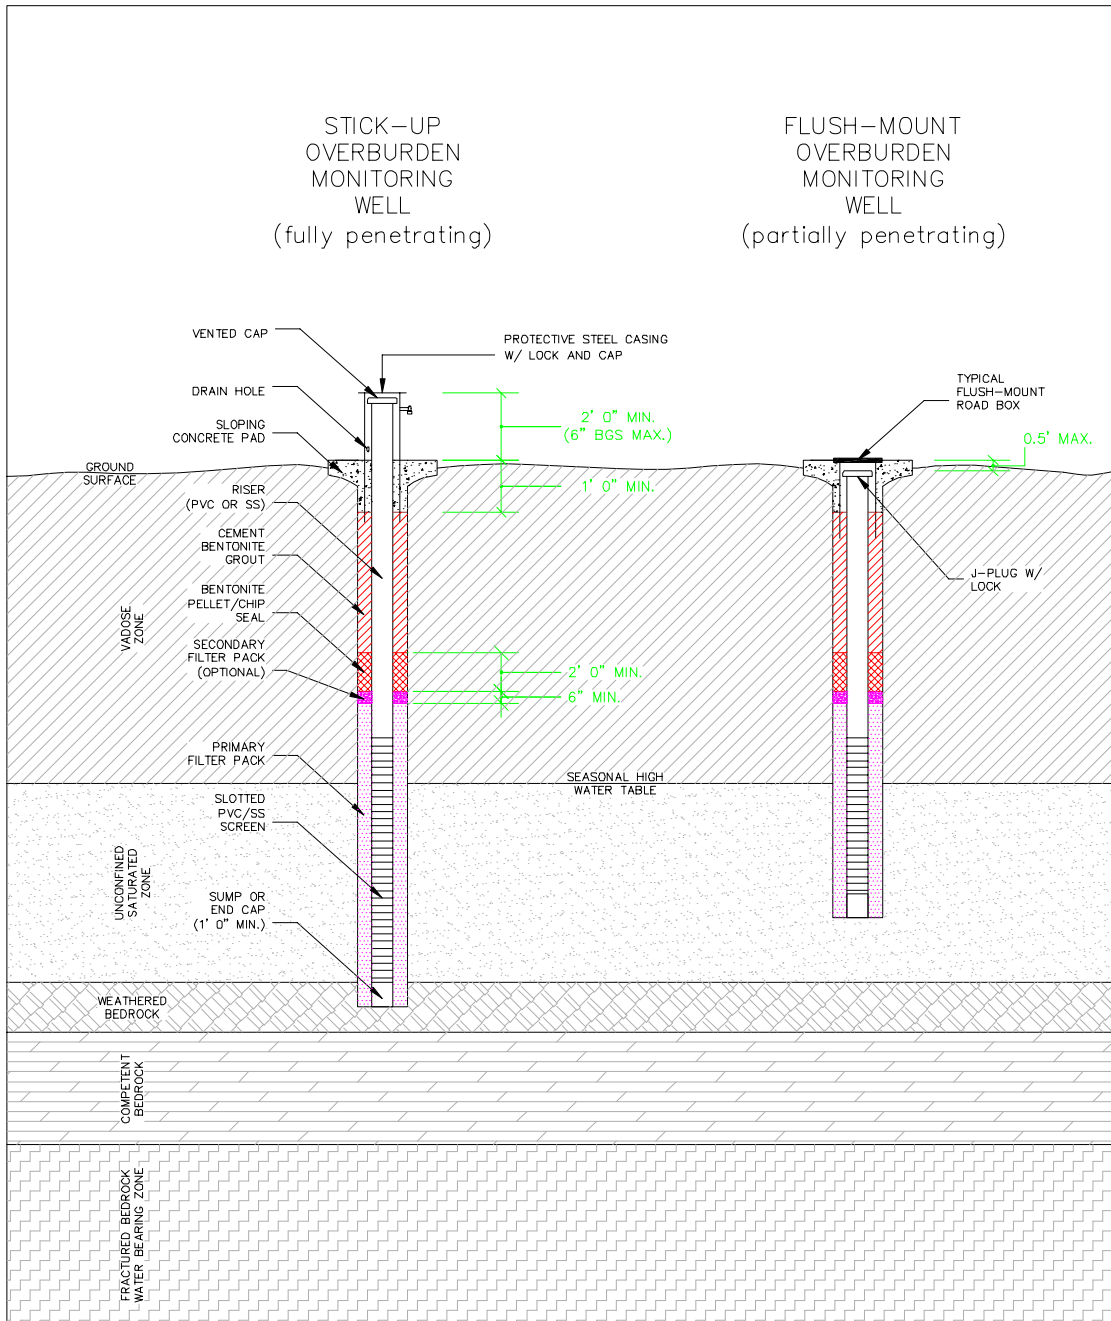
FIGURE 1

MONITORING WELL CONSTRUCTION FOR
HOLLOW STEM AUGER BOREHOLES

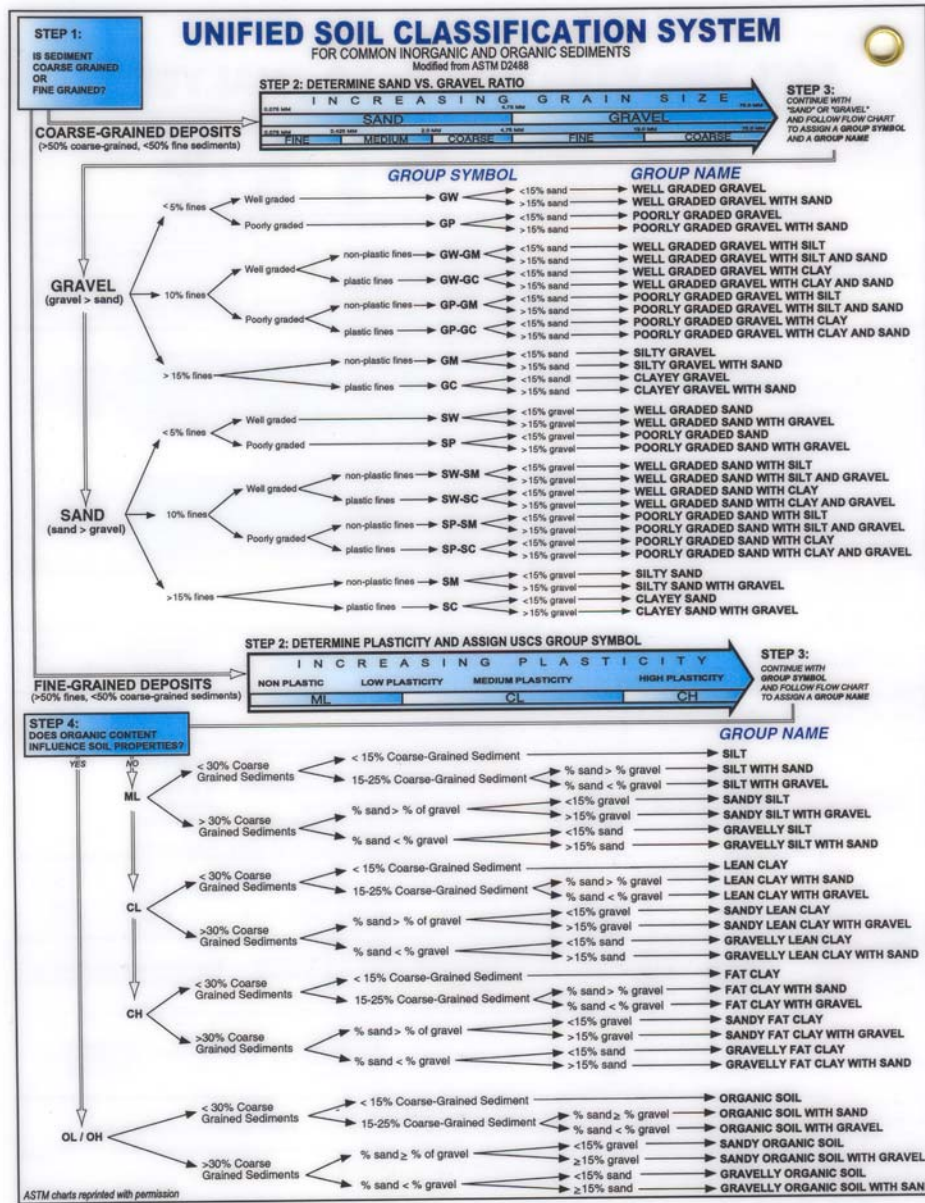
FIGURE 2

USCS SOIL CLASSIFICATION FLOW CHART
(MODIFIED FROM ASTM D2488)

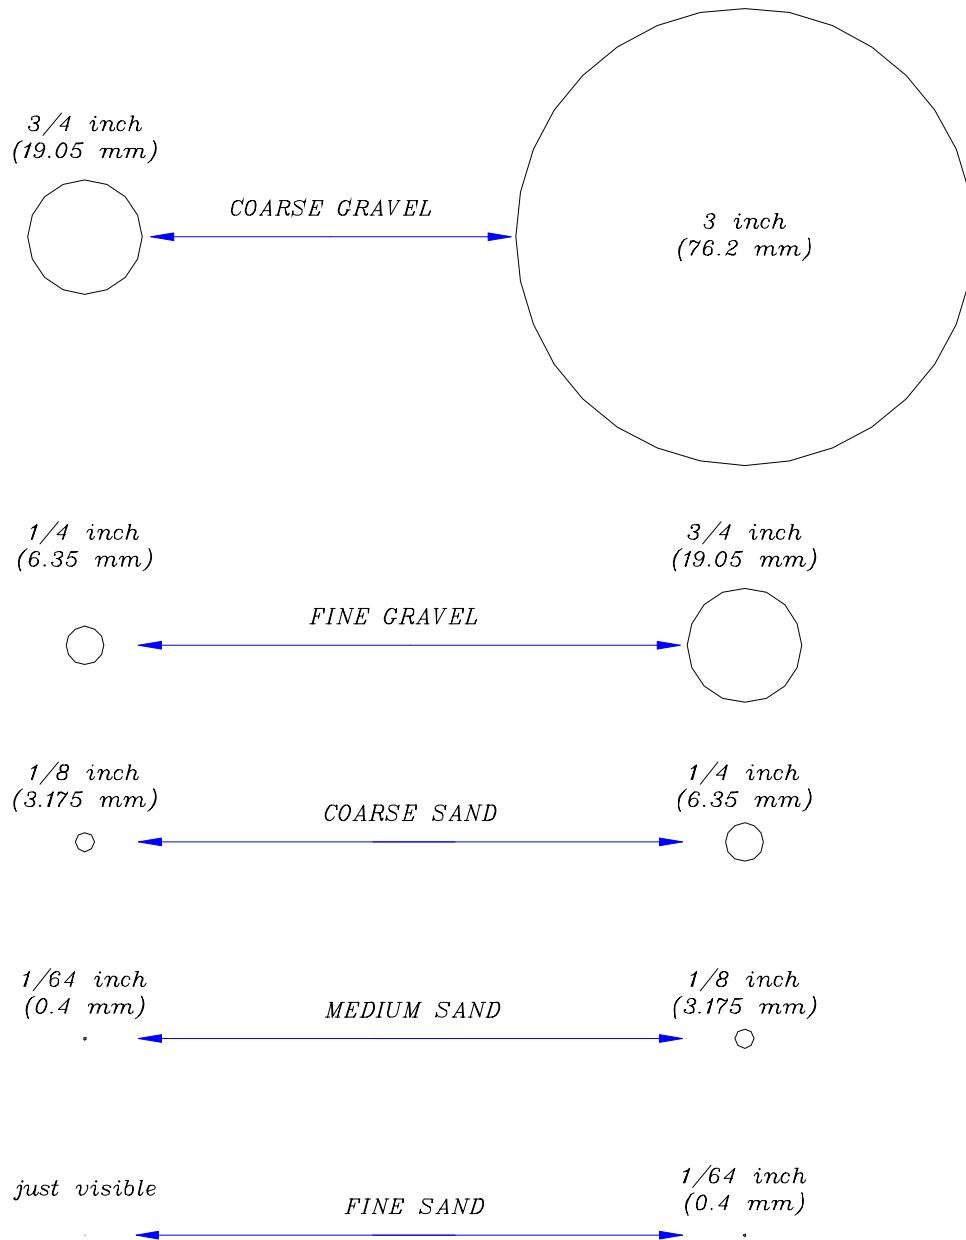
FIGURE 3

ILLUSTRATION OF PARTICLE SIZES

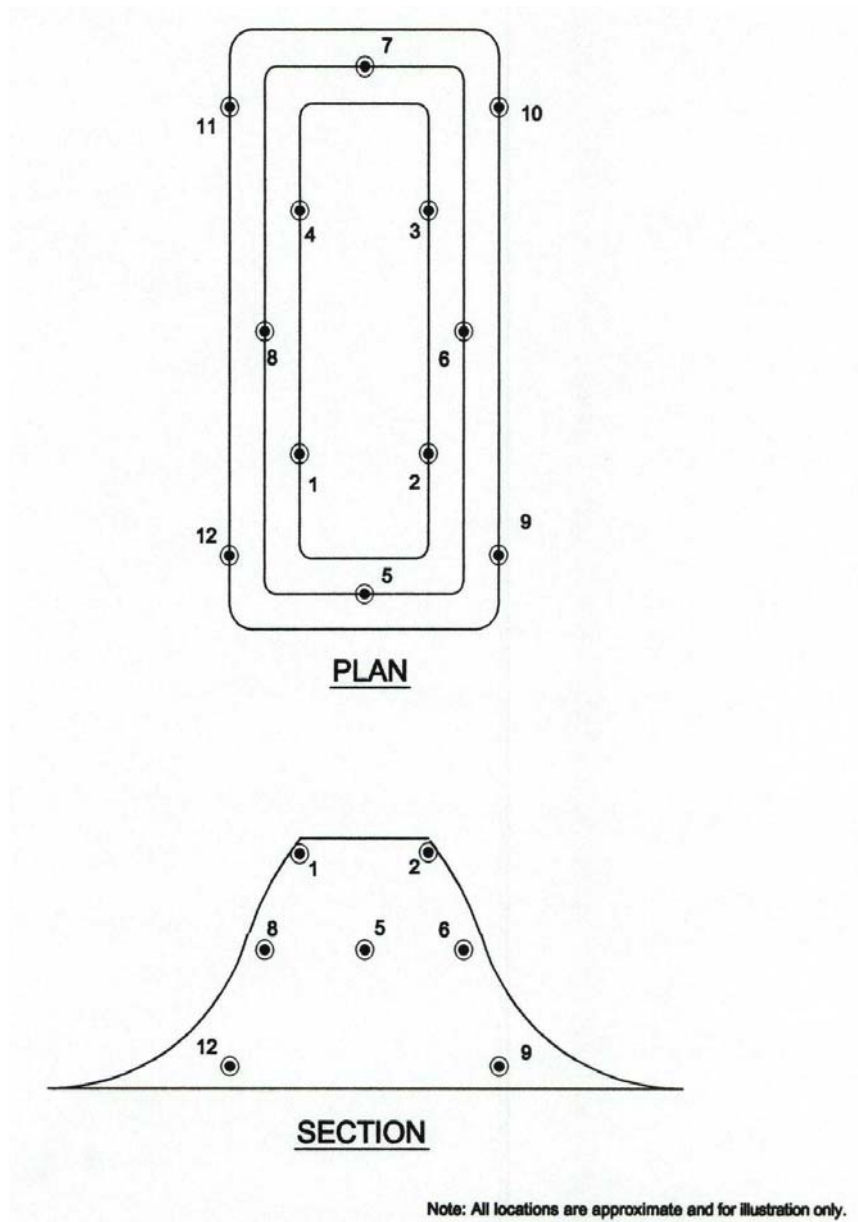
FIGURE 4
1,000 CY STOCKPILE SAMPLING METHODOLOGY

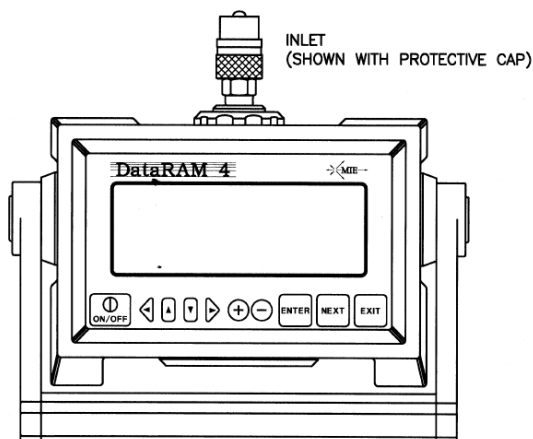
FIGURE 1. FRONT-PANEL VIEW OF DataRAM

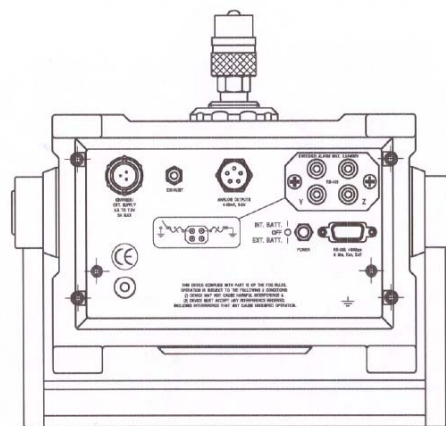
FIGURE 2. BACK-PANEL VIEW OF DataRAM

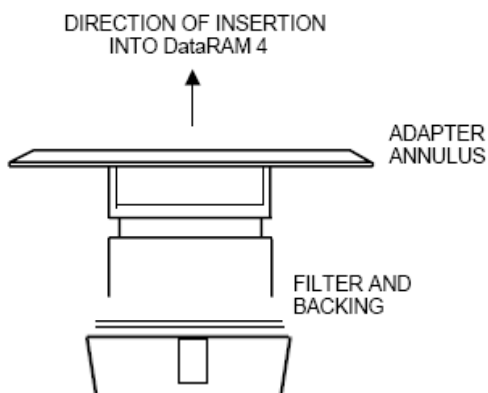
In order to remove and/or to replace the membrane filter within its holder, remove the gray plastic adapter annulus and separate (pry apart) the two transparent plastic rings that compress the membrane filter. Make sure to remove and replace only the membrane filter (using tweezers), leaving the white backing disc in the holder. A new membrane filter should then be placed over that backing and the sealing ring should then be inserted to trap and compress the filter and backing discs. For storage, the inlet cap with the blue plug should be inserted as well as the red plug on the back of the filter holder.

Analytical filter holder with adapter annulus inserted

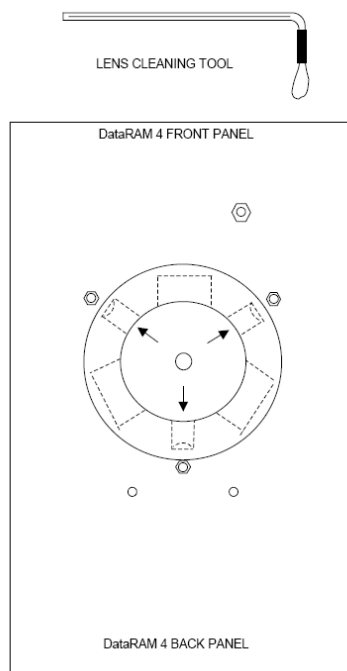
- Place the DataRAM 4 right side up and key ON. Proceed to check its optical background by running the ZERO/INITIALIZE check as. The message READY! should appear at the end of this check indicating that the lens contamination has been eliminated. Should the message BACKGROUND HIGH persist after completion of the above-described lens cleaning procedure, please contact the factory.

Lens cleaning tool and bottom view of open filter cavity showing location of sensor chamber lens cavities (arrows).
