## Lakeside Village Apartments 65-67 Lake Avenue Erie County Lancaster, New York

#### FINAL ENGINEERING REPORT

**NYSDEC Site Number: C915344**

# Prepared by: TATRIX ENVIRONMENTAL TECHNOLOGIES INC. 3730 California Road

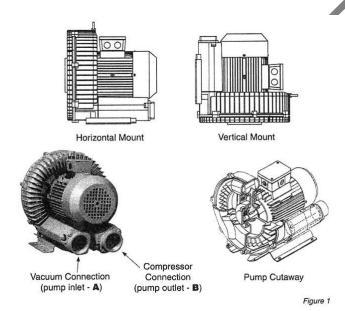
1. For vacuum operation, connect the suction pipe to connection A, and for pressure operation connect the pressure pipe to connection B (See Figure 1). Install startup screens before startup to protect pump from debris.

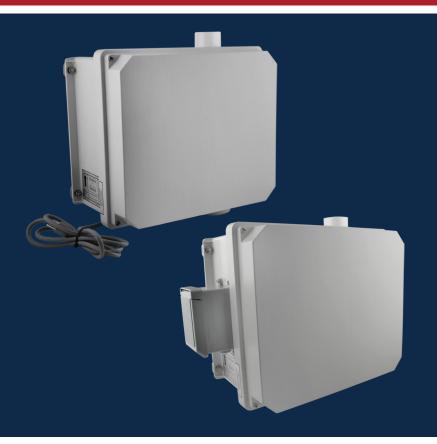
# **HS Series**

# **Radon Mitigation Fan**

HS fans offer a proven solution for tough radon mitigation jobs, providing up to 25 times the suction of inline tube fans to deal with sand, tight soil or clay sub-slab material.
