# ENVIRONMENTAL SITE ASSESSMENT

PILGRIM VILLAGE  
1100 MICHIGAN AVENUE  
BUFFALO, NEW YORK

March 2020

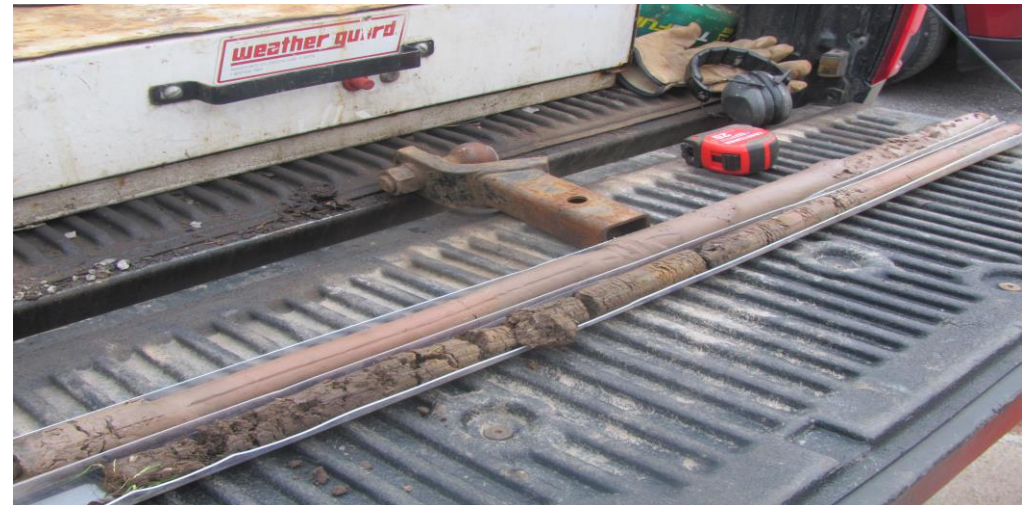
- BH-1 at 0-2 feet bgs. Total depth of boring was 8 feet bgs into native reddish-brown clay. Fill was observed to 2.5-foot bgs
- BH-2 at 0.5-1.5 feet bgs. Total depth of boring was 8 feet bgs into native reddish-brown clay. Fill was observed to 1.5-foot bgs

4. Soil cores BH-1

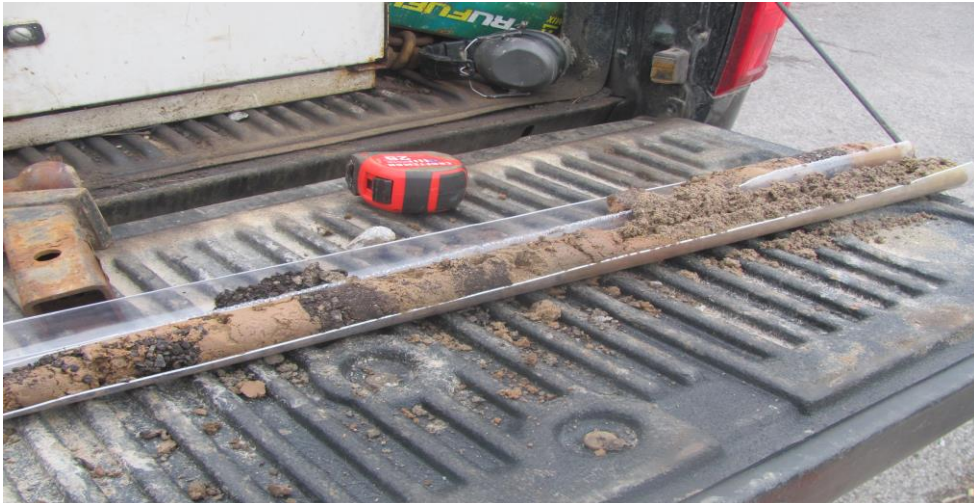
7. Soil cores from BH-2

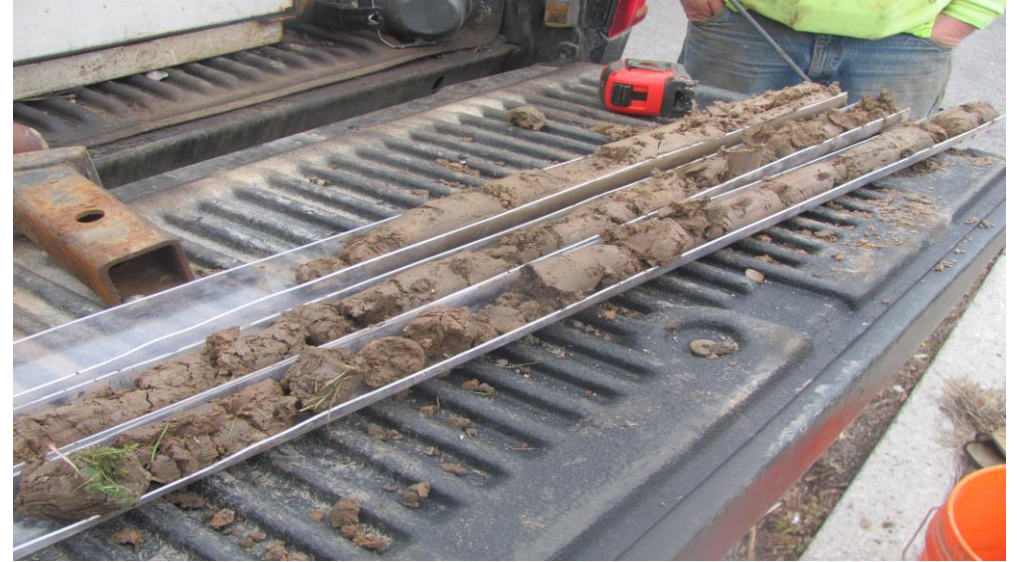
- BH-3 at 1-3.5 feet bgs. Total depth of boring was 12 feet bgs into native reddish-brown clay. Fill was observed to 3.5-foot bgs
- BH-4 at 1-3.5 feet bgs. Total depth of boring was 8 feet bgs into native reddish-brown clay. Fill was observed to 4-foot bgs

10. Soil cores from BH-3

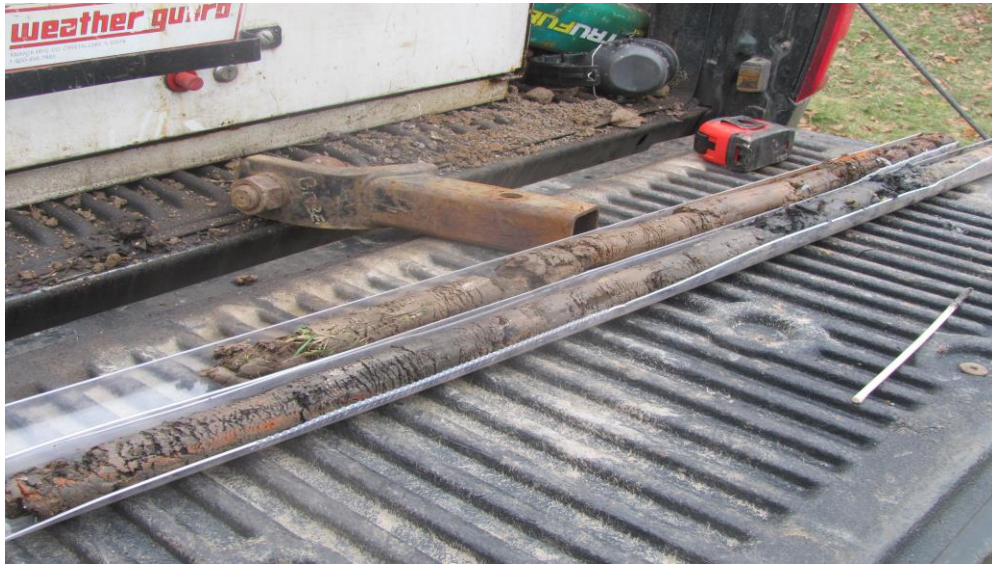
13. Soil cores from BH-4

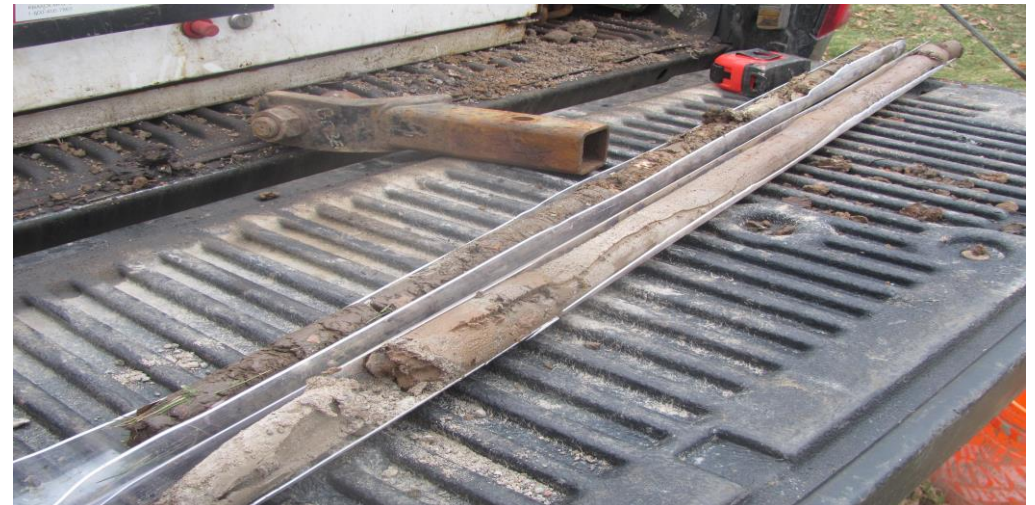
- BH-5 at 1-2 feet bgs. Total depth of boring was 8 feet bgs into native reddish-brown clay. Fill was observed to 4-foot bgs
- BH-6 at 1-2.5 feet bgs. Total depth of boring was 12 feet bgs into native reddish-brown clay. Fill was observed to 4-foot bgs

16. Soil Cores from BH-5

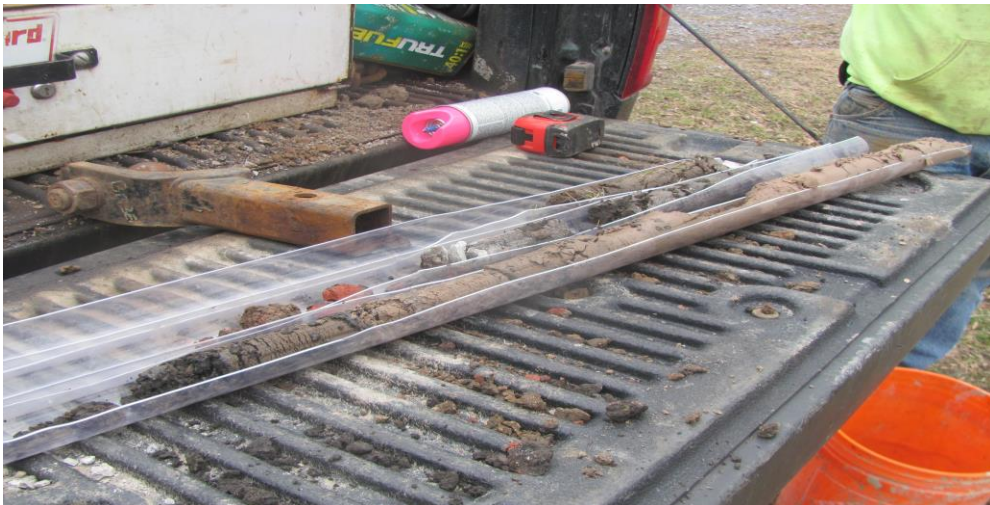
19. Soil cores from BH-6

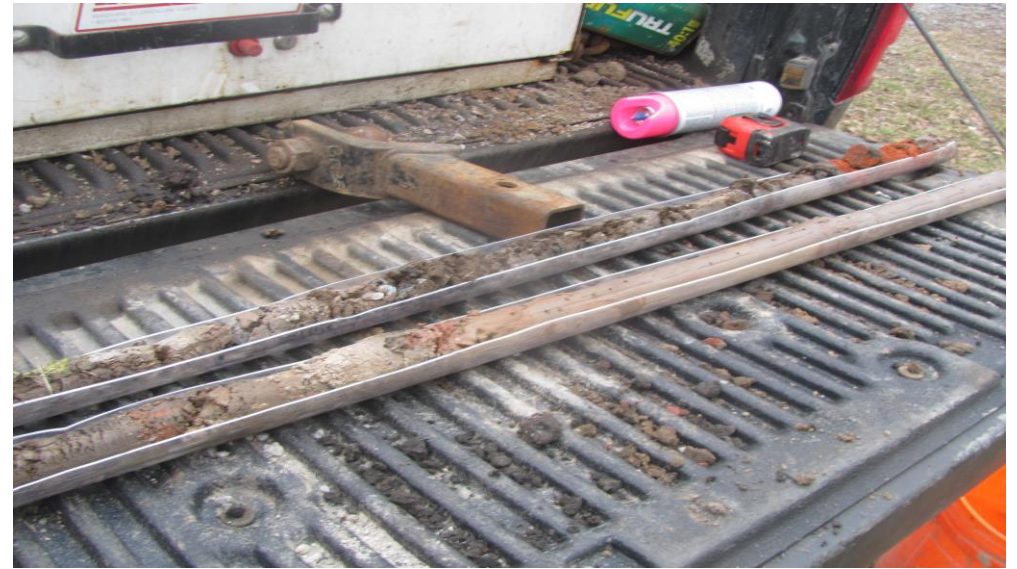
- BH-7 – No soil sample collected. Total depth of boring was 8 feet bgs into native reddish-brown clay. Fill was observed to 3.5-foot bgs
- BH-8 at 1-2.5 feet bgs. Total depth of boring was 8 feet bgs into native reddish-brown clay. Fill was observed to 3-foot bgs

22. Soil cores from BH-7

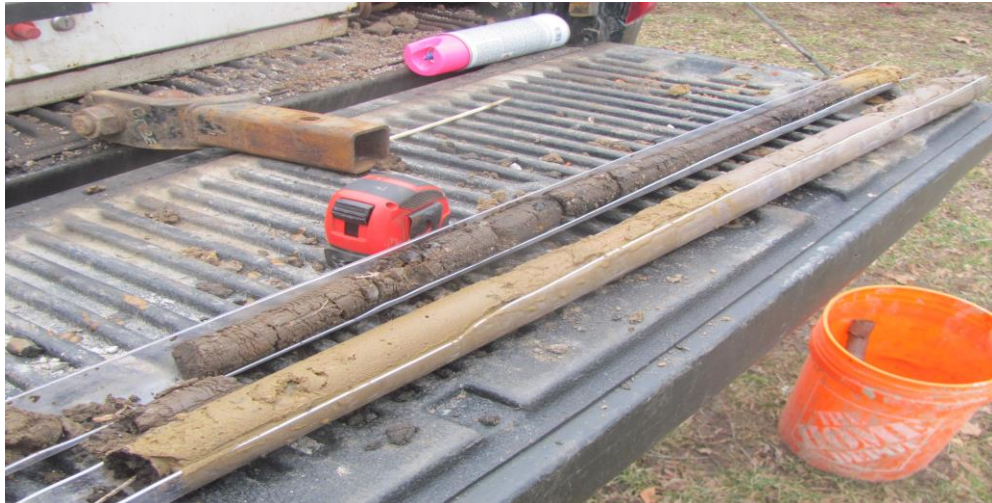
- BH-9 No soil sample collected. Total depth of boring was 8 feet bgs into native reddish-brown clay. Fill was observed to 3.5-foot bgs
- BH-10 at 0.5-2 feet bgs. Total depth of boring was 8 feet bgs into native reddish-brown clay. Fill was observed to 2-foot bgs

27. Soil cores from BH-9

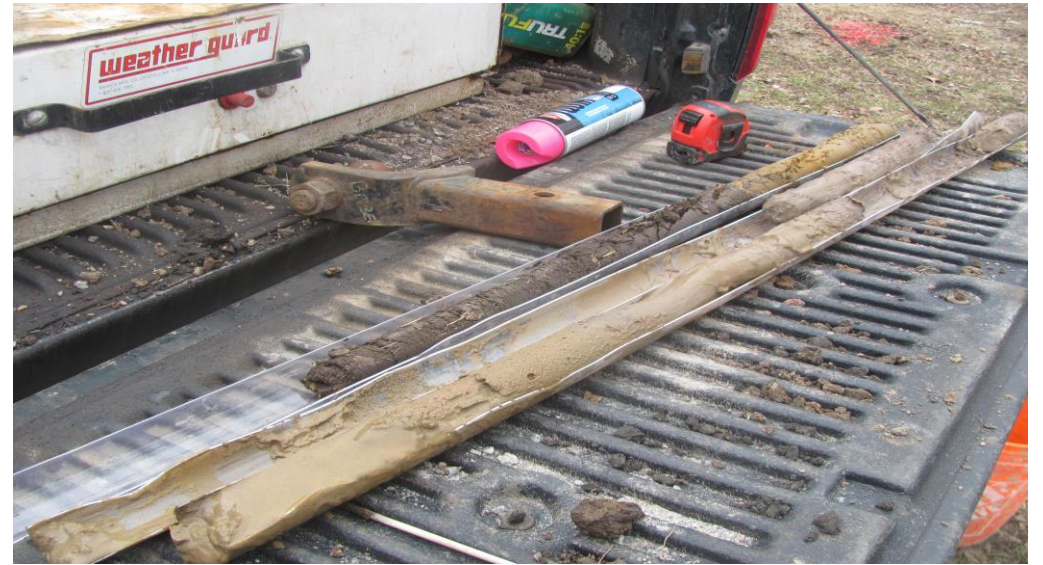
30. Soil cores from BH-10

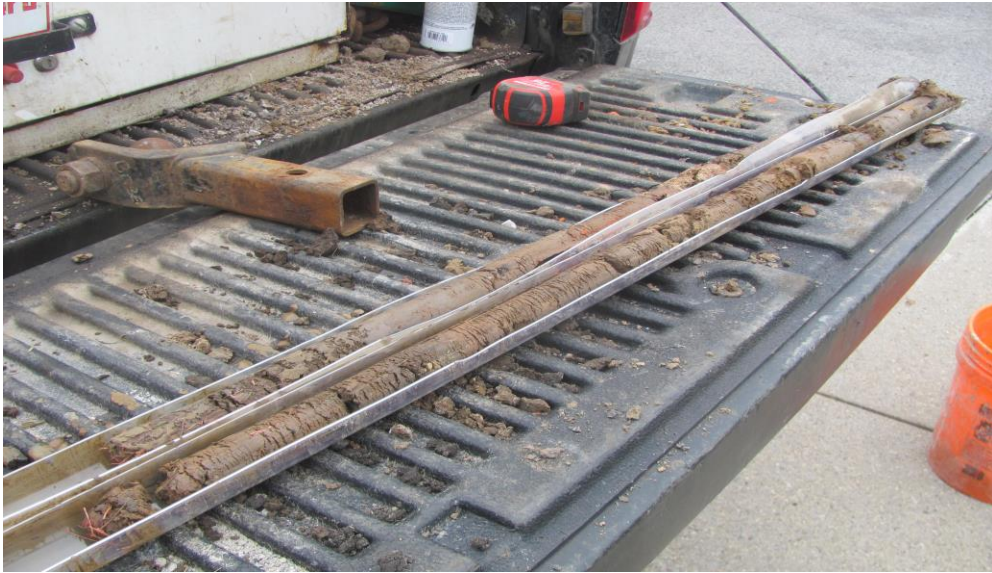
- BH-11 at 0.5-1.5 feet bgs. Total depth of boring was 8 feet bgs into native reddish-brown clay. Fill was observed to 4-foot bgs
- BH-12 – No soil sample collected. Total depth of boring was 8 feet bgs into native reddish-brown clay. Fill was observed to 4-foot bgs

33. Soil cores from Borehole BH-11

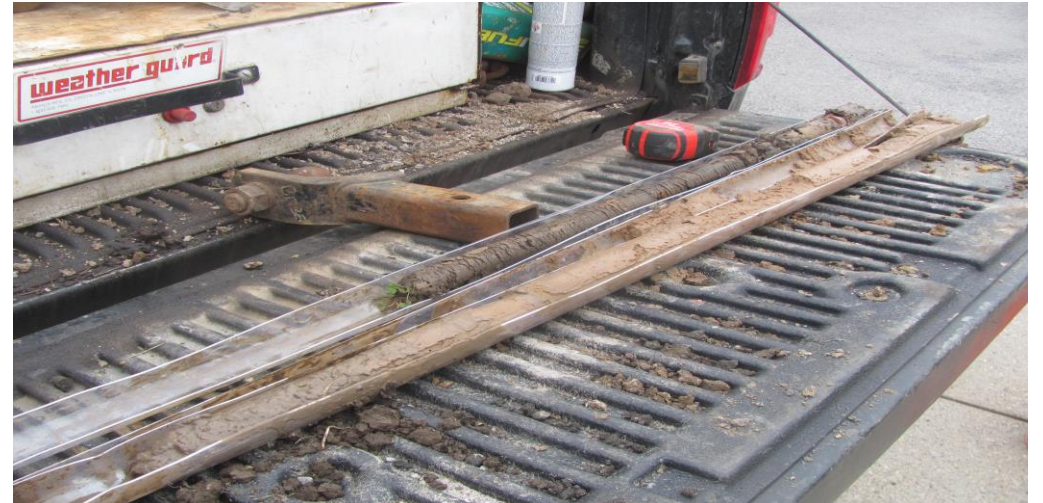
36. Soil cores from BH-12

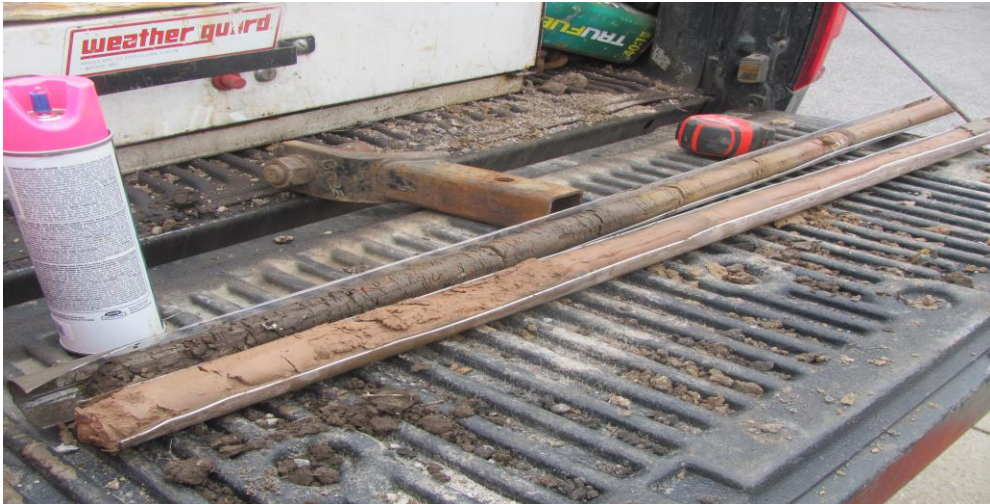
- BH-13 at 0.5-1.5 feet bgs. Total depth of boring was 8 feet bgs into native reddish-brown clay. Fill was observed to 2-foot bgs

39. Soil cores from BH-13
