Phase II Environmental Investigation Report

1095 Niagara Street Site Buffalo, New York

June 2008

0136-012-100

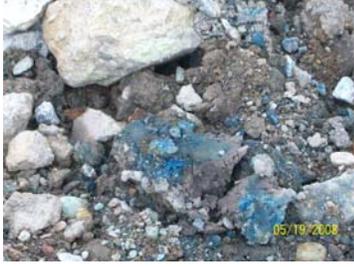
Sample Location	Rationale	Photo
SB-1 through SB-9	Subsurface soil characterization-historic metal plating facility	(none)
SS-1	Dark blue colored soils

A photograph showing a soil sample with a distinct dark blue color. The soil is surrounded by rocks and debris. A yellow timestamp '05/19/2008' is visible in the bottom right corner.
SS-2	Tan colored soils

Six (6) surface soil samples (SS-1 through SS-6) were analyzed for RCRA metals plus cyanide. As indicated on Table 1, analytical data results indicate exceedances of arsenic, cadmium, chromium, lead, mercury, and cyanide. Of particular significance, lead was reported at a concentration of up to 5,390 milligrams per kilogram (mg/kg) or parts per million (ppm), cadmium was reported at a concentration of up to 140 ppm and chromium was reported at concentration of up to 2,790 ppm.

- Elevated concentrations of metals, including chromium, cadmium, mercury, arsenic, lead and cyanide were identified in surface samples Site-wide above NYSDEC TAGM 4046 and/or Part 375 Restricted-Commercial SCOs. The surface samples were collected from discolored soil/fill that was observed in various areas of the Site in May 2008. Based on the field observations and the concentrations detected within the surface soil/fill samples, these materials would likely meet the definition of a grossly impacted material under 6NYCRR Part 375 and would require removal during future remedial work and/or redevelopment. Furthermore, based on the concentrations of cadmium (up to 140 ppm), lead (up to 5,390 ppm) and chromium (up to 2,790 ppm) detected, some of the material may potentially require handling as a hazardous waste.

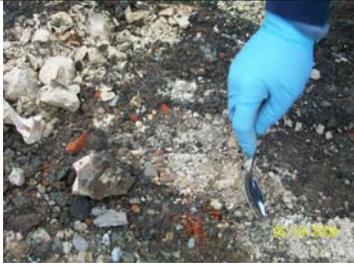
A photograph showing a soil sample with a tan or light brown color. A person wearing blue gloves is using a tool to dig into the soil. A yellow timestamp '05/19/2008' is visible in the bottom right corner.
SS-3	Light blue colored soils

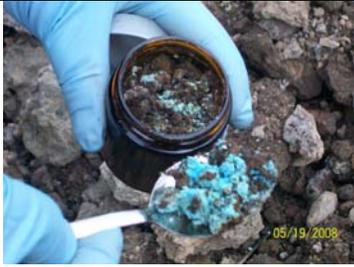
A photograph showing a soil sample with a light blue color. A person wearing blue gloves is holding a small container and a spoon, examining the soil. A yellow timestamp '05/19/2008' is visible in the bottom right corner.
SS-4	Green colored soils

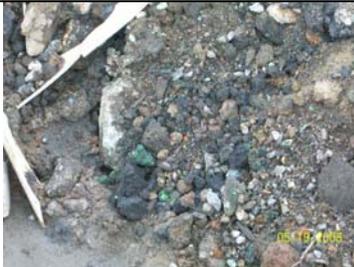
A photograph showing a soil sample with a green color. The soil is surrounded by rocks and debris. A yellow timestamp '05/19/2008' is visible in the bottom right corner.

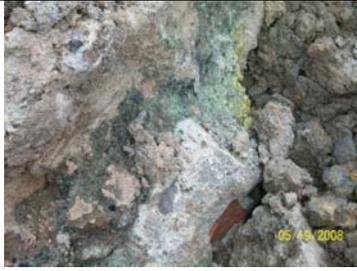
Sample Location	Rationale	Photo
SS-5	Green colored soils

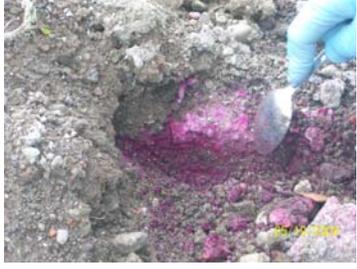
SS-6	Violet colored soil

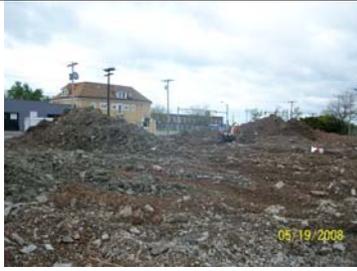
Pile	Imported backfill piles

At the request of our client, a composite soil sample was collected from the imported backfill piles that were brought to the Site sometime in May 2008. The pile sample was analyzed for TCL SVOCs, PCBs and RCRA metals. As indicated on Table 1, analytical results indicate no detections of PCBs or metals above RSCOs. SVOCs benzo(a)anthracene, benzo(b)fluoranthene, benzo(a)pyrene, chrysene, and dibenzo(a,h)anthracene were detected above TAGM 4046 RSCOs, with benzo(a)pyrene detected slightly above Part 375 Restricted-Commercial SCOs.

- Elevated concentrations of SVOCs in soil above TAGM RSCOs were identified in the imported backfill pile.
- Within a week after this investigation was completed, the current Site owner graded the Site with imported backfill. These activities have potentially commingled the impacted surface soil/fill on-Site with the imported backfill soils across the site.

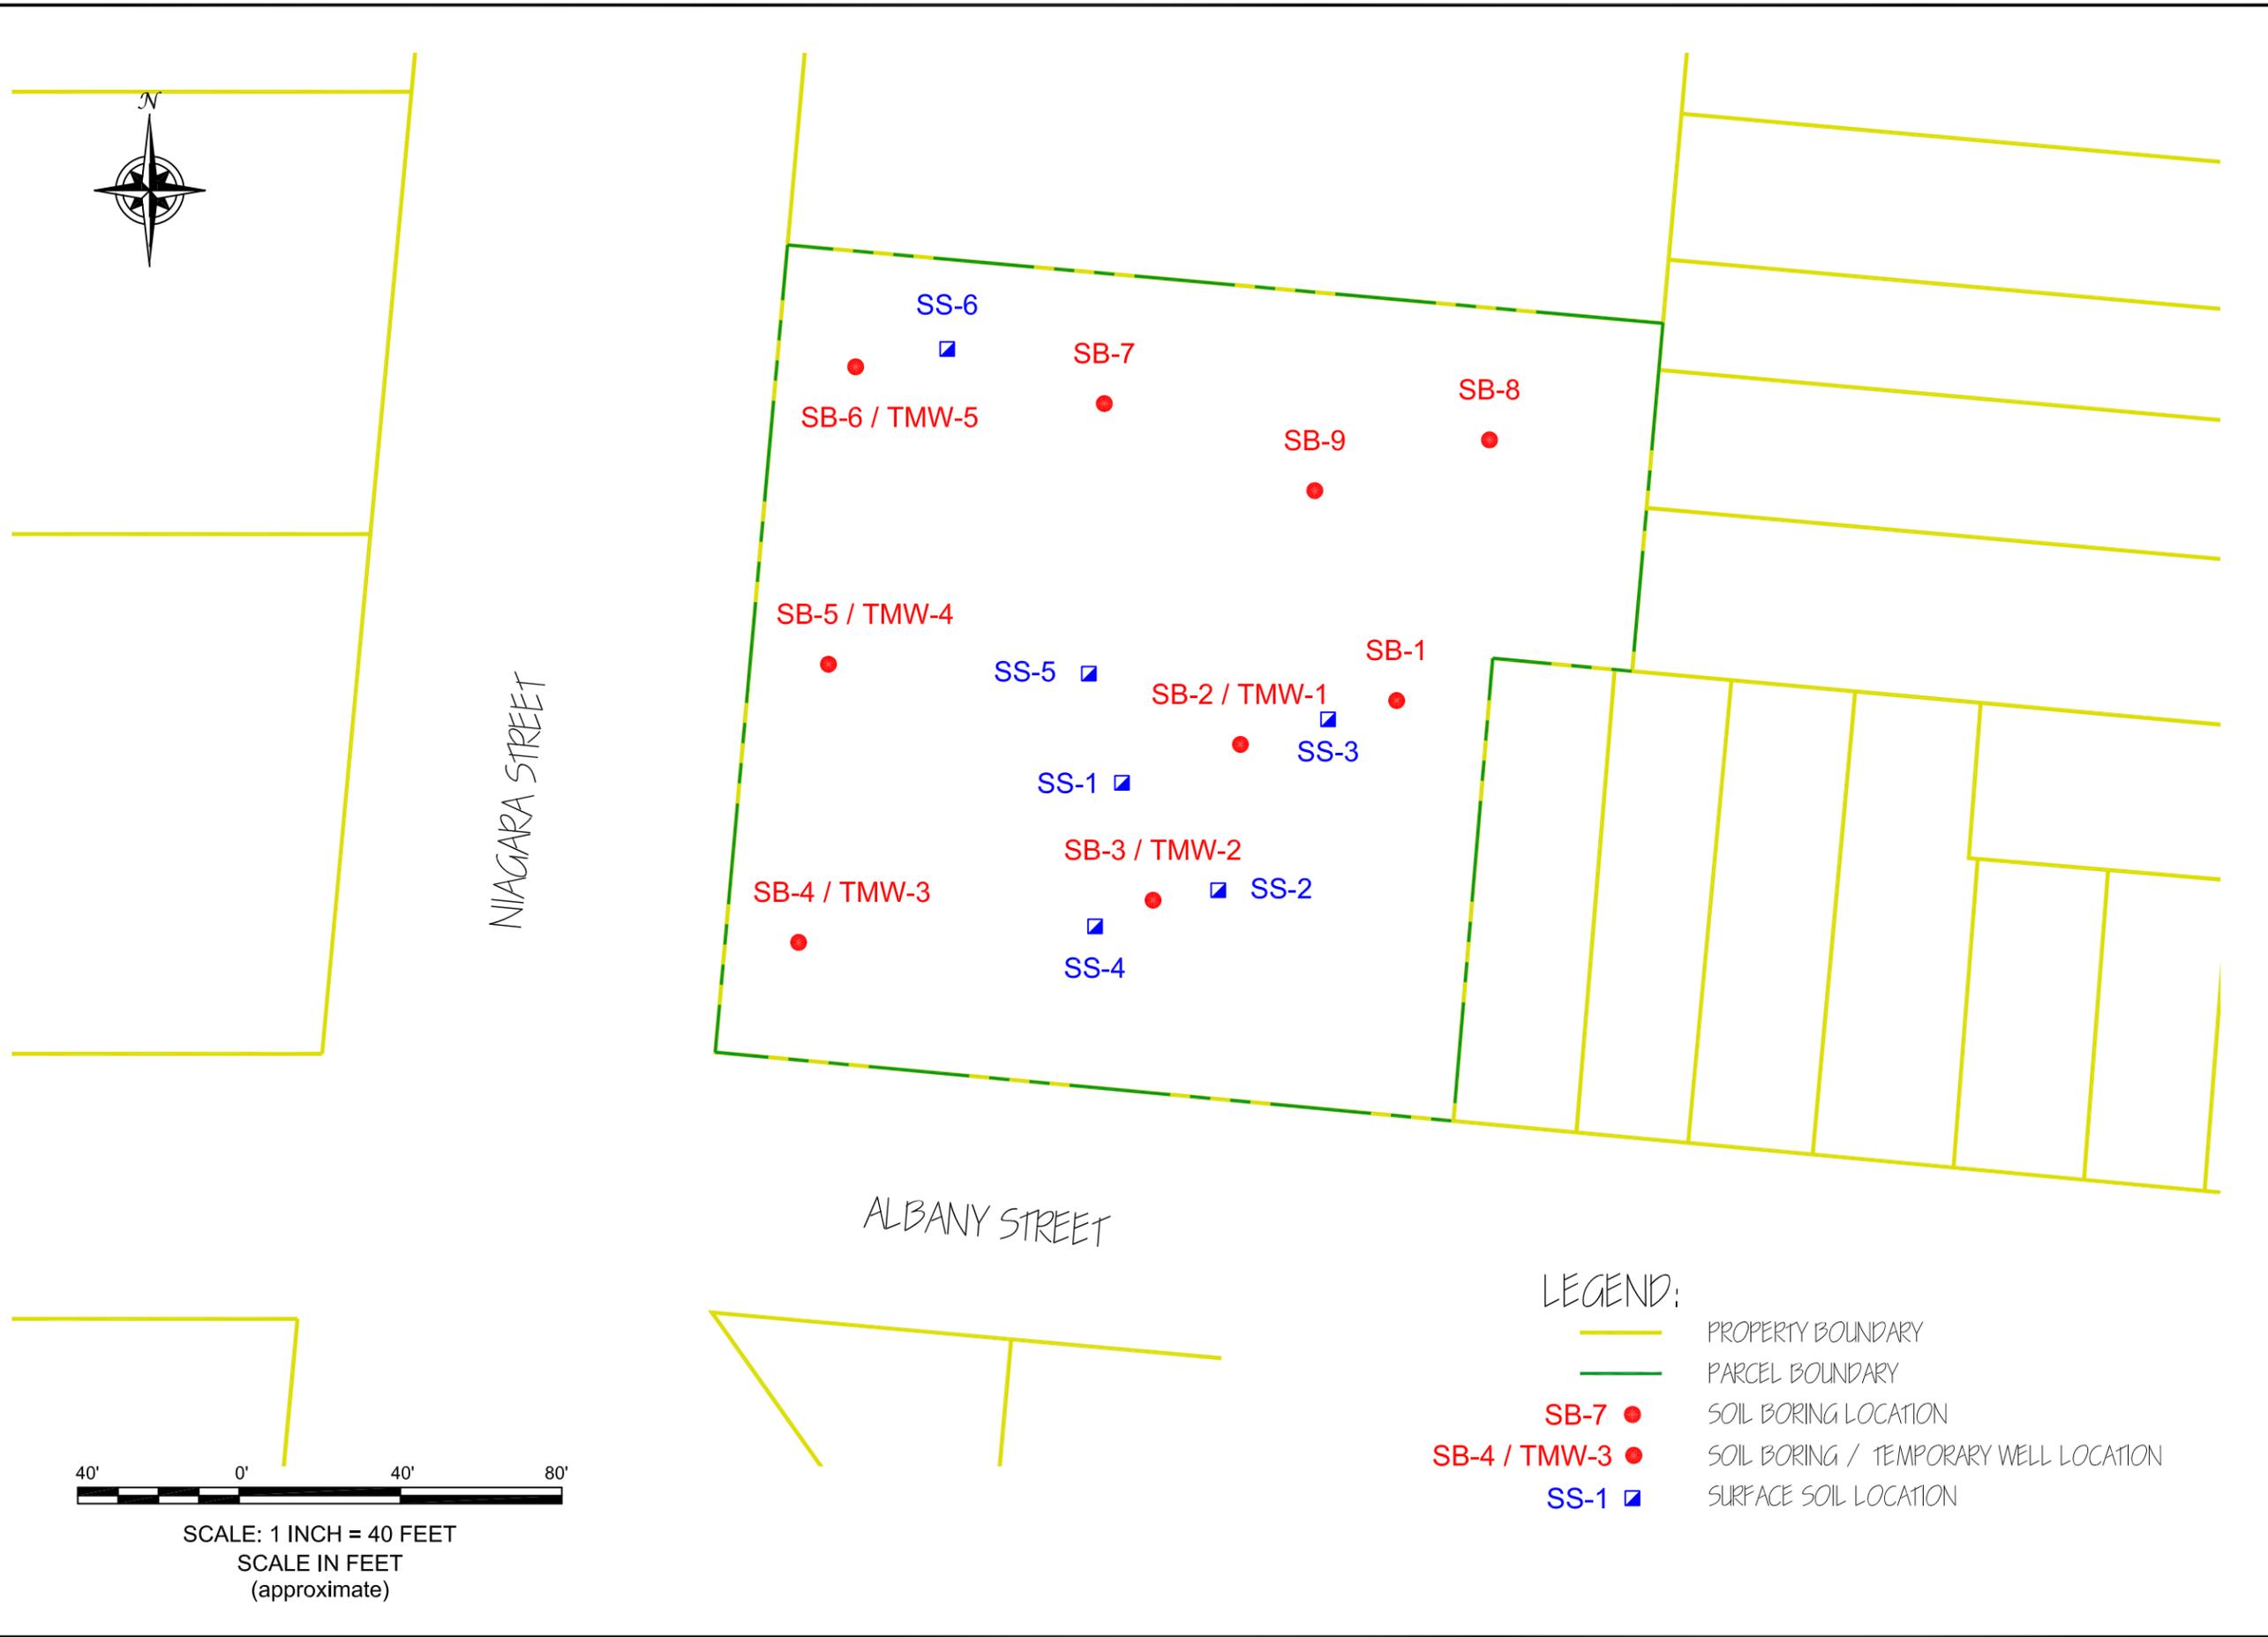
FIGURE 2

On May 19, 2008, soil borings SB-1 through SB-9 were completed on the Site (see Figure 2). A summary of the soil sample locations and rationale is included in the table below.

Nine soil borings (SB-1 through SB-9) were advanced and six surface samples (SS-1 through SS-6) were collected on May 19, 2008 (see Figure 2). A total of 14 soil samples and one (1) groundwater sample were collected for analysis. Results are presented in Table 1 (soil) and Table 2 (groundwater). For comparison purposes, Table 1 presents recommended soil cleanup objectives (RSCOs) for each of the detected parameters as published in NYSDEC TAGM HWR-94-4046 and 6NYCRR Part 375 Restricted-Commercial soil cleanup objectives (SCOs). Table 2 results are compared to the NYSDEC Division of Water Technical and Operational Guidance Series (TOGS 1.1.1) groundwater quality standards (GWQS). The analytical data package is presented in Appendix B.

SITE PLAN
