**REPORT ON
PHASE II ENVIRONMENTAL SUBSURFACE INVESTIGATION
PROSPECTIVE YMCA NORTH BUFFALO FACILITY DEVELOPMENT
UNILAND SITE
BUFFALO, NEW YORK**

File No. 134479-005
September 2020

Subject: Environmental Phase II Evaluation
Prospective YMCA North Buffalo Facility Development - Uniland Site
Buffalo, New York

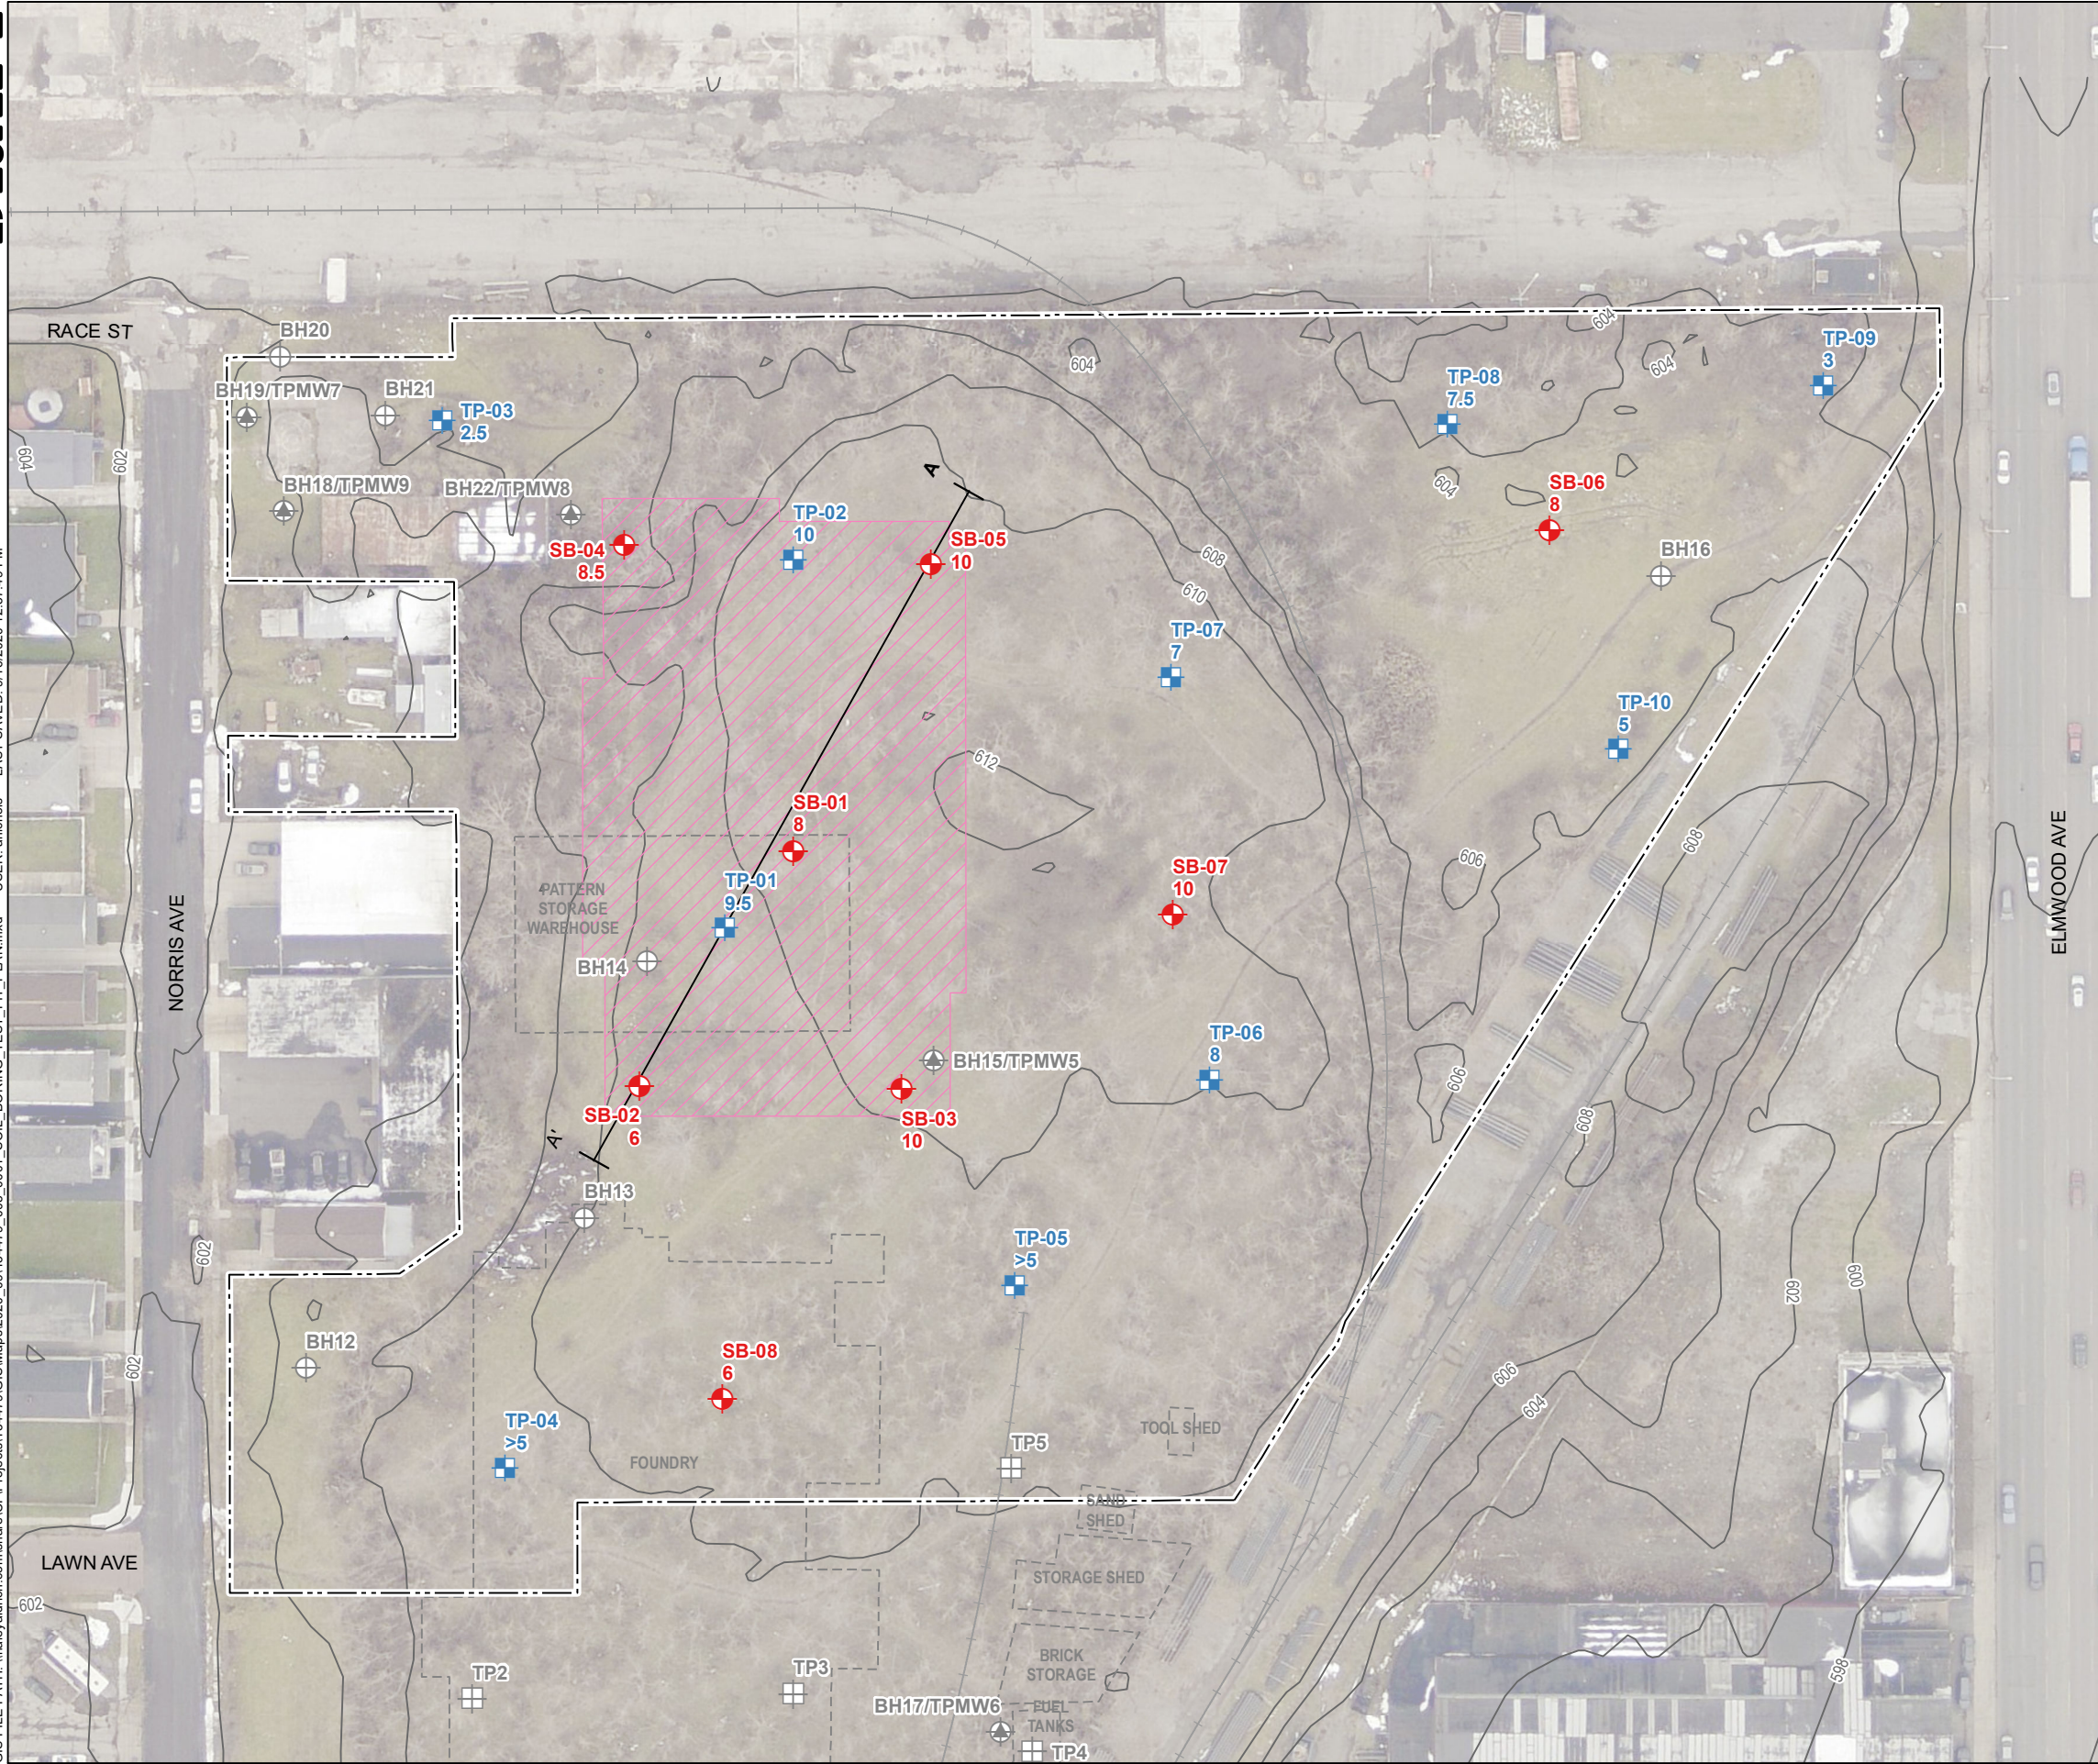
FIGURE 2

On 3 August 2020, EDI excavated 10 test pits (TP-01 to TP-10; Figure 2) to depths ranging between 3 and 10 ft bgs (below ground surface), generally stopping once native soils were observed underlying the fill materials, or upon encountering an obstruction that could not reasonably be moved by the excavator. A

**SOIL BORING AND
TEST PIT PLAN**

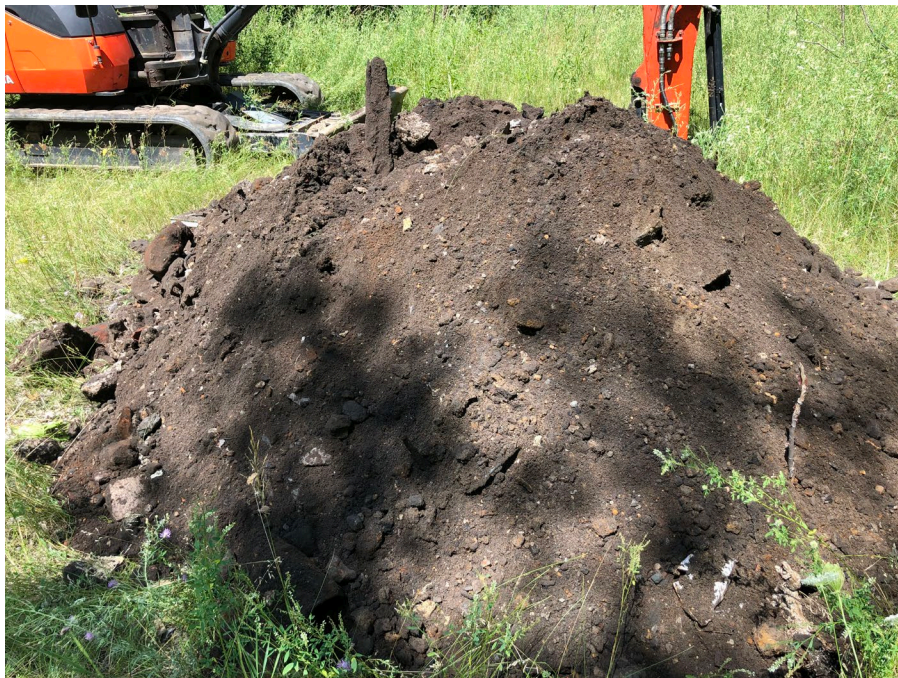
Photo 8: TP-02

Visual and olfactory field observations and PID screening of soils recovered during test pitting generally identified similar conditions to those observed during soil boring activities, with the exception of slightly elevated PID readings in test pits TP-02 (2.5 ppm; 1 to 2 ft bgs) and TP-03 (0.6 ppm; 0 to 1 ft bgs), both located in the northwest portion of the subject site. Observations from TP-02 identified a light odor within fill materials containing miscellaneous debris including metal parts (apparent remnants of steel drums), aluminum cans and polyethylene sheeting. Observations from test pit TP-03 identified approximately 2.5 ft of urban fill materials exhibiting a stronger odor and black staining of an apparent creosote-like material on the north side of the excavation at a depth of approximately 1.5 ft bgs. A lighter odor was still observed in native clays (2.5 to 3.0 ft bgs) at the bottom of test pit TP-03. Photographs of soils excavated from TP-02 and TP-03 are presented in Appendix D.

- Minor visual/olfactory evidence of contamination (dark and apparent creosote staining) was observed in fill soils excavated from test pits TP-02 and TP-03 in the northwest corner of the subject site. Similar observations were not noted in other test pits or nearby soil borings (SB-04, SB-05), suggesting the extent of observed contamination is limited.

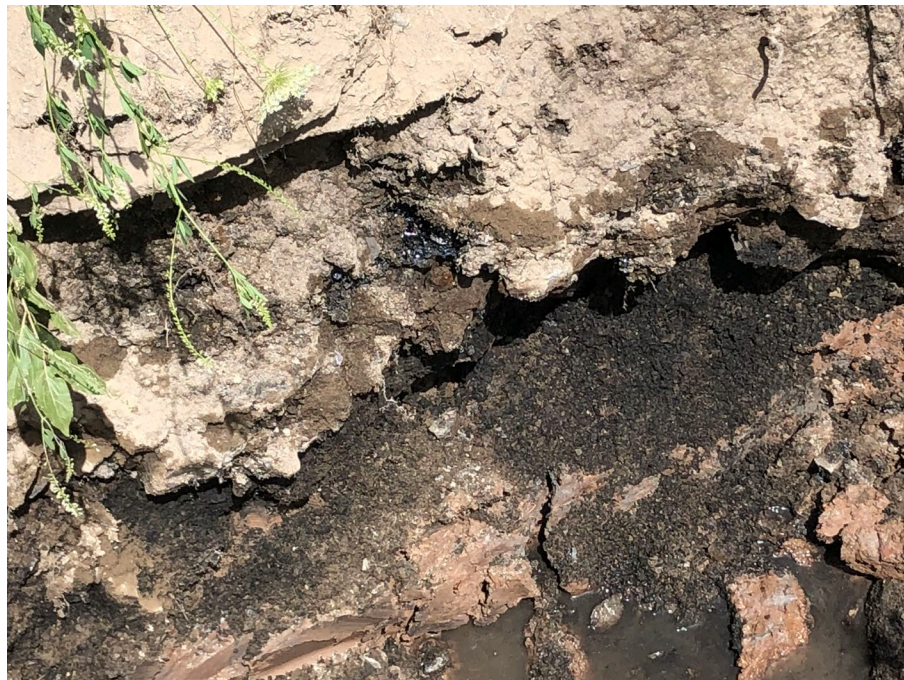
Photo 10: TP-03; black creosote-like material
