Phase I Environmental Site Assessment (ESA)

*A Portion of 703 East Delavan Avenue
Buffalo, New York*

March 2021

0408-021-001

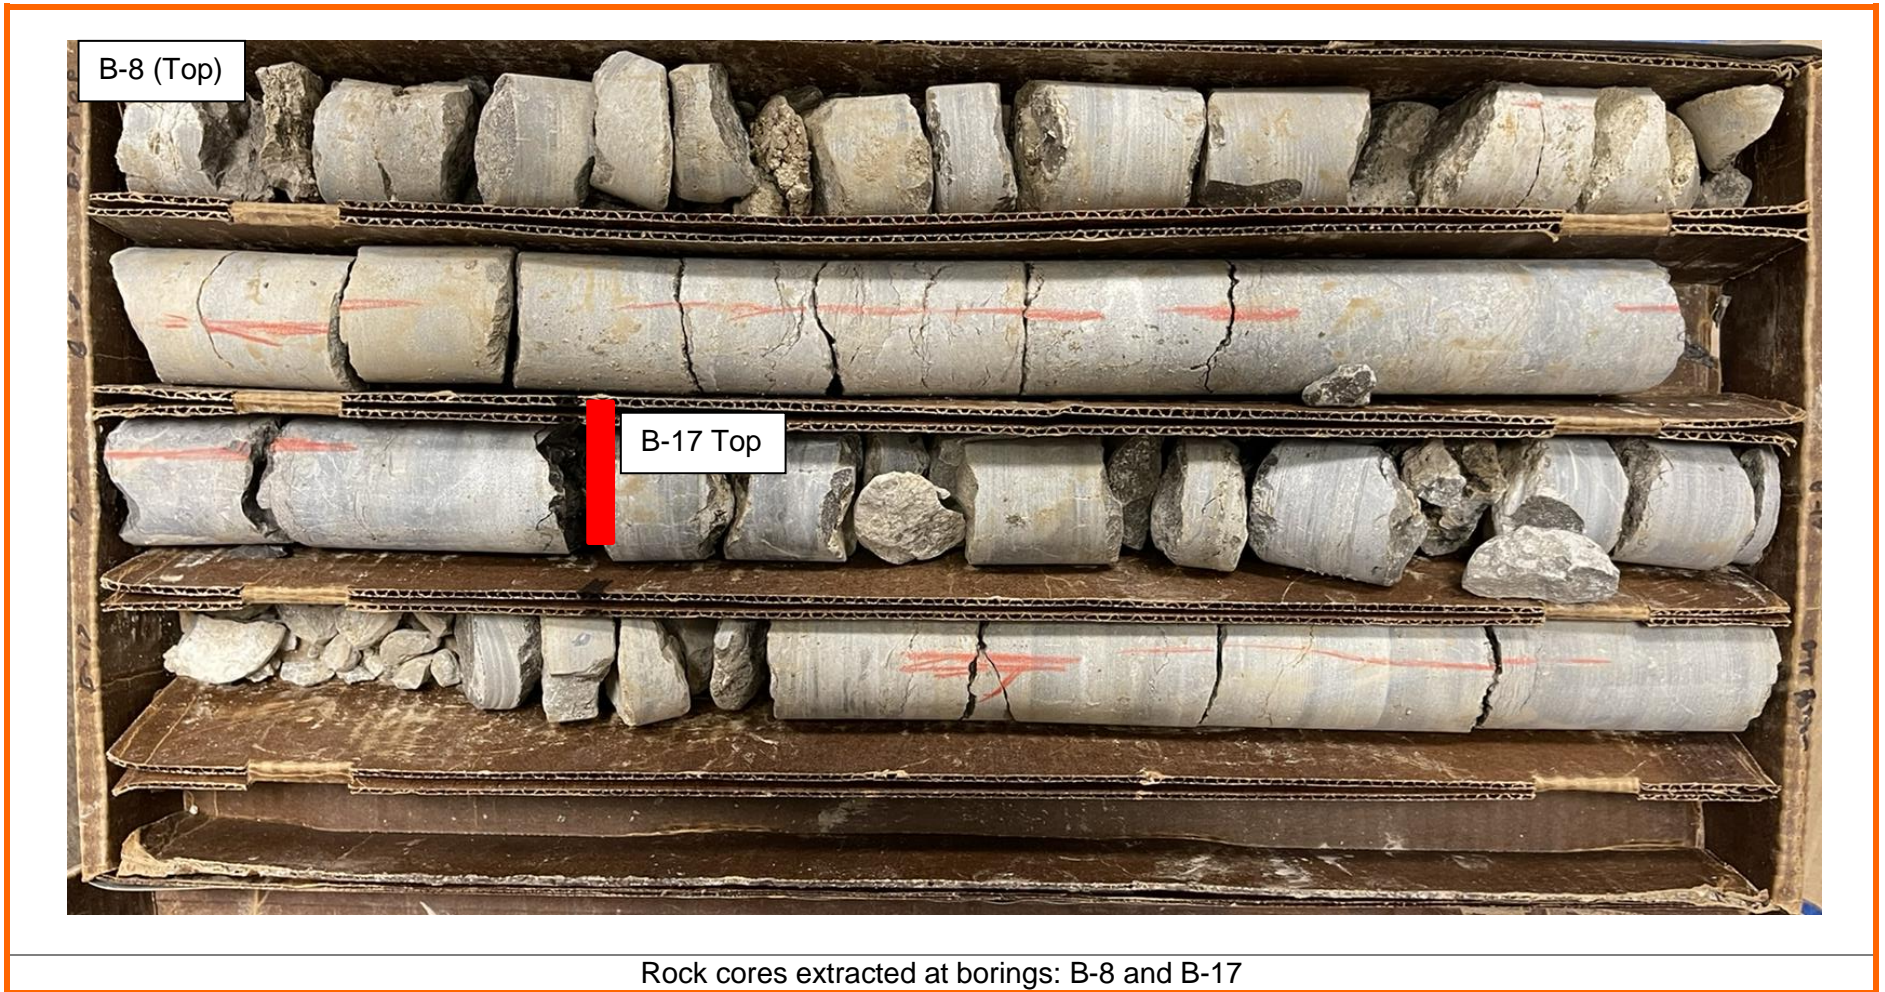
Rock cores extracted at borings: B-8 and B-17

Boring:	Depth (ft)	Recovery (%)	RQD (%)
B-8	2 to 7	80	47
B-17	2.5 to 6	86	35

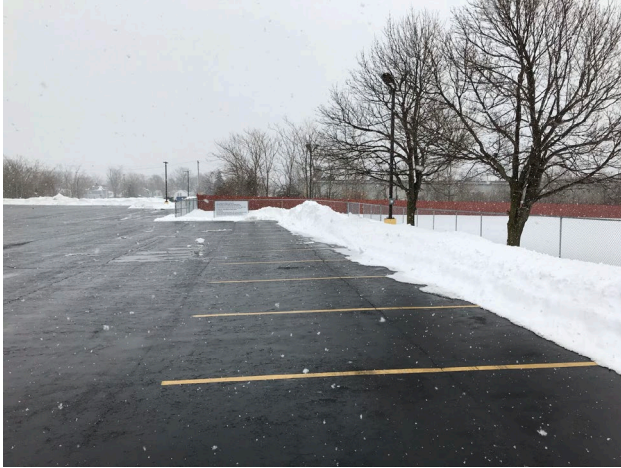
Photo 5: View of asphalt parking area on the northern portion of the Site looking east.

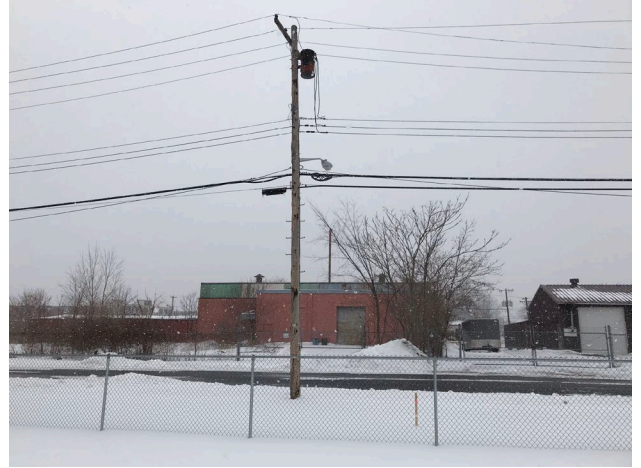
Photo 6: View of the pole mounted transformer looking west.
