**Reference: 2122 Colvin Boulevard, Tonawanda, New York
NYSDEC Voluntary Cleanup Program Site V00334
Draft Phase II Environmental Site Assessment**

This draft report summarizes the results of Stantec's Phase II Environmental Site Assessment (Phase II ESA) at 2122 Colvin Boulevard, Tonawanda, Erie County, New York (the "Property"; see location, Figure 1). Our work was performed in accordance with Stantec's March 31, 2021 change order, authorized by Boxes Builders on April 2, 2021. This work has been performed to facilitate purchase of the Property.

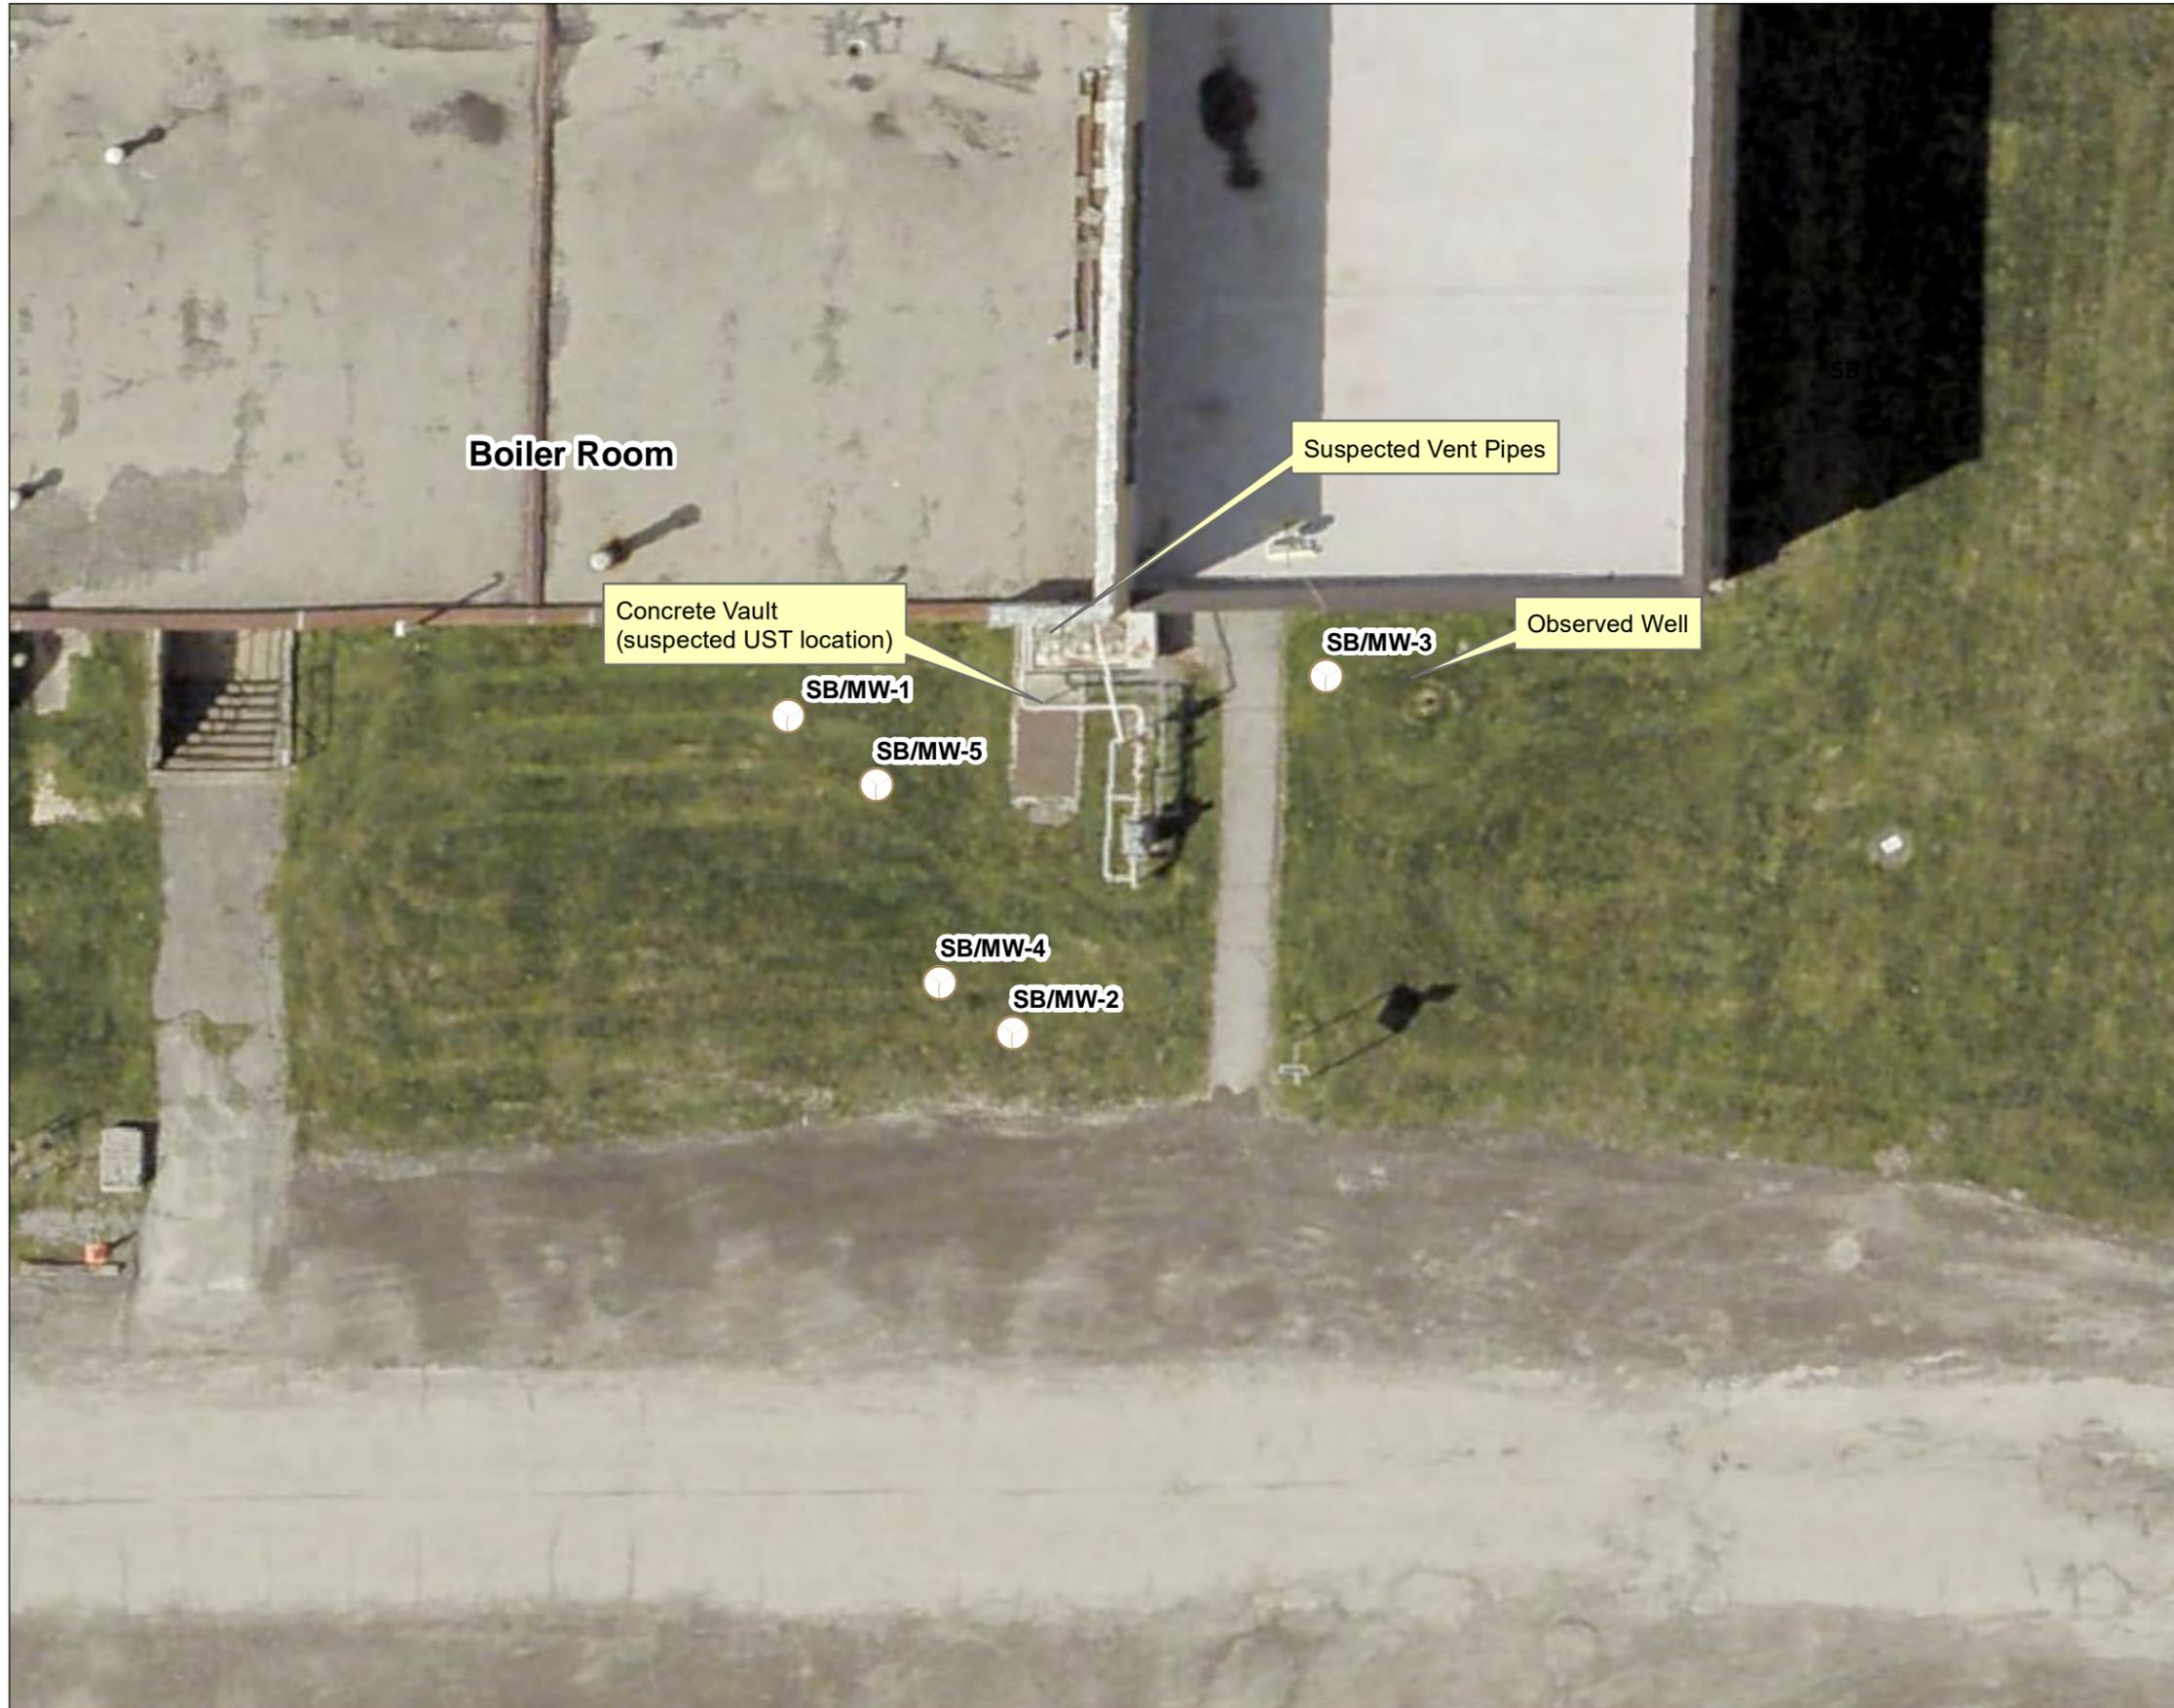
Figure No.
2

Five test borings which were converted to temporary monitoring wells were installed (SB/MW-1 through SB/MW-5) at the locations shown on Figure 2. Test boring logs are included in Appendix C. The borings were advanced to depths ranging between approximately 11.5 ft and 30 ft bgs. Soil boring installation depths varied based on the observed depth to groundwater. Continuous samples were collected using 5-foot-long Macro-Core® sleeves.

Title
Investigation Locations

An apparent well, constructed out of 2-in. diameter PVC pipe within a metal outer casing, was observed east of the concrete vault (see Figure 2 and Appendix B). At the time of the investigation the well was dry and approximately 13 ft deep. When an ERM representative, the consultant for Sonoco, met Stantec on-site, he stated that he did not know what this well was used for and that it was not a well installed as part of the VCP. The 1998 report from ERM stated that following closure of the USTs groundwater samples were collected; however, this data was never provided. It is possible that this observed well is related to the closure of the USTs.

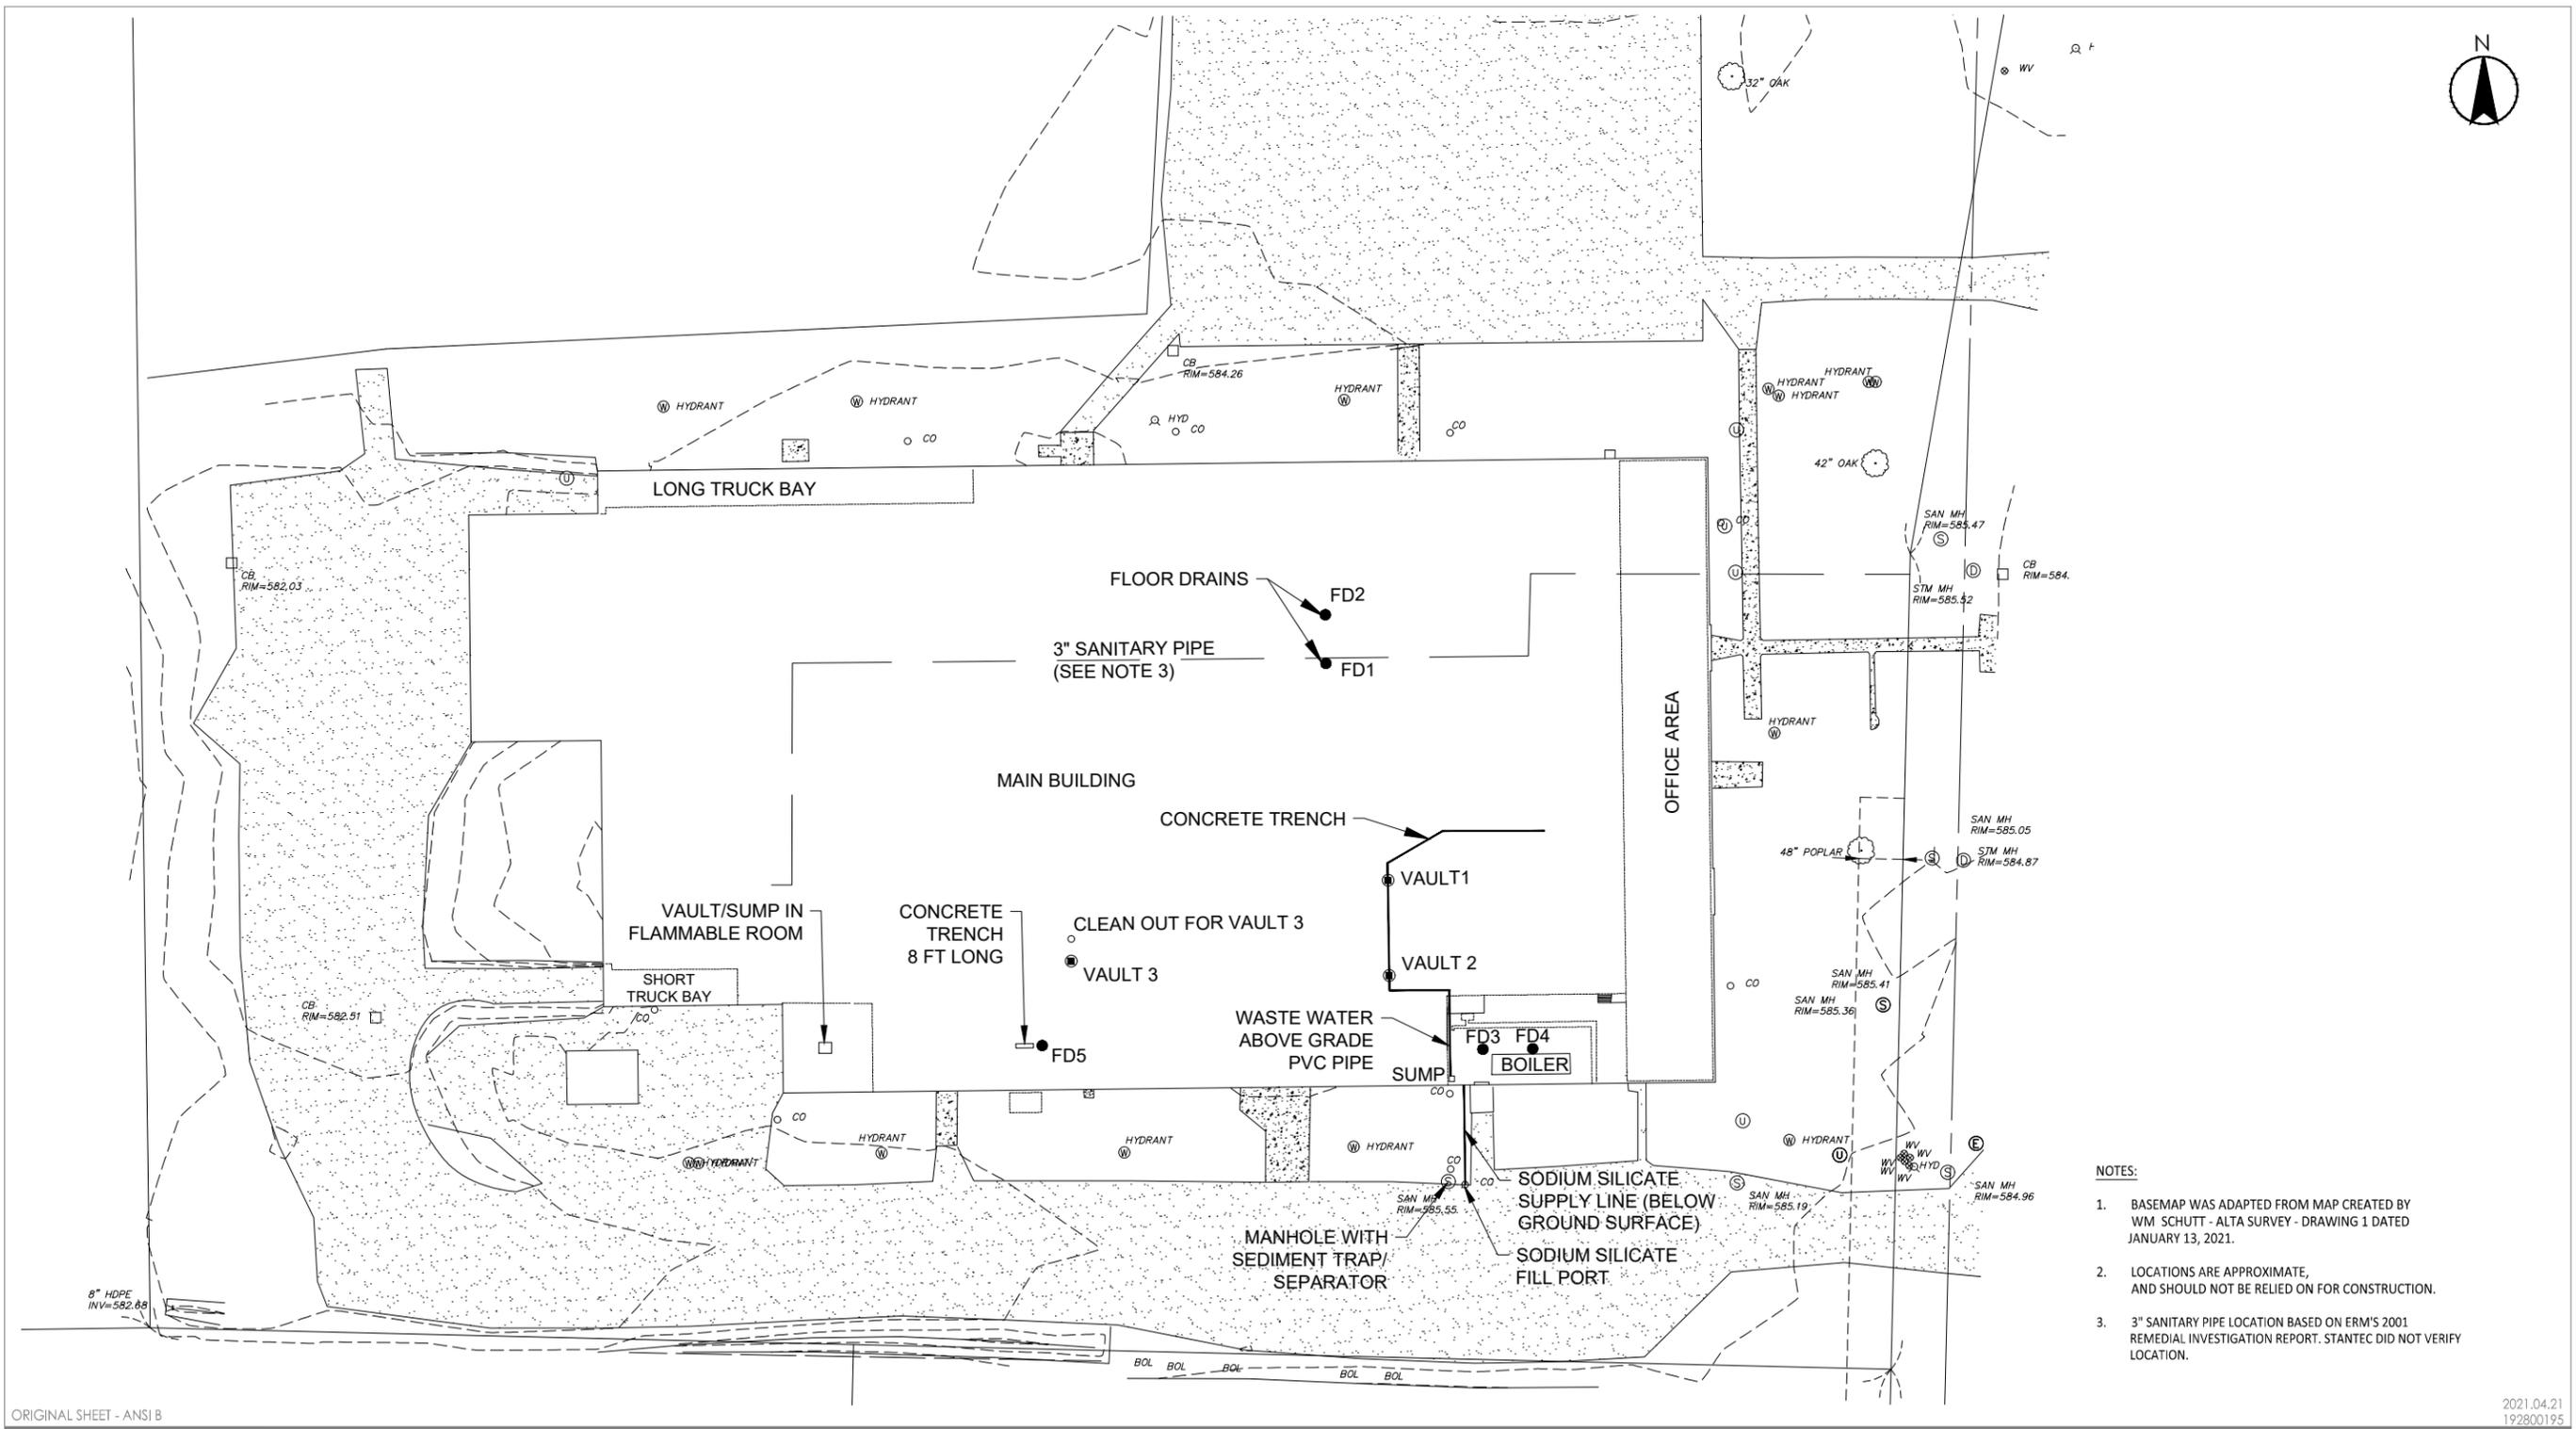
Figure No.
FIGURE 3
 Title
FLOOR DRAIN AND VAULT LOCATIONS

A series of six videos were collected from accessible floor drains and vaults located in the former production space and an exterior sodium silicate (previously used by the facility as glue) supply line. The video footage was captured as a series of digital files. Floor drain and vault locations are included on Figure 3. Findings from the survey are summarized below.

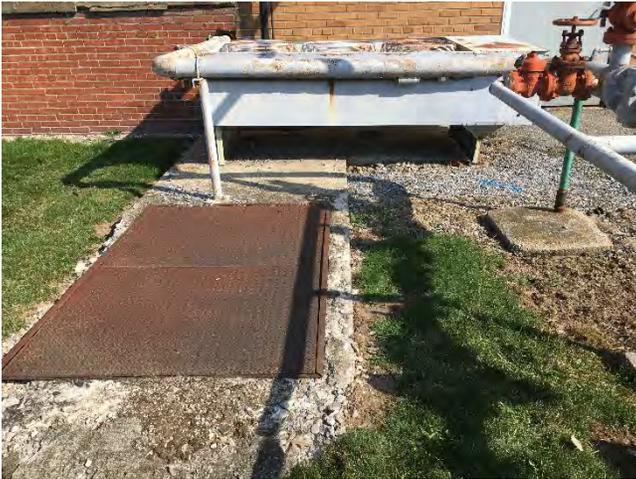
Concrete vault with metal cover

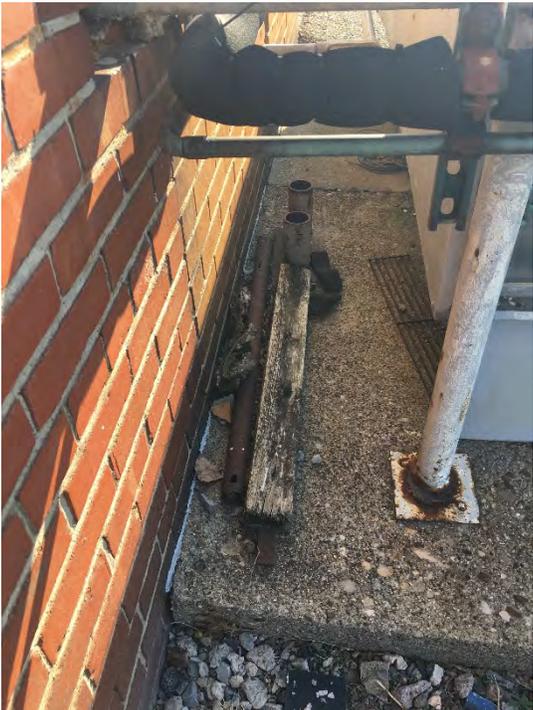
Suspected former vent pipes

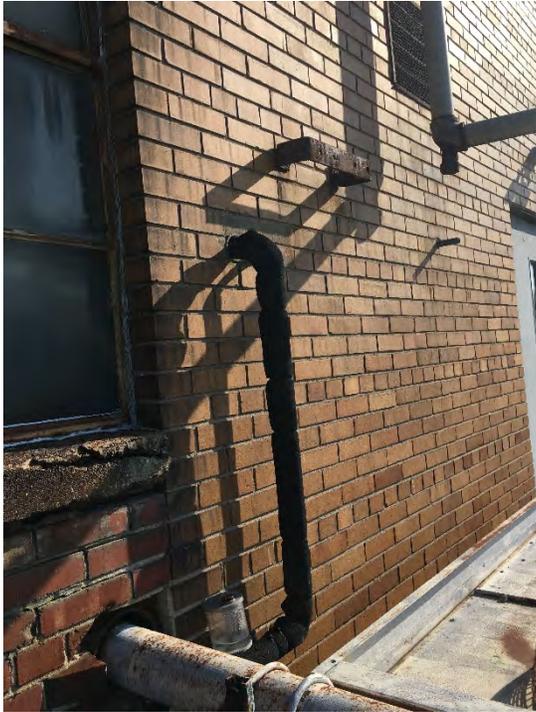
Apparent mounting bracket above suspected vent pipes

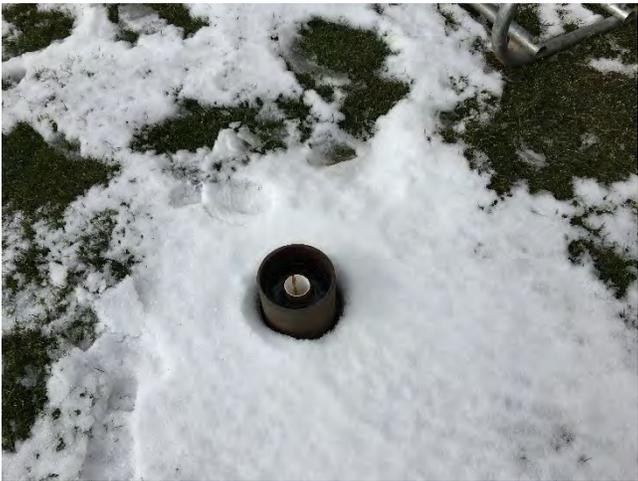
Observed existing well (photograph from Phase I ESA)

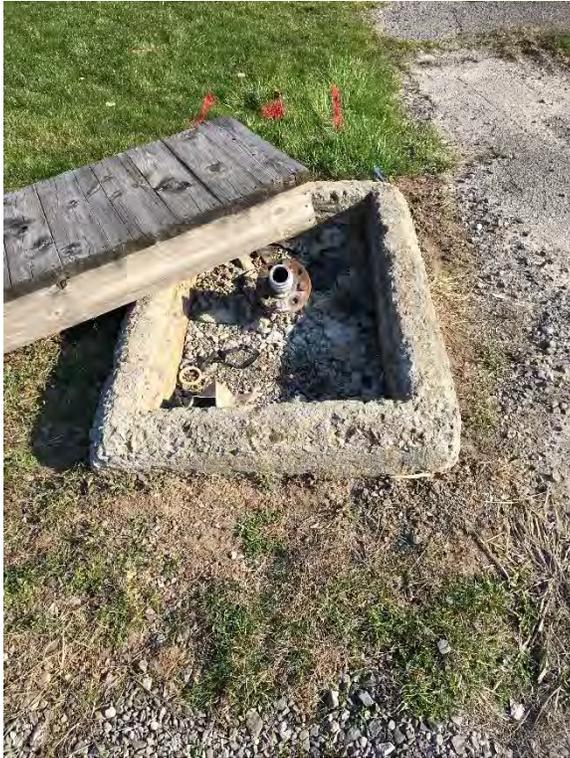
- The below grade portion of an exterior sodium silicate supply line (approximately 47 ft long) was video surveyed. The fill port is located south of the building and the supply line is metal. An above grade pump for the sodium silicate line is located in the boiler room. A hole in the bottom of the supply line was observed approximately 26 ft north of the fill port. This hole may have resulted in releases of sodium silicate which may have resulted in impacts to the adjacent soil. Sodium silicate has a high pH; thus, disposal of any potentially impacted soil in the vicinity of the sodium silicate supply line may require pre-treatment or disposal as a hazardous waste.

Fill port for sodium silicate supply line

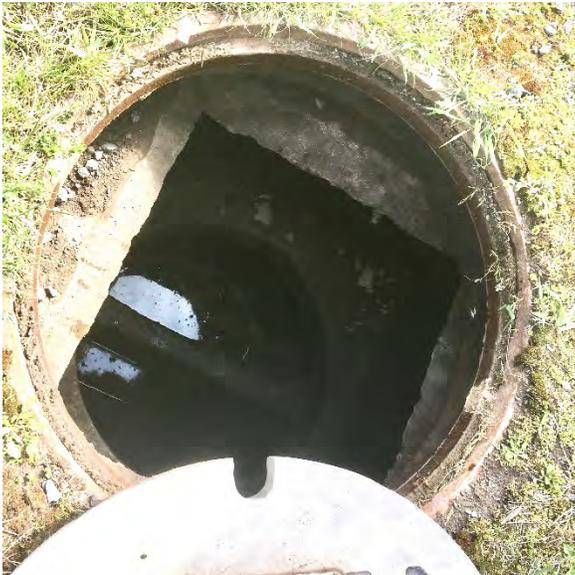
- Given the high levels of sediment in the floor drain in the boiler room and sodium silicate wastewater lines, the Roto-Rooter technician suspected that a sediment trap/separator was likely present south of the building before connecting to the sewer main. A manhole south of the boiler room was opened and a two-chamber sediment trap/separator was observed (see Figure 3 and Appendix B). One chamber appeared to be full of water which had a sheen. It is recommended that this sediment trap/separator be cleaned, and sediments be tested and properly disposed of during site redevelopment.

Sediment trap/separator

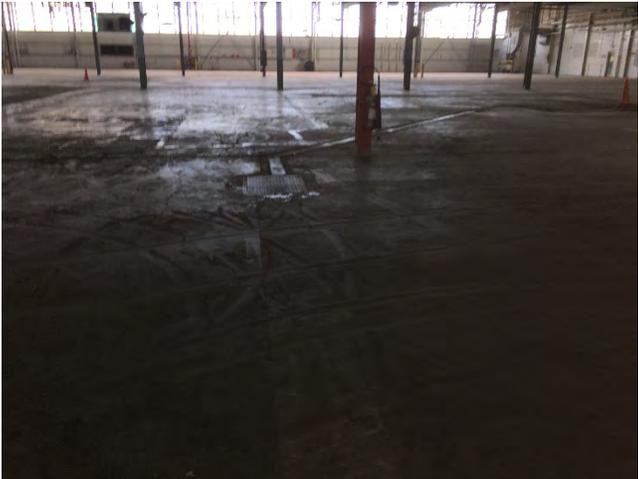
- There is a narrow concrete trench within the central eastern portion of the building that appears to have formerly been connected to or situated below pieces of equipment. The trench was mostly filled with sediment and glue. Stantec used a spade in several locations and confirmed that the bottom of the trench was concrete and intact; however, the entire length was not inspected.

- Both Vault 1 and Vault 2 are 3 ft by 2 ft and approximately 4 ft deep. The bottom and sidewalls of the vault could not be fully observed due to the presence of water and buildup of glue and sediment. A shovel was used to feel the bottom and side walls of the vault. They appeared to be concrete.

Concrete trench and Vault 1

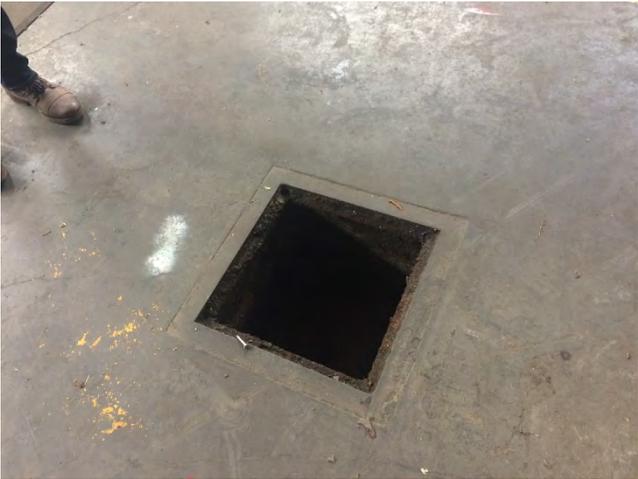
- The vault in the flammable room was further inspected with a shovel. The vault is approximately 1.6 ft by 1.6 ft and is 1.6 ft deep. Water and sediment were present at the bottom of the vault. No outlets were observed, and the bottom and sidewalls of the vault appeared to be made of

Vault in Flammable Storage Room

concrete and in good condition. It is recommended that during redevelopment, the water and sediment in the vault be tested and properly disposed of.

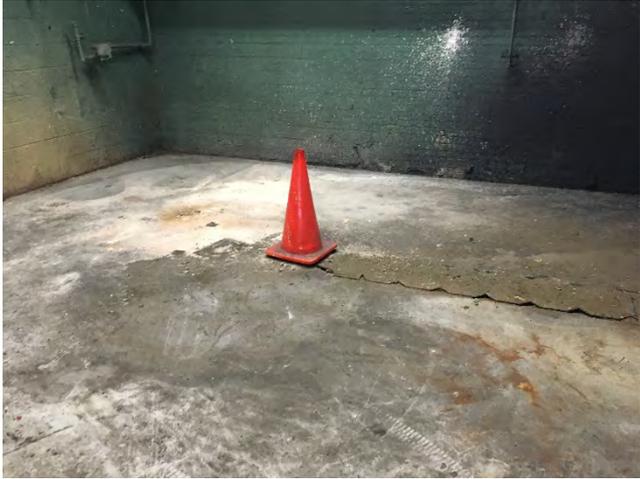
- FD5 is located in a small room in the southern portion of the building. This room contains a sink which discharges to a concrete trench which is pitched towards FD5. The camera survey was able to trace the line east approximately 120 ft and the cast iron pipe appeared to be intact. The camera survey was able to confirm that this drain is connected to the sanitary main.

Concrete Trench and Floor Drain 5 (below cone)
