Re: Conceptual Site Model (CSM) and
Supplemental Remedial Investigation Work Plan (RIWP)
2122 Colvin Boulevard, BCP Site No. C915380
2122 Colvin Boulevard, Tonawanda, New York

BMTK has prepared this letter to provide a CSM and SOW for the SRI in areas NYSDEC requested additional investigation/information.

CONCEPTUAL SITE MODEL

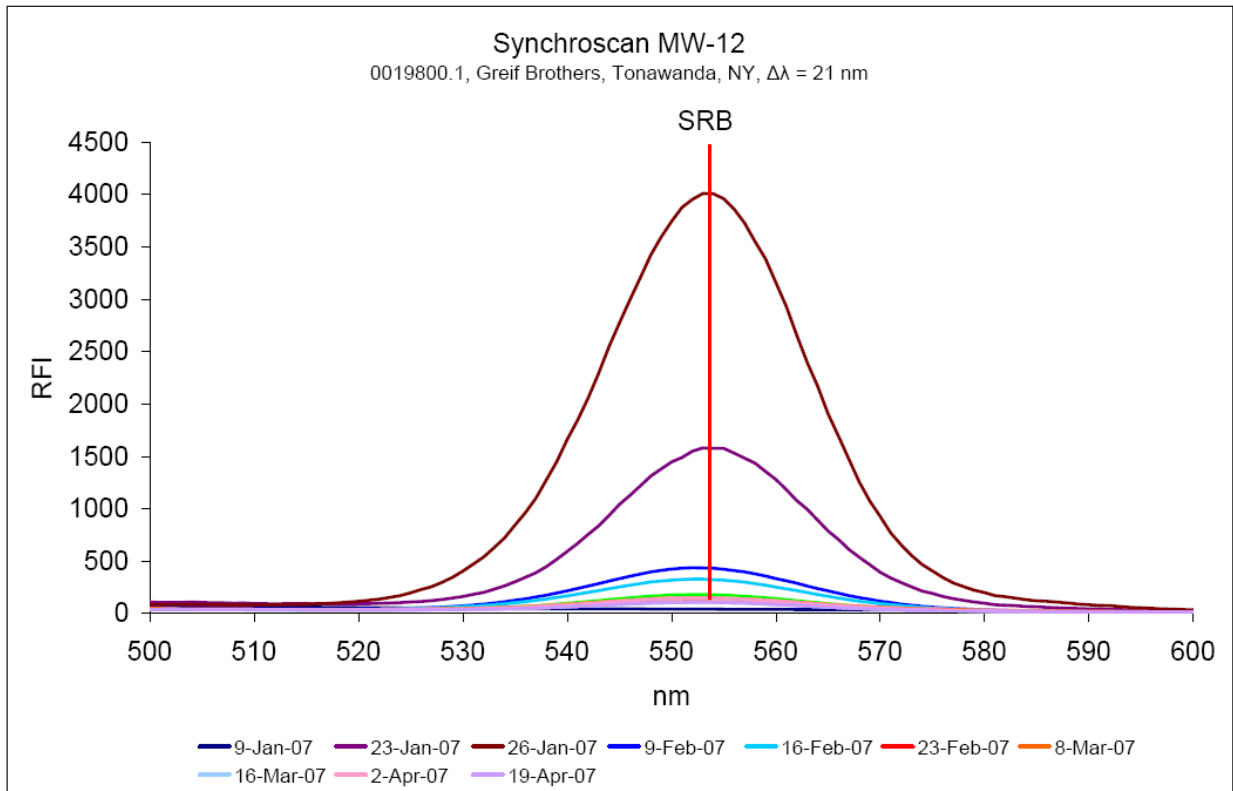
Figure B1: Sulforhodamine G dye reached this well 12 days after dye injection. The maximum concentration of the dye arrived three days later.

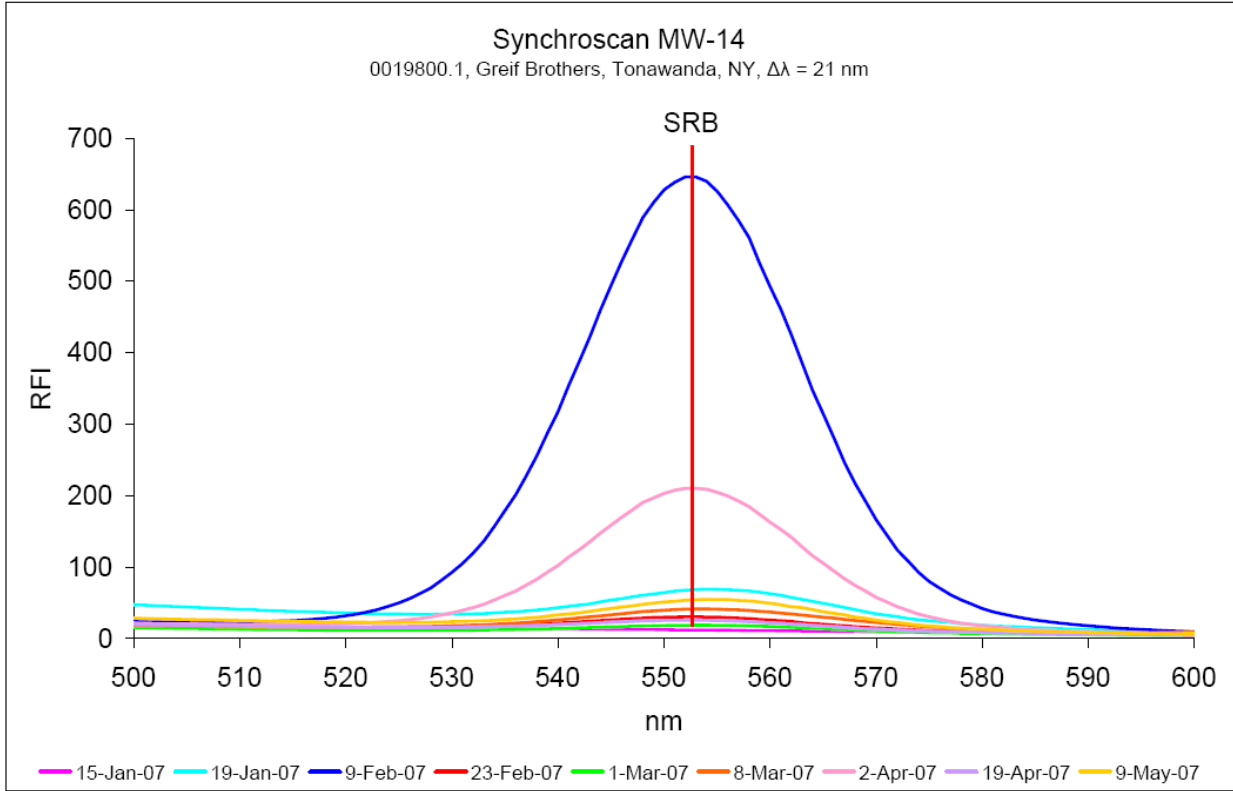
Figure B4: Sulforhodamine G dye reached this well 8 days after dye injection. The maximum concentration of the dye arrived at the well 21 days later.

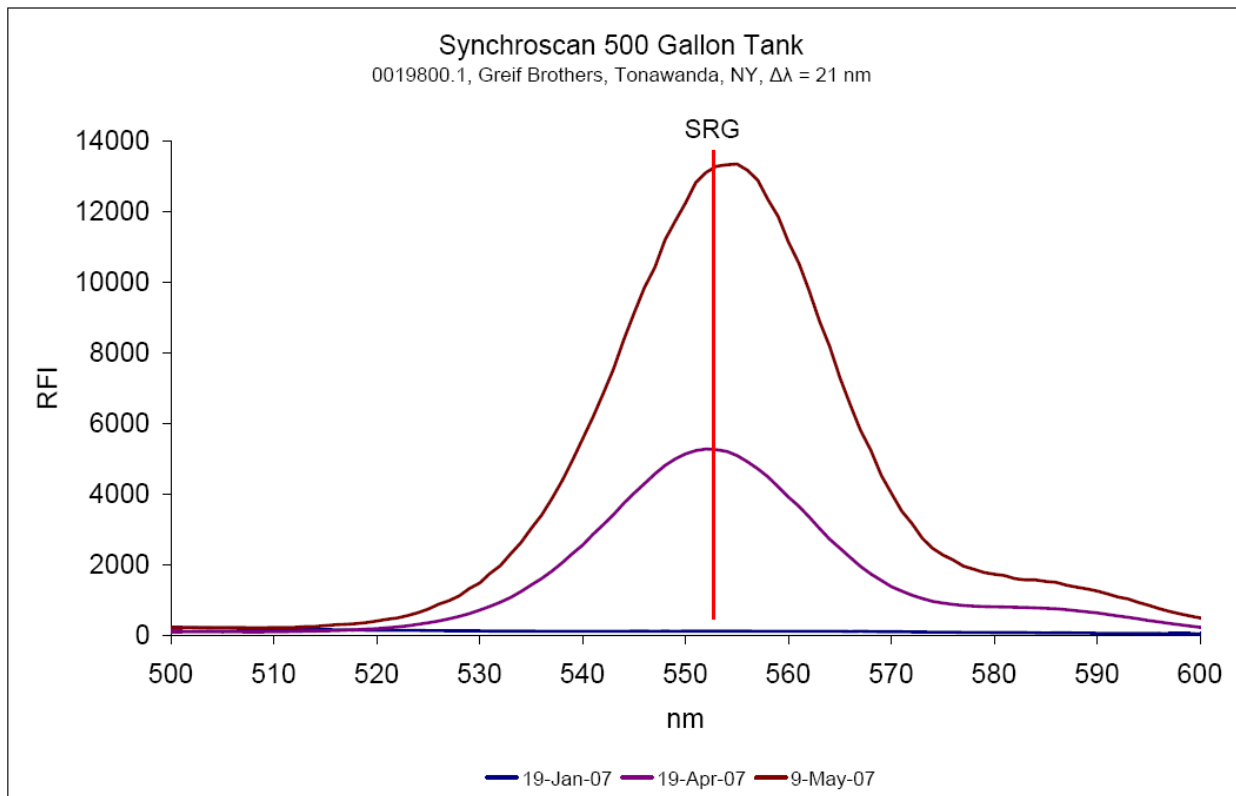
Figure B20: Sulforhodamine G dye was first detected in the liquid storage tank for the DNAPL Recovery IRM Pumping System 12 days after dye injection. However, the dye concentration had not reached its maximum after 109 days when the observation period of the dye test was ended. The liquid recovery tank collected the total fluids being pumped from recovery wells RW-1, RW-2, RW-4 and RW-5 throughout the FDT.

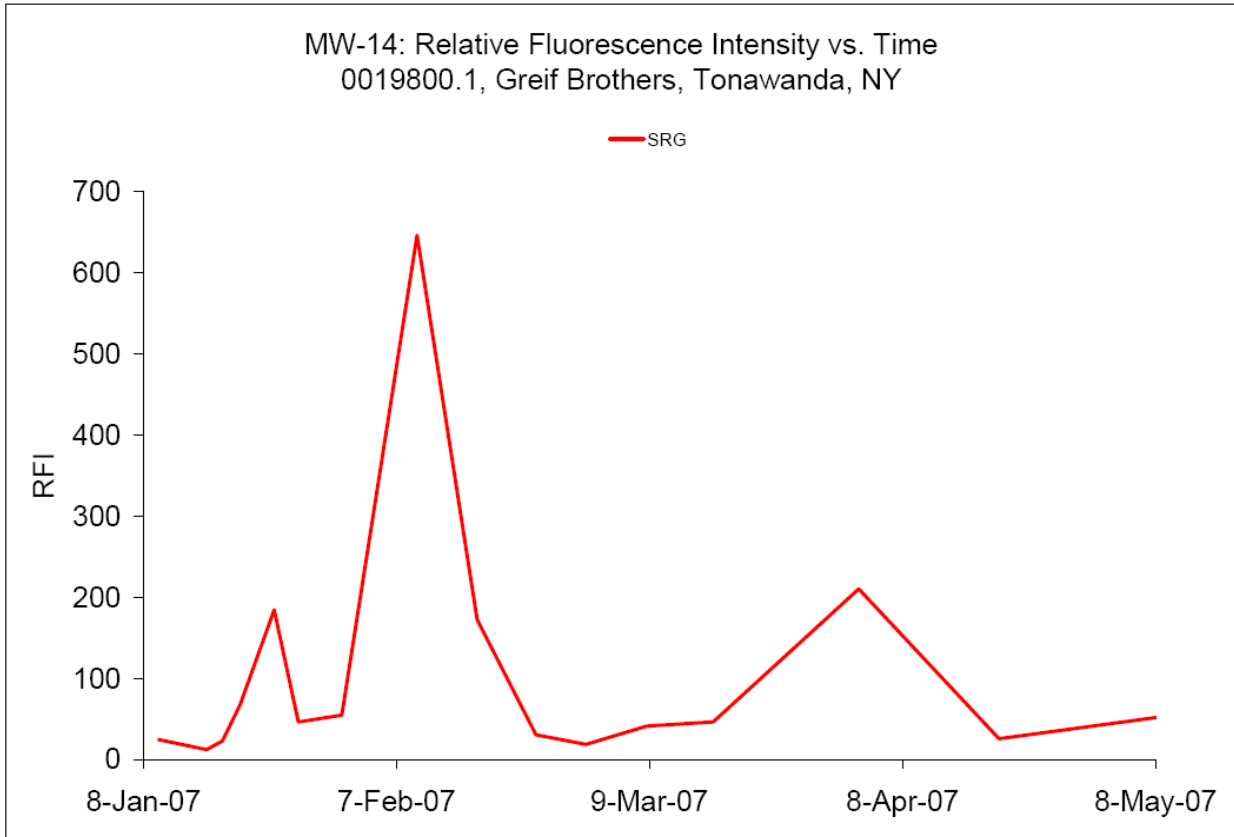
Figure C3: The dye breakthrough curve shows that the maximum dye concentration reached this well 29 days after dye injection.

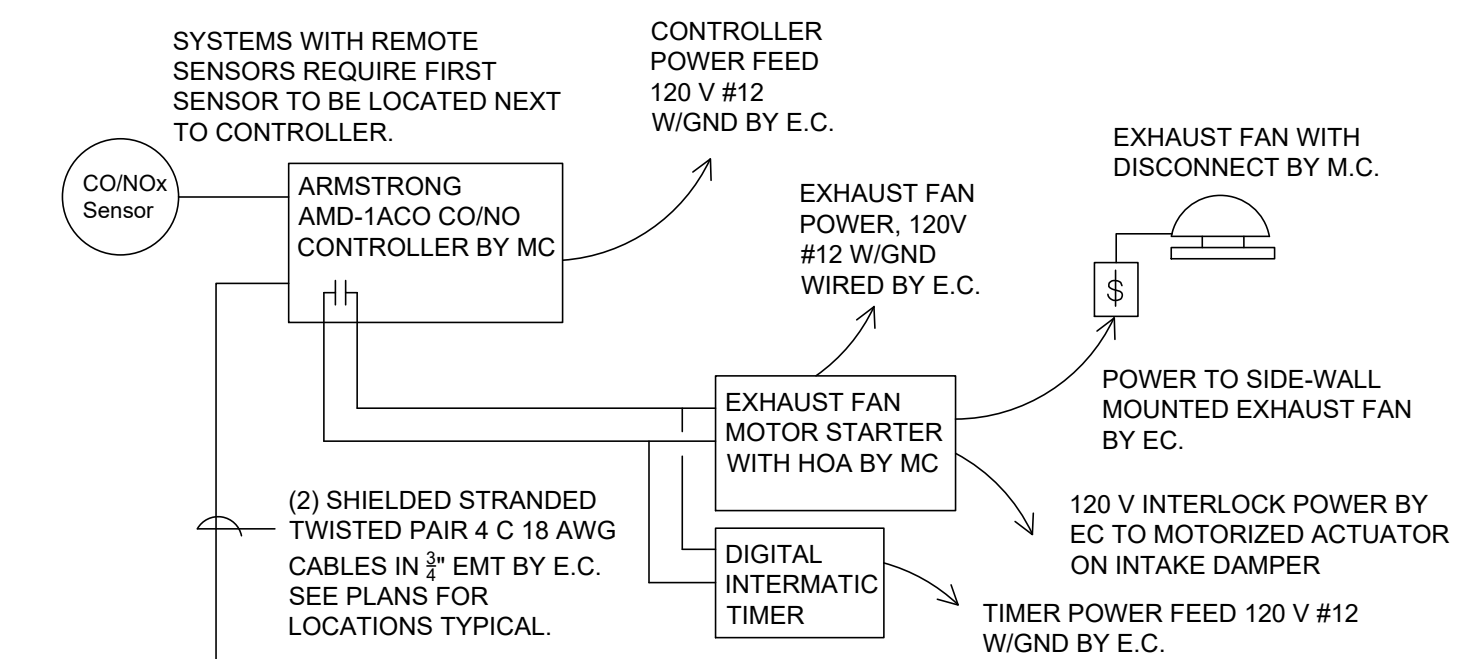
SEQUENCE OF OPERATION

1. HAND OFF AUTO SWITCH IN "AUTO"
 - a. FAN AUTOMATICALLY STARTS ON CO/NO2 CONTROLLER ALARM PER STATE CODE.
 - b. TIME AUTOMATICALLY STARTS AND RUNS FAN FOR ONE HOUR A MINIMUM OF (5) TIMES PER DAY.
 - c. INTAKE DAMPER OPENS ANYTIME FAN IS RUNNING
2. HAND OFF AUTO SWITCH IN "MANUAL"
 - a. FAN RUNS CONTINUOUSLY.
 - b. INTAKE DAMPER OPENS ANYTIME FAN IS RUNNING.
