# REMEDIAL INVESTIGATION/ ALTERNATIVE ANALYSIS REPORT

**AMHERST COMMONS  
BCP SITE NO. C915397**

**47 EAST AMHERST STREET  
BUFFALO, ERIE COUNTY, NEW YORK**

September 2025

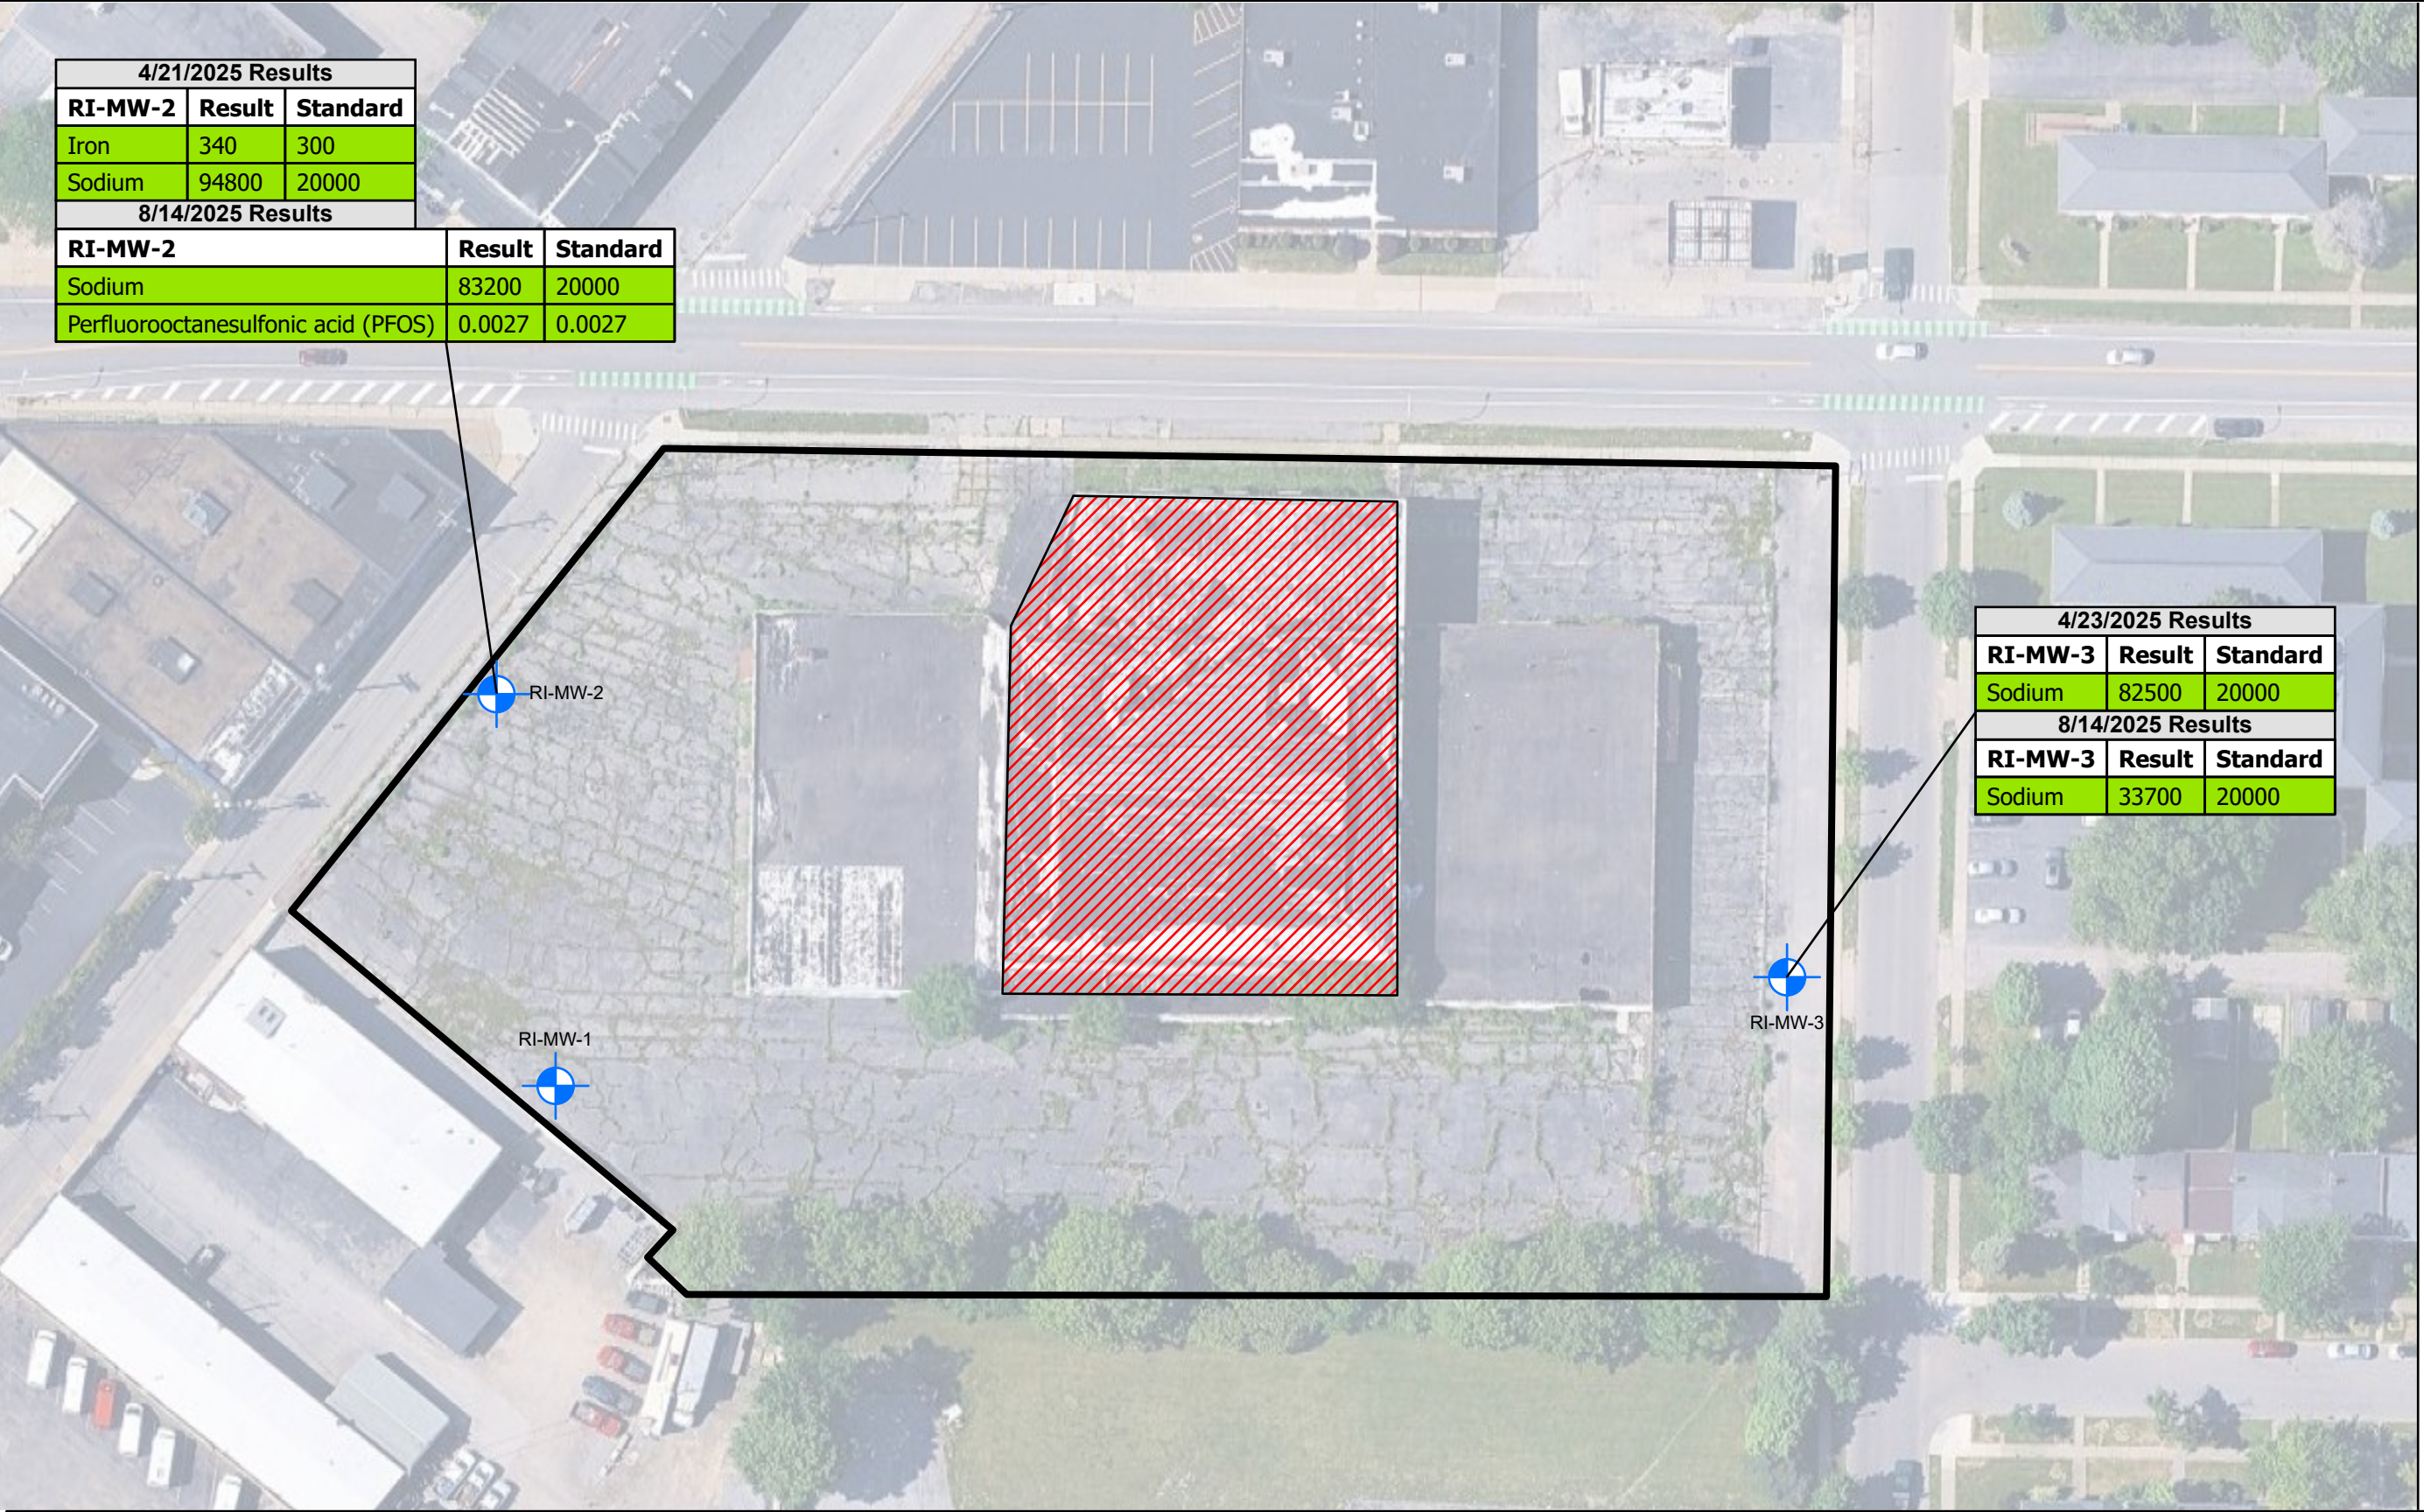
| 4/21/2025 Results | | |
| RI-MW-2 | Result | Standard |

The initial round of groundwater sampling yielded the following results: **iron was noted above the TOGS 1.1.1 standard** of 300 ppb in RI-MW-2 (340 ppb) and **sodium was noted above the TOGS 1.1.1 standard** of 20,000 ppb in RI-MW-2 (94,800 ppb) and RI-MW-3 (82,500 ppb).

The second round of groundwater sampling yielded the following results: **sodium was noted above the TOGS 1.1.1 standard** of 20,000 ppb in RI-MW-2 (83,200 ppb) and RI-MW-3 (33,700 ppb).

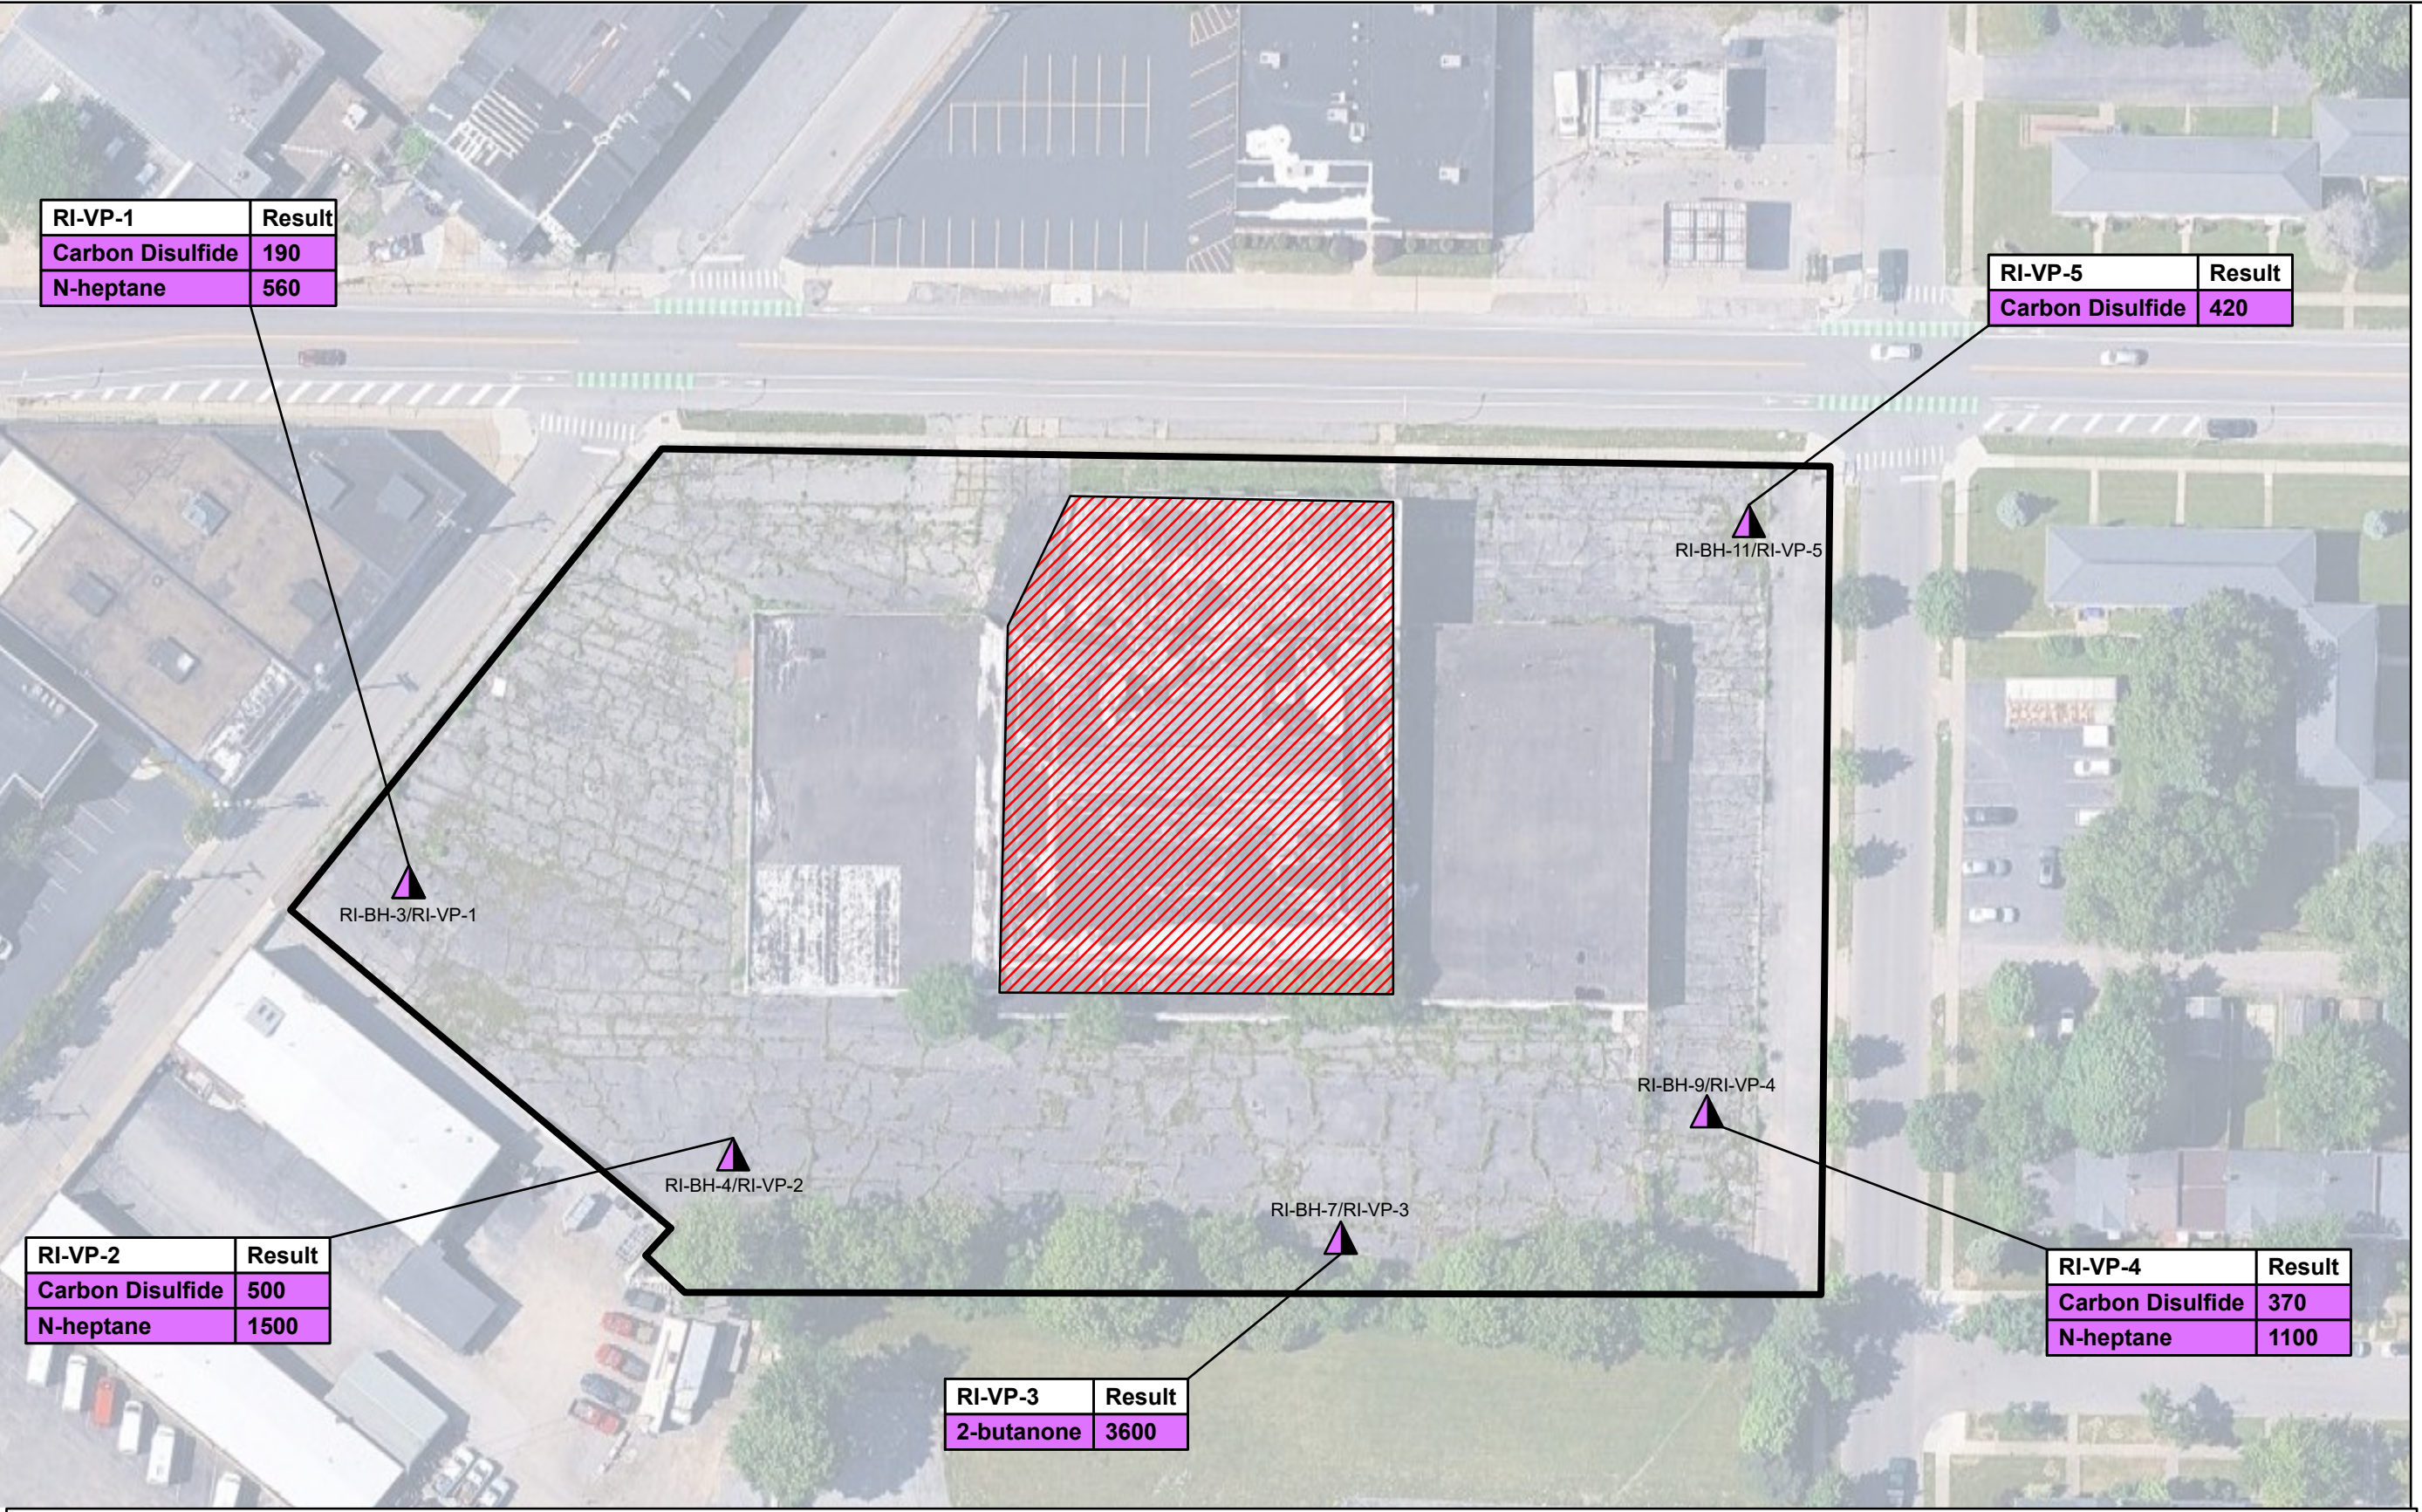
| RI-VP-1 | Result |
| Carbon Disulfide | 190 |

Elevated levels of the following petroleum-related VOCs were noted in specified samples: methyl ethyl ketone (2-butanone) in RI-VP-3 (3600 ug/m<sup>3</sup>), carbon disulfide in RI-VP-1 (190 ug/m<sup>3</sup>), RI-VP-2 (500 ug/m<sup>3</sup>), RI-VP-4 (370 ug/m<sup>3</sup>) and RI-VP-5 (420 ug/m<sup>3</sup>) and n-heptane in RI-VP-1 (560 ug/m<sup>3</sup>), RI-VP-2 (1500 ug/m<sup>3</sup>) and RI-VP-4 (1100 ug/m<sup>3</sup>). These elevated results are illustrated in **Figure 7**.

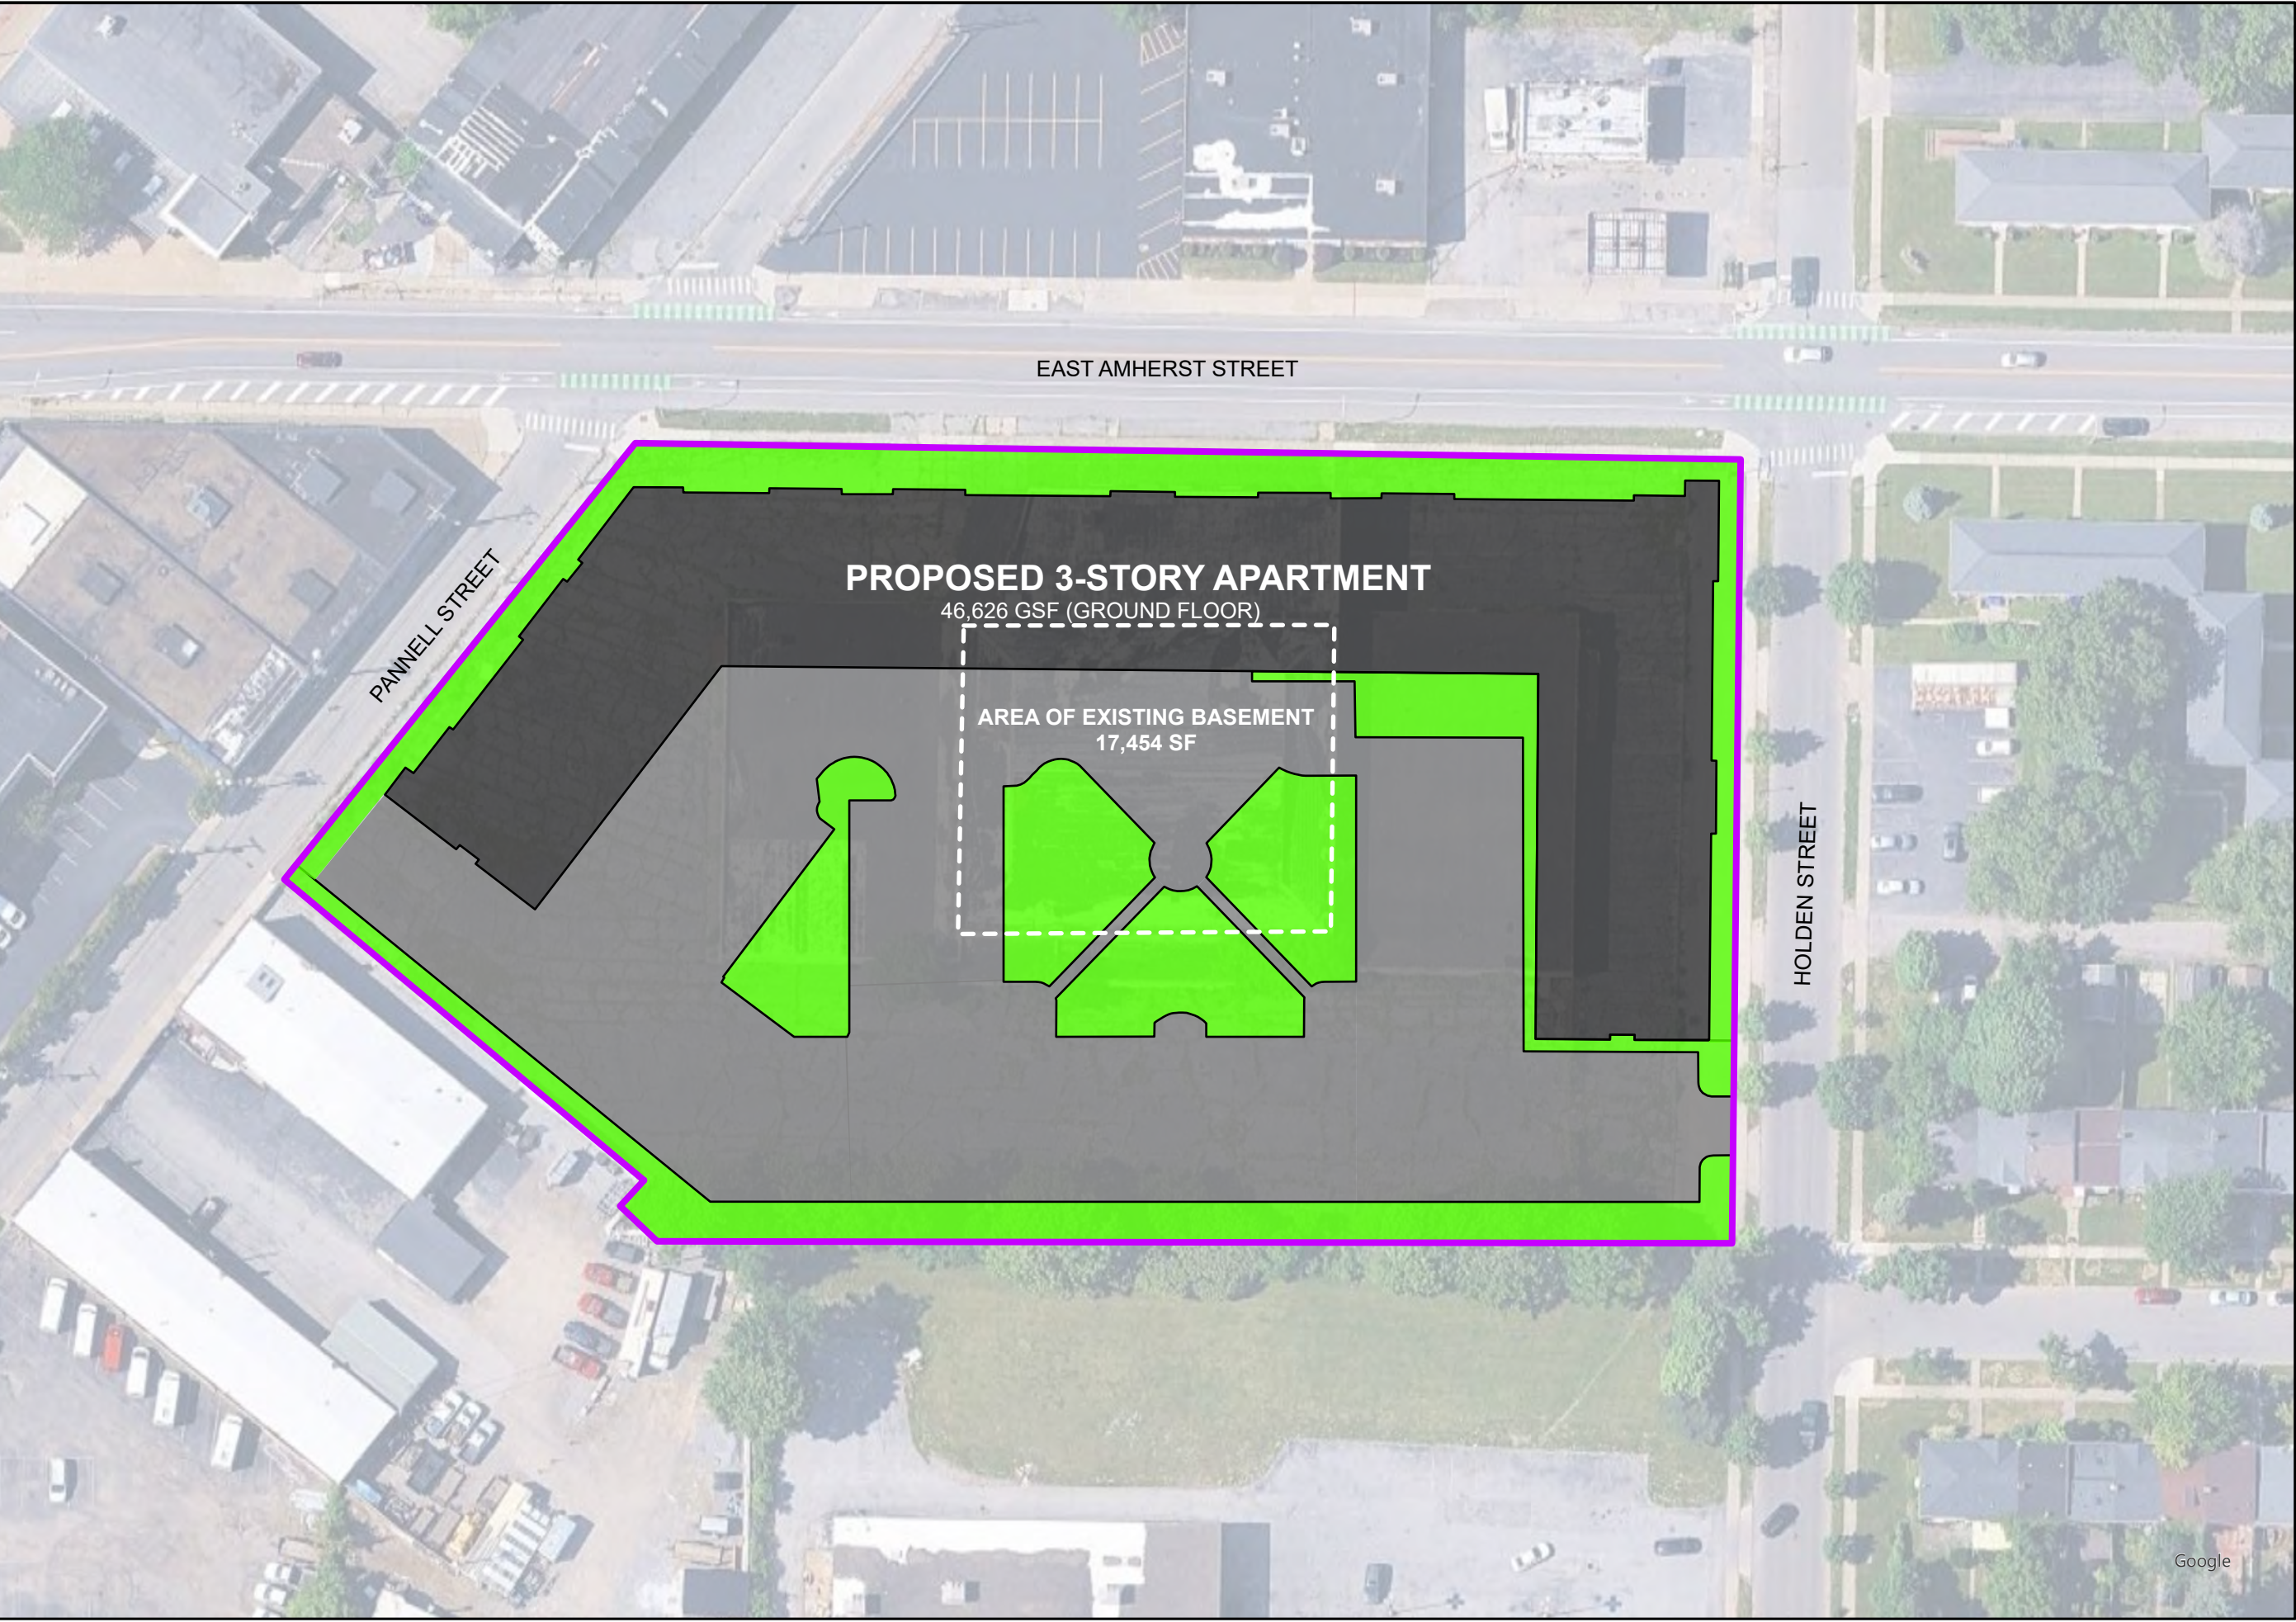
- 8,309 TONS OF SOIL REQUIRE REMOVAL.
- 2,403 TONS OF CLEAN FILL MUST BE IMPORTED TO MEET COVER REQUIREMENTS.
- 4,356 TONS OF CLEAN FILL MUST BE IMPORTED TO BRING THE EXISTING BASEMENT TO FINAL GRADE REQUIREMENTS (BASED ON AVERAGE 5.5 FOOT DEPTH).
- ESTIMATES ARE BASED ON AN ASSUMED AVERAGE DEPTH TO BEDROCK OF 5.5 FEET.
- (GSF): (GROSS) SQUARE FEET

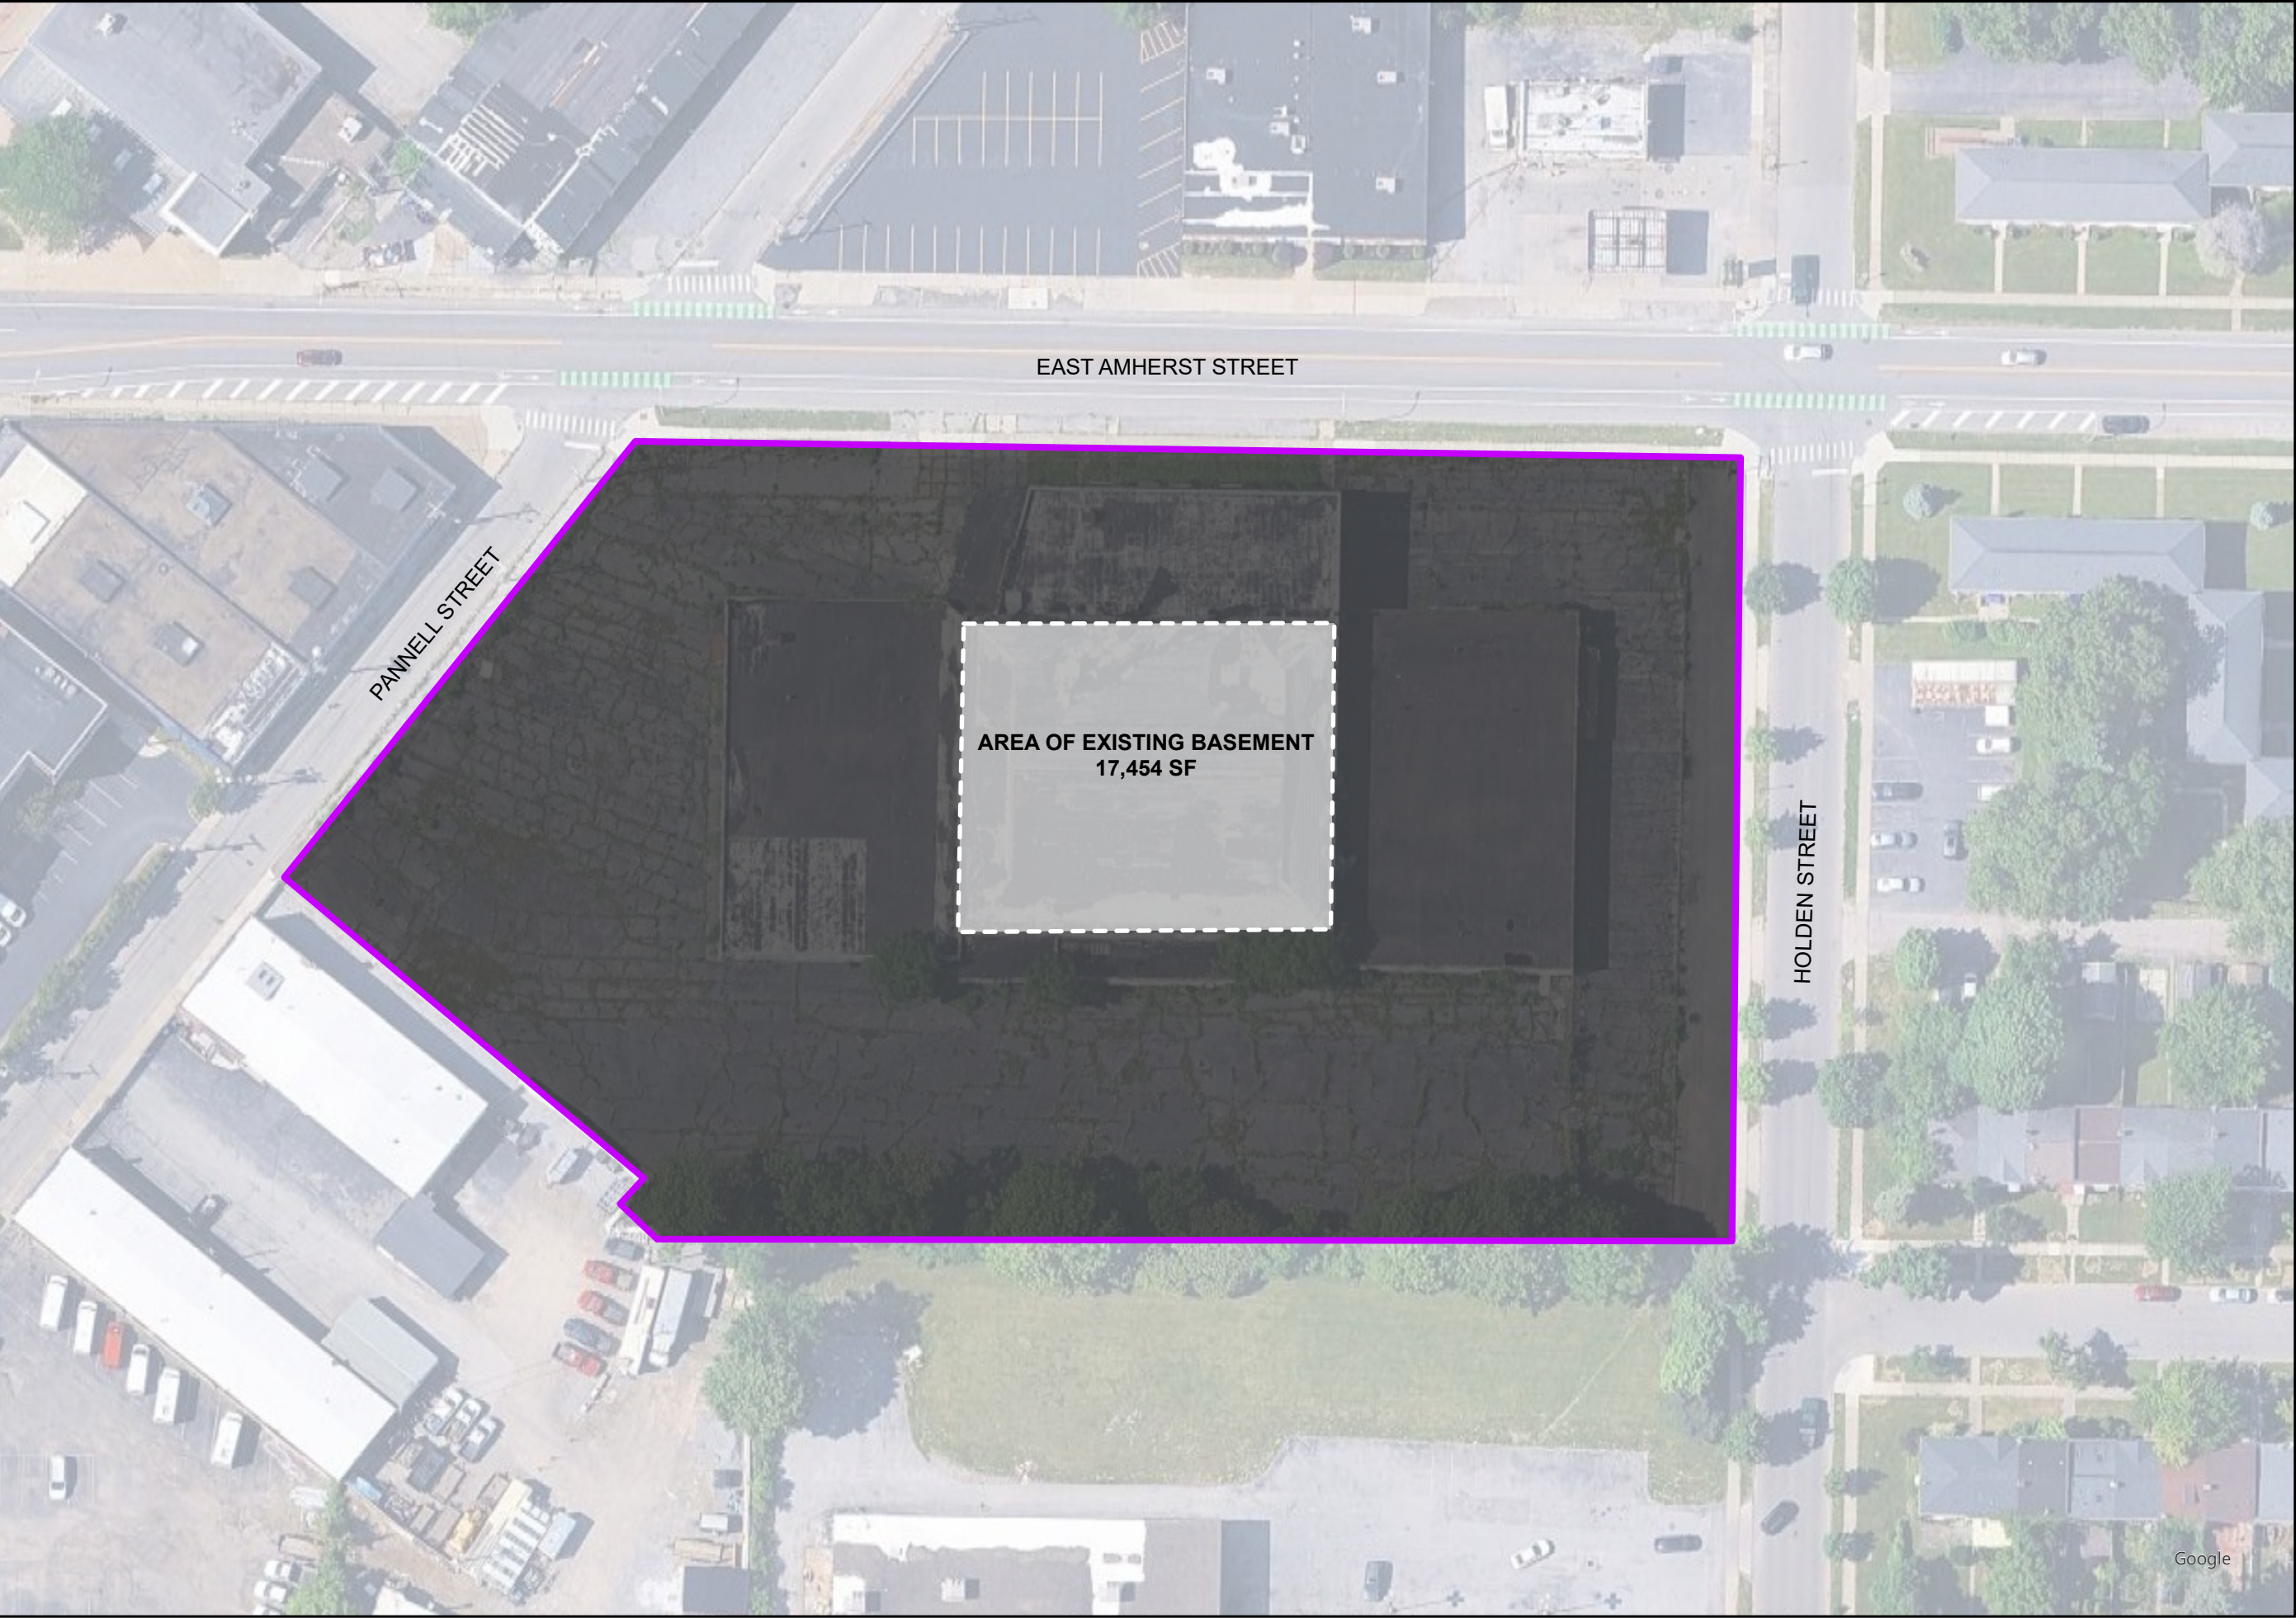
- 1.) 38,998 TONS OF SOIL REQUIRE REMOVAL (I.E., ALL SITE SOILS).
- 2.) 33,185 TONS OF CLEAN FILL MUST BE IMPORTED TO BRING THE SITE TO FINAL GRADE REQUIREMENTS.
- 3.) 4,356 TONS OF CLEAN FILL MUST BE IMPORTED TO BRING THE EXISTING BASEMENT TO FINAL GRADE REQUIREMENTS (BASED ON AVERAGE 5.5 FOOT DEPTH).
- 4.) ESTIMATES ARE BASED ON AN ASSUMED AVERAGE DEPTH TO BEDROCK OF 5.5 FEET.

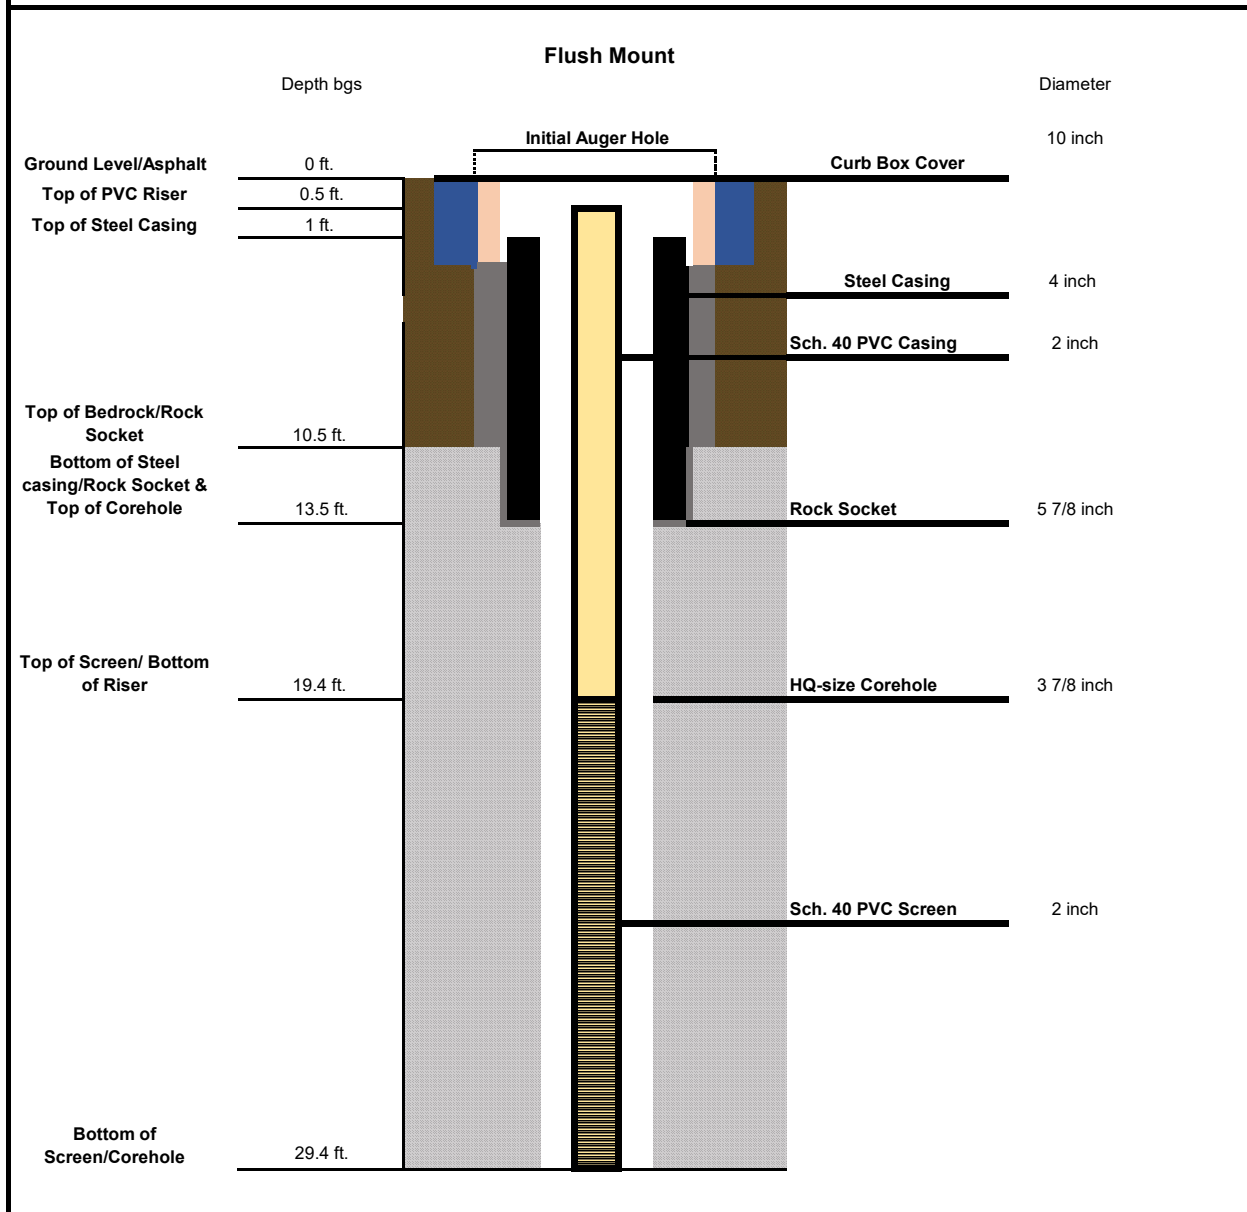
| Prepared for Regan Development Corp.<br> | Amherst Commons<br>47 East Amherst Street<br>Buffalo, Erie County, New York<br>NYSDEC BCP Site No. 915397 | Well ID: RI-MW-1 |

| DRILLING SUMMARY | | COMMENTS |
|---|---|---|
| <b>Geologist:</b> | Tim Burmeier | 1. The well was not sand packed therefore the white spacing on either side of the PVC riser and screen represents void space.<br>2. The steel casing was positioned 3 feet into bedrock.<br>3. All depths are measured from ground surface.<br>4. Well was extended 9.4' to attempt to reach the water table on 4/23/25.<br>5. No filter material was utilized. |

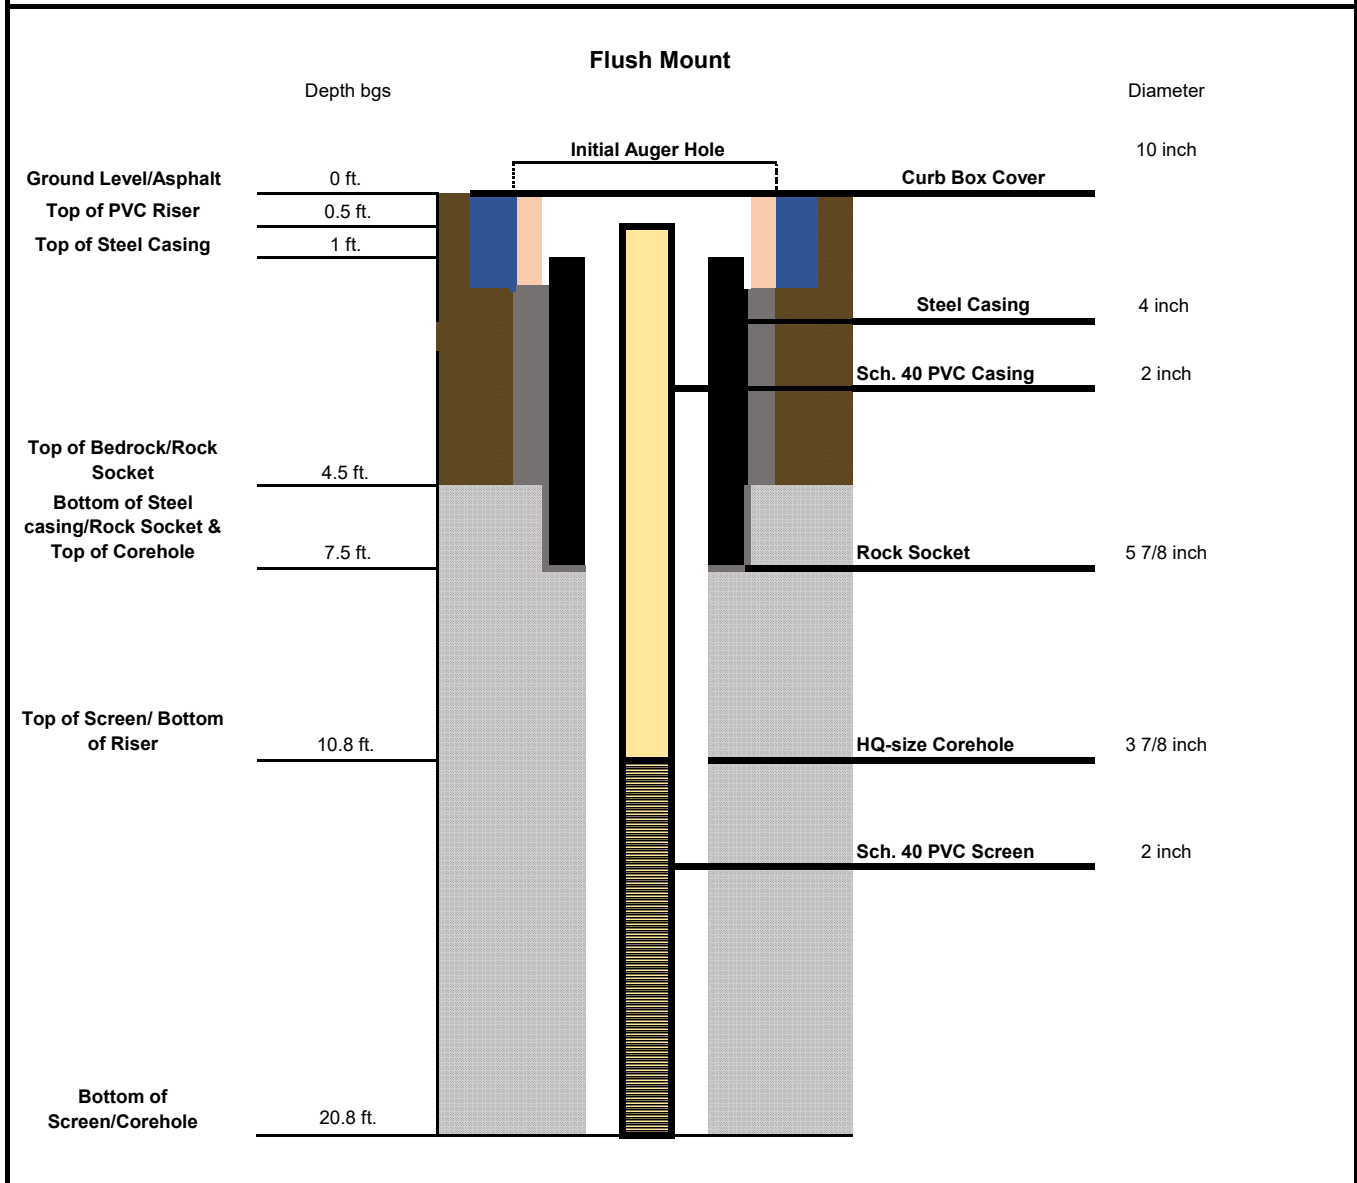
| Prepared for Regan Development Corp.<br> | Amherst Commons<br>47 East Amherst Street<br>Buffalo, Erie County, New York<br>NYSDEC BCP Site No. 915397 | Well ID: RI-MW-2 |

| DRILLING SUMMARY | | COMMENTS |
|---|---|---|
| <b>Geologist:</b> | Tim Burmeier | 1. The well was not sand packed therefore the white spacing on either side of the PVC riser and screen represents void space.<br>2. The steel casing was positioned 3 feet into bedrock.<br>3. All depths are measured from ground surface.<br>4. No filter material was utilized. |

Three permanent monitoring wells installed to a depth of 20 feet below ground surface (bgs) and associated sampling was included in the RIWP. During well installation, the casing in RI-MW-3 was at risk of becoming dislodged around 18 feet bgs due to vibrational force from the drill rig. As the well demonstrated a significant volume of water and notable fractures in the first few feet of bedrock, the well was left at this depth.

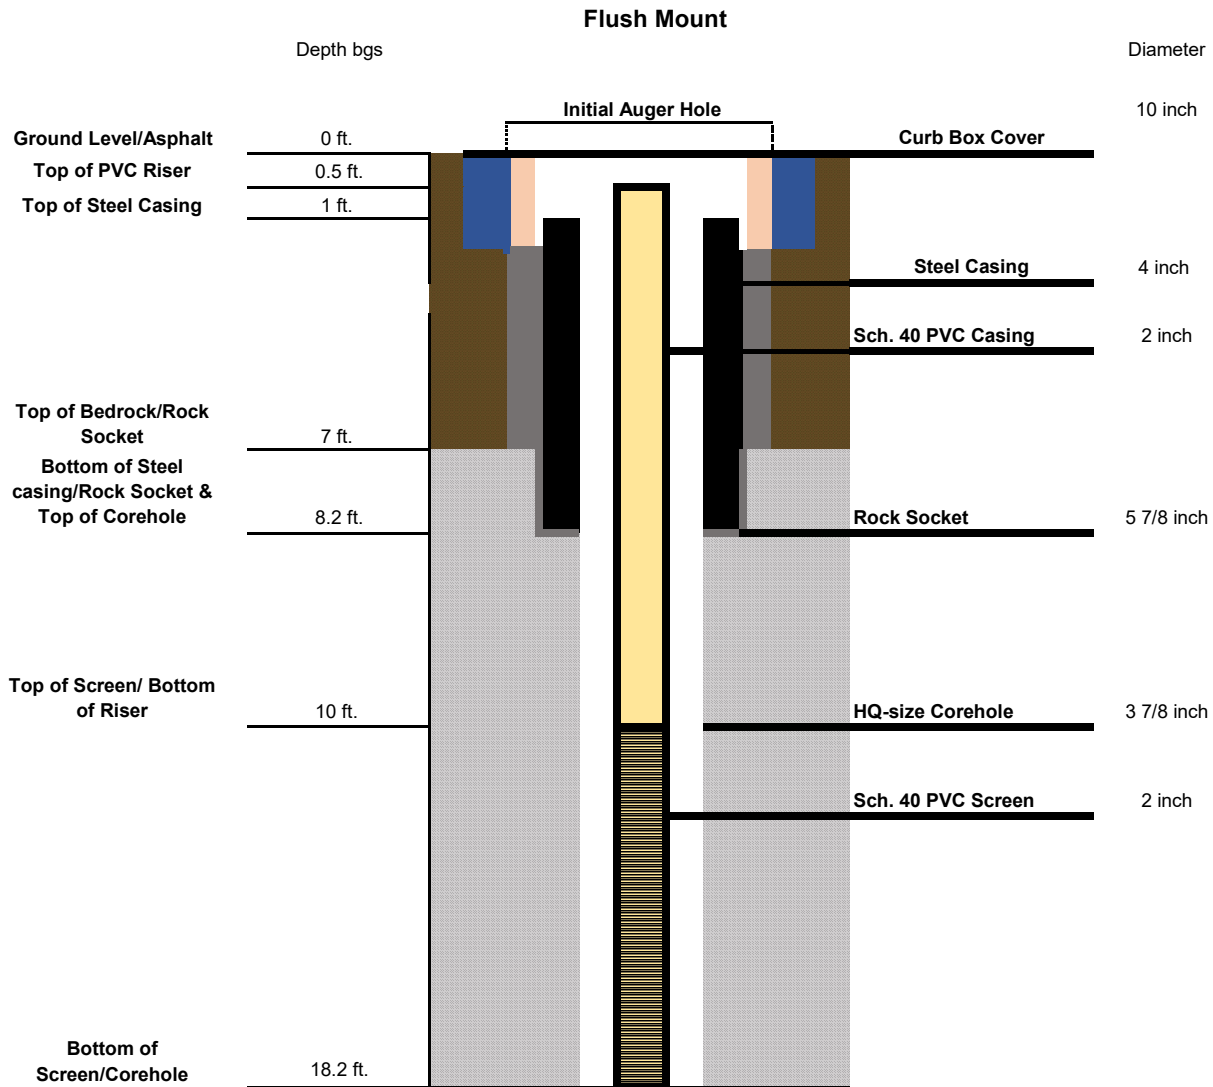
**Geologist:** Tim Burmeier  
**Contractor:** Empire Exploration and Geology  
**Operator:** Jason TadarSKI  
**Model:** CME 550 X ATV Drilling Rig  
**Date:** 4/10/2025
