SUBSURFACE PHASE II ENVIRONMENTAL SITE ASSESSMENT

**743 MAIN STREET
BUFFALO, ERIE COUNTY, NEW YORK**

July 2023

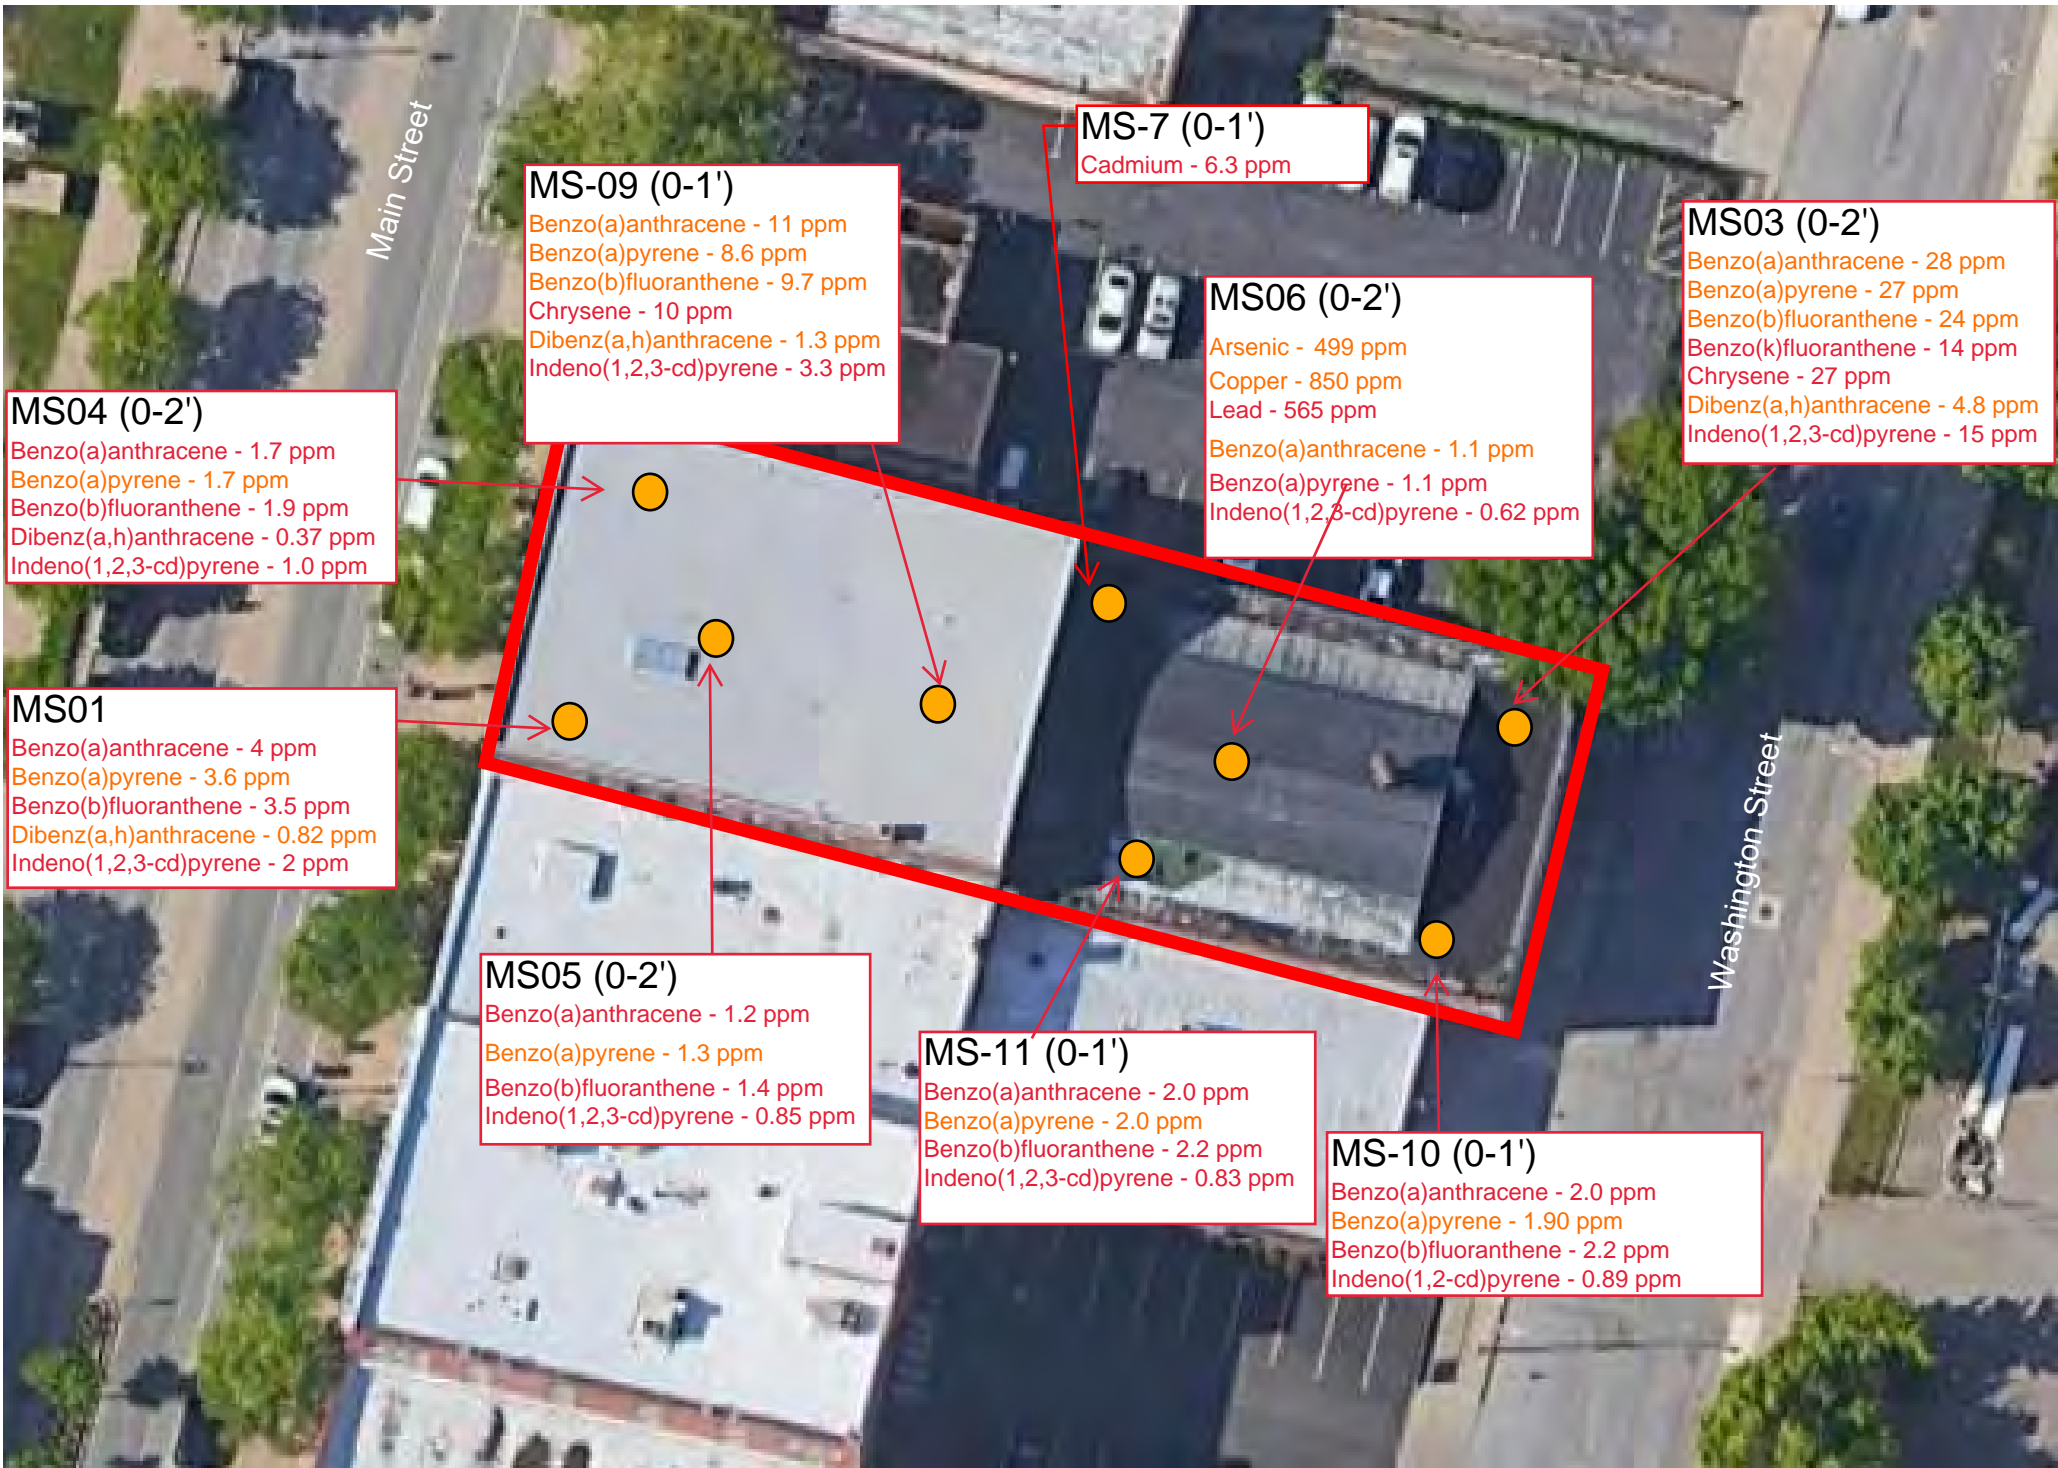
Figure 1: 743 Main Street - Boring Locations

This assessment included an investigation across the property (refer to **Figure 2**). The purpose of the assessment was to obtain information and data for assessing potential eligibility for the New York State Department of Environmental Conservation (NYSDEC) Brownfield Cleanup Program (BCP).

Metal compounds were observed in all soil samples analyzed. A summary of metals above NYSDEC SCOs is provided in **Table 1** and **Figure 2**. The following results were above NYSDEC restricted residential SCOs:

SVOC compounds were observed in all soil samples analyzed. A summary of SVOCs above NYSDEC SCOs is provided in **Table 1** and **Figure 2**. The following results were above NYSDEC restricted residential SCOs:

The laboratory results indicate that there are urban fill conditions existing at the property to at least 0-8 feet bgs resulting in target compounds (metals and SVOCs) above NYSDEC restricted residential and commercial SCOs. Historical use, previous environmental investigations, and this assessment indicate environmental impacts exist on the property in soils above NYSDEC SCOs.

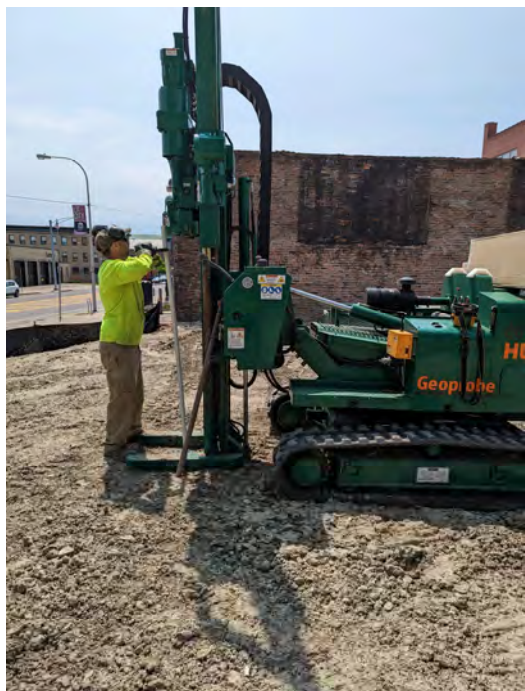
Geoprobe - Bore 09

Date:	Tuesday, May 9, 2023		
Site Name:	743 Main St.		
Location:	743 Main St.		
Contractor/Sub-Contractor:	TREC		
Weather Conditions:	Sunny	54 °F	SW 7 mph
<u>Description of Work Performed:</u> Driller mmobilized and performed nine borings with a geoprobe. BE3 evaluated material and pulled samples for analysis.			
Problems/Observations:	None.		
Health and Saftey Concerns:	None.		
Contractor Work Force:	TREC: 1 Operator		
Contractor Equipment			
Attachments : Daily report, Photo Log			
Inspectors Name	Libby Broderick
