Re: Limited Phase II Environmental Site Assessment (ESA)  
160 Empire Drive, West Seneca, NY

PHASE II ENVIRONMENTAL SITE ASSESSMENT

160 EMPIRE DRIVE  
WEST SENECA, NEW YORK

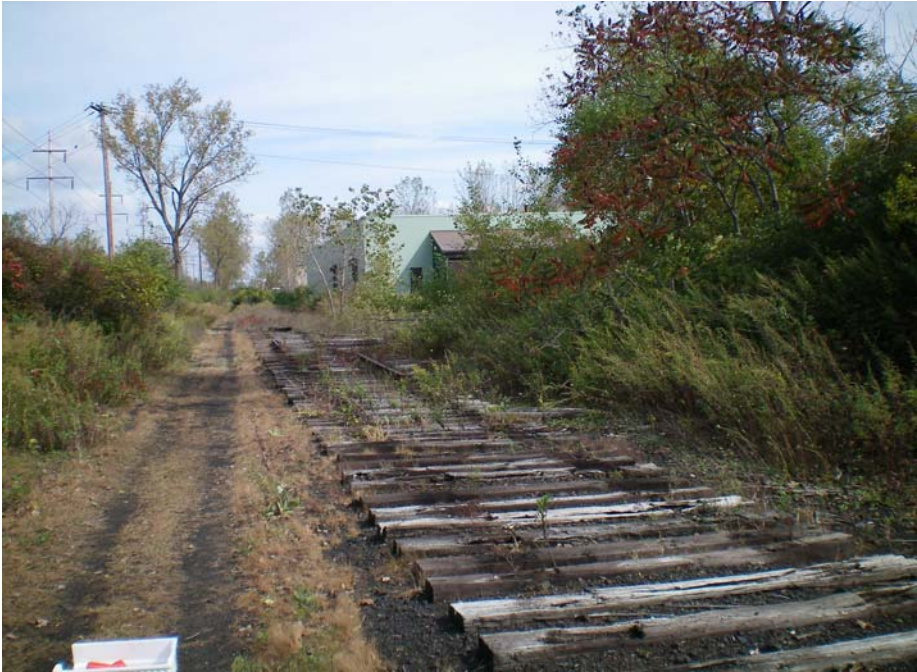
| <b>Photo No.</b><br><br>1 | <b>Date</b><br><br>10/08/09 | | |

The Site was generally flat, although elevated approximately four feet above all surrounding grade, with very dense vegetative cover, with one exception. The railroad corridor, located along the western property boundary, was generally free of vegetation with only railroad ties and ballast exposed at the surface (see Attachment 1). Subsurface soil at each test pit (from grade) was generally described as a non-native unit comprised of black, non-cohesive, cindery material with occasional pieces of coal, brick, piping, and steel underlain by a native brown, silty clay (CL/ML).

| <b>Description:</b><br>Railroad bed along western property boundary. | | | |

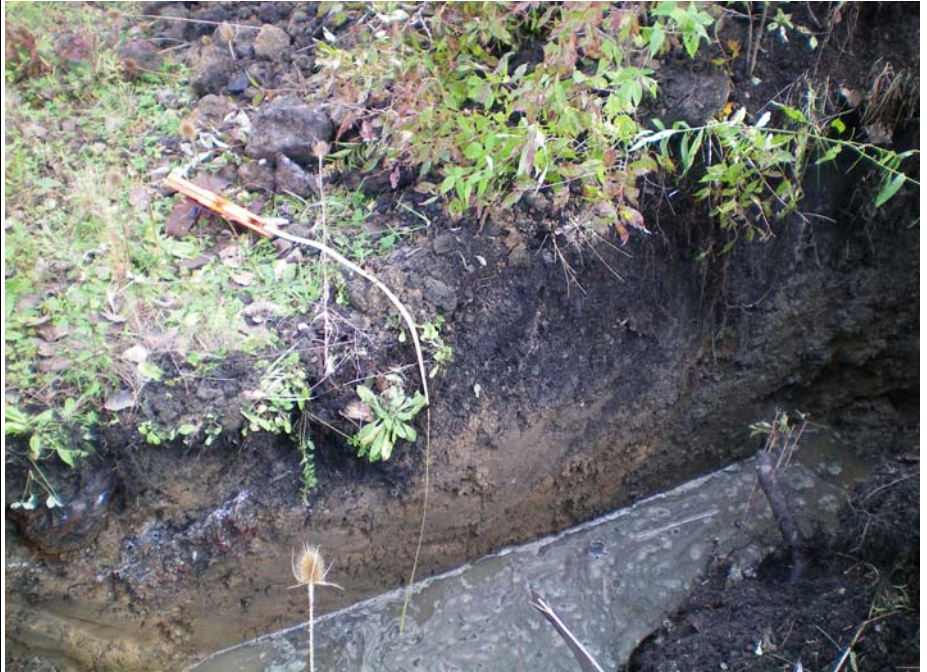
| <b>Photo No.</b><br><br>3 | <b>Date</b><br><br>10/08/09 | | |

Based upon visual, olfactory, and PID observations, environmental impacts were not identified within any of the 8 test pits excavated at the site. The first water bearing zone (i.e., saturated zone) was not encountered within 6.5 feet of the surface, although a perched condition was observed on top of the native low permeable silty clay unit.

| <b>Description:</b><br>Typical cross-section and soil profile of test pits along RR corridor; notice perched water condition. | | | |

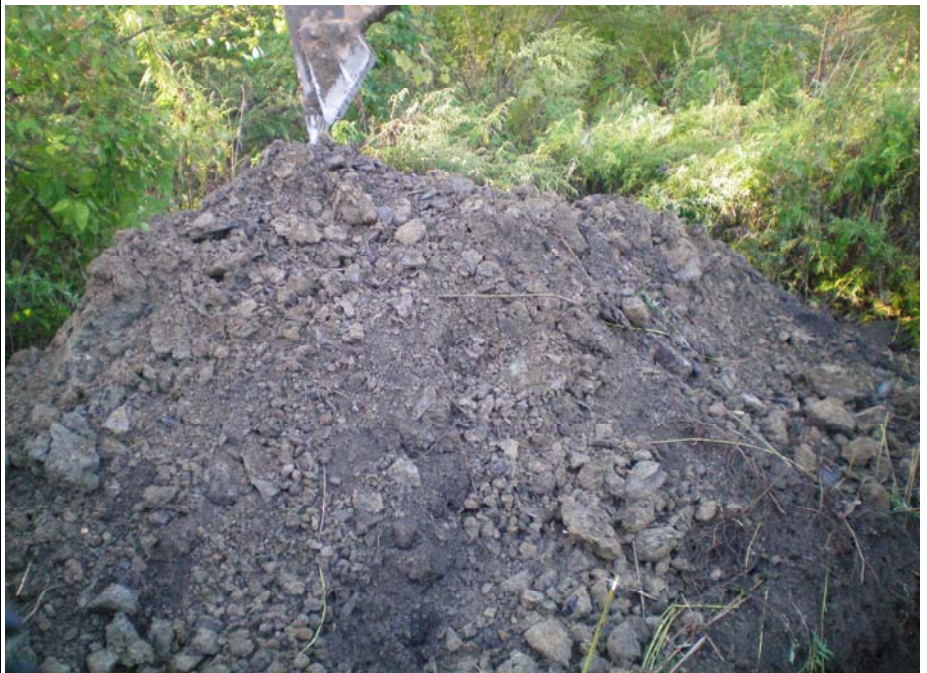
| <b>Photo No.</b><br><br>4 | <b>Date</b><br><br>10/08/09 | |

| <b>Description:</b><br>Spoils pile from test pit TP-1. | | |

Following completion of each test pit, excavated material was returned to the excavation in the opposite order it was removed and compacted to roughly match the existing grade.

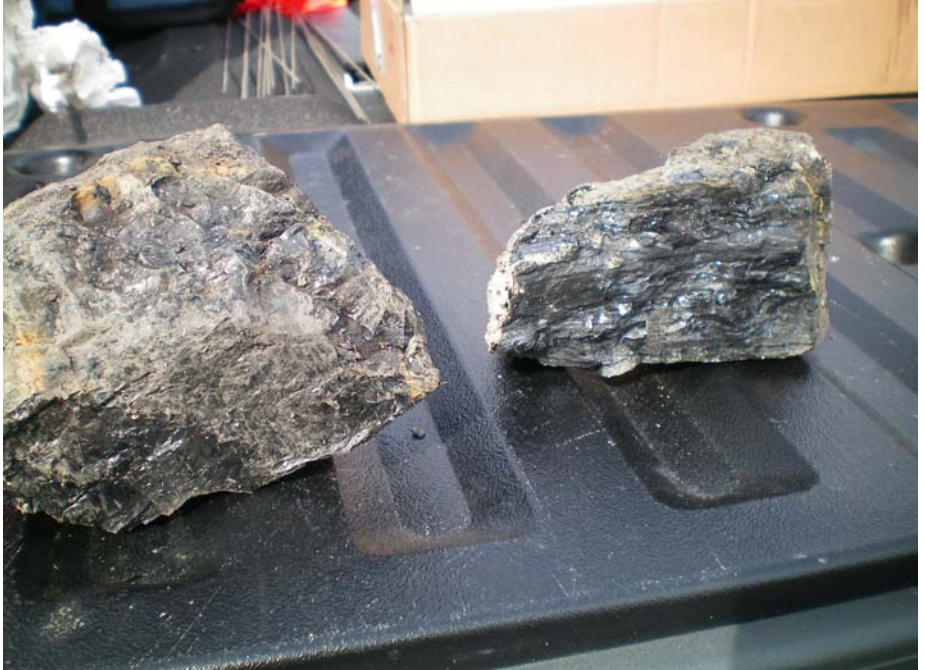
| <b>Photo No.</b><br><br>5 | <b>Date</b><br><br>10/08/09 | | |

| <b>Description:</b><br>Pieces of coal recovered from test pit TP-2. | | | |

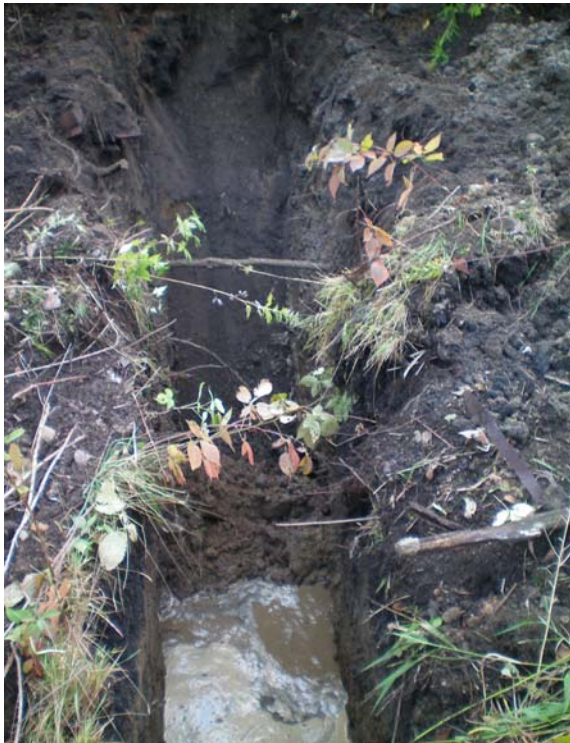
| <b>Photo No.</b><br><br>6 | <b>Date</b><br><br>10/08/09 | |

| <b>Description:</b><br>Test pit TP-5; perched water is coming from the railroad bed side of the excavation. | | |
