Re: Supplemental Phase II Environmental Site Assessment
160 Empire Drive, West Seneca, NY

SUPPLEMENTAL PHASE II ENVIRONMENTAL SITE ASSESSMENT

160 EMPIRE DRIVE
WEST SENECA, NEW YORK

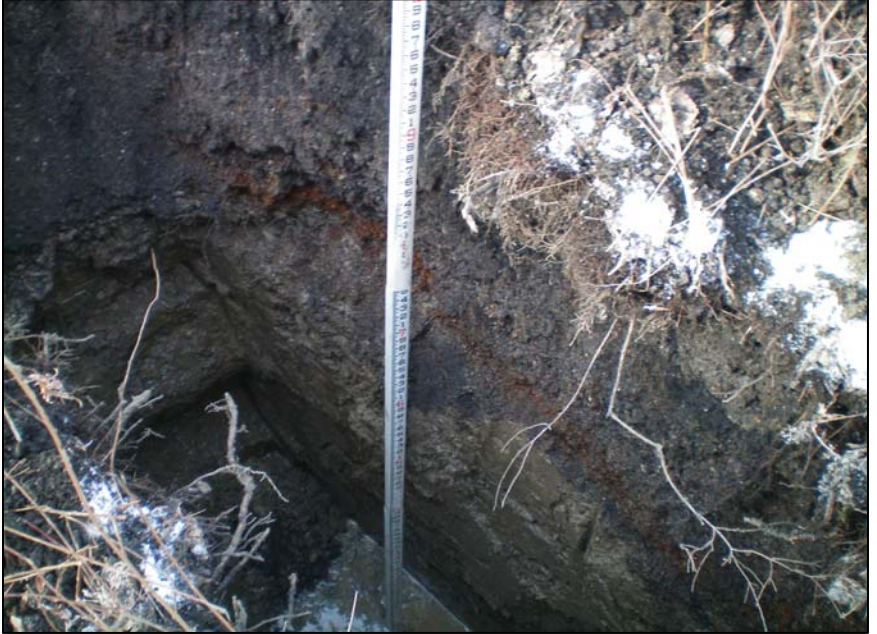
Client Name: Derrick Corporation		Site Location: 160 Empire Drive, West Seneca, NY	Project No.: 0207-001-100
Photo No. 1	Date 12/18/09

Direction Photo Taken: NA			
Description: Slag/cinder soil/fill overlying reworked silty clay encountered at test pit TP-09.

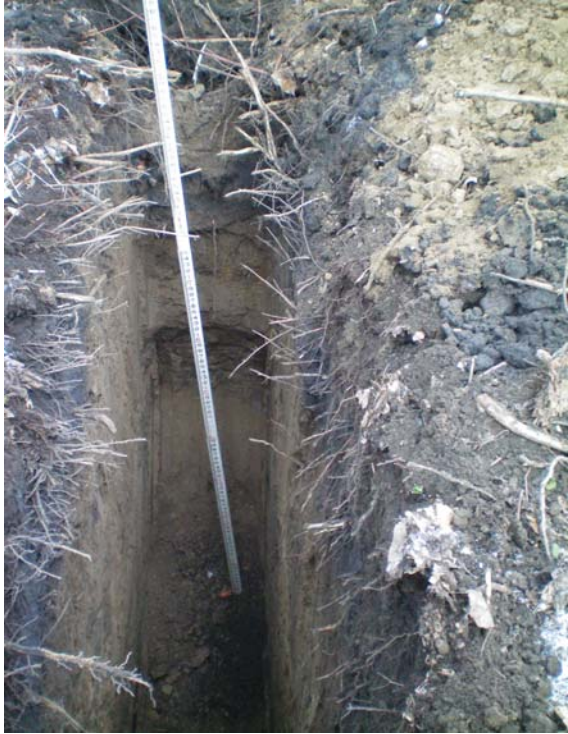
Client Name: Derrick Corporation		Site Location: 160 Empire Drive, West Seneca, NY	Project No.: 0207-001-100
Photo No. 3	Date 12/18/09

Direction Photo Taken: NA			
Description: Typical subsurface lithology observed at the Site (native clayey silt underlying a black/dark brown soil/fill unit). TP-12 is shown here.

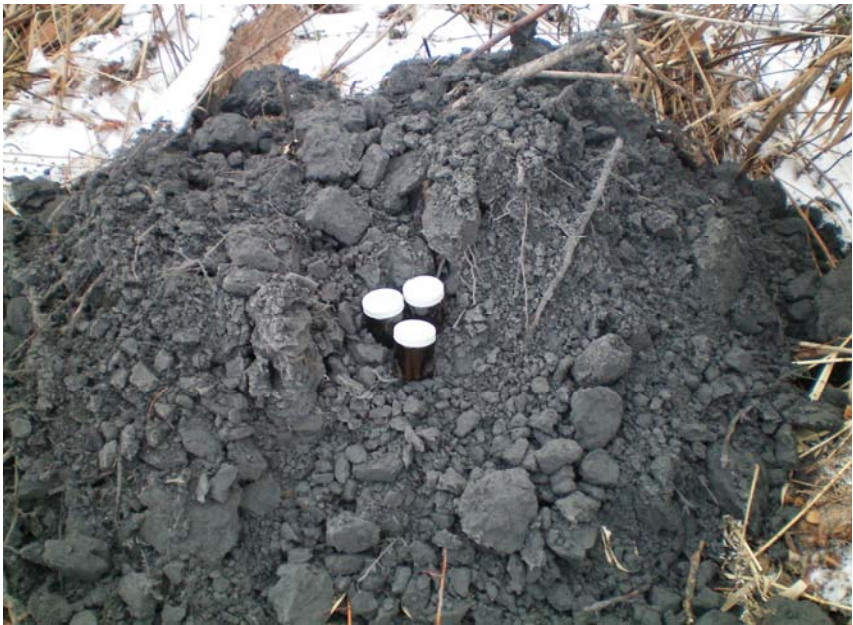
Photo No. 4	Date 12/18/09

Direction Photo Taken: NA		
Description: Typical black soil/fill encountered at the Site. The location shown is from test pit TP-12.

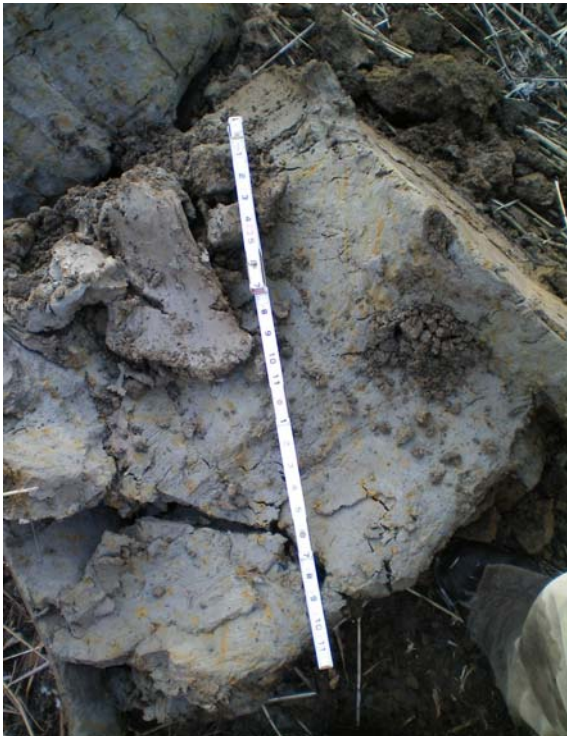
Client Name: Derrick Corporation		Site Location: 160 Empire Drive, West Seneca, NY	Project No.: 0207-001-100
Photo No. 5	Date 12/18/09

Direction Photo Taken: NA			
Description: Typical native clayey silt soils from test pit TP-15; notice iron-stained mottling.

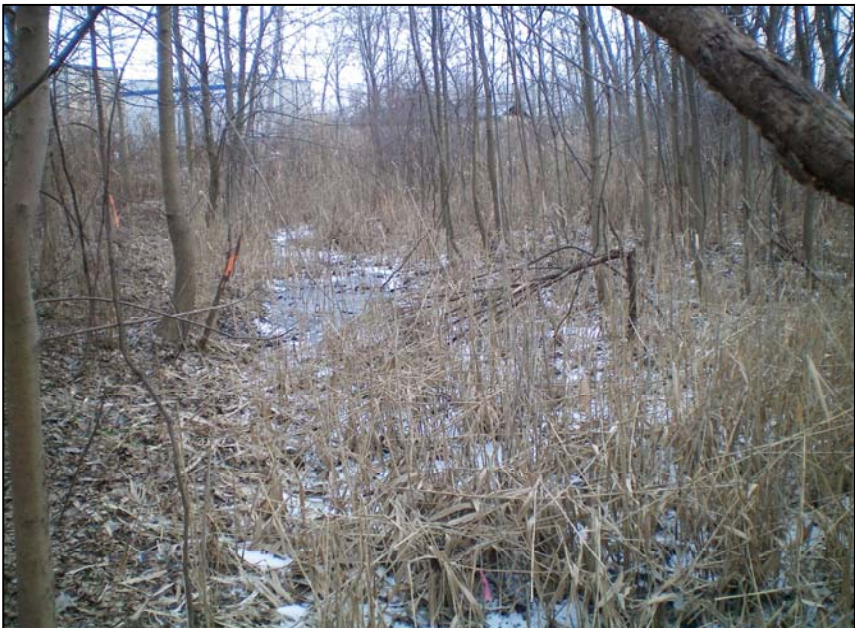
Photo No. 6	Date 12/18/09

Direction Photo Taken: west		
Description: Photograph shows a low-lying wet area southeast of test pit TP-14. The proposed test pit was not excavated in this area.
