# SUBSURFACE ENVIRONMENTAL SITE ASSESSMENT

**375 MICHIGAN AVENUE  
BUFFALO, ERIE COUNTY, NEW YORK**

August 2020

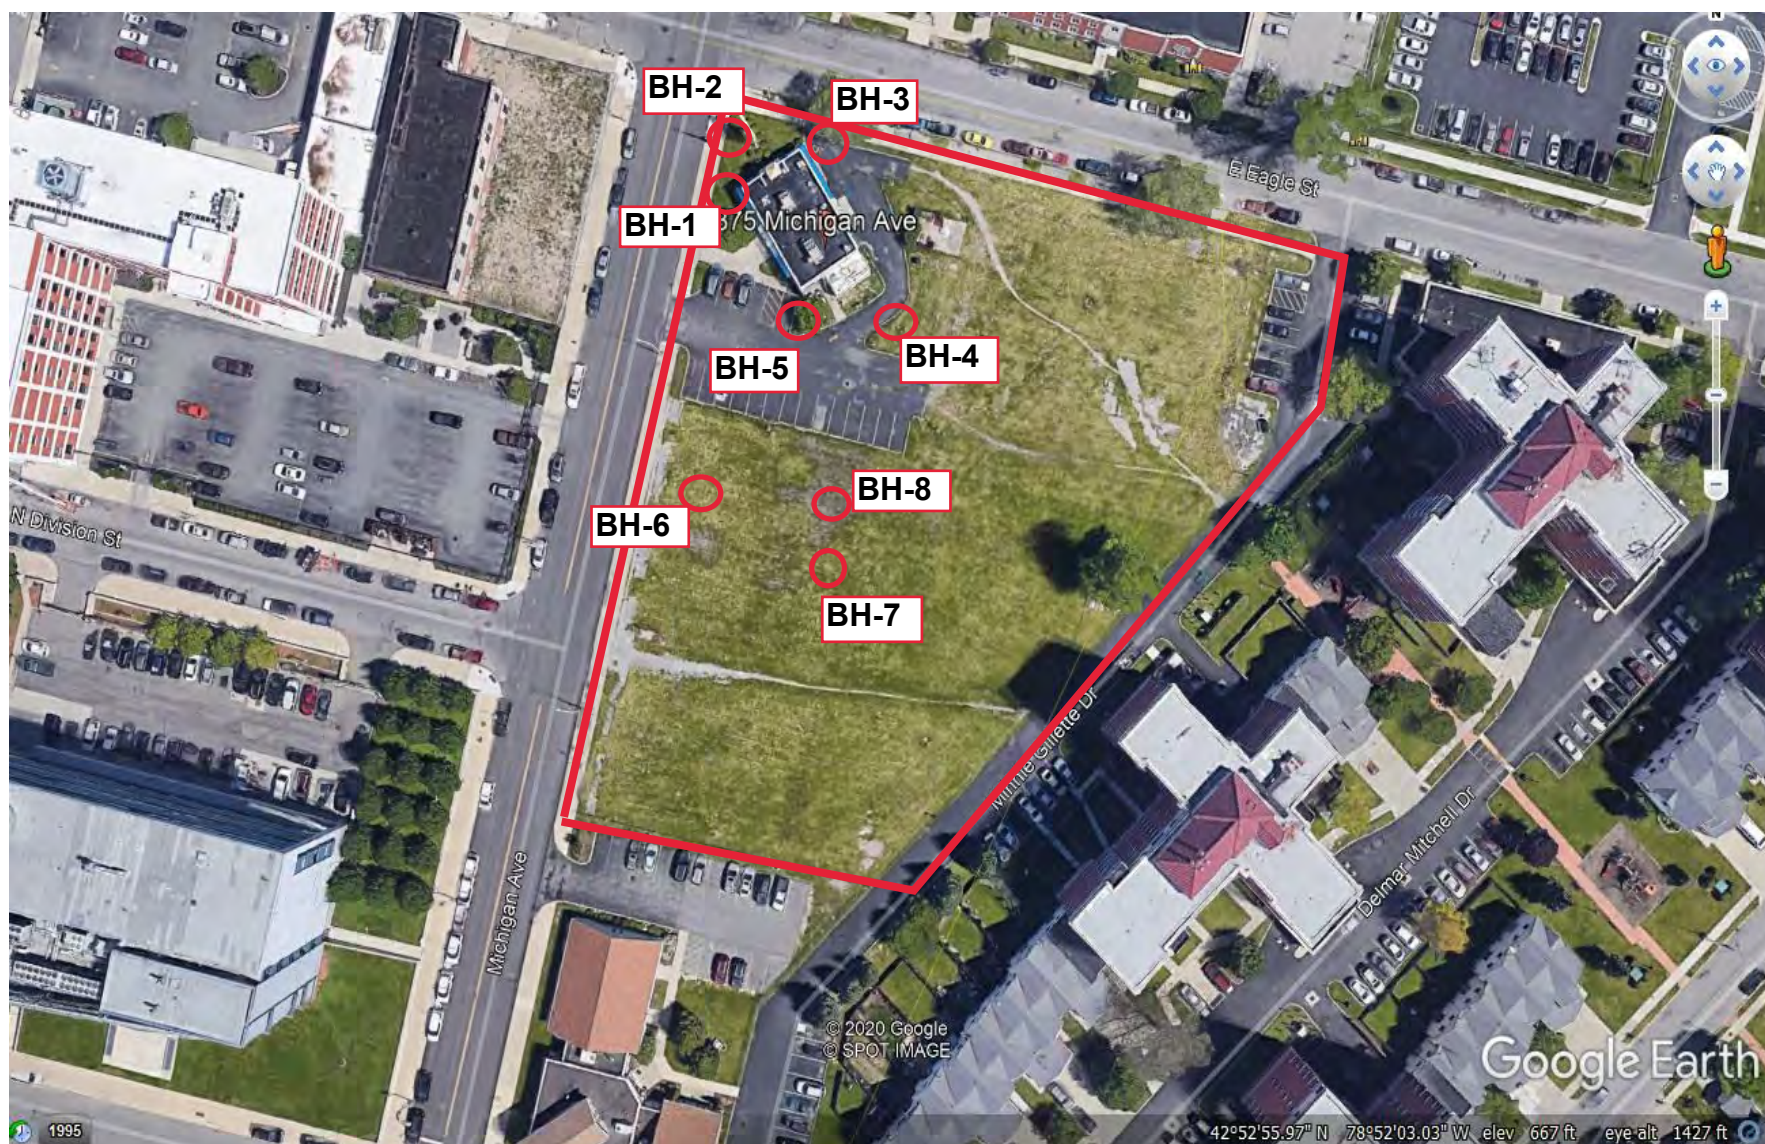
**FIGURE 2: Property Location and borehole locations**

The subsurface soil assessment was focused in those areas (**Refer to Figure 2**). The purpose of the assessment was to obtain additional information and data for assessing potential environmental impacts at the property.

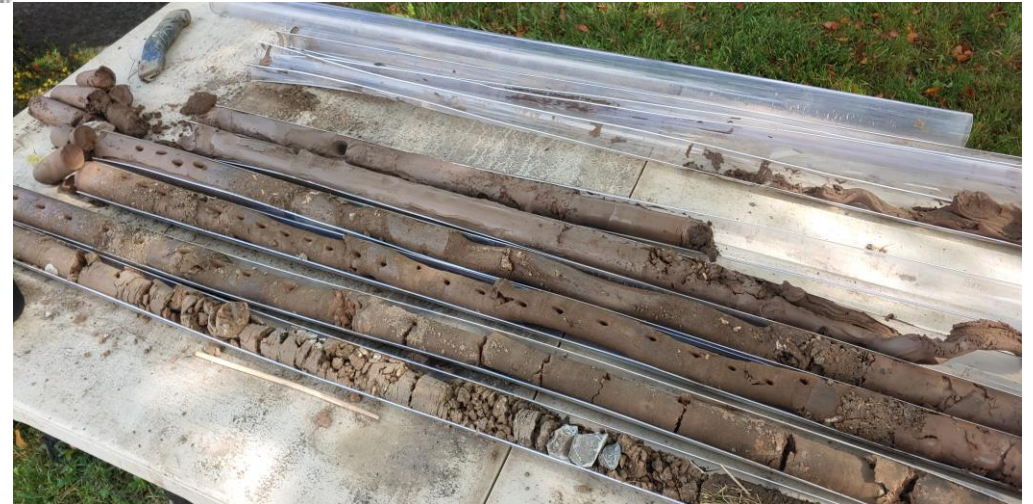
4. Soil cores BH-1

The borings indicate that subsurface conditions generally consisted of fill material to about 1-2 feet in most locations consisting of stone from the former parking area and silty soil with some pieces of concrete, brick and wood. This is deeper in areas of former building locations. Below the fill is stiff, tight red-brown clay to 12 feet at least. In some locations this was less stiff at deeper depths. Boreholes were completed at 8 to 12 feet bgs with borehole BH-1 completed at 20 feet bgs. .

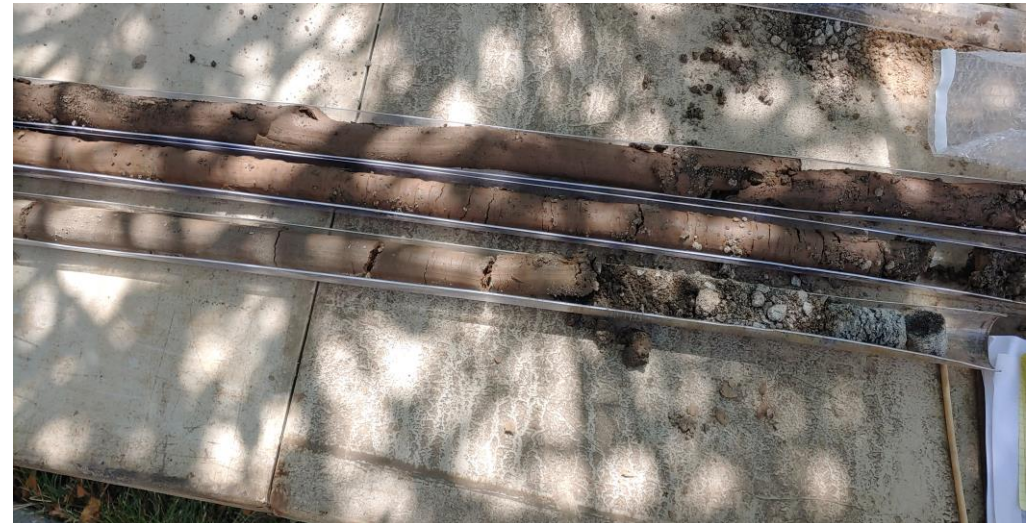
16. Soil Cores from BH-5

- BH-5 at 8 feet bgs. Total depth of boring was 8 feet bgs;
- BH-8 at 5.5-6 feet bgs. Total depth of boring was 12 feet bgs;

There was no indication of subsurface impacts from petroleum or solvents in any of the borings. A total of two samples were collected to confirm visual and field screening observations as noted in Section 2.1. The results did not indicate the presence of volatile organic compounds in either soil sample.

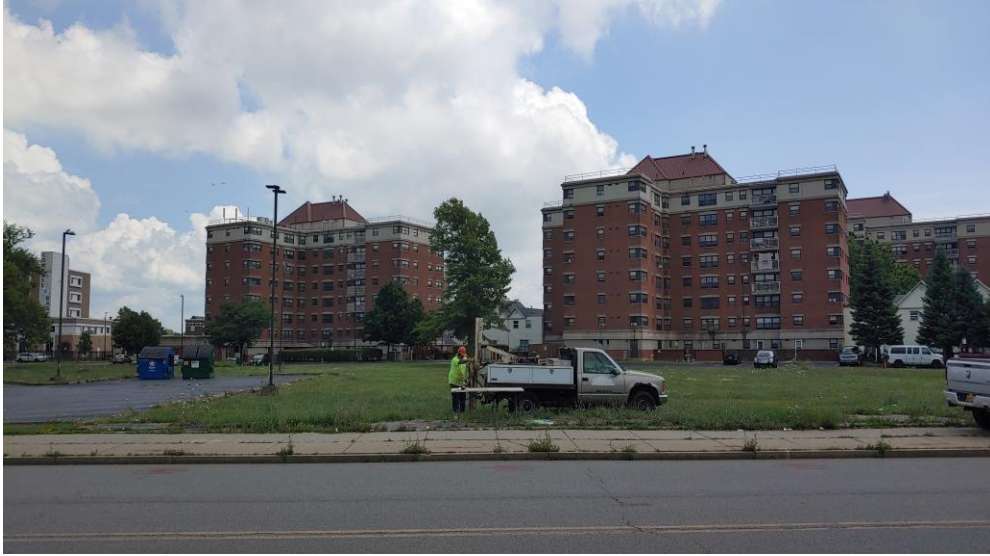
17. Location of Borehole BH-6 (Top of Berm) from west facing east
