REMEDIAL INVESTIGATION/  
ALTERNATIVES ANALYSIS/  
INTERIM REMEDIAL MEASURES REPORT

FORMER REMINGTON-RAND FACILITY  
184 SWEENEY STREET  
CITY OF NORTH TONAWANDA  
NIAGARA COUNTY, NEW YORK

Panamerican  
Environmental, Inc.

NOVEMBER 2010

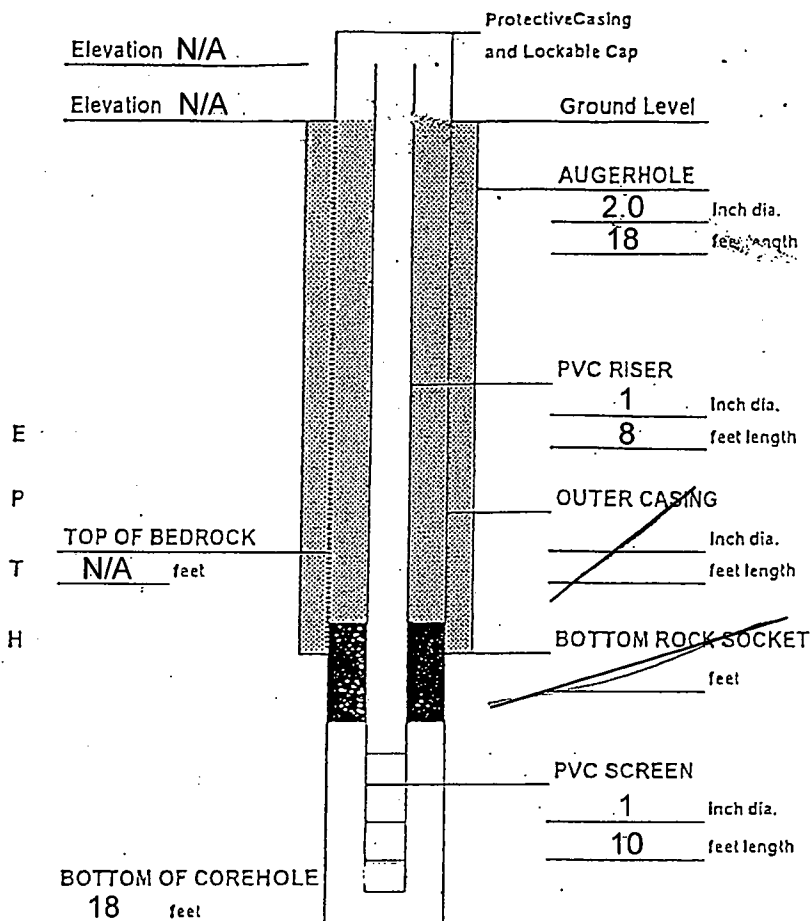
WELL DESIGN		
CASING MATERIAL	SCREEN MATERIAL	FILTER MATERIAL
Surface:	Type: 1" threaded PVC	Type: Sand Setting: 2' - 18' bgs
Monitor:	Slot Size: 0.01	SEAL MATERIAL
		Type: Grout Setting:
COMMENTS	ROCK CORING	LEGEND
Grout from 2' to 0' bgs	Cored Interval:	Cement/Bentonite Grout
	Core Diameter:	Bentonite Seal
	Reamed Diameter:	Silica Sandpack
		Bedrock
Client: The Kissling Intrests, LLC	Location:	Project No.: E8033
	WELL CONSTRUCTION DETAILS	Well Number: RR-MW-01

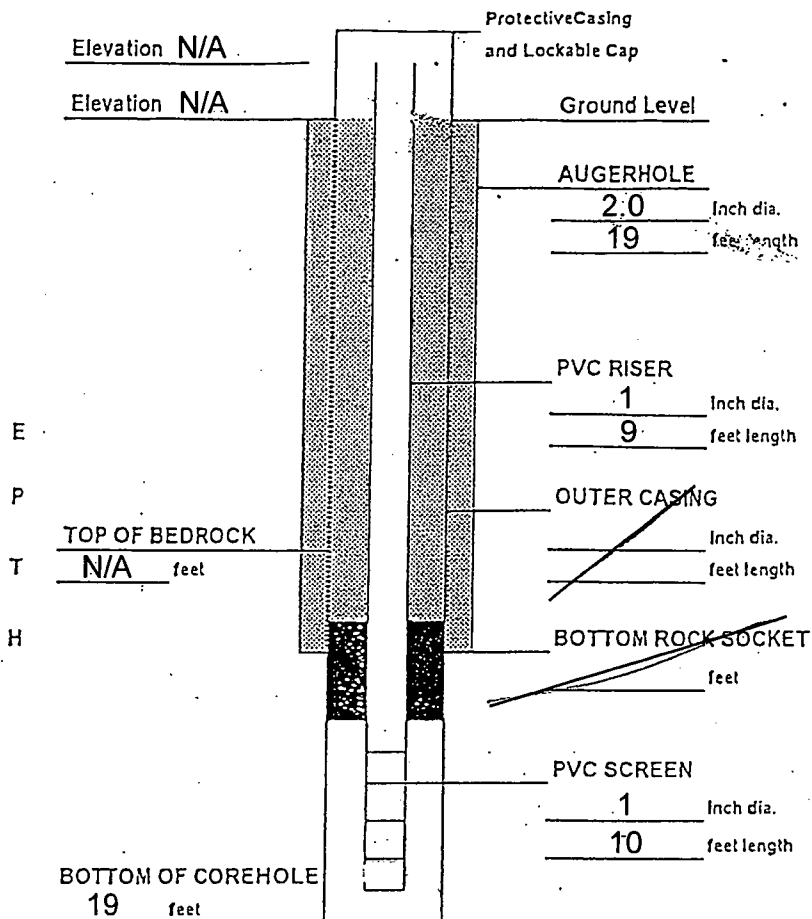
WELL DESIGN		
CASING MATERIAL	SCREEN MATERIAL	FILTER MATERIAL
Surface:	Type: 1" threaded PVC	Type: Sand Setting: 2' - 19' bgs
Monitor:	Slot Size: 0.01	SEAL MATERIAL
		Type: Grout Setting:
COMMENTS	ROCK CORING	LEGEND
Grout from 2' to 0' bgs	Cored Interval:	Cement/Bentonite Grout
	Coring Diameter:	Bentonite Seal
	Reamed Diameter:	Silica Sandpack
		Bedrock
Client: The Kissling Intrests, LLC	Location:	Project No.: E8033
	WELL CONSTRUCTION DETAILS	Well Number: RR-MW-02

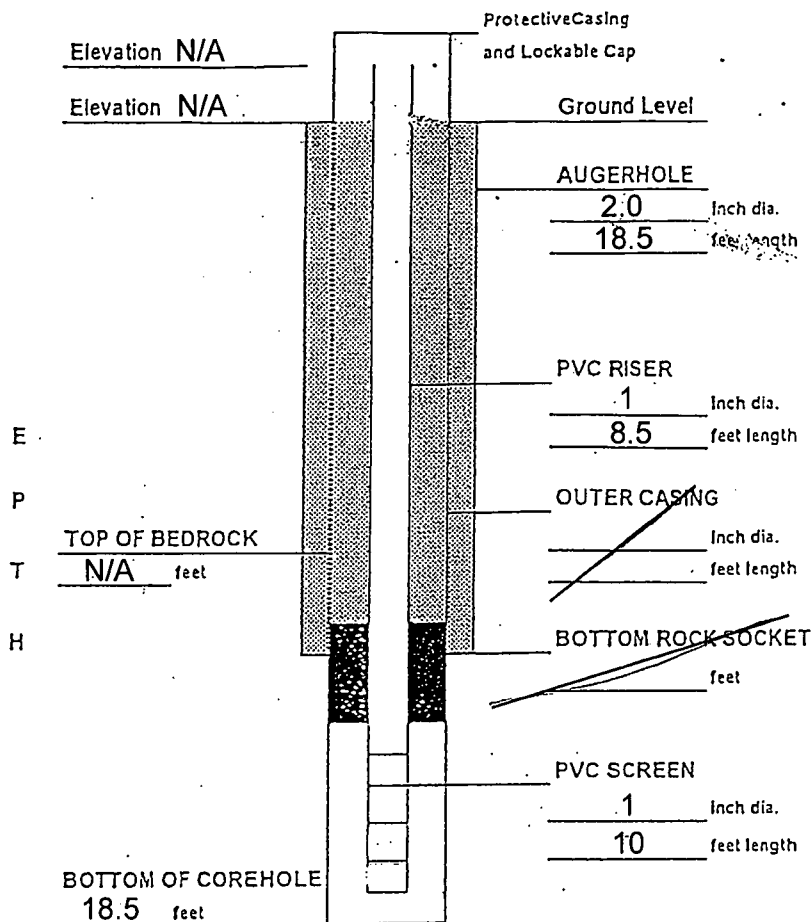
WELL DESIGN		
CASING MATERIAL	SCREEN MATERIAL	FILTER MATERIAL
Surface:	Type: 1" threaded PVC	Type: Sand Setting: 2' - 18.5' bgs
Monitor:	Slot Size: 0.01	SEAL MATERIAL
		Type: Grout Setting:
COMMENTS	ROCK CORING	LEGEND
Grout from 2' to 0' bgs	Cored Interval:	Cement/Bentonite Grout
	Core Diameter:	Bentonite Seal
	Reamed Diameter:	Silica Sandpack
		Bedrock
Client: The Kissling Intrests, LLC	Location:	Project No.: E8033
	WELL CONSTRUCTION DETAILS	Well Number: RR-MW-03

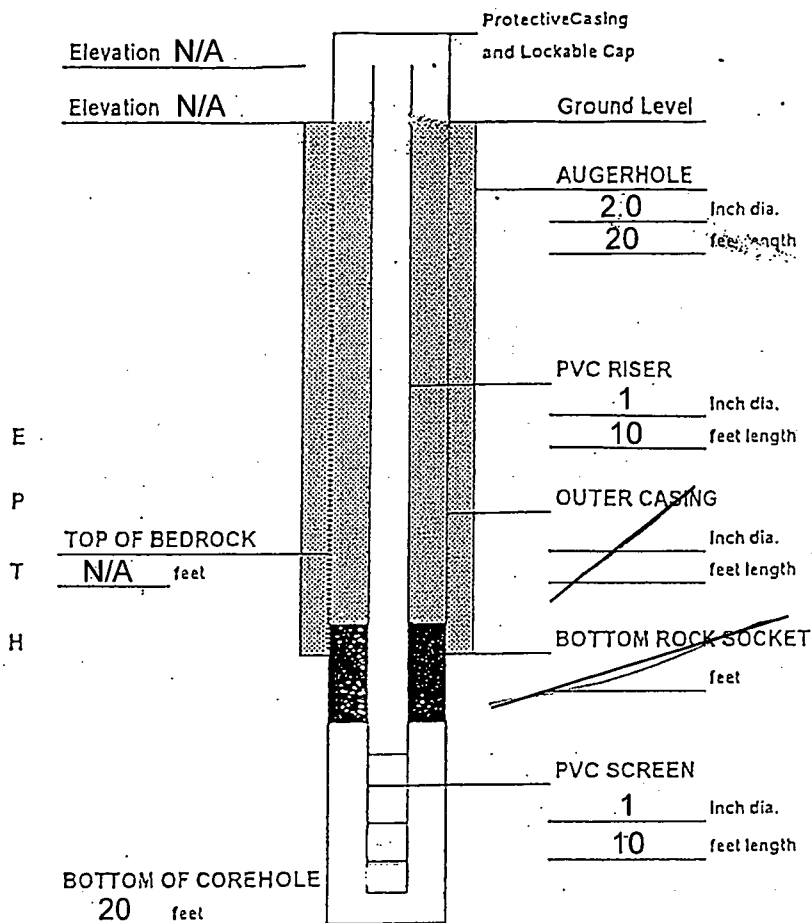
WELL DESIGN		
CASING MATERIAL	SCREEN MATERIAL	FILTER MATERIAL
Surface:	Type: 1" threaded PVC	Type: Sand Setting: 2' - 20' bgs
Monitor:	Slot Size: 0.01	SEAL MATERIAL
		Type: Grout Setting:
COMMENTS	ROCK CORING	LEGEND
Grout from 2' to 0' bgs	Cored Interval:	Cement/Bentonite Grout
	Core Diameter:	Bentonite Seal
	Reamed Diameter:	Silica Sandpack
		Bedrock
Client: The Kissling Intrests, LLC	Location:	Project No.: E8033
WELL CONSTRUCTION DETAILS		Well Number: RR-MW-04

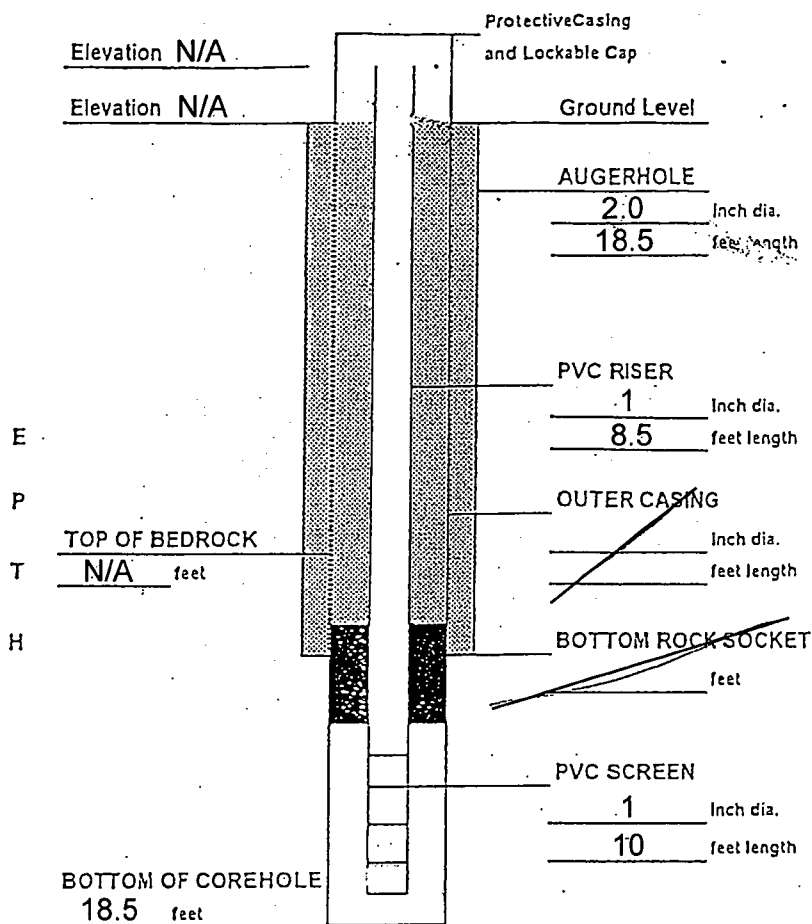
WELL DESIGN		
CASING MATERIAL	SCREEN MATERIAL	FILTER MATERIAL
Surface:	Type: 1" threaded PVC	Type: Sand Setting: 2' - 18.5' bgs
Monitor:	Slot Size: 0.01	SEAL MATERIAL
		Type: Grout Setting:
COMMENTS	ROCK CORING	LEGEND
Grout from 2' to 0' bgs	Cored Interval:	Cement/Bentonite Grout
	Core Diameter:	Bentonite Seal
	Reamed Diameter:	Silica Sandpack
		Bedrock
Client: The Kissling Intrests, LLC	Location:	Project No.: E8033
	WELL CONSTRUCTION DETAILS	Well Number: RR-MW-05

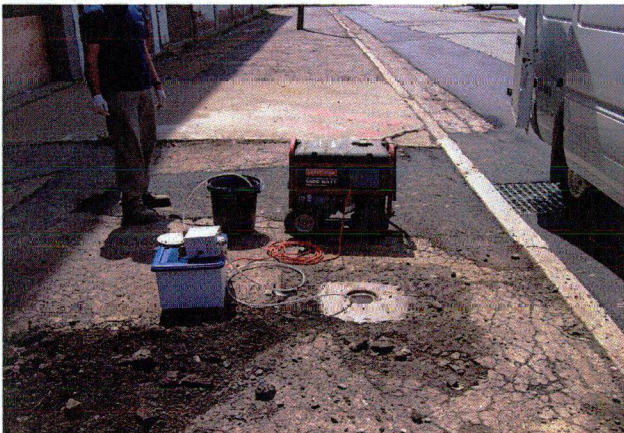
**Photograph 9.** Developing well at RR-MW-04

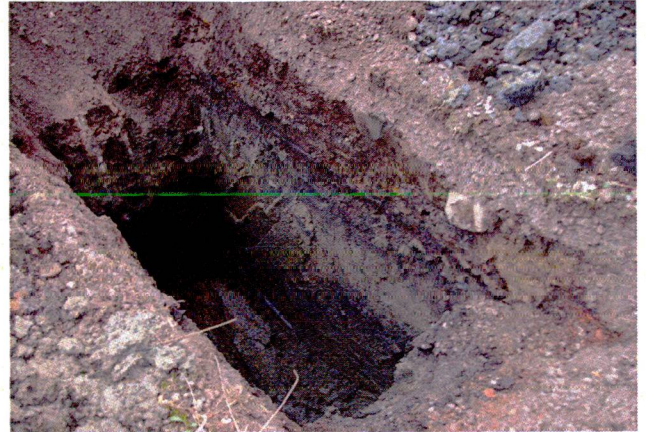
**Photograph 14.** Stratigraphy of RR-TP-07

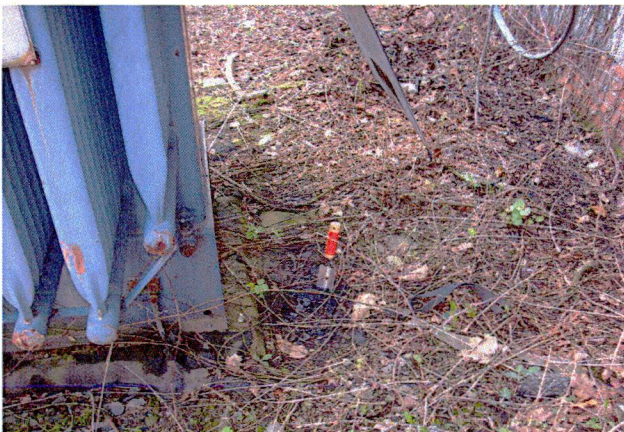
**Photograph 17.** Location of RR-SS-11, to rear of large courtyard transformer
