# Vapor Intrusion/Indoor Air Evaluation

Remington Rand Building  
184 & 185 Sweeny Street  
North Tonawanda, New York  
NYSDEC BCP Site #C932142

LaBella Project No. 2191060

May 31, 2019

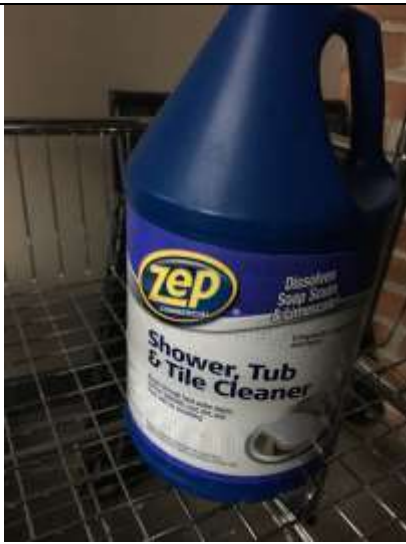
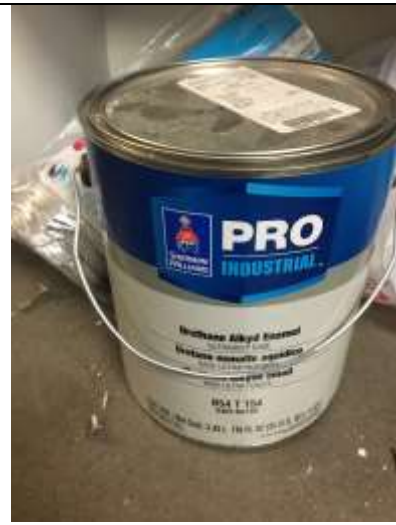
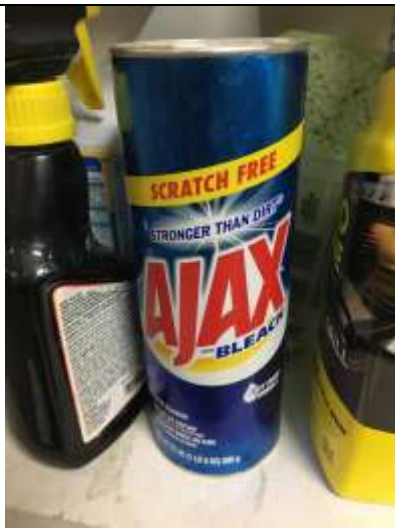
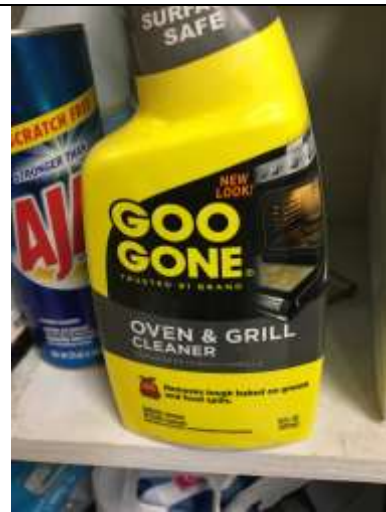
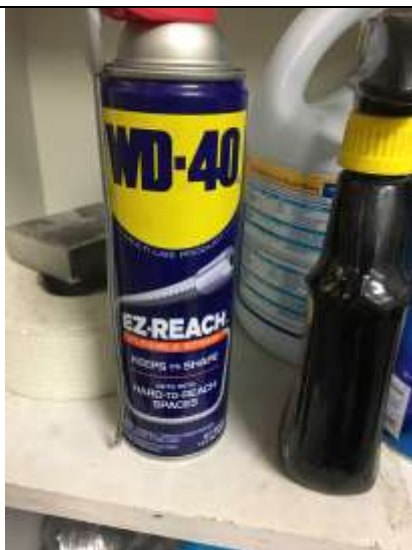
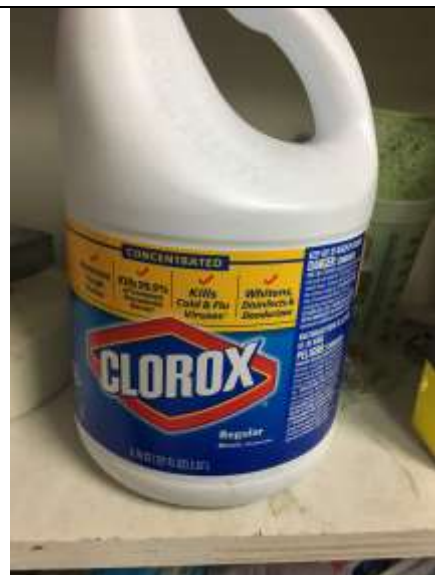
LaBella walked the interior of the first floor of the Site Building to inventory readily accessible sink, floor, trench, and shower drains. Generally, PID measurements collected from drains located within the Former Core Fitness, the Restaurant, and the Garage measured total VOC concentrations between 0.0 and 0.3 ppm; however, PID measurements collected from the drains located within the Former Salon detected higher PID measurements when compared to drains evaluated outside the Former Salon, with Former Salon drain total VOC concentrations between 1.1 and 1.4 ppm.

- Total VOC PID measurements collected from drains within the Former Salon were between 1.1 and 1.4 ppm and above the ambient outdoor air measurement of 0.5 ppm. Although the source of the total VOC PID measurements cannot be confirmed (i.e. chemical constituents, sewer gas, etc.) it appears unlikely that VOC emissions from the drains within the Former Salon are significantly impacting indoor air quality.

Former Salon

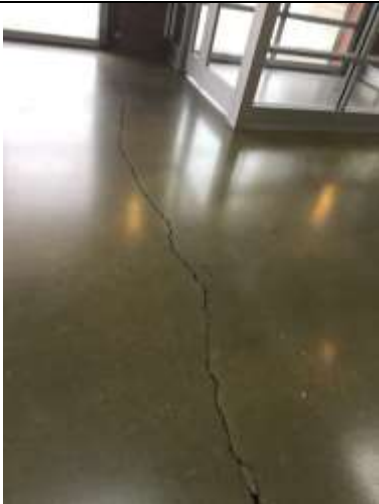
One floor crack and several less significant fine cracks are located within the Lobby of the Site Building. During LaBella site reconnaissance, no other significant floor cracks were observed within the Site Building. A photo of the floor crack is included within the Figures and Photographs Appendix of this report. LaBella collected direct PID measurements from two locations along the floor crack. Total VOC concentrations of 0.3 and 0.5 ppm were detected.

Floor crack in lobby

- The floor cracks located within the Lobby of the Site Building were assessed and total VOC concentrations were detected at 0.3 and 0.5 ppm, below or at the ambient outdoor air concentration of 0.5 ppm. The floor cracks in the Lobby of the Site Building do not appear to be a significant VOC pathway at this time.

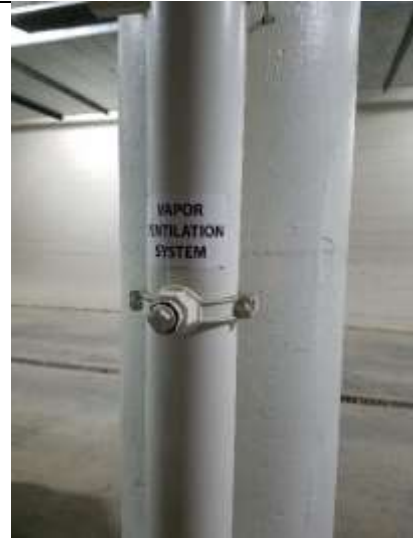
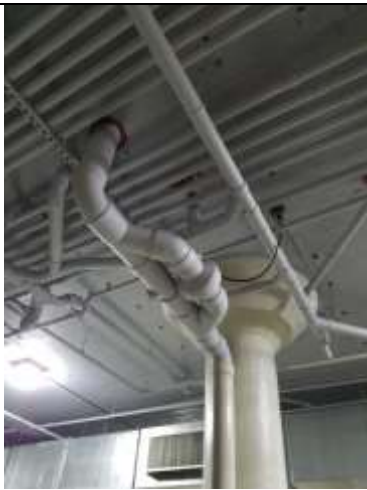
Concurrent with activities summarized within Section 3.1, LaBella evaluated the location of the sub-slab depressurization roof vent and heating, ventilation, and air conditioning (HVAC) air inlets. The location of the SSDS and SSDS roof vent are depicted on the Interim Remedial Measures construction drawing, IRM-103 included in Appendix 2. Photographs of the SSDS and SSDS roof vent are included in the Figures and Photographs Appendix. Although several apparent HVAC mechanical systems, pipes, and vents are located in the immediate vicinity of the SSDS roof vent, building maintenance personnel reported that the systems observed proximate the SSDS roof vent are not related to HVAC air intake and are associated with sanitary waste ventilation and bathroom fan exhaust. As such, it does not appear that any air intakes are located within 10 feet of the SSDS roof vent. Additionally, the SSDS roof vent is located above the eave of the roof, greater than 10 feet above the ground, more than 10 feet away from any opening, and more than 10 feet from any adjacent building.

Photo of SSDS

Based on the findings of this indoor air and vapor intrusion evaluation, no further investigation appears warranted at this time. The SSDS should remain active to mitigate any potential vapor intrusion concerns with the Site Building.

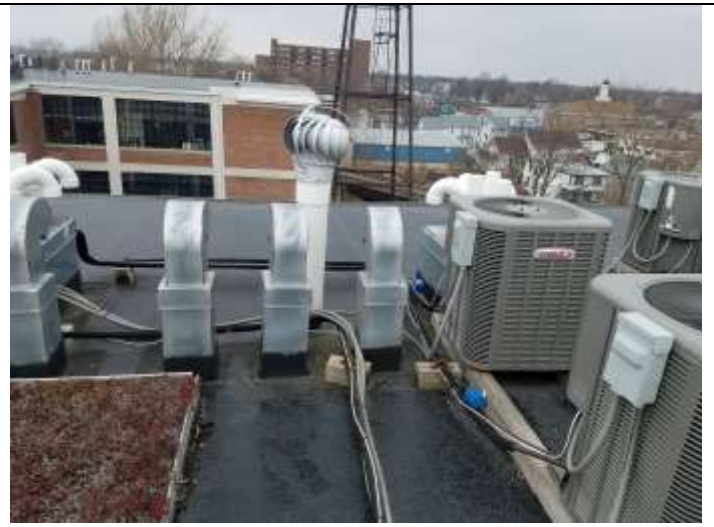
SSDS Roof Vent

- Based on the interviews conducted and Site observation, the SSDS roof vent appears to be located greater than 10 feet away from any air intakes.
- Based on the results of the resampling of indoor air in the Site Building subsequent activation of the SSDS, all VOC concentrations in the indoor air samples were detected below the BASE database 90th percentile values and May 2017 NYSDOH Indoor Air Matrices.
