# 2021 Periodic Review Report

Remington Rand Building  
184 and 185 Sweeney Street  
North Tonawanda, New York  
NYSDEC BCP Site #C932142

LaBella Project No. 2191060

December 9, 2021

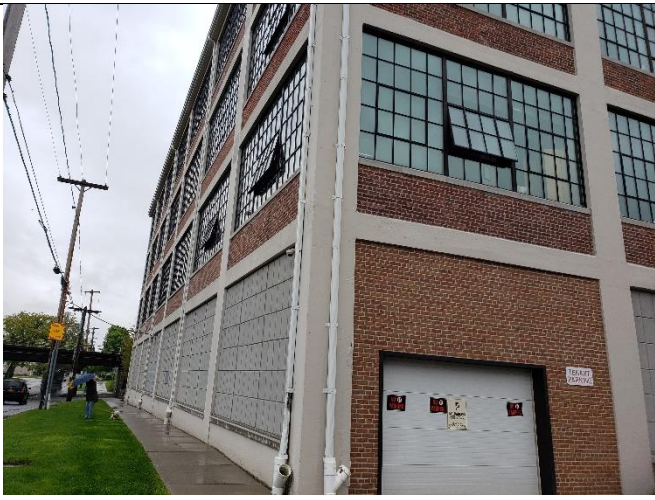
The cover system was inspected by LaBella's Julia Torres on May 7, 2021, and is in place with no apparent disturbances since its initial placement and is in compliance with the requirements of the SMP. The Site Wide Inspection Form is included in Appendix 2. Photographs taken at the time of the inspection are included in Appendix 3.

North exterior Site Building

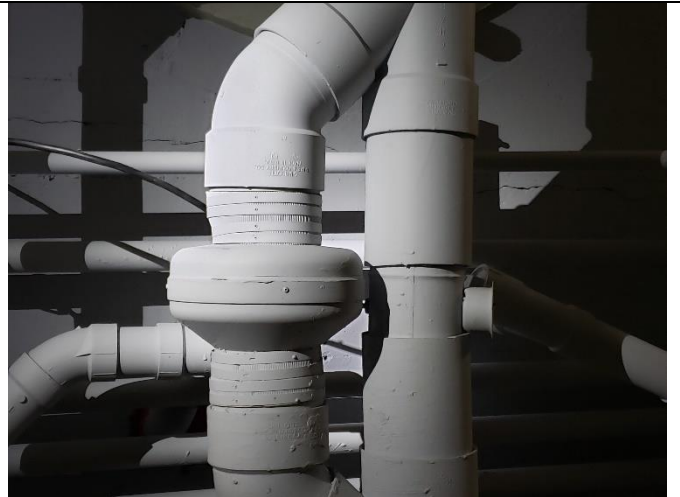
An in-line fan has been installed and activated as part of the SSDS in the vent stack near the ceiling of the first floor of the Site Building to draw a vacuum on the system. At the time of the annual inspection the fan was confirmed to be active and caulk seals were inspected and were deemed satisfactory. No operation and maintenance deficiencies were noted during the inspection.

Vapor system was on and functioning. The in-line fan in the vent stack near the ceiling of the first floor of the Site Building was observed to be active and drawing vacuum. Caulk seems were also inspected and deemed satisfactory.

Active fan associated with SSDS system
