2025 Periodic Review Report

Remington Rand Building
184 Sweeney Street
North Tonawanda, New York
NYSDEC BCP Site #C932142

LaBella Project No. 2191060

September 9, 2025

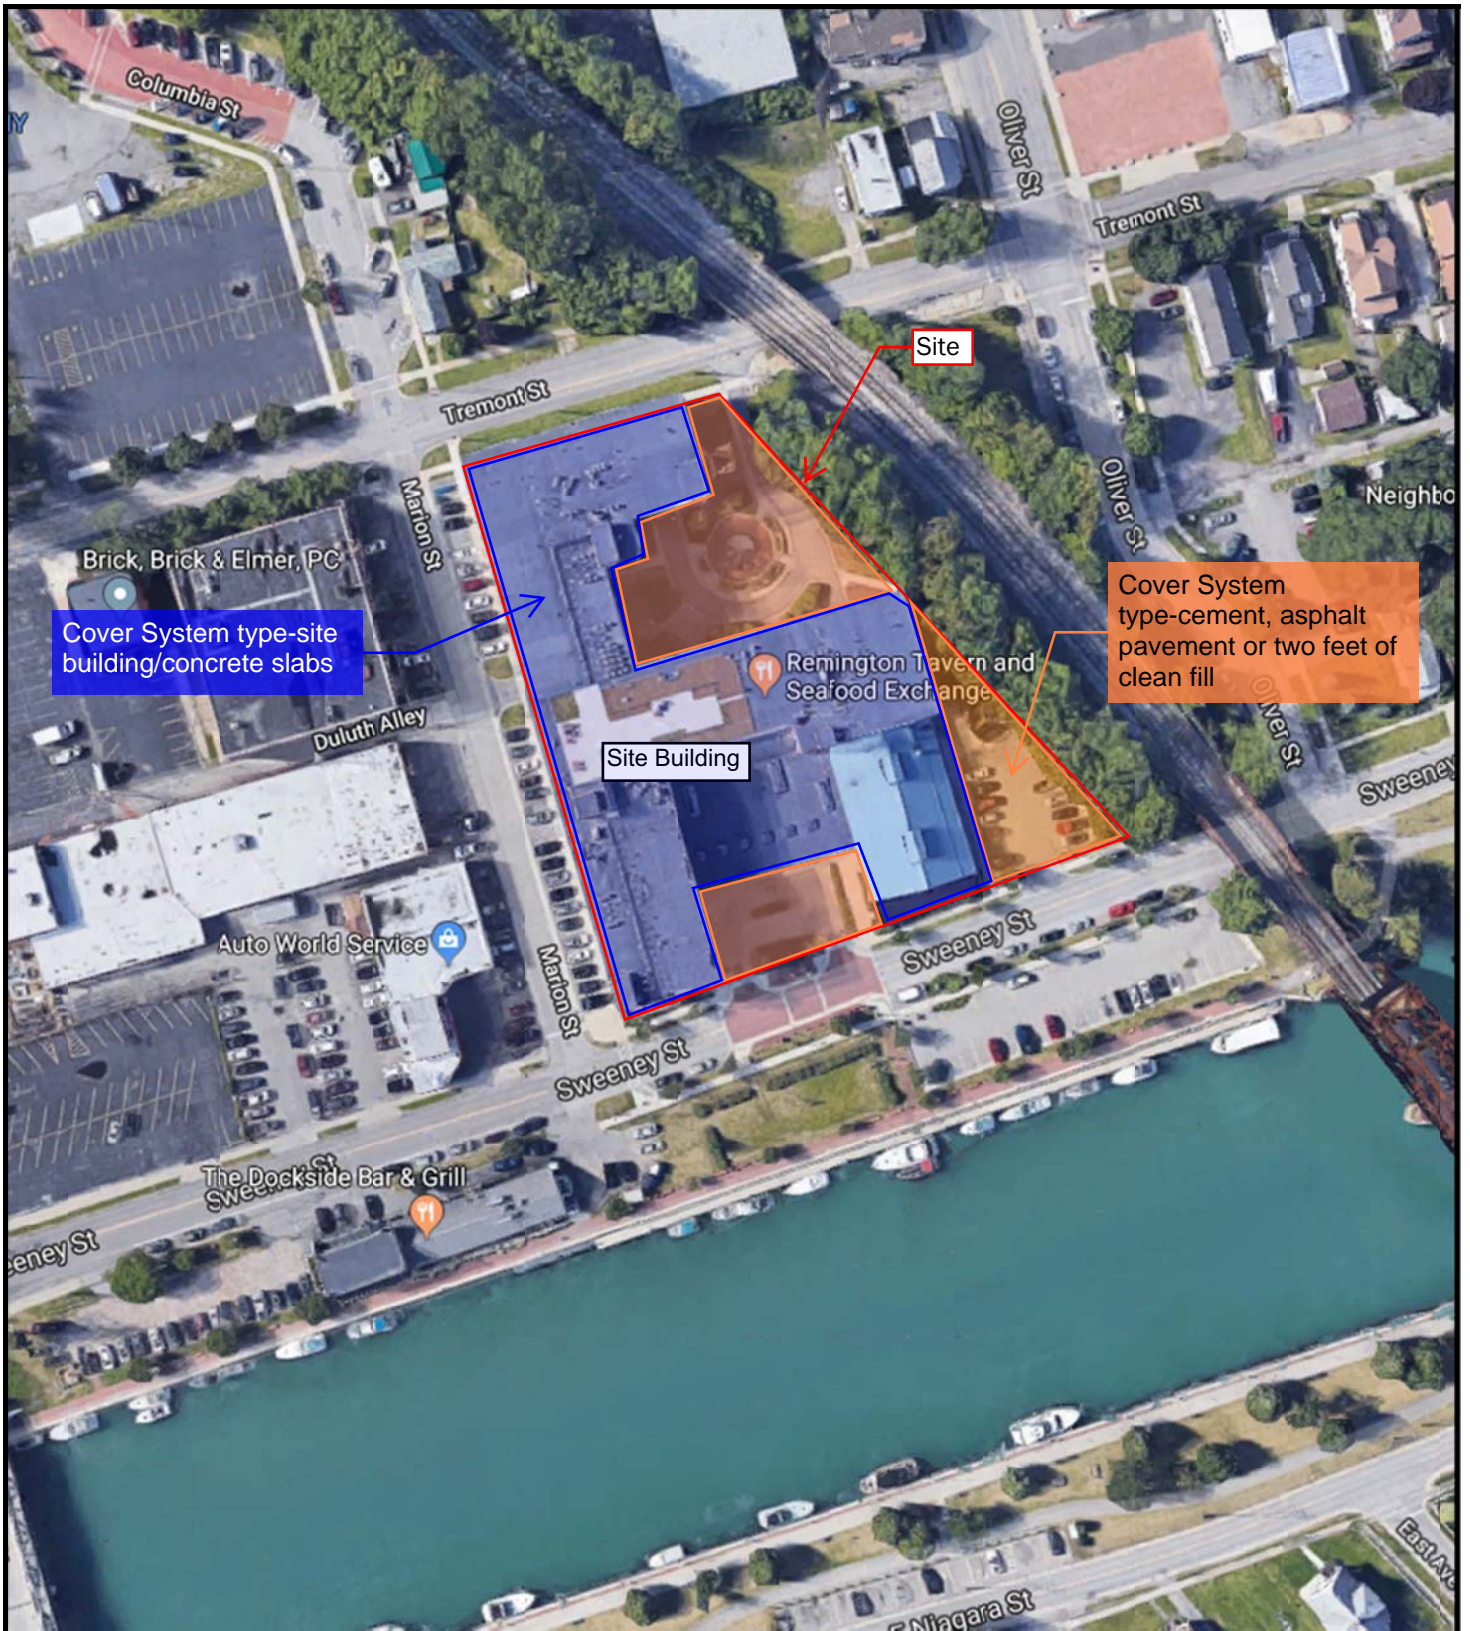
FIGURE 2 SITE BASE MAP

Salon-occupied and indoor air sampled as of May 2021

Golf Simulator and Bar-occupied and indoor air sampled as of May 2024

Restaurant-Occupied as of 2012 and indoor air last sampled January 2020

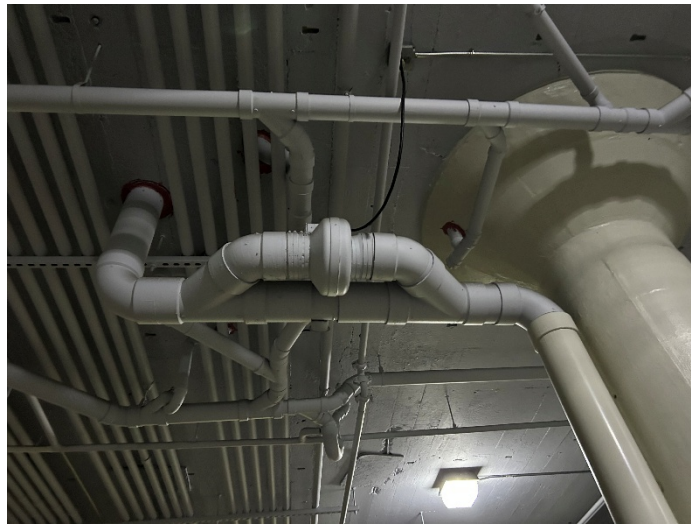
Active SSDS Fan

The SSDS was converted to an active system in January 2019 and the in-line fan was confirmed operational by LaBella on May 15, 2025, and the associated caulk seams were observed to be in good condition. To evaluate the effectiveness of the SSDS, the SMP specifies annual sample collection from the vent stack port and indoor air sampling of any unoccupied first-floor tenant space that becomes occupied (for a one-time event) along with one corresponding outdoor ambient air sample. The air samples are to be analyzed for Target Compound List (TCL) VOCs by Environmental Protection Agency (EPA) Method TO-15. Monitoring of the SSDS and associated air sampling is discussed further in Section 5.0. The NYSDOH Guidance for Evaluating Soil Vapor Intrusion in the State of New York (with updates) was adhered to during the course of this certifying period.

Vapor system was on and functioning. The in-line fan in the vent stack near the ceiling of the first floor of the Site Building was observed to be active and drawing vacuum. Caulked seams were also inspected and deemed satisfactory.

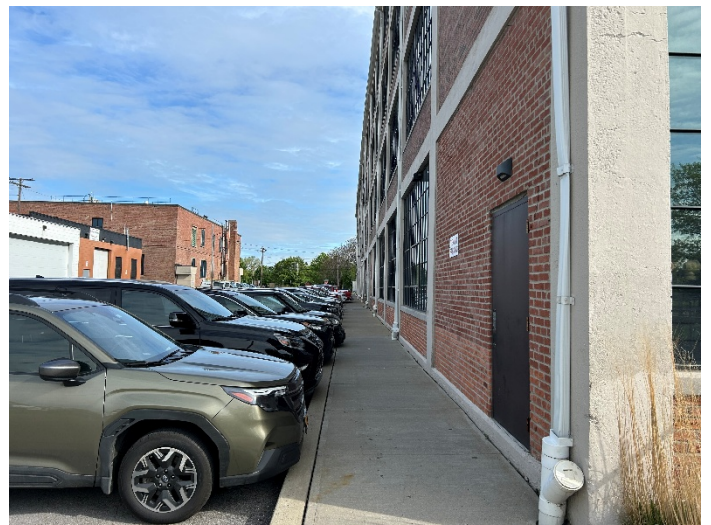
Western portion of Building Exterior

The property is in compliance with the ICs/ECs. The cover system is in-tact and well-maintained. No excavations into the cover system were observed. The vapor system is on and functioning.
