Former Mill No. 2 Site
NIAGARA COUNTY, NEW YORK

Final Engineering Report

NYSDEC BCP Site Number: C932150

JUNE 2012

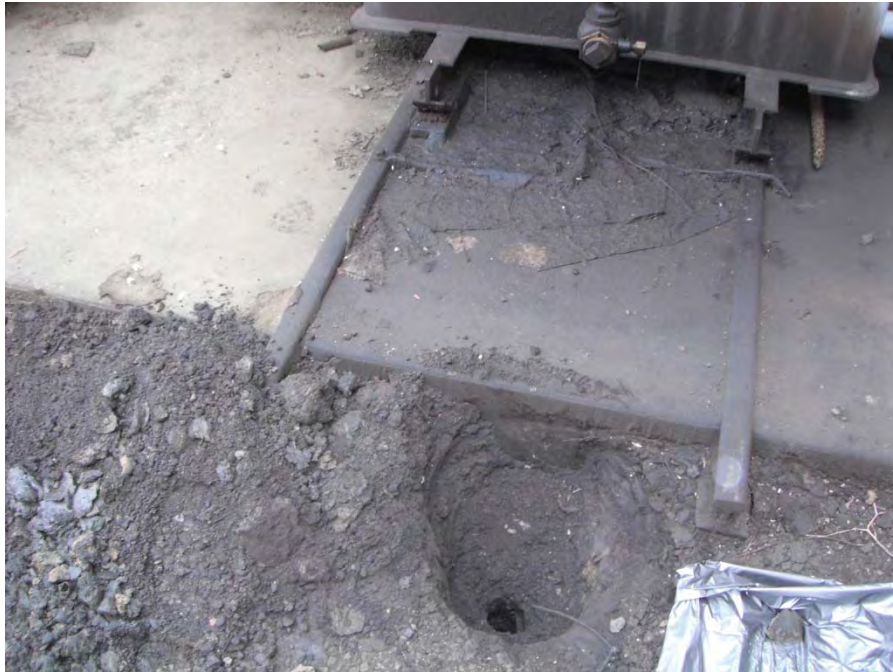
Photo 1: View of soil sample location by existing transformer area on-site (date: 04/12/2011).

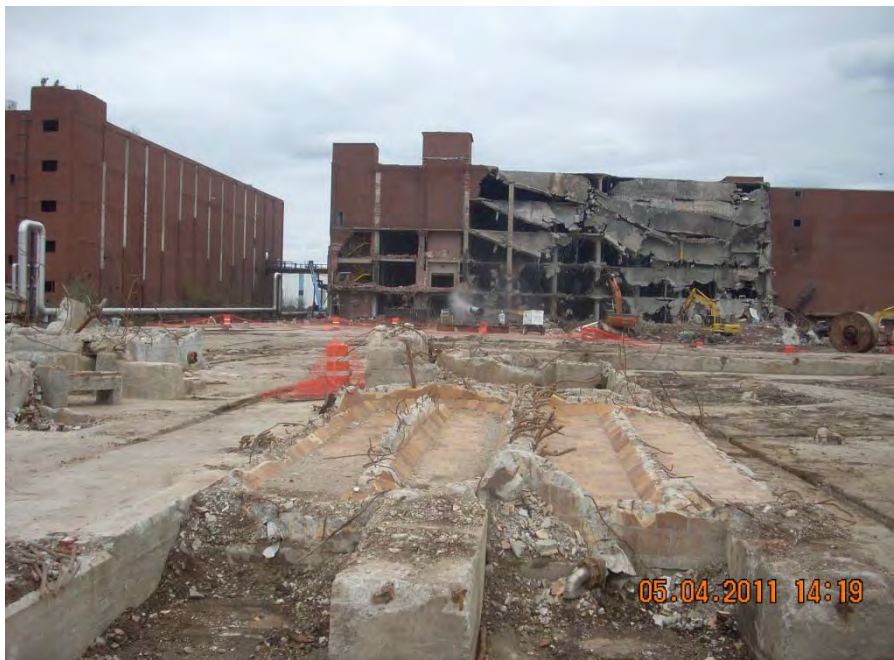
Photo 2: View looking north towards demolition of existing on-site buildings (date: 05/04/2011).

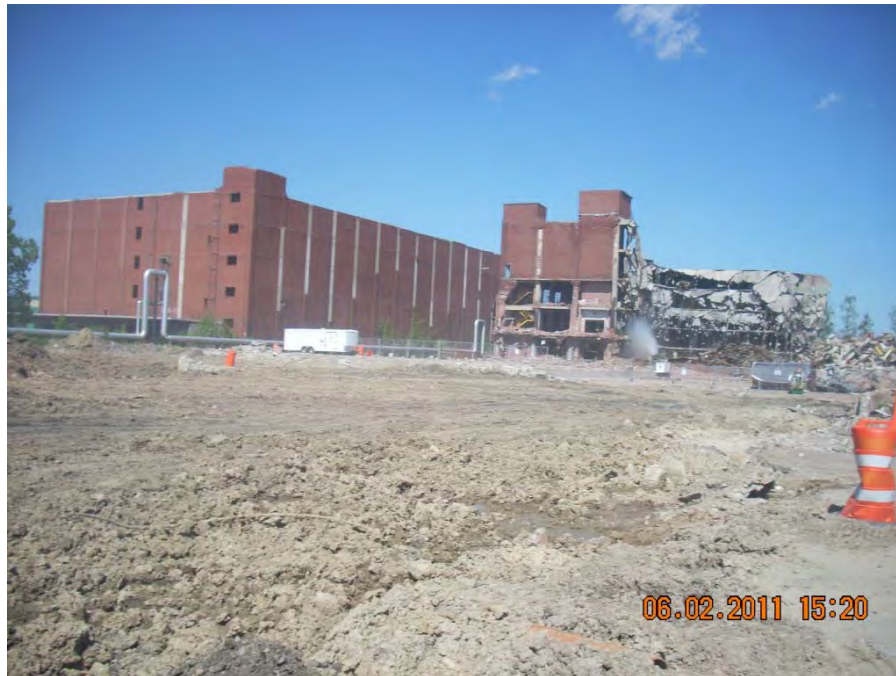
Photo 3: View looking northeast towards continuing demolition of existing on-site buildings (date: 06/02/2011).

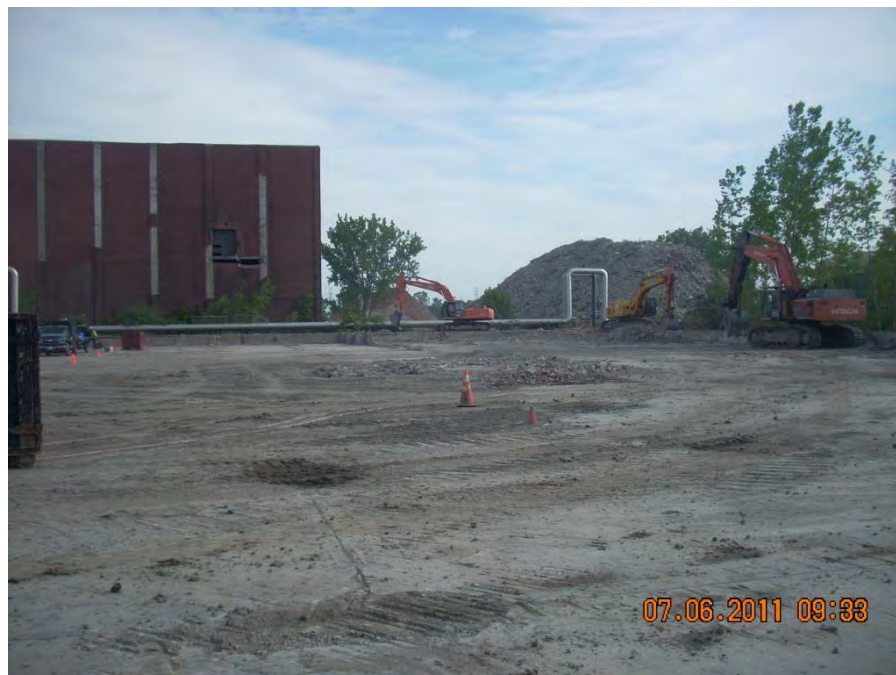
Photo 4: View looking north towards the crushed concrete piles from demolished building material which were sampled for laboratory analyses to evaluate potential reuse on site (date: 07/06/2011).

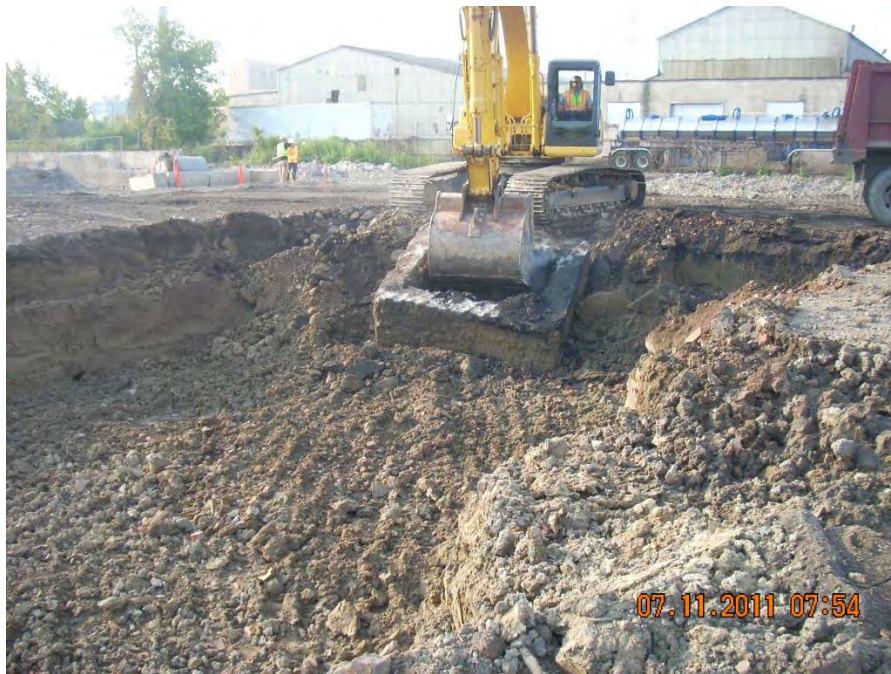
Photo 5: View looking south towards excavation area. Remnants of old building foundations were locally encountered and excavated (date: 07/11/2011).

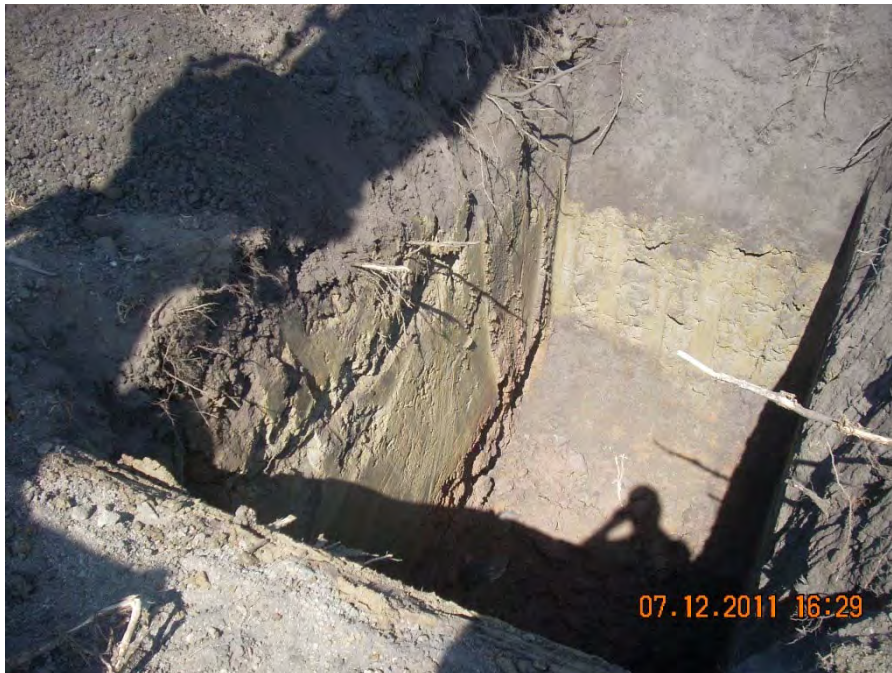
Photo 6: View of test pit located on the eastern area of the site by Phase 1 (date: 07/12/2011).

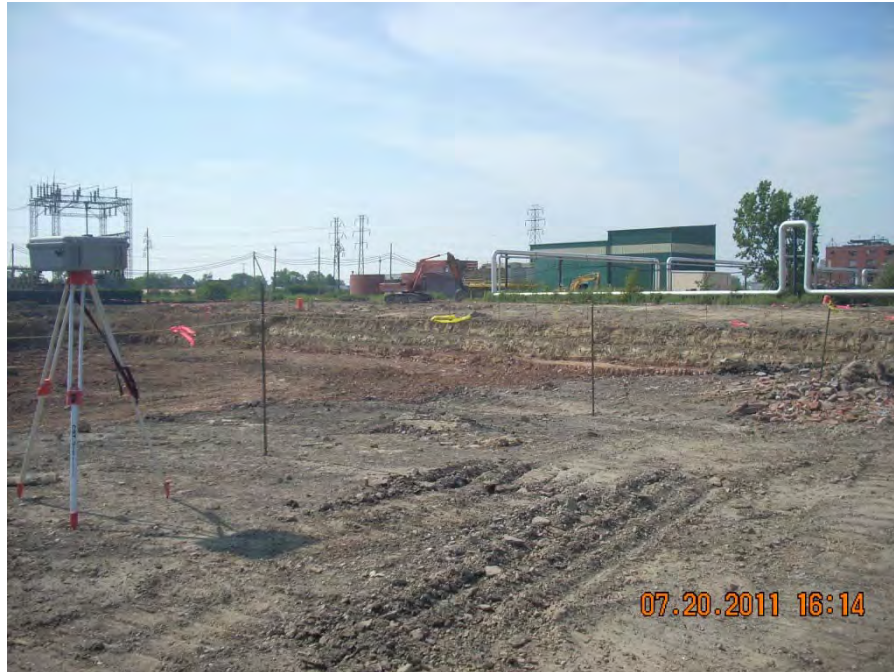
Photo 7: View looking northeast towards excavation area. Community air monitoring equipment is set-up at the excavation extents and areas are marked off prior to backfill (date: 07/20/2011).

The PM-10 level exceeded the 100 microgram per cubic meter ($\mu\text{g}/\text{m}^3$) action level sporadically throughout the excavation period and measures including watering down the excavation area were taken to control dust. There were also sporadic PM-10 levels above the 150 $\mu\text{g}/\text{m}^3$ action level, and additional spraying of water and/or modifying work activities was utilized to reduce these levels. Visible dust was not observed leaving the Site. There were limited occurrences where the NE and SW PID readings exceeded the 5 ppm action level established in the CAMP, but the durations were short-term (less than 15 minutes), and the time-weighted average (TWA) for each day was less than 5 ppm.

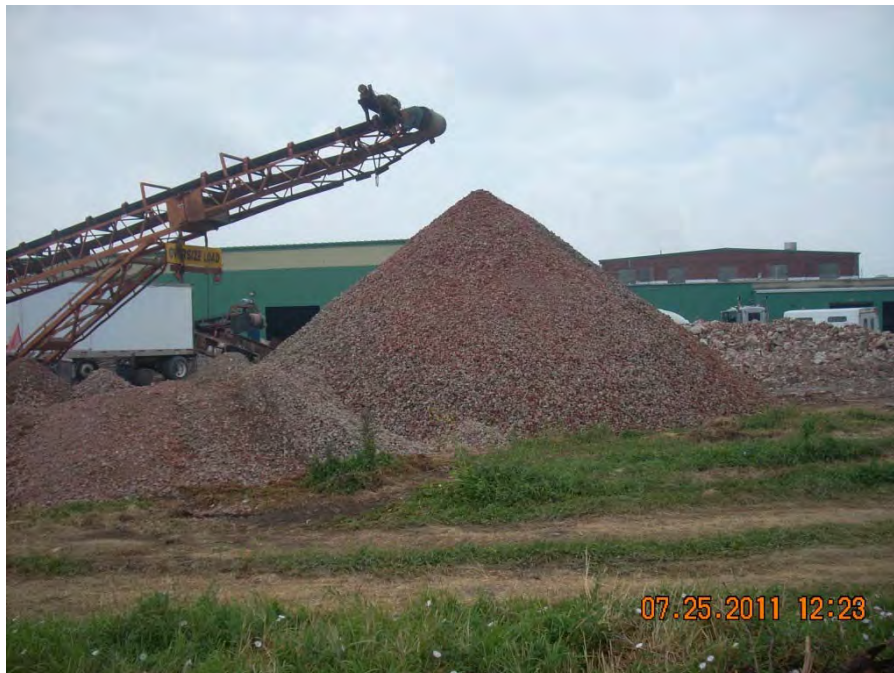
Photo 8: View looking east towards crushed brick piles from demolished building material which was sampled to evaluate potential reuse at the site (date: 07/25/2011).

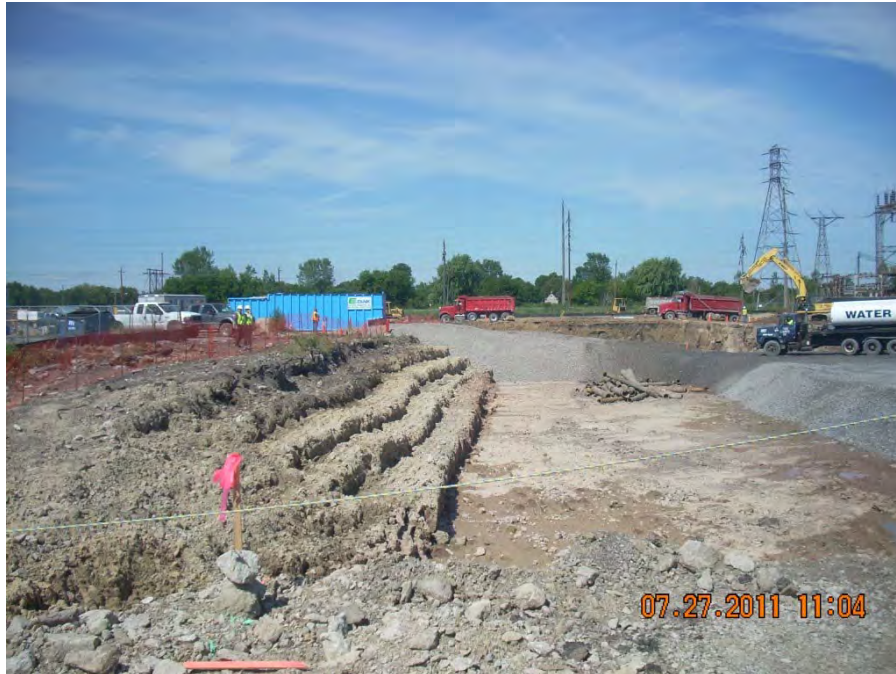
Photo 9: View looking east towards the benched excavation area. Pipes were encountered during excavation and went off-site as contaminated material, and water trucks were used to control dust (date: 07/27/2011).

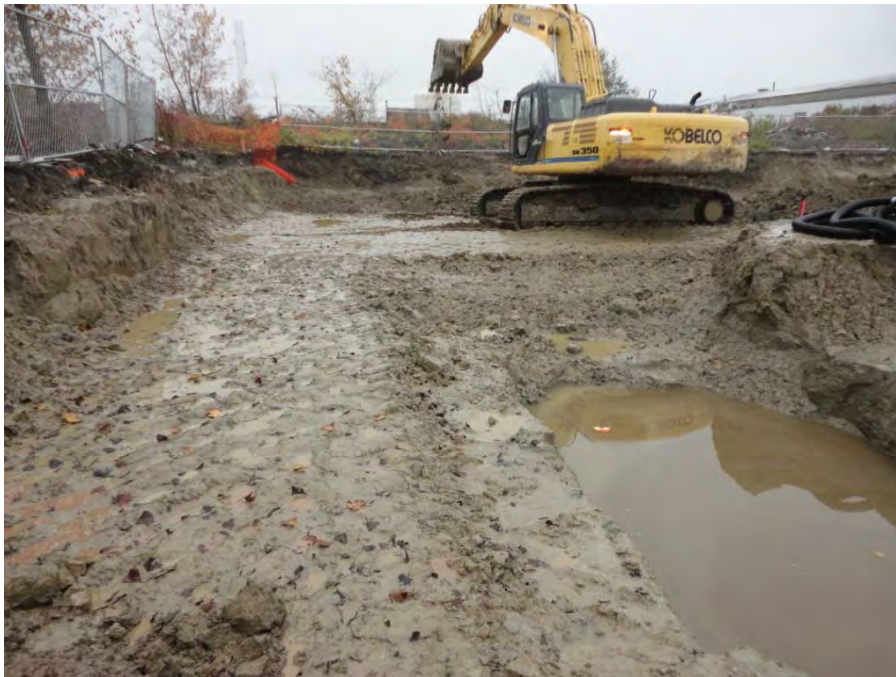
On 28 September 2011, ERM personnel noted elevated PID readings above the action level of 5-ppm in Grid (Quad) 88 in the southeast corner of the BCP Site. ERM obtained a sample of the VOC-affected soil in an effort to determine appropriate disposal characteristics and to determine if it could be a potential hazardous waste. Elevated chlorobenzene compounds were detected in the original round of sampling results received on 12 October 2011. These results

Photo 10: View looking south of the Quad 88 excavated area with RAD and VOC readings greater than action level. Water which accumulated on-site was pumped through hoses into mobile temporary storage tanks on-site for subsequent characterization as shown in Photo 9 (date: 07/27/2011).

were followed by additional analysis for TCLP metals, TCLP SVOCs, and TCLP VOCs. Results indicated the material was non-hazardous. ERM also oversaw the excavation and stockpiling of these VOC-affected soils in the southeast corner of the BCP site until the lab results were received. Upon receipt of all data, it was determined that the VOC-affected soil would be transported to Allied for disposal as contaminated material.

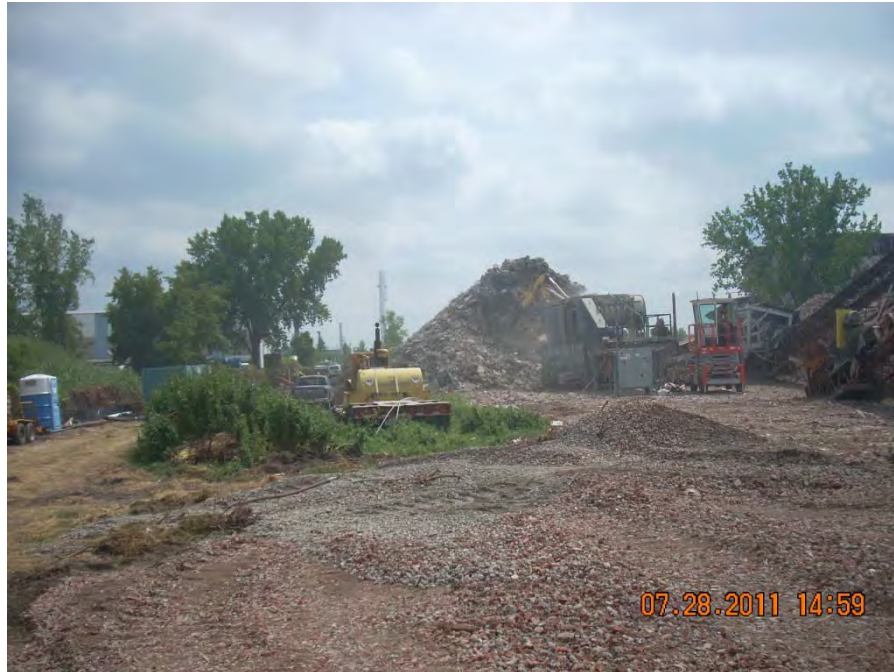
Photo 11: View looking south towards crushed concrete and brick piles. Crushed brick was temporarily used to pave roads. Crushed concrete was approved by NYSDEC and used as backfill on-site (date: 07/28/11).

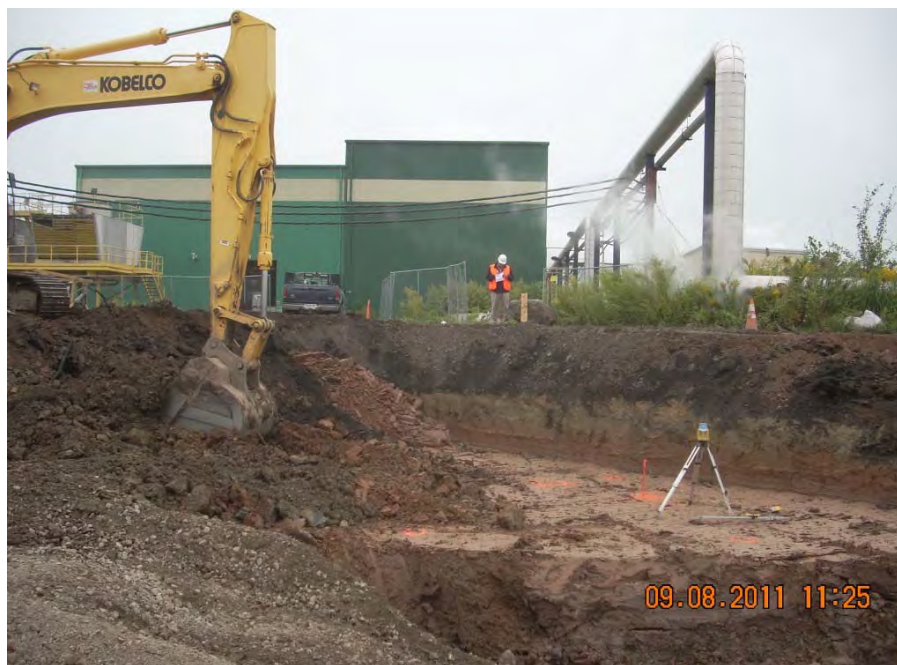
Photo 12: View looking north towards excavation area with laser level used to check excavation elevations. ERM personnel were present to screen for contamination and GRD personnel were present to screen for RAD material (date: 09/08/2011).

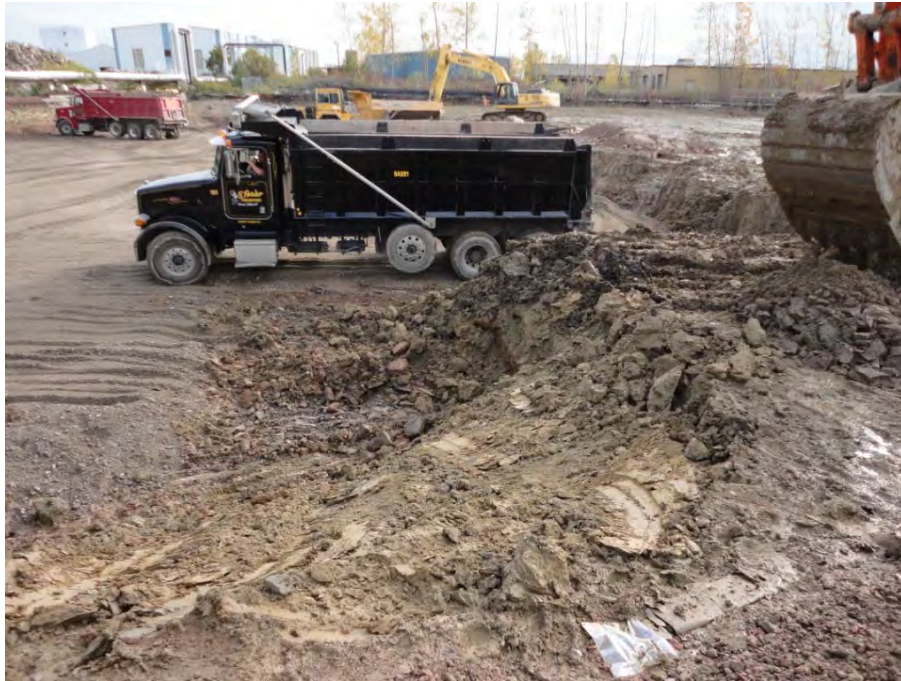
Photo 13: View looking west towards excavation area with trucks loaded with clean or contaminated historic fill or soil (date: 10/13/2011).

Excavated soil (all non-hazardous) was direct-loaded without stockpiling into trucks for transport to Allied or Modern Corporation (Modern) landfills in Niagara Falls, New York in accordance with Table 3-1. Any RAD soil was temporarily staged before loading and sent off-site to EQ Facility in Belleville, Michigan. Clean soil determined by modeled delineations as below Residential SCOs and meeting field screening criteria was sent to Allied or Modern for reuse, or reused on-site if determined structurally suitable.

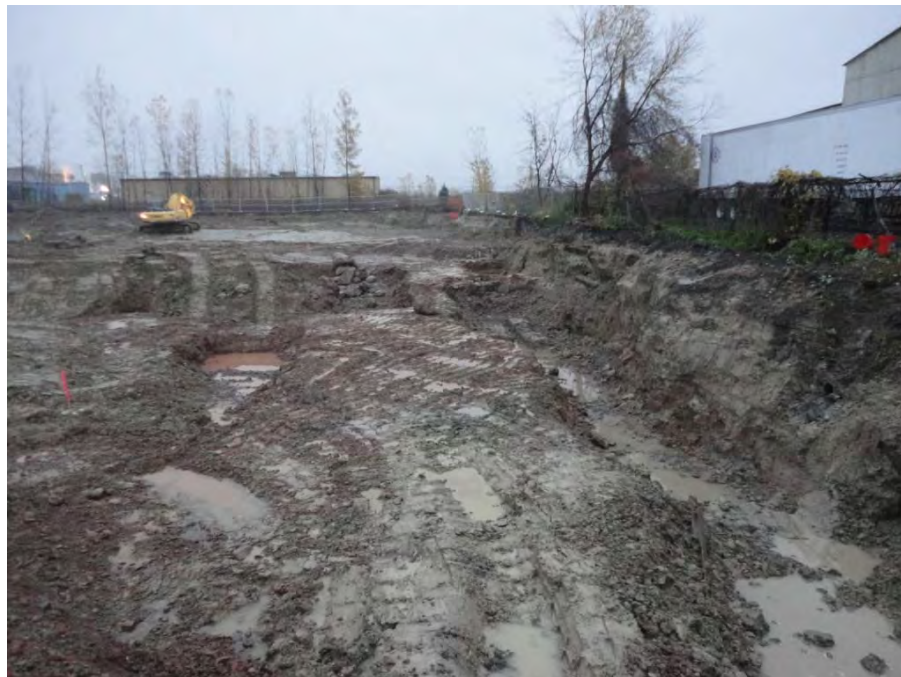
Photo 14: View looking west towards Phase 3 excavation area. Clean soil was reused onsite as backfilling in some excavated areas (date: 10/26/2011).

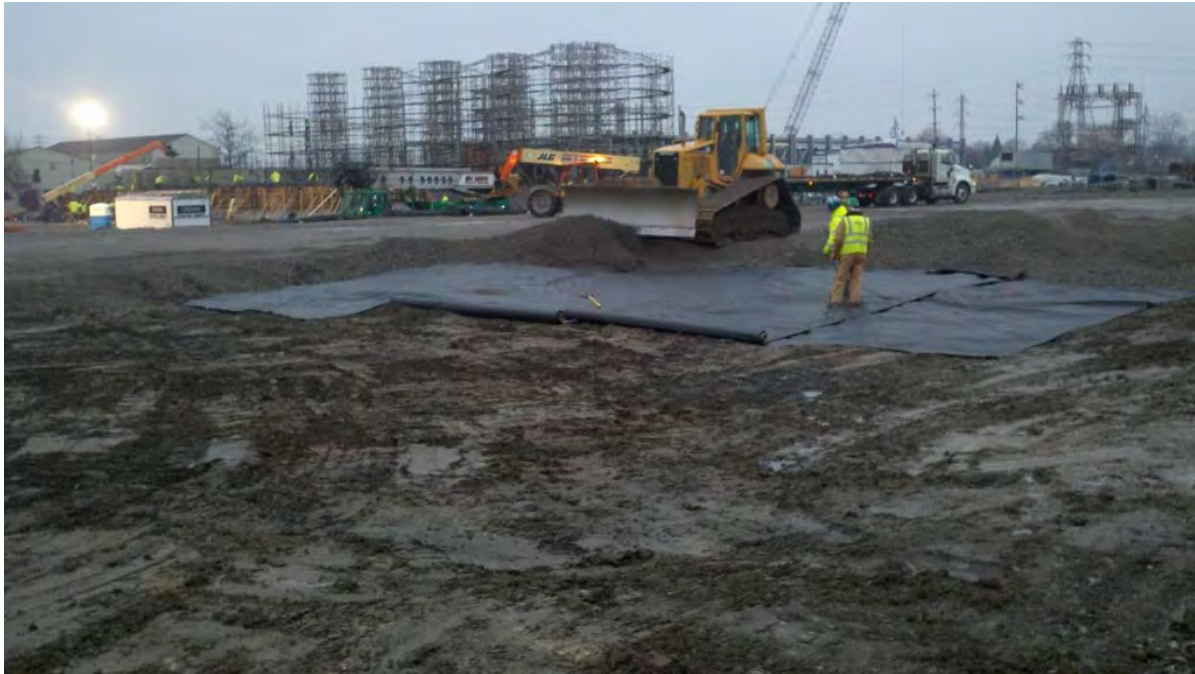
Photo 15: View looking northeast towards excavated area being backfilled with clean stone (date: 12/30/2011).

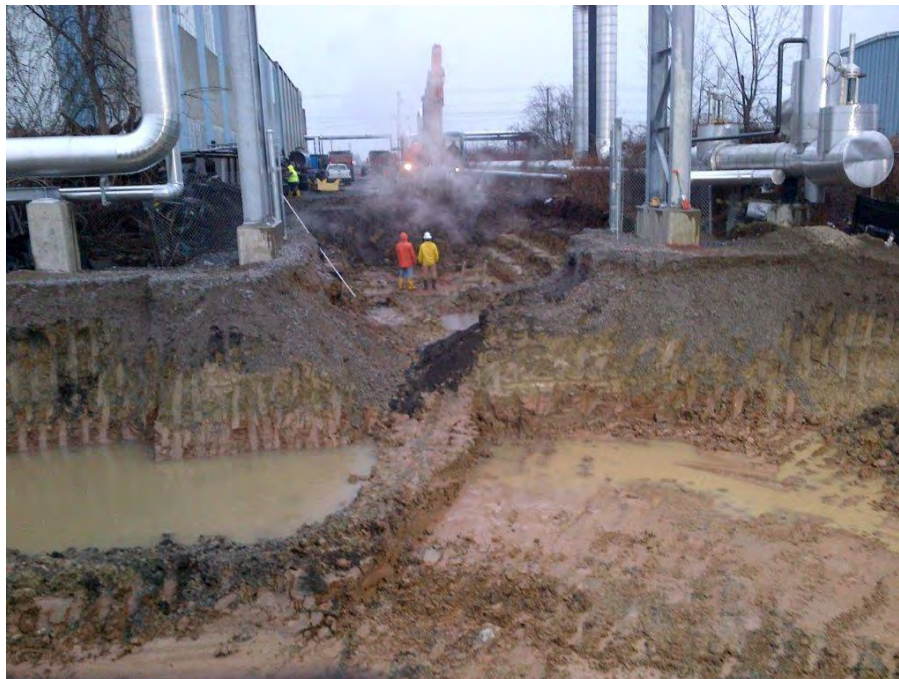
Photo 16: View looking east towards C-7 excavation showing excavation extent and the locations of the active steam line and its foundations (date: 12/30/2011).

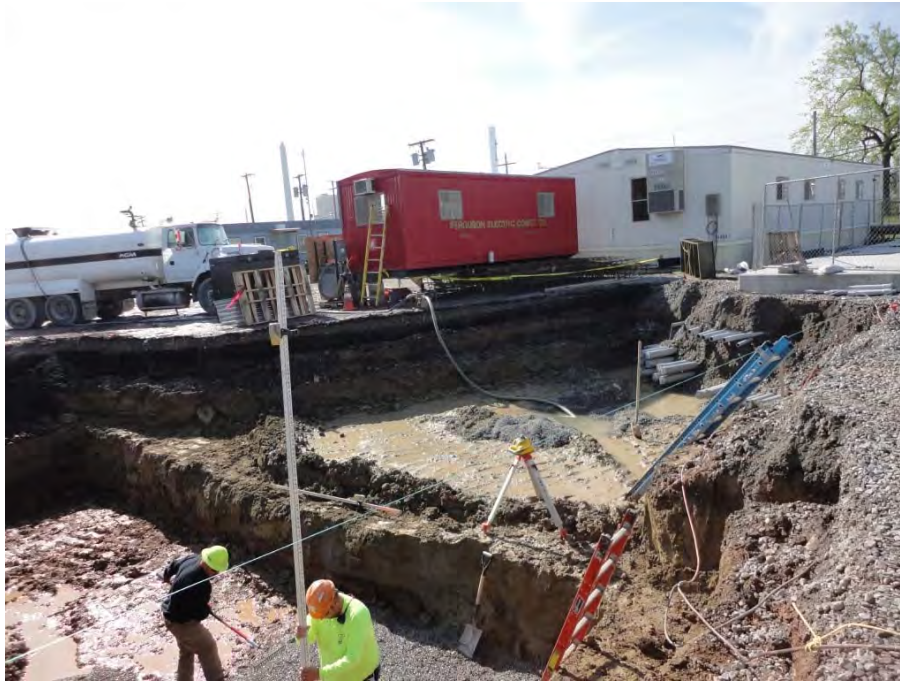
Photo 17: View looking south towards excavated area for utility installation being backfilled with clean stone. Rain accumulated on site is pumped into a holding tank and discharged back onto site (date: 05/09/2012).

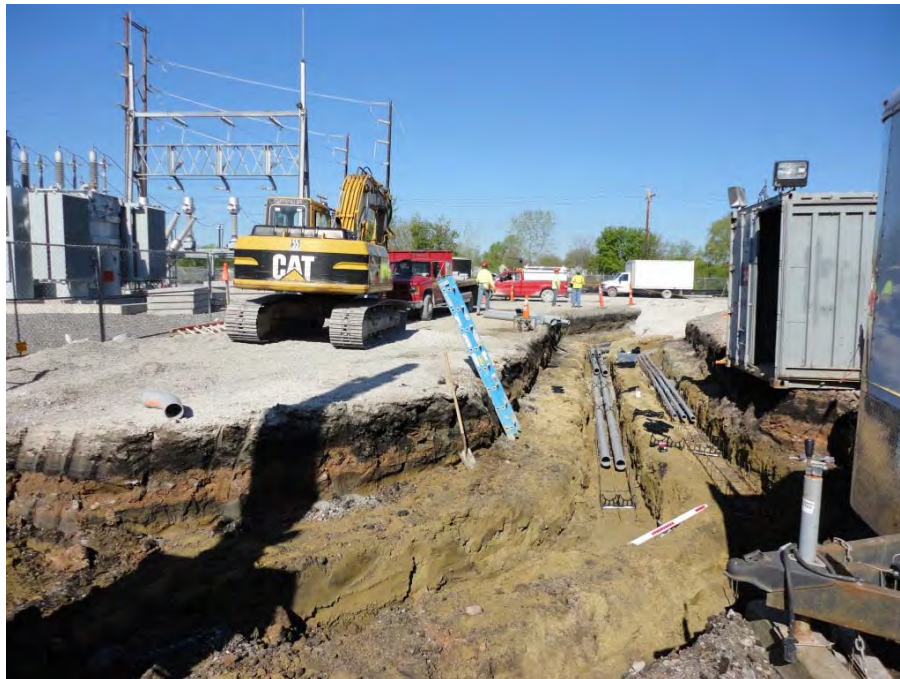
Photo 18: View looking east towards excavation area for utility installation. Soil stratigraphy with black historic fill at the top underlain by yellow-brown sandy silt layers is observed (date: 05/11/2012).
