CONSOLIDATED REMEDIAL INVESTIGATION REPORT

TRACT I SITE 3123 HIGHLAND AVENUE NIAGARA FALLS, NIAGARA COUNTY, NEW YORK SITE NO. C932157

Amec Environment & Infrastructure, Inc. 800 North Bell Avenue, Suite 200 Carnegie, PA 15106 Project 3410110832 May 2012

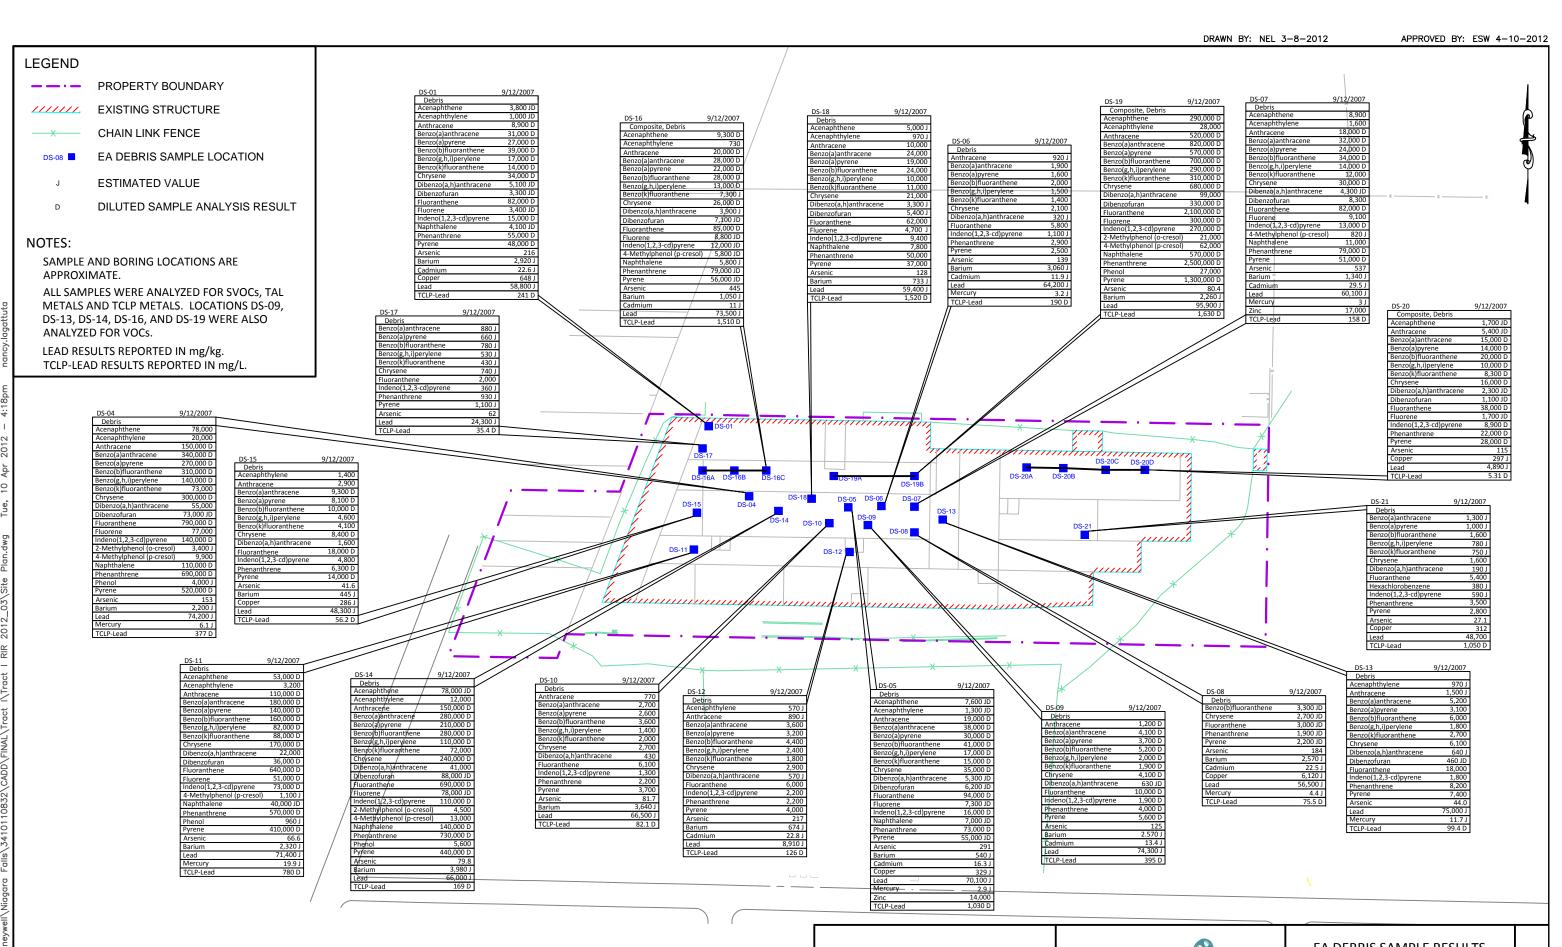
Figure: 7

It should be noted that during the USEPA Removal Acton in 2010 (discussed in Section 2.2) and as shown on Figure 7, materials associated with all EA debris samples, except DS-13, DS-20 and DS-21 were removed and disposed of off-Site by USEPA. Debris associated with samples DS-13, DS-20 and DS-21 remain at the Site, as this area was not addressed by the USEPA due to safety concerns regarding the building structure. These three debris samples contained four metals (arsenic, copper, lead and mercury) and 17 SVOCs (acenaphthene, acenaphthylene, anthracene, benzo(a)anthracene, benzo(a)pyrene, benzo(b)fluoranthene, benzo(g,h,i)perylene, benzo(k)fluoranthene, chrysene, dibenzo(a,h)anthracene, dibenzofuran, fluoranthene, fluorene, hexachlorobenzene, indeno(1,2,3-cd)pyrene, phenanthrene, and pyrene) above Commercial SCOs.
