## INSPECTION REPORT

**Site Number:** C932164

**Site Name:** 401, 402 & 430 Buffalo Ave

**Location:** Buffalo Ave Niagara Falls, Niagara  
County

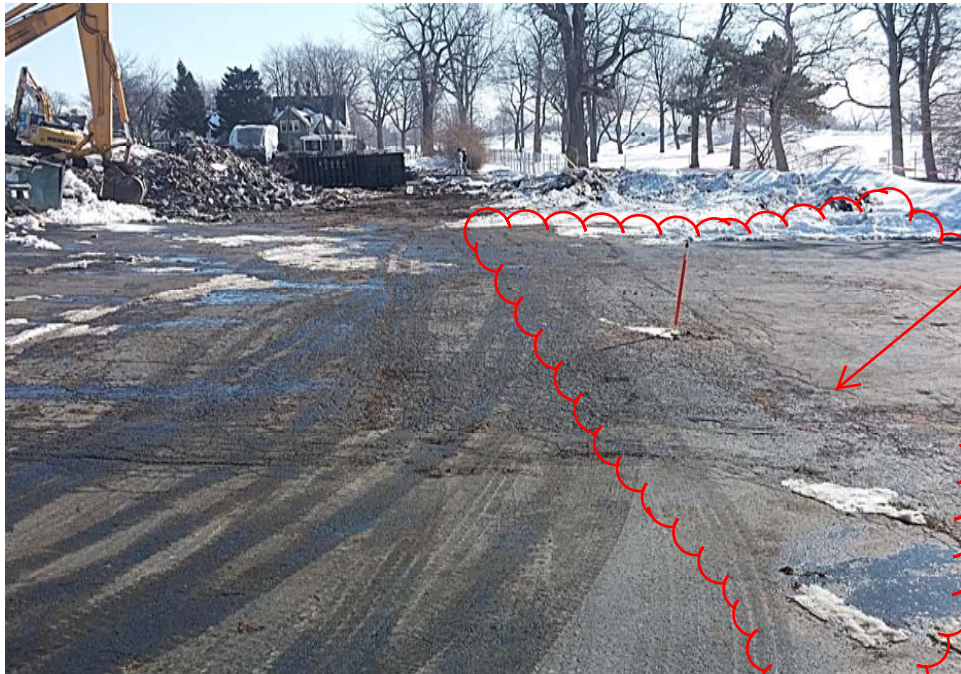
Rad Area

Additional Rad area found in back parking lot that extends off site. Advised Benchmark that they do not have to chase the off-site rad unless the removal of the asphalt disturbs

it then they are required to handle it regardless if it is off site or not.
