# Phase II Environmental Investigation Report

Spill No. 1505941

*784-790 Center Street and an Unaddressed Parcel  
on Onondaga Street  
Lewiston, New York*

September 2015

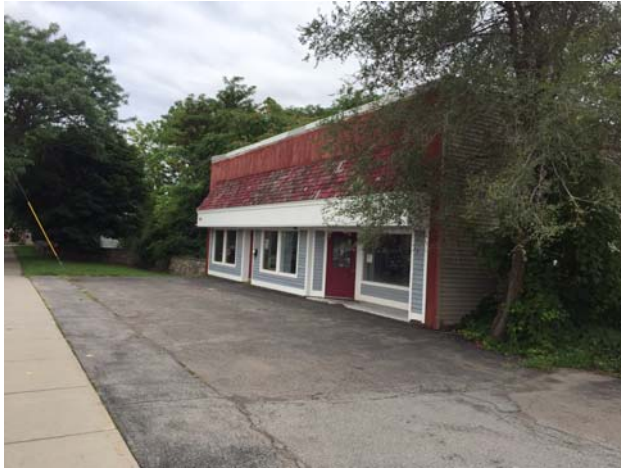
Photo 1: View of the approximate location of SBs -1 and -2 south of the former dry cleaning building.

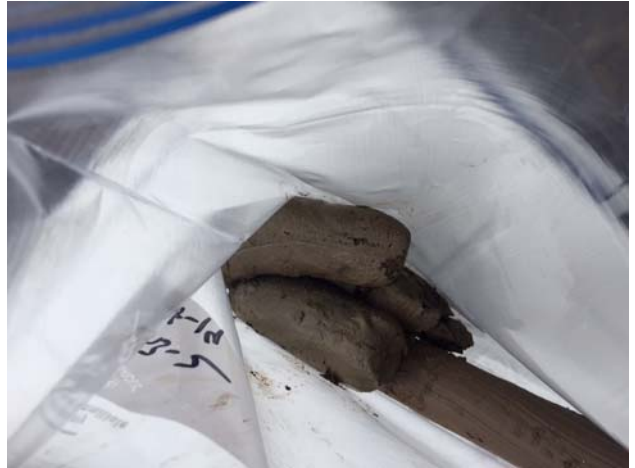
As summarized on Table 1, an elevated PID reading of 1,080 parts per million (ppm) and olfactory evidence of impact (petroleum-like odors) were observed at SB-2 (18 to 19 foot interval) completed south of Building 2.

Photo 2: View of the sample interval exhibited elevated PID readings and olfactory evidence of impact.

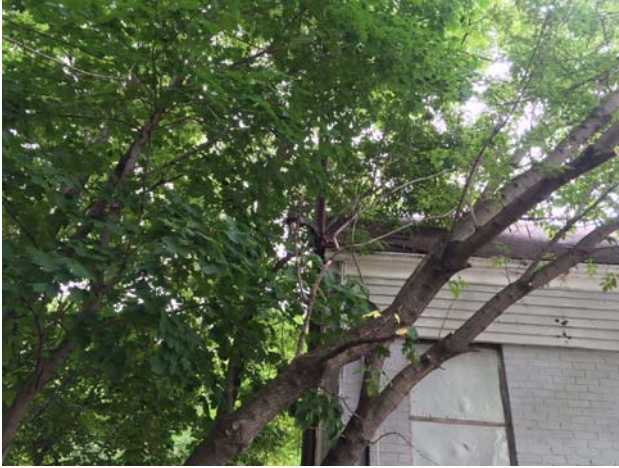
**Photo 5:**

A soil boring was advanced proximate to an asphalt depression, a suspected remaining tank location west of Building 1, and equipment refusal was encountered at approximately 3 fbg, a depth common for the top of a tank. Vibrations from the drill rig were noted on the vent pipes remaining along the exterior wall of Building 1. This suggests that abandoned tank(s) may remain on-site.

Photo 5: View of the three remaining vent pipes at the northwest corner of the former gasoline station building.

- Abandoned USTs may remain on-Site.
- NYSDEC Spill No. 1505941 was issued for the Site.
- Due to the nature of historic operations, the potential for additional areas of environmental impact exist on-Site, especially in areas of the former junk yard.

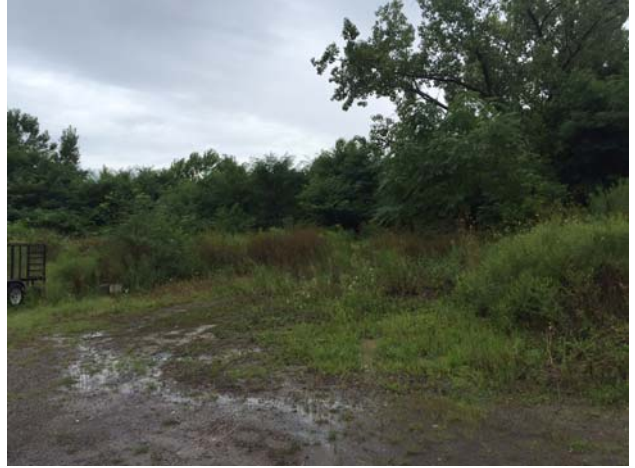
**Photo 6:**

PCBs (specifically, aroclor 1260) exceeded the Part 375 Commercial Use SCO in one (1) of the seven (7) soil samples submitted for PCB analysis. A PCB concentration of 1.4 mg/kg, which exceeds the Commercial SCO of 1 mg/kg, was identified at SB-11 (0-4') completed in the former junk yard.

Photo 6: View of the approximate locations of SBs -10 and -11 to assess the former junk yard.
