# Remedial Investigation Work Plan

235 River Road  
North Tonawanda, New York

January 2025

**Roux Environmental Engineering  
and Geology, D.P.C.**  
2558 Hamburg Turnpike, Suite 300  
Buffalo, New York 14218

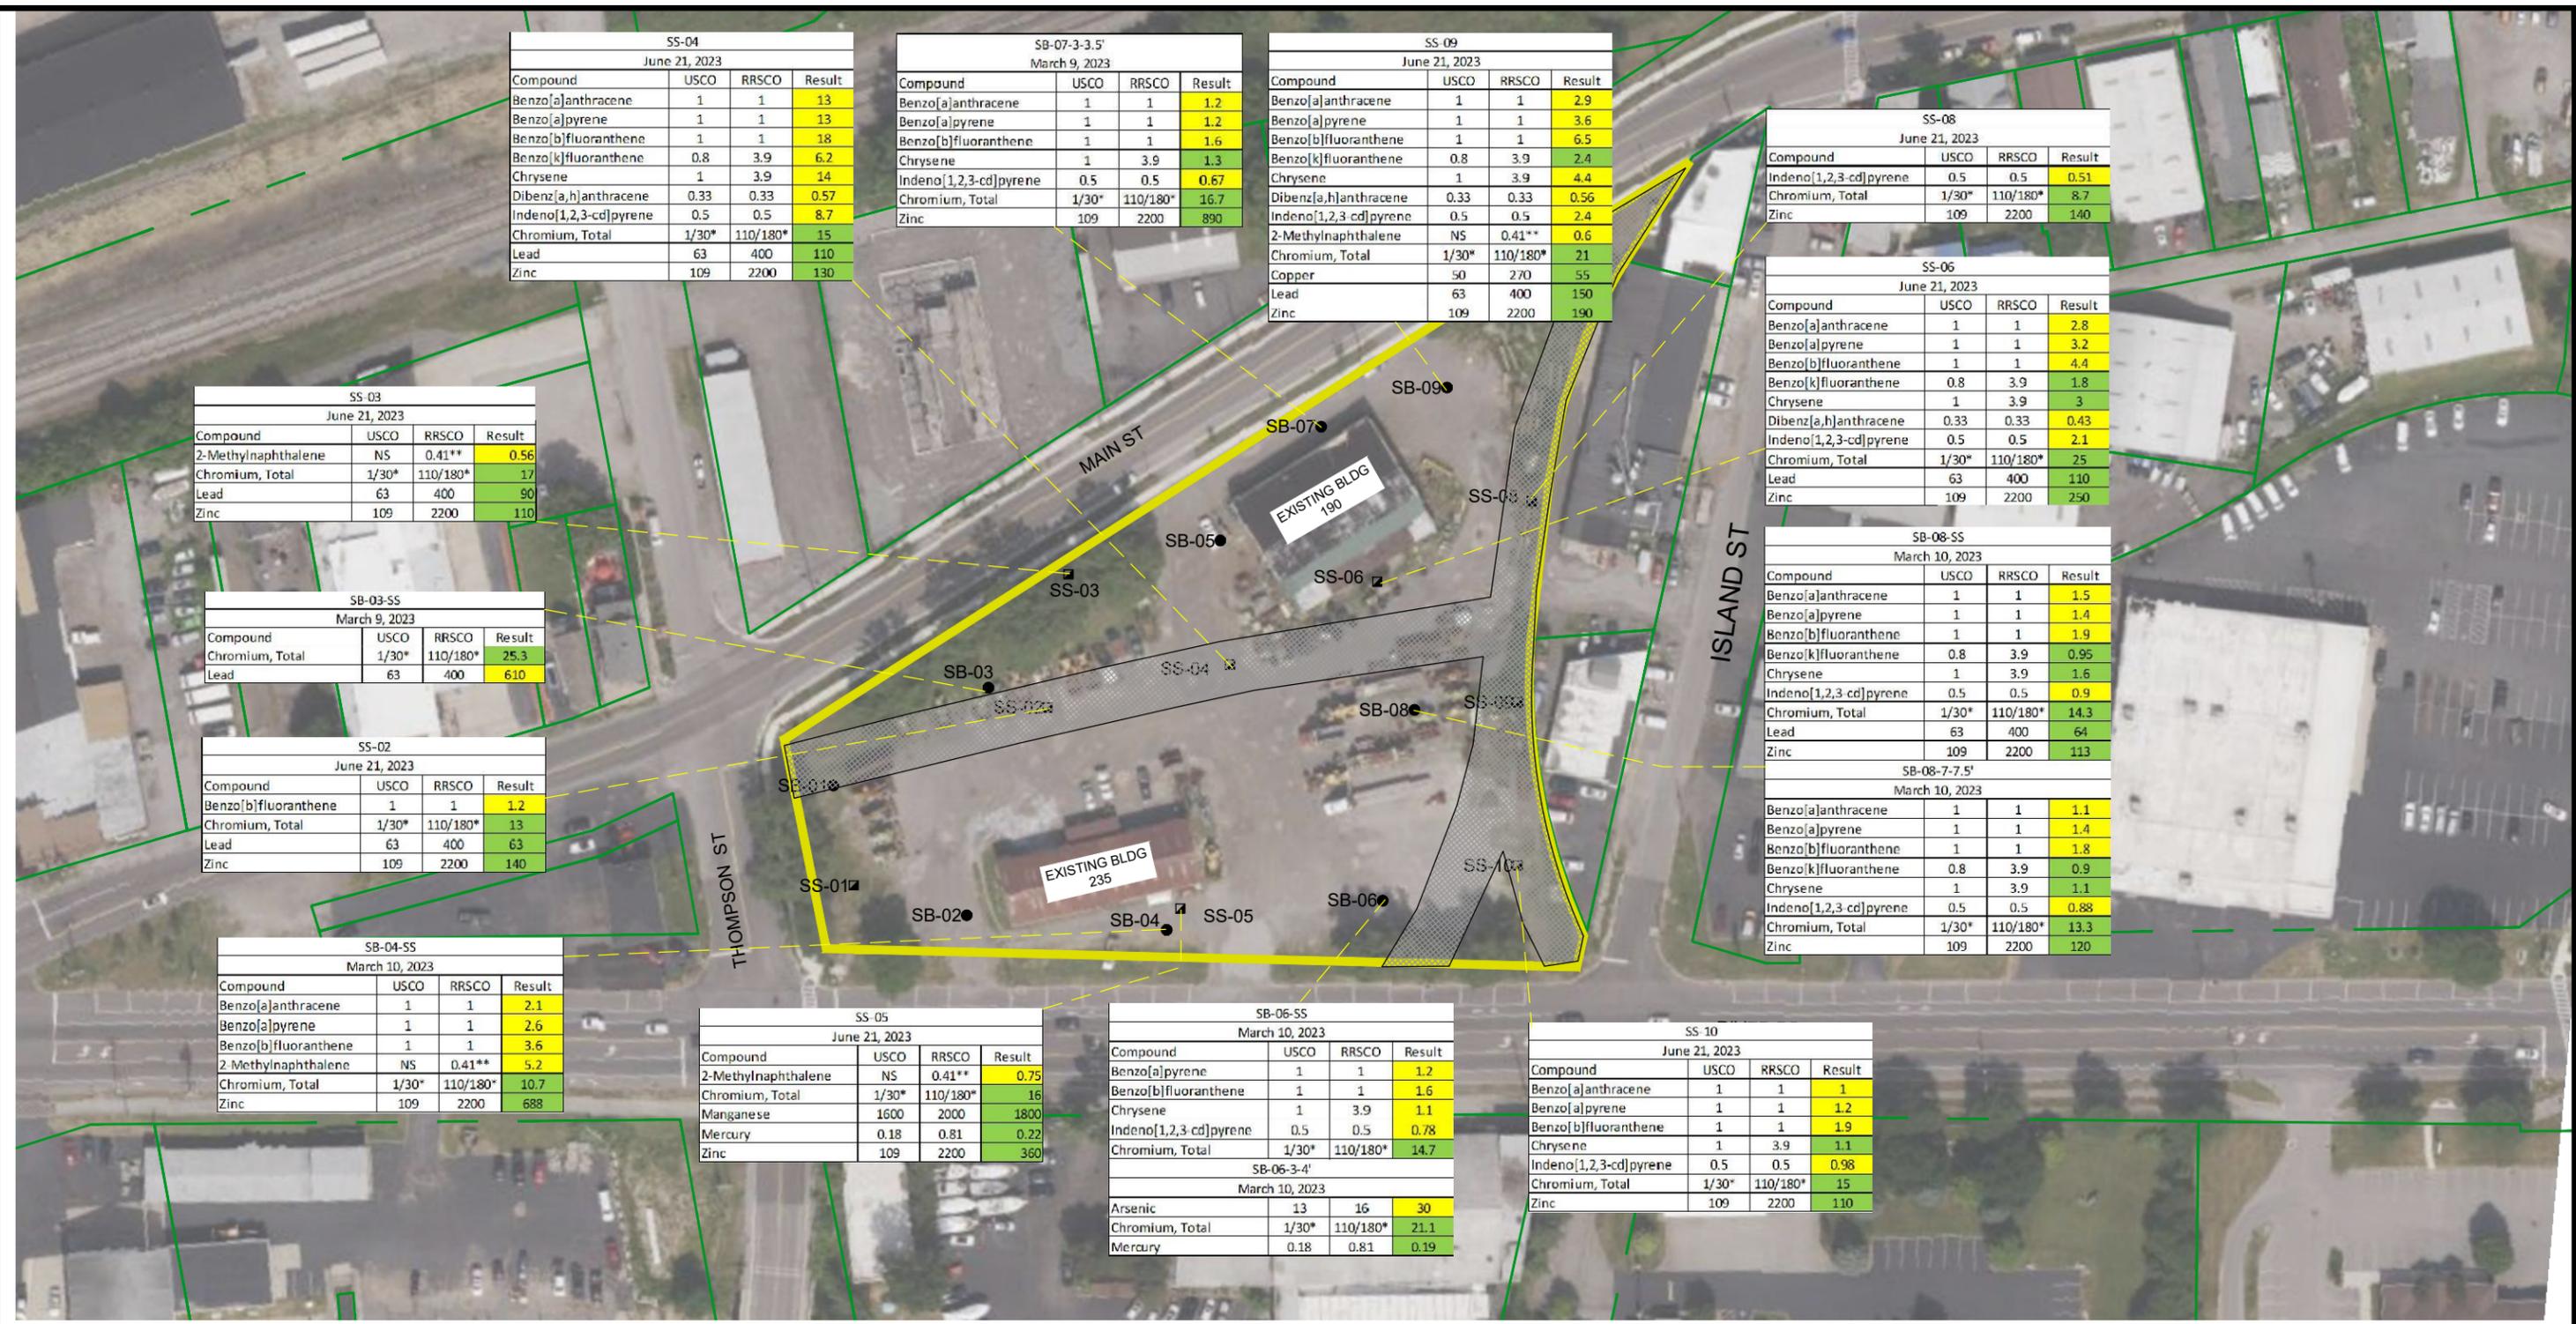
<p>Title:</p> <p><b>SITE PLAN</b></p> <p><b>REMEDIAL INVESTIGATION WORK PLAN</b></p> <p><b>235 RIVER ROAD SITE</b></p> <p>NORTH TONAWANDA, NEW YORK</p>		
<p>Prepared for:</p> <p style="text-align: center;">235 RIVER ROAD, LLC</p>		
	<p>Compiled by: RFL      Date: AUGUST 2024</p> <p>Prepared by: RFL      Scale: AS SHOWN</p> <p>Project Mgr: MAL      Project: 4750.0001B000</p> <p>File: FIGURE 2; SITE PLAN_235.DWG</p>	<p>FIGURE</p> <p style="font-size: 24pt; font-weight: bold;">2</p>

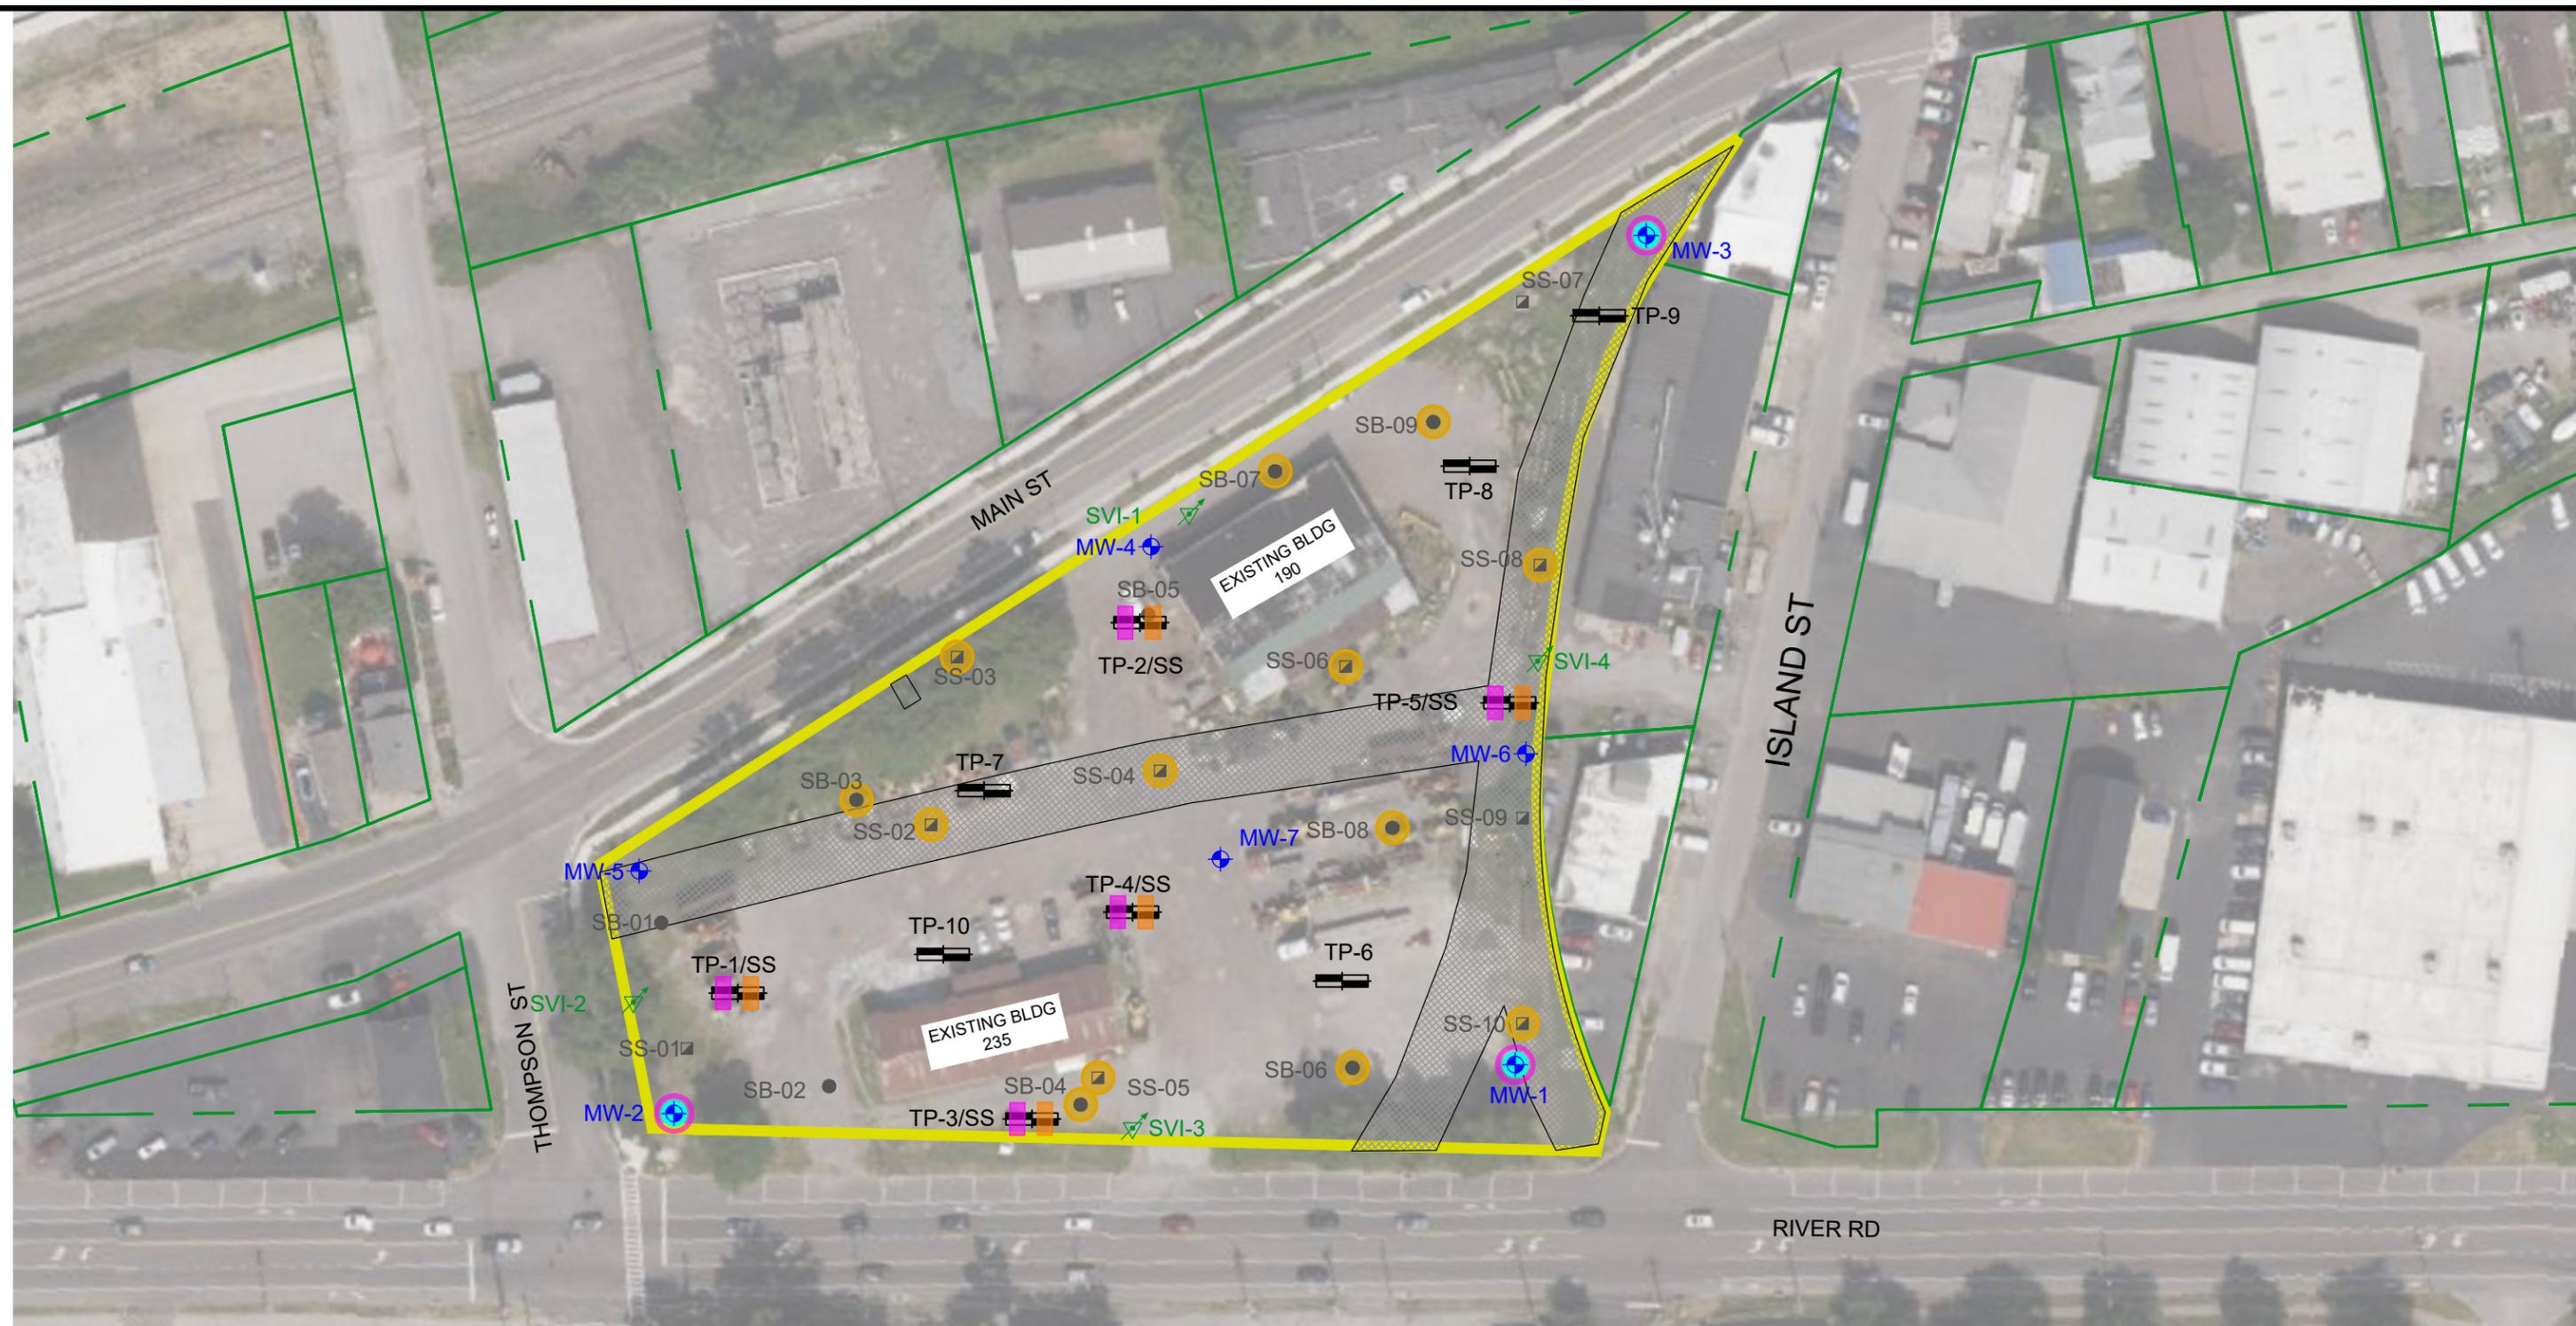
F:\CAD\0-ROUX\235 RIVER RD\FIGURE 4: RI INV LOC\_235RR.DWG

- BCP/PROPERTY BOUNDARY
- PARCEL BOUNDARY
- SB-1 ● HISTORICAL SOIL BORING
- SS-1 ▣ HISTORICAL SURFACE SOIL SAMPLE
- ▨ APPROX. LIMITS OF FORMER RAILROAD LANDS
- HISTORICAL SOIL SAMPLE CONCENTRATIONS EXCEED RRSCO.
- TP-10/SS ▩ PLANNED RI TEST PIT (10), SS=SURFACE SOIL SAMPLE (5)
- MW-1 ◆ PLANNED MONITORING WELL (7)
- SVI-1 ↗ PLANNED SOIL VAPOR MONITORING POINT (4)
- PLANNED GROUNDWATER SAMPLE TESTING FOR PFAS (3)
- ▩ PLANNED SOIL SAMPLE TESTING FOR FULL SUITE OF PARAMETERS FROM FILL MATERIAL (5)
- ▩ PLANNED SOIL SAMPLE TESTING FOR FULL SUITE OF PARAMETERS FROM NATIVE SOIL (5-15 FBGS) (5)
- PLANNED SOIL BORING FOR FULL SUITE OF PARAMETERS FROM FILL MATERIAL (3)

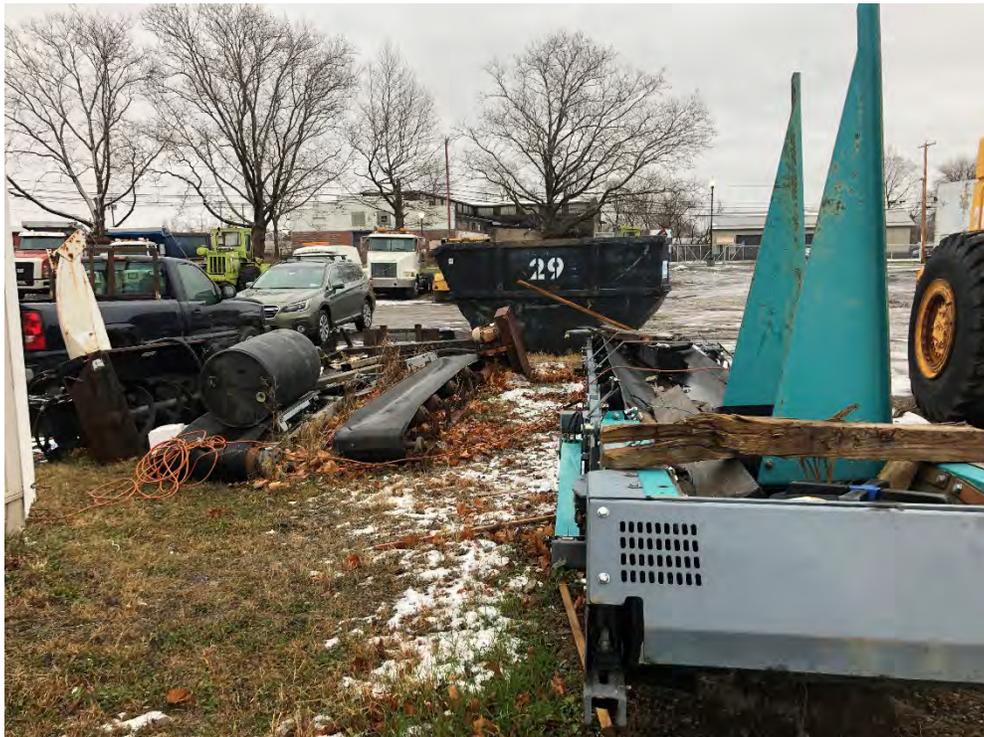
**View of various debris/equipment stored on south side of Building 2. Open dumpster and 55-gallon drum noted.**

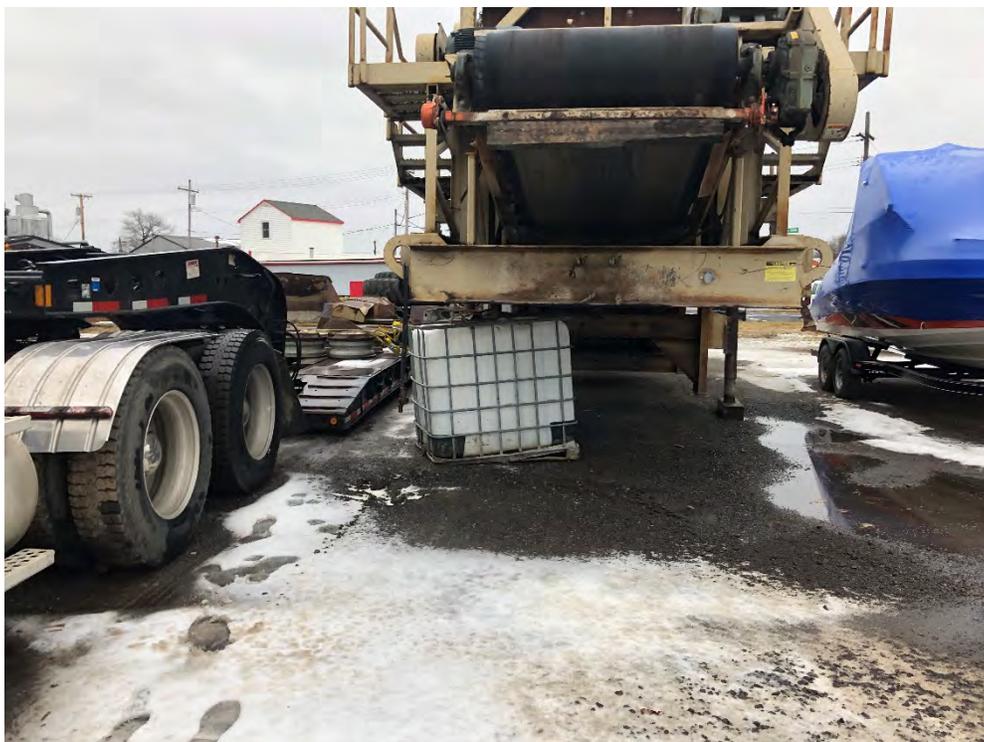
**Two 275-gallon storage totes found empty beneath equipment on north side of Sit**

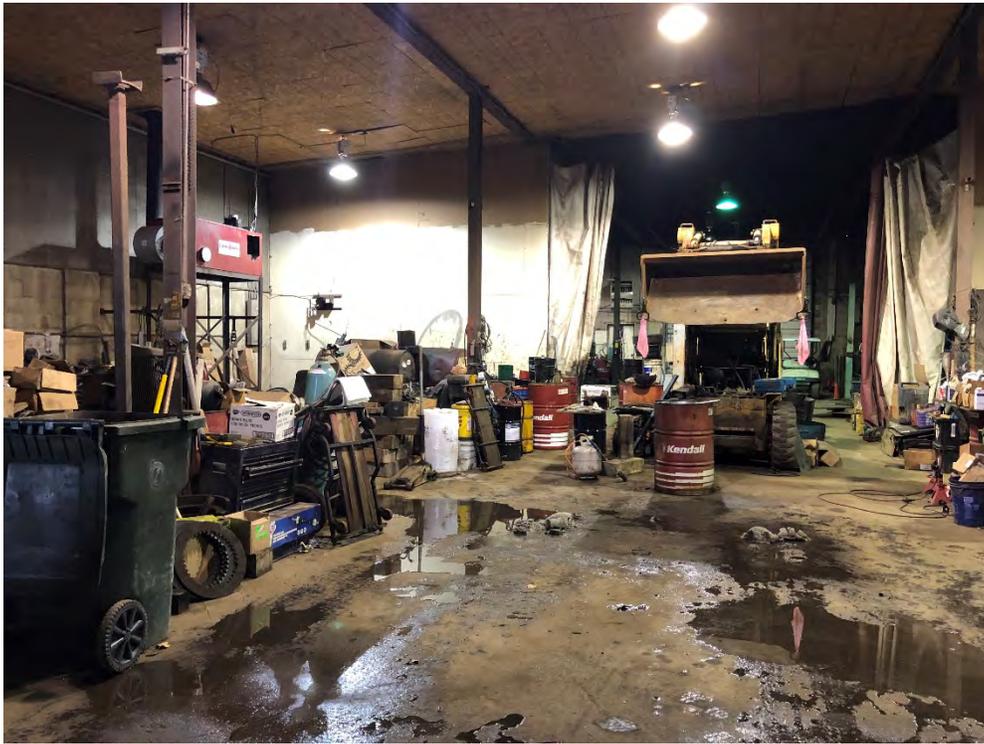
**View of interior of Building 1; repair shop.**

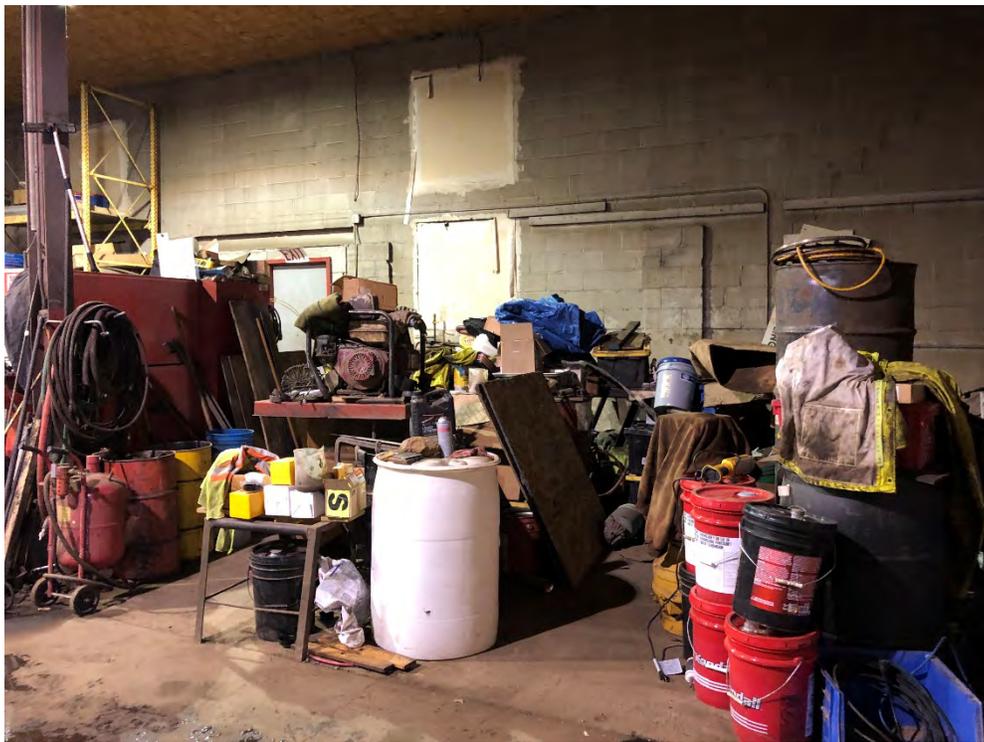
**Various containers of petroleum products and degreasers inside Building 1.**

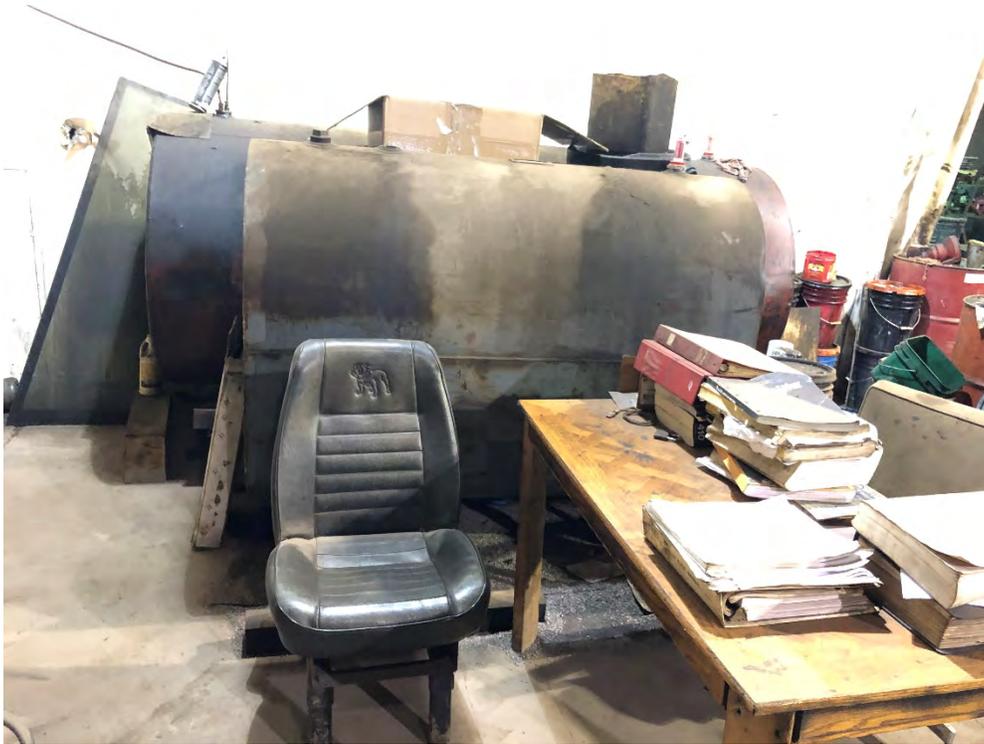
**Two above ground waste oil tanks found inside Building 1. Connected to waste oil burner and used as heating fuel source.**

- Multiple 55-gallon drums were located within the warehouse building. Most were empty and used as supports to place equipment on, but a few reportedly contained waste oil. The repair garage contained two tanks of waste oil (575 and 275 gallons) which were used to heat the garage through a used oil burner. Evidence of staining was observed in the repair garage building, including around both used oil tanks, likely from the filling of the tanks. The previous spills appeared to be contained by the concrete floor of the garage, but floor integrity was not able to be fully assessed because of the tanks' location.

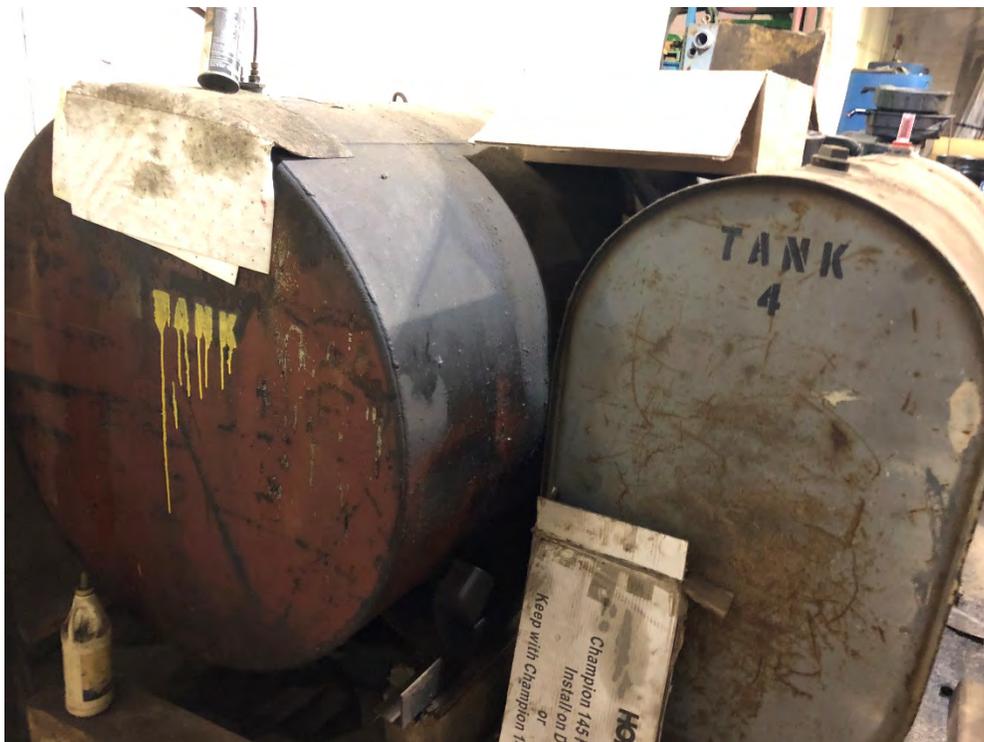
**Tanks 3 and 4 – waste oil tanks. Evidence of consistent spilling below tanks.**

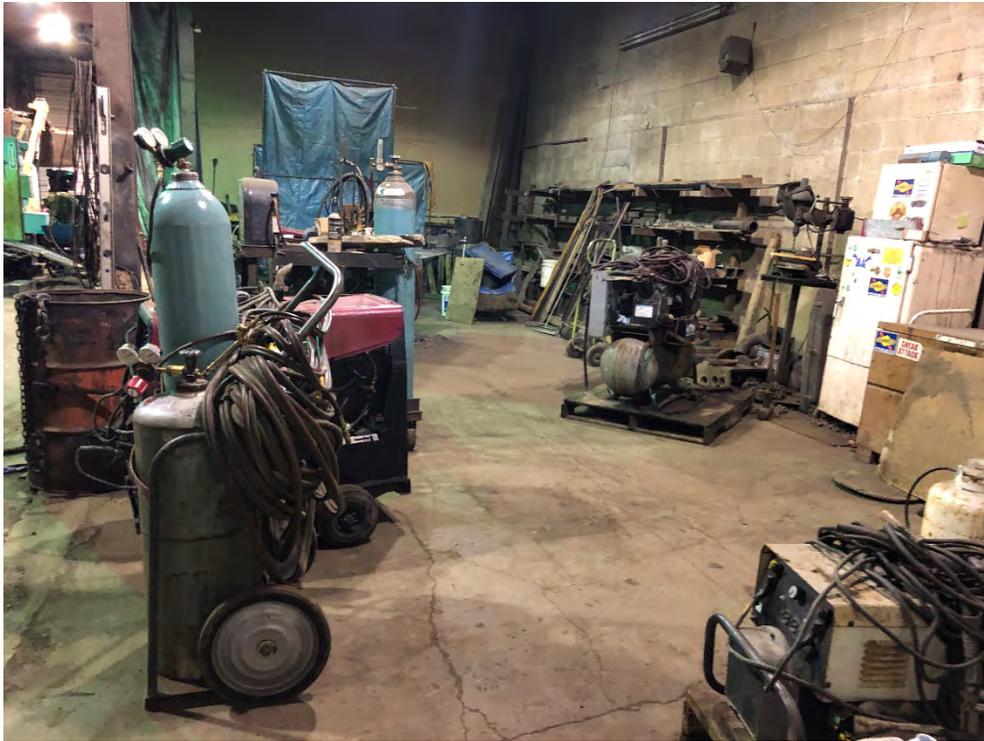
**Additional repair equipment on south side of Building 1.**

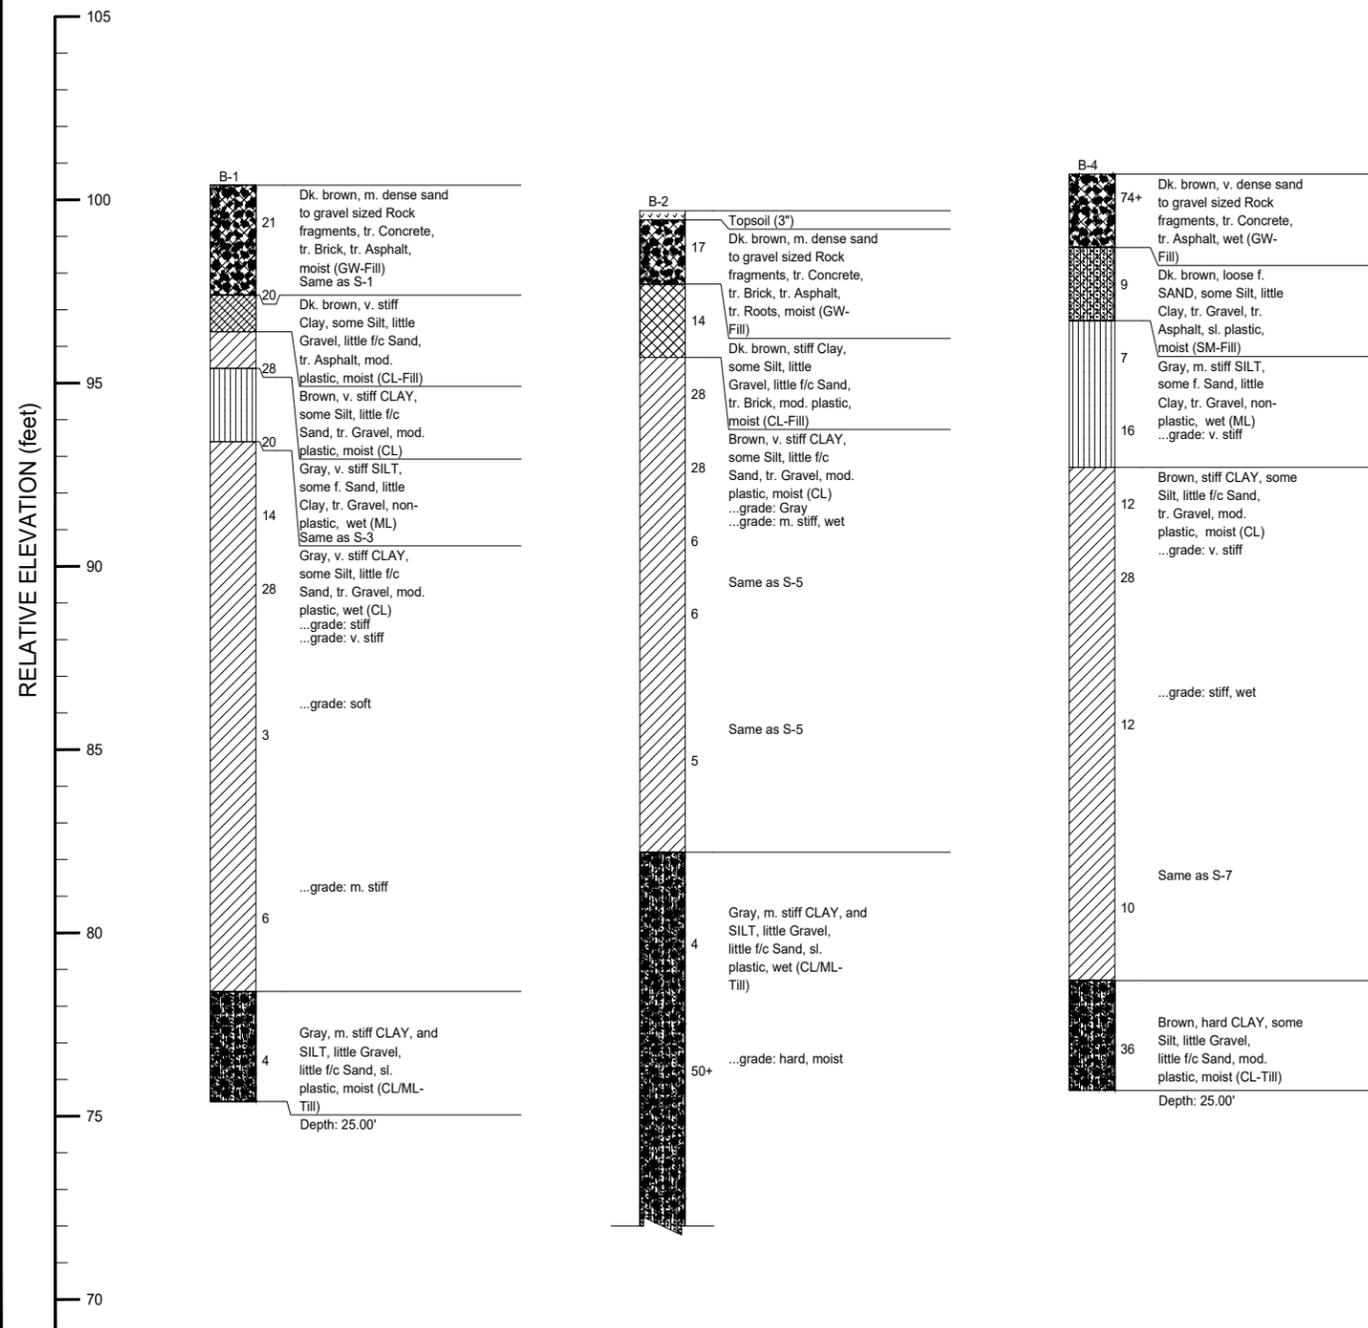
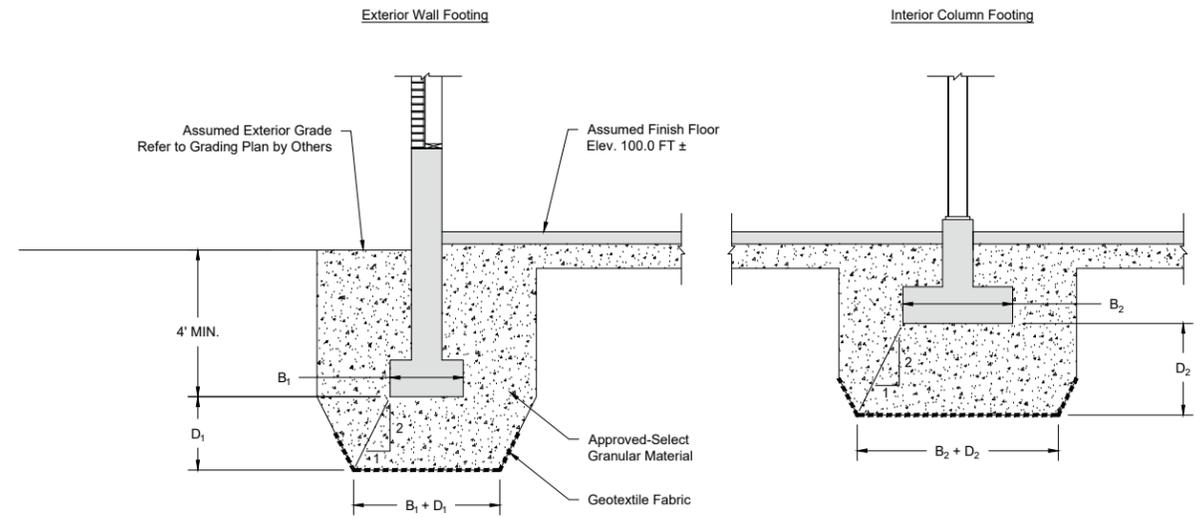
# "PROFILE OF BORING"

- NOTES:**
- Install Foundations per Architect or Structural Engineer.
  - Adhere to Building Code of New York State.
  - Elevations are relative to Bench Mark established in field. Please refer to Test Boring Location Plan.
  - Bear footings on stable, natural, hard soils (N-values > 30 blows) or with approved select granular fill undercut, placed in loose lifts no greater than 12 inches thick and compacted to 95% of maximum-dry density as per ASTM D1557.
  - Undercuts likely required.
  - Bearing Grades should be approved by a qualified inspector, during construction.
  - On Above Conditions: USE Q<sub>ALLOW</sub> = 2,500 PSF

Well graded gravel	Clay fill	Low plasticity clay	Silt	Natural till	Granular fill	Sand fill	Drill rejection
			Topsoil	Boring continues

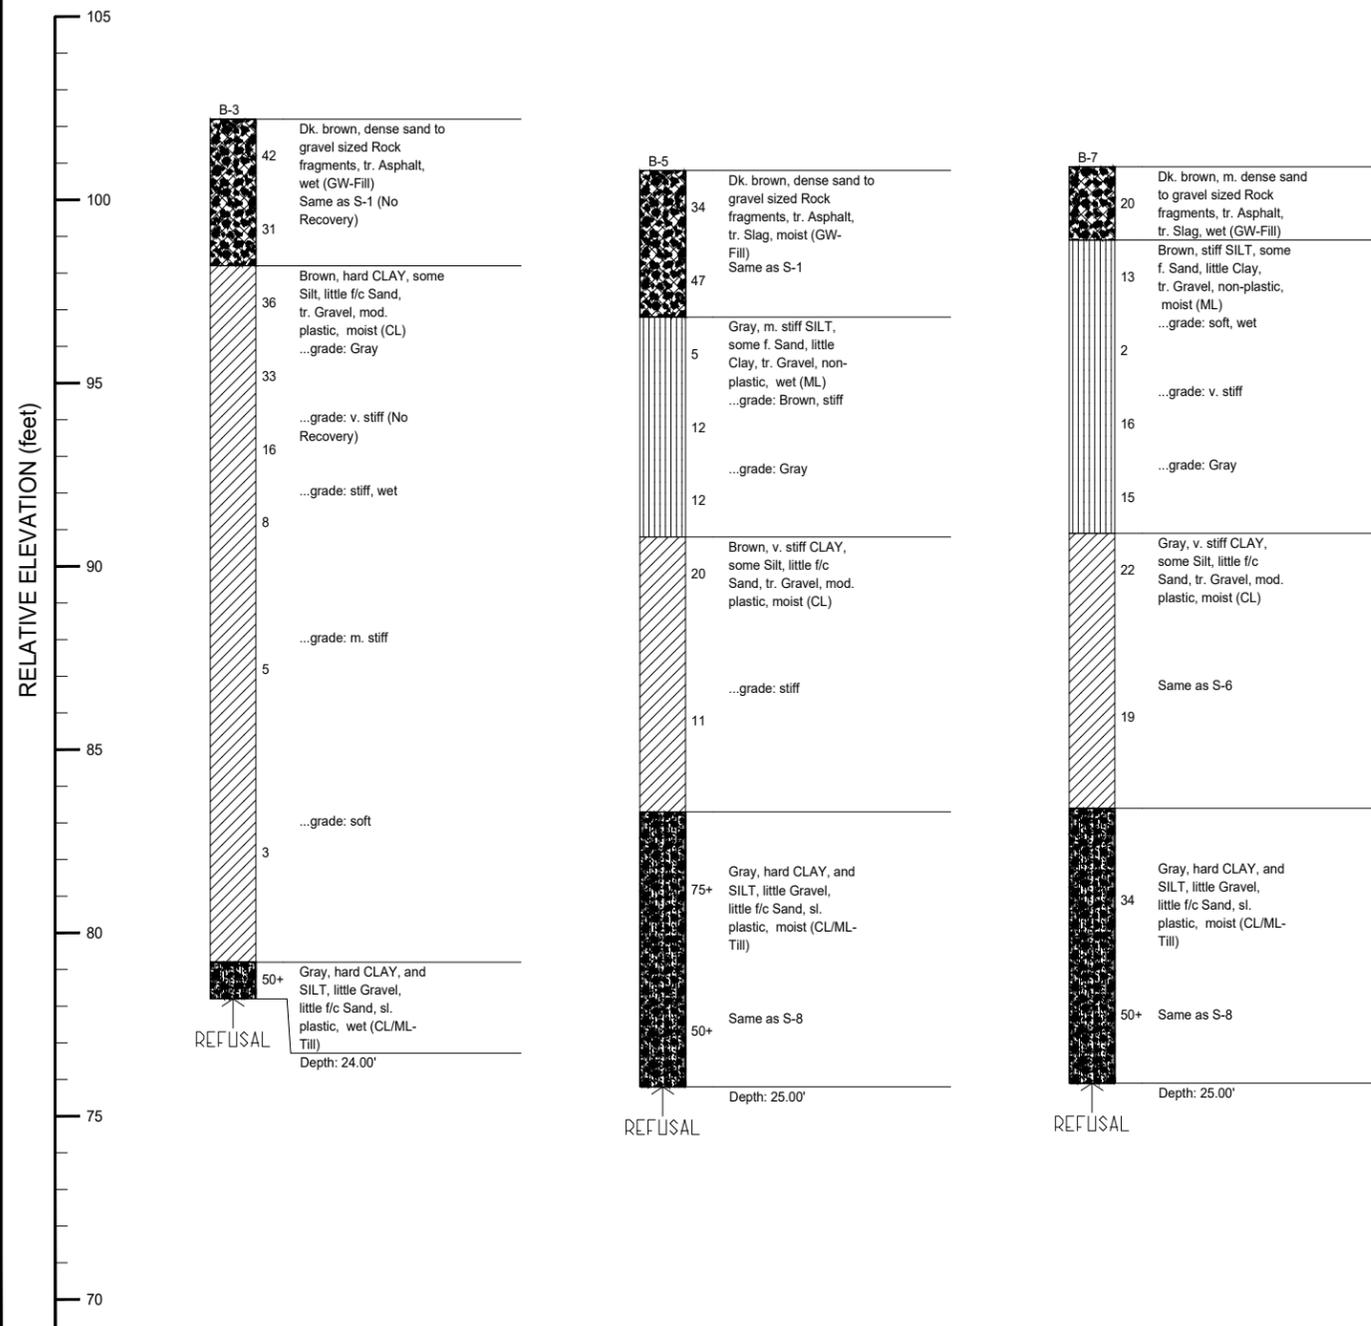
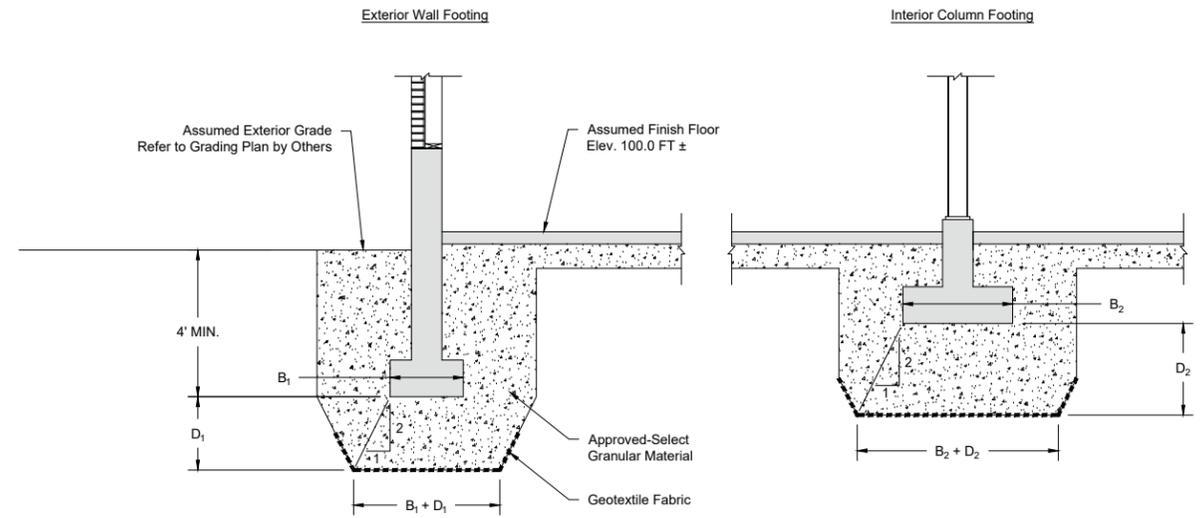
# "PROFILE OF BORING"

- NOTES:**
- Install Foundations per Architect or Structural Engineer.
  - Adhere to Building Code of New York State.
  - Elevations are relative to Bench Mark established in field. Please refer to Test Boring Location Plan.
  - Bear footings on stable, natural, hard soils (N-values > 30 blows) or with approved select granular fill undercut, placed in loose lifts no greater than 12 inches thick and compacted to 95% of maximum-dry density as per ASTM D1557.
  - Undercuts likely required.
  - Bearing Grades should be approved by a qualified inspector, during construction.
  - On Above Conditions: USE  $Q_{ALLOW} = 2,500$  PSF

Well graded gravel	Clay fill	Low plasticity clay	Silt	Natural till	Granular fill	Sand fill	Drill rejection
	Topsail				Boring continues

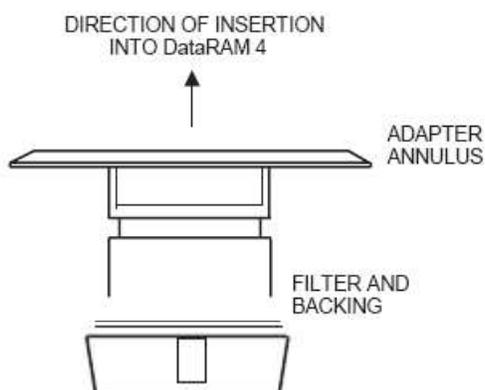
#### *Analytical filter holder with adapter annulus inserted*
