ENGINEERING INVESTIGATIONS AT INACTIVE HAZARDOUS WASTE SITES

PHASE I INVESTIGATION

Chisholm Ryder
City of Niagara Falls

Site No. 932009
Niagara County

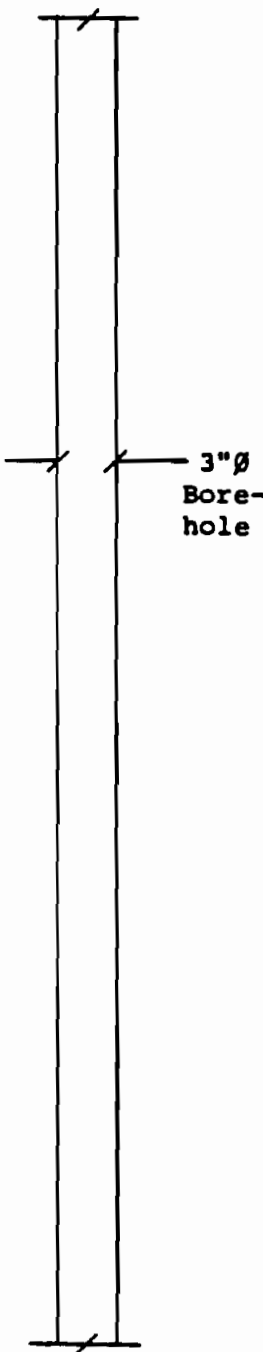
HOLE N^o : F-7D Page 2 of 3
 DATE COMPLETED : May 11, 1983
 GEOLOGIST/ENGINEER : W. CLARKE/J. KAY
 GROUND ELEVATION : 578.3
 TOP OF PIPE ELEVATION : _____

3"Ø Bore- hole								
535										
530										
525	Gray fine grained DOLOMITE									
520										
515										
510	Gray aphanitic DOLOMITE									
505										
500
