ENGINEERING INVESTIGATIONS AT INACTIVE HAZARDOUS WASTE SITES

PHASE II INVESTIGATION

Chisholm - Ryder
City of Niagara Falls

Site No. 932009
Niagara County

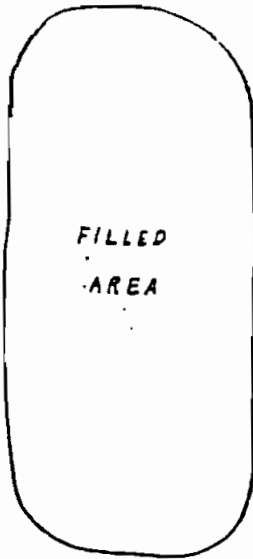
FILLED
AREA

EXPOSED DRUMS
& REFUSE
