# ENVIRONMENTAL SITE ASSESSMENT

**3800 Highland Avenue  
Niagara Falls NY**

**e2i Acquisitions  
75 Bird Ave  
Buffalo NY 14213**

**March 2022**

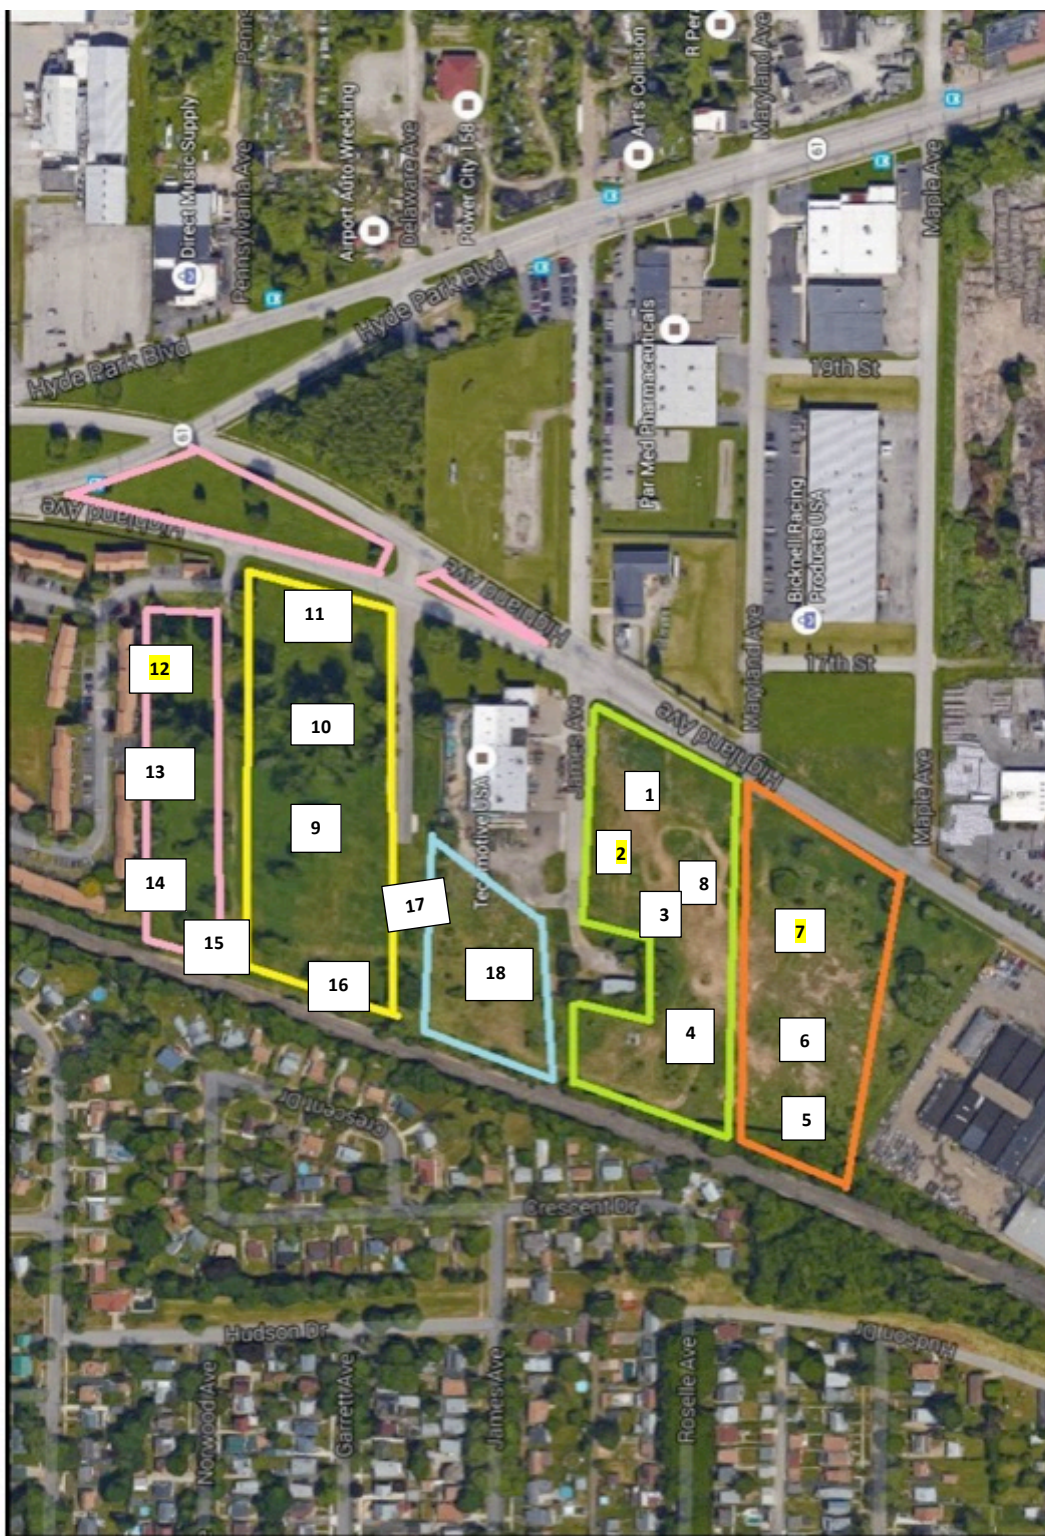
FIGURE 1 – TRENCH LOCATIONS

TEST PIT #2 – Small amount of TENORM

TEST PIT #4- Small amount of Petroleum Contamination

Taking a conservative approach, if any invasive site improvement (i.e., earthwork, utility construction) is conducted, if and unknown materials if found should be set aside for further evaluation. The fill material in TP-4 would need to be disposed of it would appear that it could not be reused. The fill material was at surface levels and no deeper than 3' bgs. TENORM would need to be disposed if disturbed on site.

Armand Cerrone excavated 18 soil trench's from ground surface to various depth though out the site. Figure 1 shows the sampling locations. Each trench location was assessed for visual impairment, olfactory indications of impairment, total VOCs using a photoionization detector (PID) and sampled. Material description and physical evidence of contamination (odors, staining or sheen) of each trench sample was recorded on soil trench logs provided in Appendix A.

An investigation was conducted at the site during the test pit excavation. The material was found in only TP-2. In the Niagara Falls NY area this material was generated from phosphorus production during the 1900-1970. The slag material has been used throughout WNY for fill material. At TP-2 the counts were 90,000cpm which is 18x the background levels of 5000cpm
