# INVESTIGATION REPORT

Mayville Water Supply Contamination  
Spill Number 2008000  
Village of Mayville  
Chautauqua County  
March 2021

Prepared by  
New York State Department of Environmental Conservation  
Region 9  
270 Michigan Avenue  
Buffalo, New York 14203

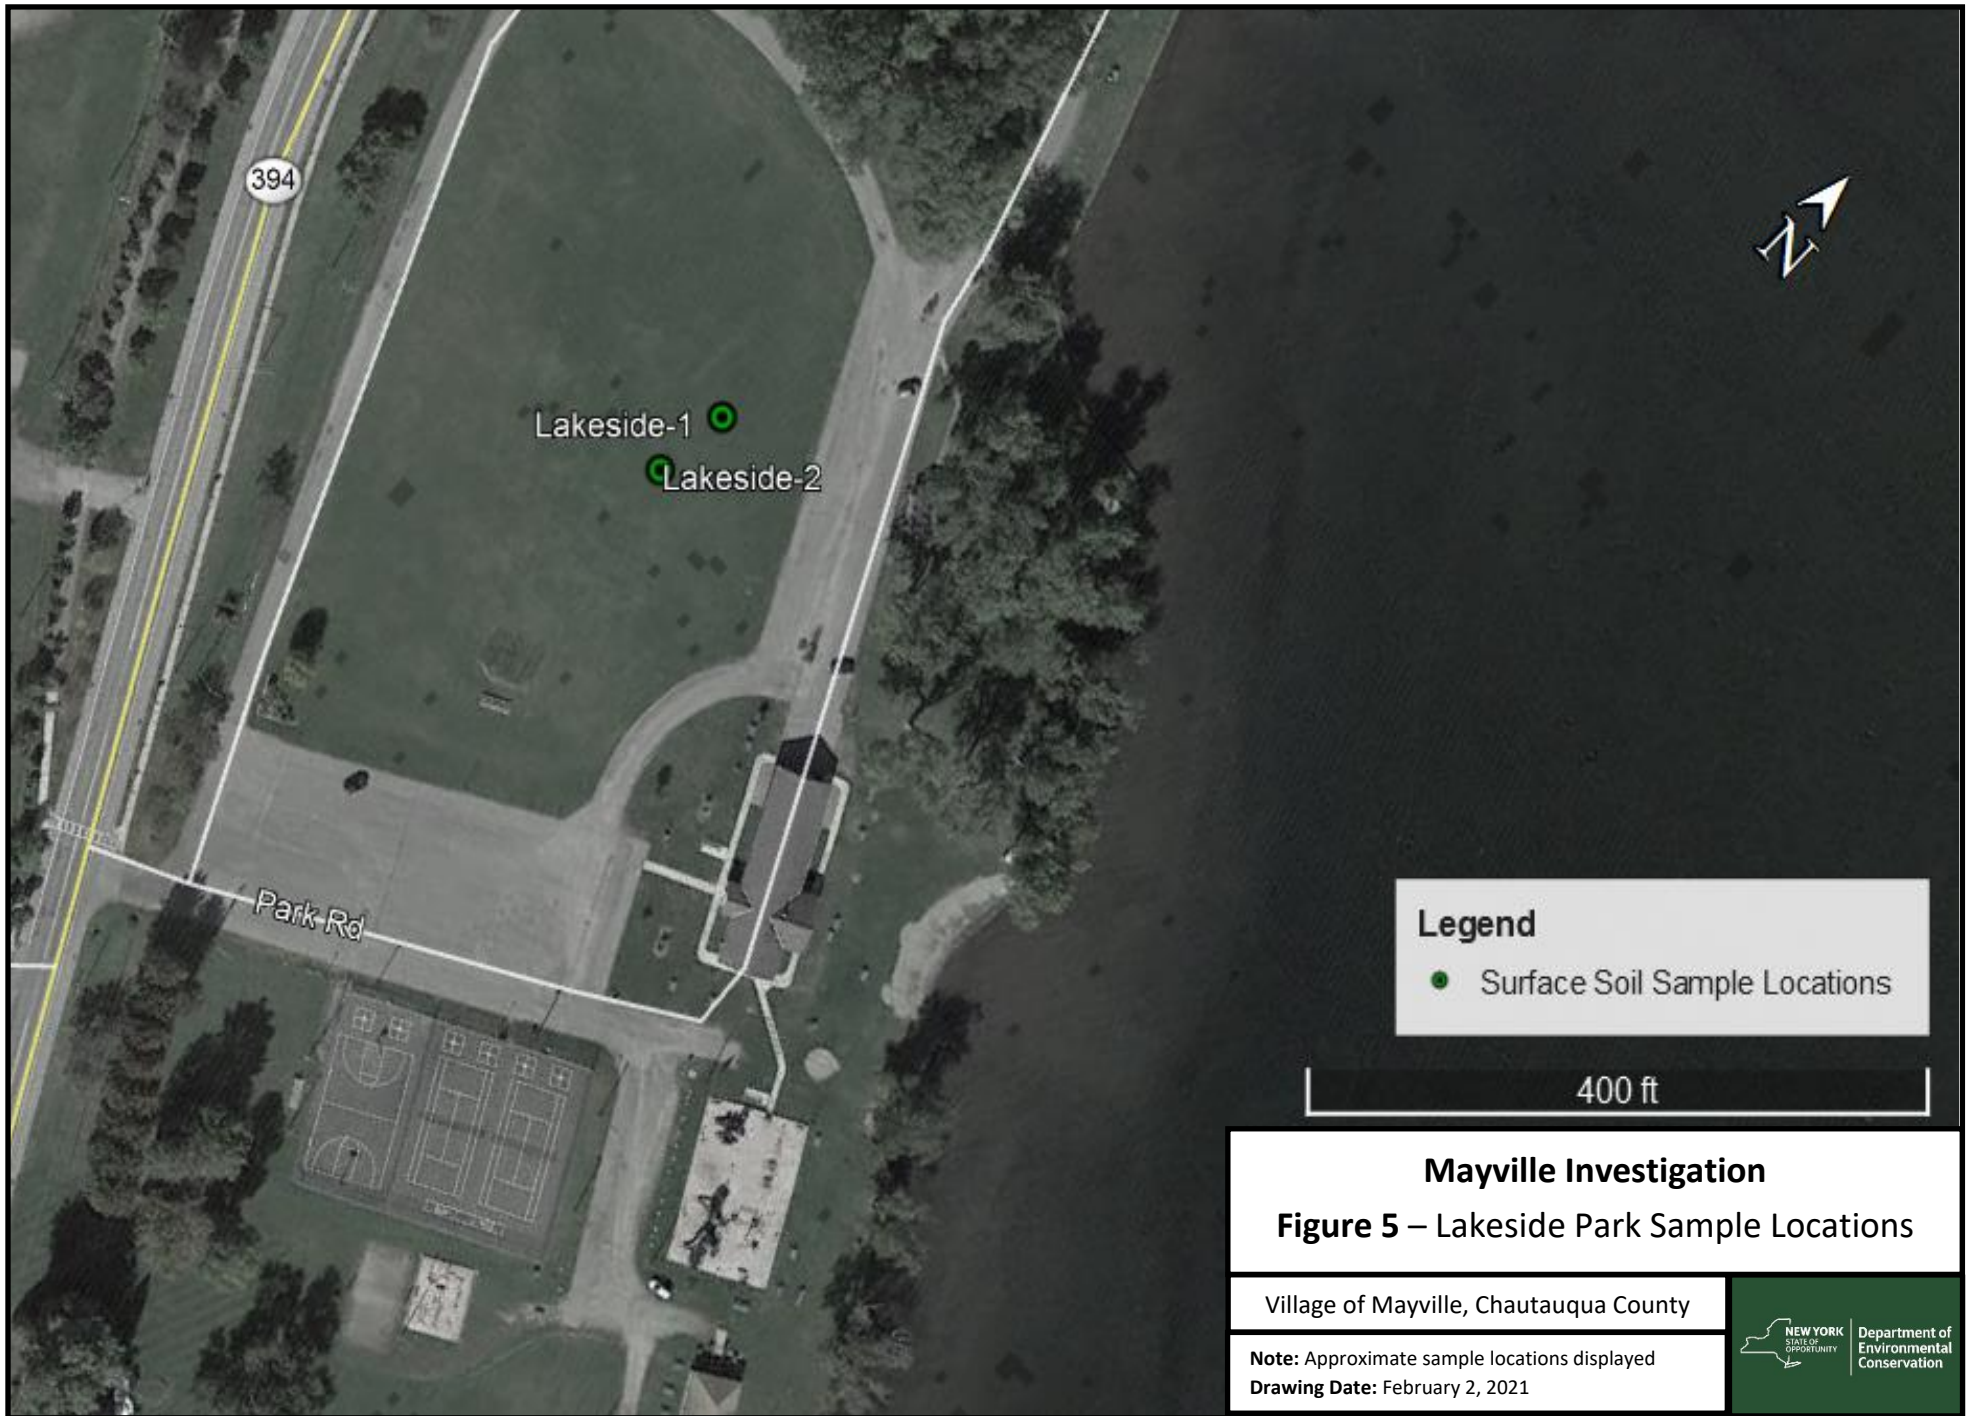
Lakeside Park is located along South Erie Street adjacent to the northwest end of Chautauqua Lake. Based on accounts from local fire department personnel, fire training foam was sprayed in three (3) locations at the park. Due to the use of training foam at Lakeside Park, two (2) surface soil samples were collected from a depth of 0 to 6 inches bgs at two (2) locations within the park circle where the baseball diamond is situated, which was reportedly the location that received the greatest number of foam applications. Sample locations for Lakeside Park are displayed on Figure 5.
