**SUFFOLK COUNTY FORMER BELLPORT GAS STATION
1401 MONTAUK HIGHWAY, EAST PATCHOGUE, NY
SITE: #E-1-52-194**

PWGC Project No. SHD0902

**REMEDIAL
INVESTIGATION
REPORT
January 2010**

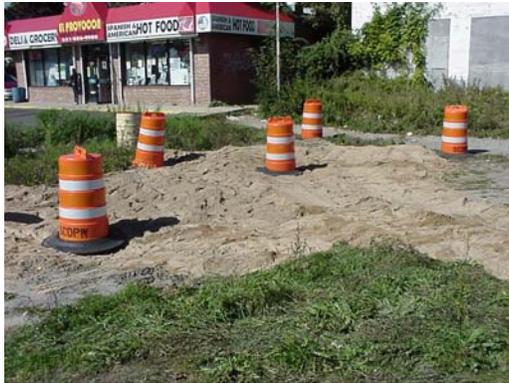
Photo #5

The DW-2 storm drain was backfilled with 12 yards of "certified clean fill". The area was brought to grade and marked off with SCDPW road marker drums (Photo #5 attached)
