**SUBJECT:** Environmental Restoration Projects Application  
36 Elm Street, E-557019

**City of Glens Falls**  
**TECHNOLOGY ACCELERATOR BROWNFIELD PROJECT**

**Application for Assistance**

The following site plan for 36 Elm Street was prepared by Clough, Harbour & Associates (CHA) of Albany as part of the Phase I Environmental Site Assessment (ESA) completed for the property in late 2002 and early 2003. That site assessment was intended to identify initial areas of concern regarding the property's known manufacturing history and any potential environmental hazards observed on the site and along surrounding properties.

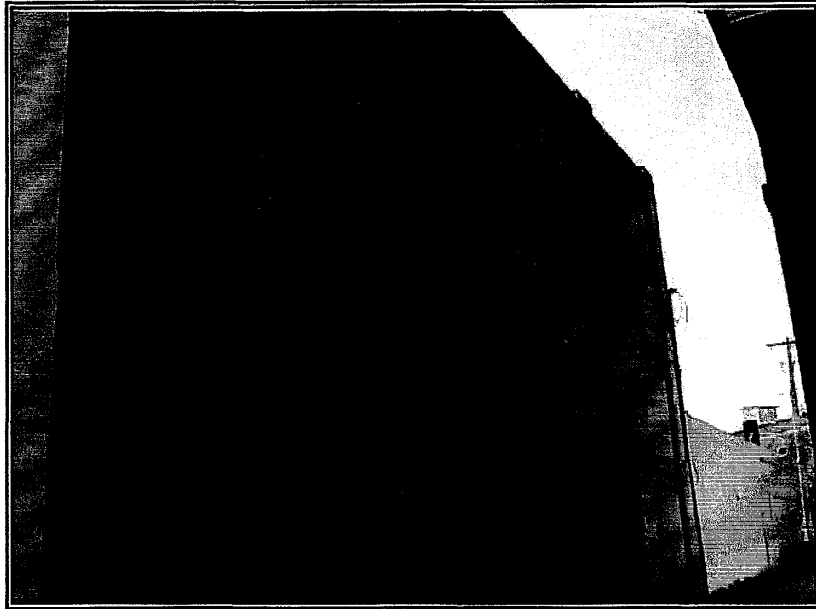
View of the exterior of 36 Elm Street from the alley along the northwestern side of Elm Street (top). Looking at the top two floors of the rear of the building from the southern side (below).
