Re: Remedial Investigation Report  
1333 East Dominick St., Site E633060  
City of Rome, Oneida County, New York

<u>Section</u>	<u>Page</u>
Executive Summary .....	E-1
1.0 Introduction.....	1
1.1 Objectives .....	1
1.2 Report Organization.....	2
1.3 Special Terms and Conditions .....	2

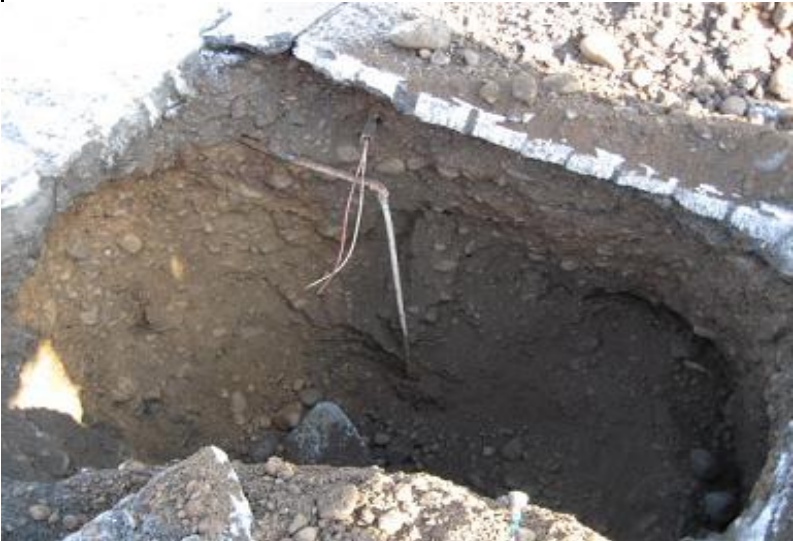
PHOTO OF TEST PIT NO.: TP-05

DEPTH FT	PID PPM	SOIL CLASSIFICATION	NOTES/OBSERVATIONS			PHOTO FILE NO.
1	NO ELEVATED PID READINGS	Brown SAND AND GRAVEL, some Cobble (FILL)	Electrical conduit and copper piping (1" dia.) apparently runs from street to building toward pump island, water observed in pipe.  No visual/olfactory evidence of contamination.			001-007
2						
3						
4						
5						
6						
7						
8						
9						
10						
GW DEPTH		TOTAL DEPTH 7 ft	FINAL DIMENSIONS 6 ft x 6 ft	NORTHING tbd	EASTING tbd	ELEVATION tbd

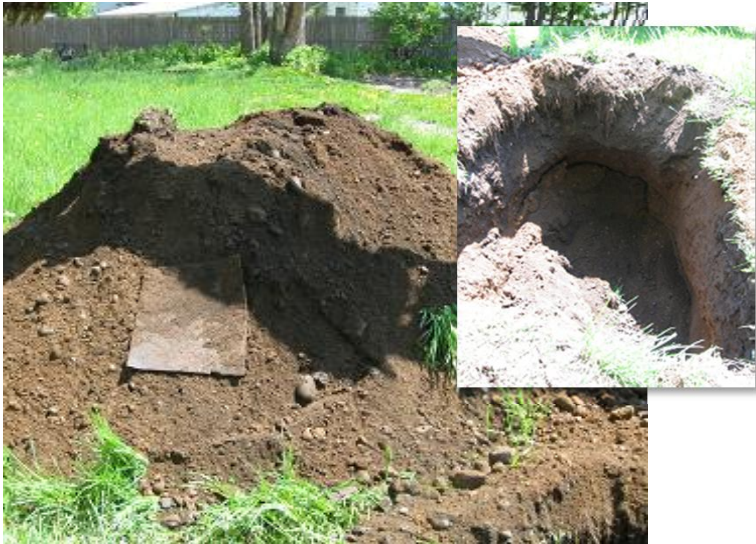
PHOTO OF TEST PIT NO.: TP-06

DEPTH FT	PID PPM	SOIL CLASSIFICATION	NOTES/OBSERVATIONS			PHOTO FILE NO.
1	Max 0.3 (back-ground)	Brown fine to medium SAND AND GRAVEL, loose, trace coarse Gravel and fine Cobble.	Approx. 2 ft square piece of scrap metal encountered at ~1 ft bgs.  No visual/olfactory evidence of contamination observed.			048-050
2						
3						
4						
5						
6						
7						
8						
9						
10						
GW DEPTH		TOTAL DEPTH 6 ft	FINAL DIMENSIONS 5 ft x 8 ft	NORTHING tbd	EASTING tbd	ELEVATION tbd

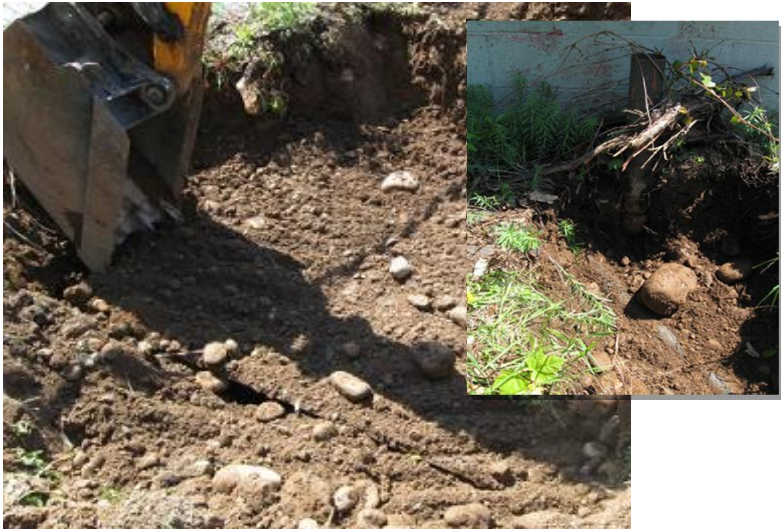
PHOTO OF TEST PIT NO.: TP-1

DEPTH FT	PID PPM	SOIL CLASSIFICATION	NOTES/OBSERVATIONS			PHOTO FILE NO.
1	0.2	Brown SAND AND GRAVEL, some fine to medium Cobble, loose, bony	No obvious fill material observed from 0-4 ft, so extend pit ~10 ft east toward 4 - 5 in dia. standpipe, trace pipe to ~1 ft bgs at which point it enters bldg wall.  A 2 - 3 in dia. pipe oriented northwest-southeast horizontally found, followed ~20 ft northwest to where it appears to enter buried concrete block vault covered by ~1/4 in thick sheet metal (approx. 6 x 6 ft) and ~2 - 2.5 ft bgs, cover not removed - contents not identified and depth of structure is unknown - a second line (3 in dia.?) from southeast corner of vault may be associated with vent/fill pipes near single garage bay door.			106-119
2						
3						
4						
5						
6						
7						
8						
9						
10						
GW DEPTH		TOTAL DEPTH 1.5 ft	FINAL DIMENSIONS 2.5 ft x 7 ft (estimated)	NORTHING tbd	EASTING tbd	ELEVATION tbd

COMMENTS:  file no's.: img_116.jpg, img_112.jpg  Image on left shows edges of metal cover on top of concrete block vault.  Image on right shows 4 - 5 in standpipe and buried 2 - 3 in line leading to vault.
--	--	---

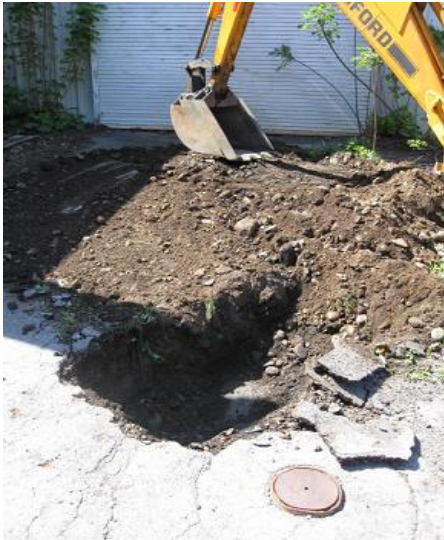
PHOTO OF TEST PIT NO.: TP-2

DEPTH FT	PID PPM	SOIL CLASSIFICATION	NOTES/OBSERVATIONS			PHOTO FILE NO.
1	0.5	Brown SAND AND GRAVEL, some Brick/Concrete Debris	Slight fuel/gas odor, top of tank uncovered at ~15 in bgs, oriented east-west, lengthwise parallel to bldg brick wall, buried fill or vent pipe approx. 3 ft from garage door (assumed tank end), other end confirmed near 8 in cover in asphalt, grey staining, strong odor/PID hits around this cover, tank ~25 ft long, est width ~ 6 ft.			120-127
2	250					
3						
4						
5						
6						
7						
8						
9						
10						
GW DEPTH		TOTAL DEPTH Max. 2 ft	FINAL DIMENSIONS	NORTHING tbd	EASTING tbd	ELEVATION tbd

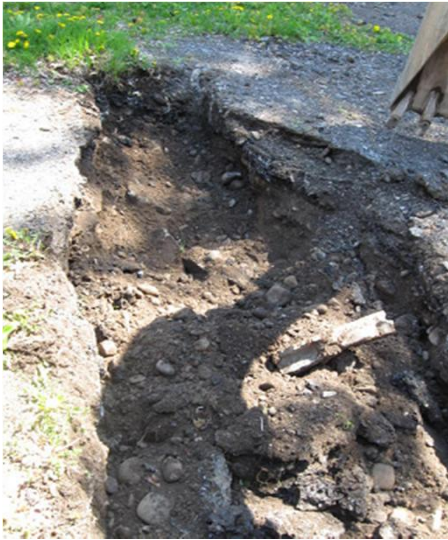
<div> <div>PHOTO OF TEST PIT NO.: TP-3</div>

DEPTH FT	PID PPM	SOIL CLASSIFICATION	NOTES/OBSERVATIONS			PHOTO FILE NO.
1	0.2	6 in ASPHALT Brown SAND & GRAVEL, little fm Cobble, loose	Petroleum odor noted beneath asphalt, low PID hits, refusal on uneven concrete debris at ~1.5 ft, attempted to extend pit east but hard concrete debris continues.			104-105
2						
3						
4						
5						
6						
7						
8						
9						
10						
GW DEPTH		TOTAL DEPTH 1.5 ft	FINAL DIMENSIONS 2.5 ft x 7 ft (estimated)	NORTHING tbd	EASTING tbd	ELEVATION tbd

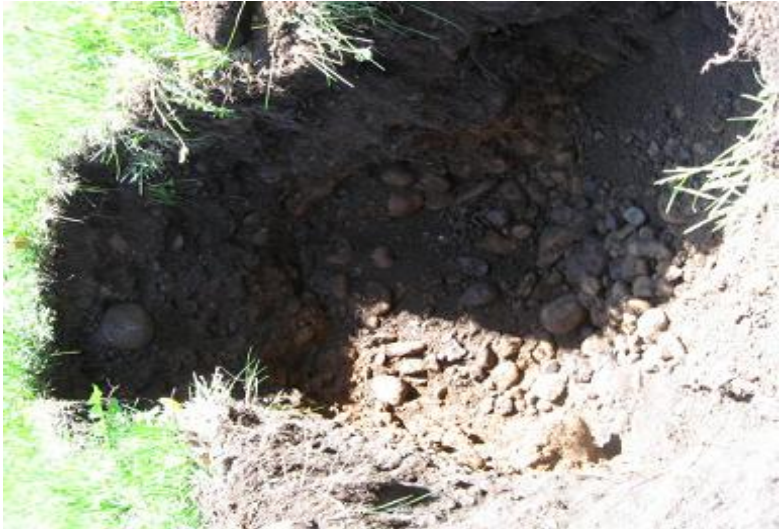
PHOTO OF TEST PIT NO.: TP-4

DEPTH FT	PID PPM	SOIL CLASSIFICATION	NOTES/OBSERVATIONS			PHOTO FILE NO.
1	NO ELEVATED PID READINGS	Dark Brown Silty GRAVEL AND COBBLE, some Concrete and Debris (FILL).	Concrete fragments, debris such as glass bottles.			100-103
2		Light Brown GRAVEL AND COBBLE, some coarse to medium Sand, moist, loose, bony.	No odor or visual evidence of contamination observed, no elevated PID readings.			
3						
4						
5						
6						
7						
8						
9						
10						
GW DEPTH		TOTAL DEPTH 5 ft	FINAL DIMENSIONS 2.5 ft x 9 ft	NORTHING tbd	EASTING tbd	ELEVATION tbd

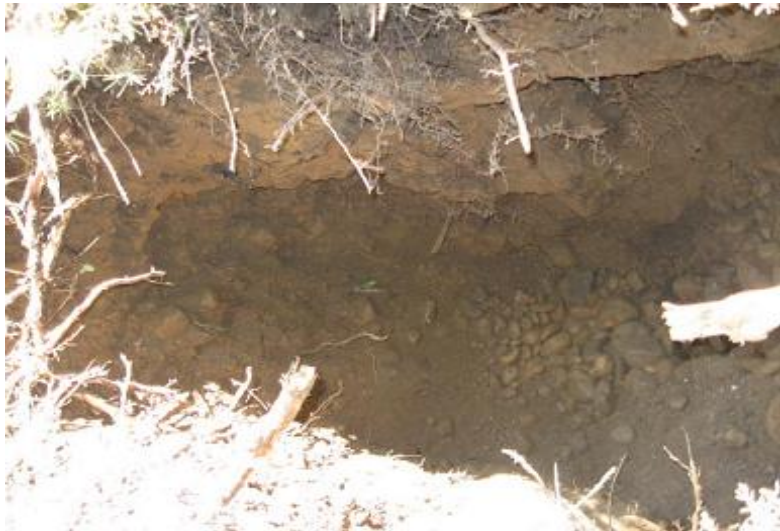
PHOTO OF TEST PIT NO.: TP-7

DEPTH FT	PID PPM	SOIL CLASSIFICATION	NOTES/OBSERVATIONS			PHOTO FILE NO.
1	1.3 (max obs)	Miscellaneous FILL	Old wheel encountered at 6-12 in bgs, occasional miscellaneous scrap metal, license plate (NY '32), pipe scraps that don't appear to be in tact, miscellaneous fill from 0-2 ft bgs.			088-098
2		Light Brown fine to medium SAND AND GRAVEL, some fine to medium Cobble, loose.	No visual/olfactory evidence of contamination.			
3						
4						
5			Appears to be clean material @ depth.			
6						
7						
8						
9						
10						
GW DEPTH		TOTAL DEPTH	FINAL DIMENSIONS	NORTHING	EASTING	ELEVATION
		6 ft	6 ft x 6 ft	tbd	tbd	tbd

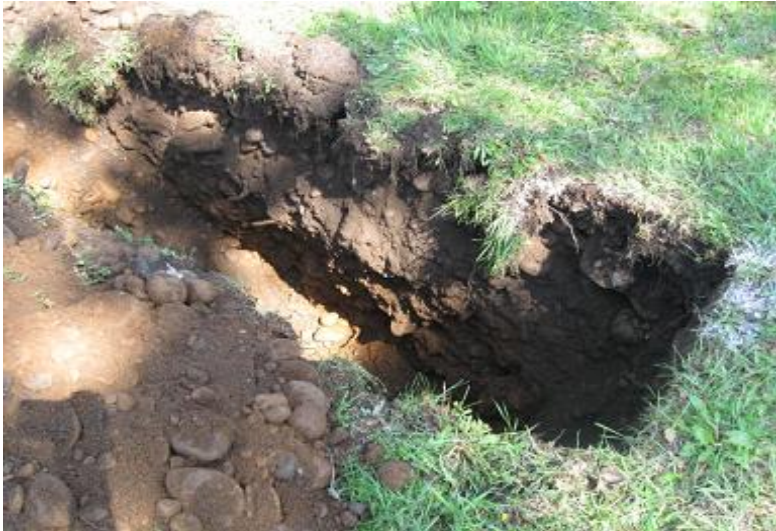
PHOTO OF TEST PIT NO.: TP-8

DEPTH FT	PID PPM	SOIL CLASSIFICATION	NOTES/OBSERVATIONS			PHOTO FILE NO.
1	NO ELEVATED PID READINGS	Brown COBBLE, SAND AND GRAVEL (rounded), some Brick and Concrete fragments, loose.	1.5 in dia. Pipe or scrap encountered immediately below surface.  No visual/olfactory evidence of contamination, no PID hits.			075-079
2						
3						
4						
5						
6						
7						
8						
9						
10						
GW DEPTH		TOTAL DEPTH 6 ft	FINAL DIMENSIONS 2 ft x 8 ft	NORTHING tbd	EASTING tbd	ELEVATION tbd

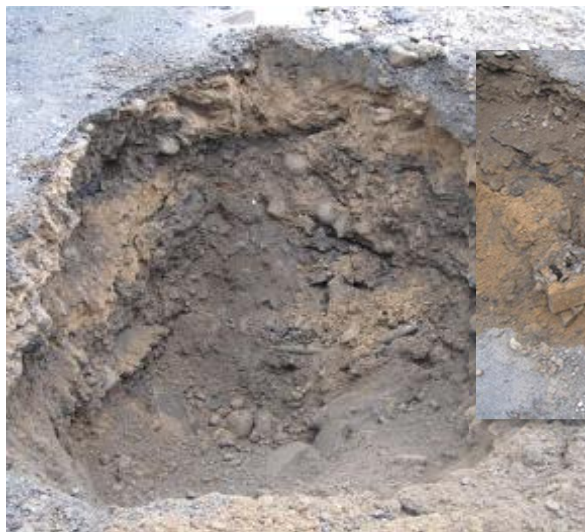
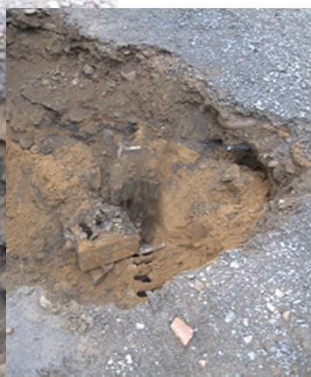
PHOTO OF TEST PIT NO.: TP-03

0.4 (back-ground)	ASPHALT AND SUBBASE (FILL) Light Brown fine to medium SAND and coarse to fine GRAVEL, some fine to medium COBBLE, loose, occasional lense of fine Sand	Large (~3 ft x 4 ft) reinforced concrete debris, scrap metal, buried asphalt, mixed with Sand, Gravel, Cobble, loose.  Encountered concrete wall oriented north-south, approximately 10 ft off of west wall of existing building, encountered at ~2 ft bgs, some stained sand observed but no major odors or PID detections, did not follow further east due to unknown location of water utilities to bldg, additional pipe scraps observed in fill.  ~3 in dia. galvanized pipe, not in tact, encountered ~ 5 ft bgs.			137-145
2						
3						
4						
5						
6						
7						
8						
9						
10						
GW DEPTH		TOTAL DEPTH 6 ft	FINAL DIMENSIONS 10 ft x 10 ft	NORTHING tbd	EASTING tbd	ELEVATION tbd

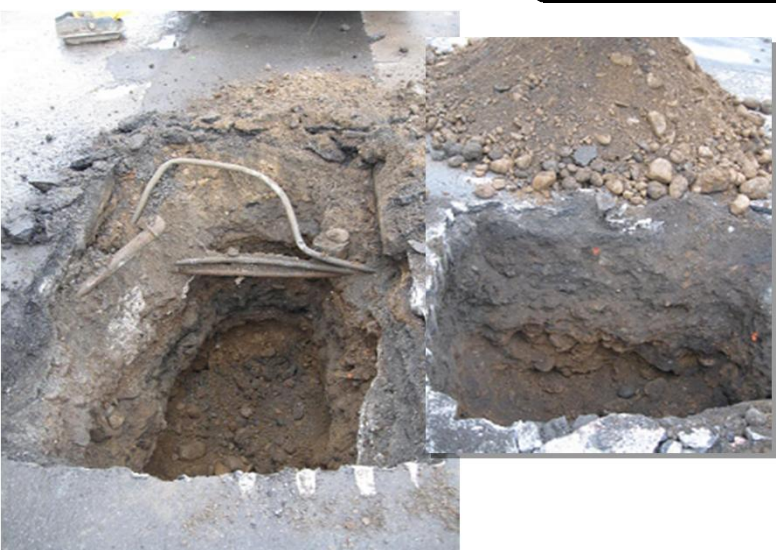
PHOTO OF TEST PIT NO.: TP-04

Brown SAND AND GRAVEL, loose, moist to wet.	Moist to wet, no odor or visible evidence of contamination observed.				
7							
8							
9							
10							
GW DEPTH 8 ft		TOTAL DEPTH 8 ft		FINAL DIMENSIONS 4.5 ft x 6 ft	NORTHING tbd	EASTING tbd	ELEVATION tbd

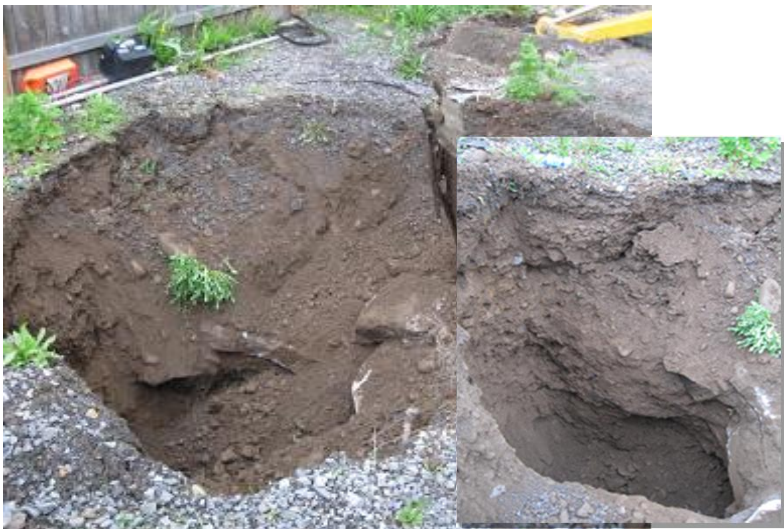
PHOTO OF TEST PIT NO.: TP-06

03	Brown Silty SAND AND GRAVEL, little fine to medium Cobble. CONCRETE debris	Located behind fence. Large pieces of buried reinforced concrete encountered, rebar, some pieces too large to remove with backhoe (est. 16 cubic feet).			159-166
2			No odor or staining observed.			
3						
4			Material is moist to wet.			
5		Brown fine to medium SAND AND GRAVEL, little Cobble, trace Silt, loose, moist to wet.	Some coal or asphalt encountered at ~5.5 ft bgs.			
6						
7						
8						
9	Note: Current tenant says that this used to be location of railroad					
10						
GW DEPTH <8 ft		TOTAL DEPTH 8 ft	FINAL DIMENSIONS 6 ft x 8 ft	NORTHING tbd	EASTING tbd	ELEVATION tbd
