EXCAVATION AND DISPOSAL COMPLETION AND FINAL ENGINEERING REPORT

121 Ridge Road
City of Lackawanna, Erie County, New York

June 1, 2018

Terracon Project No. J5171046
NYSDEC Site Number: E915188

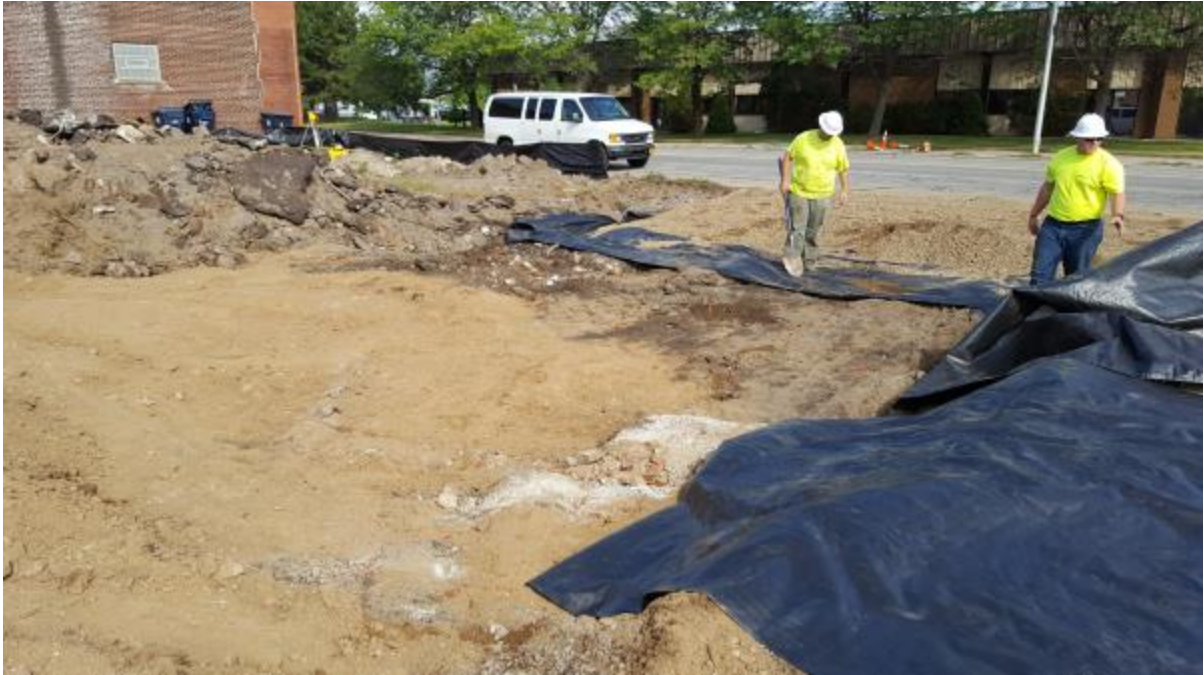
Photo 1 : Contractor preparing "Construction" entrance to site. Fills noted approximately 20' south of sidewalk off Ridge Road.

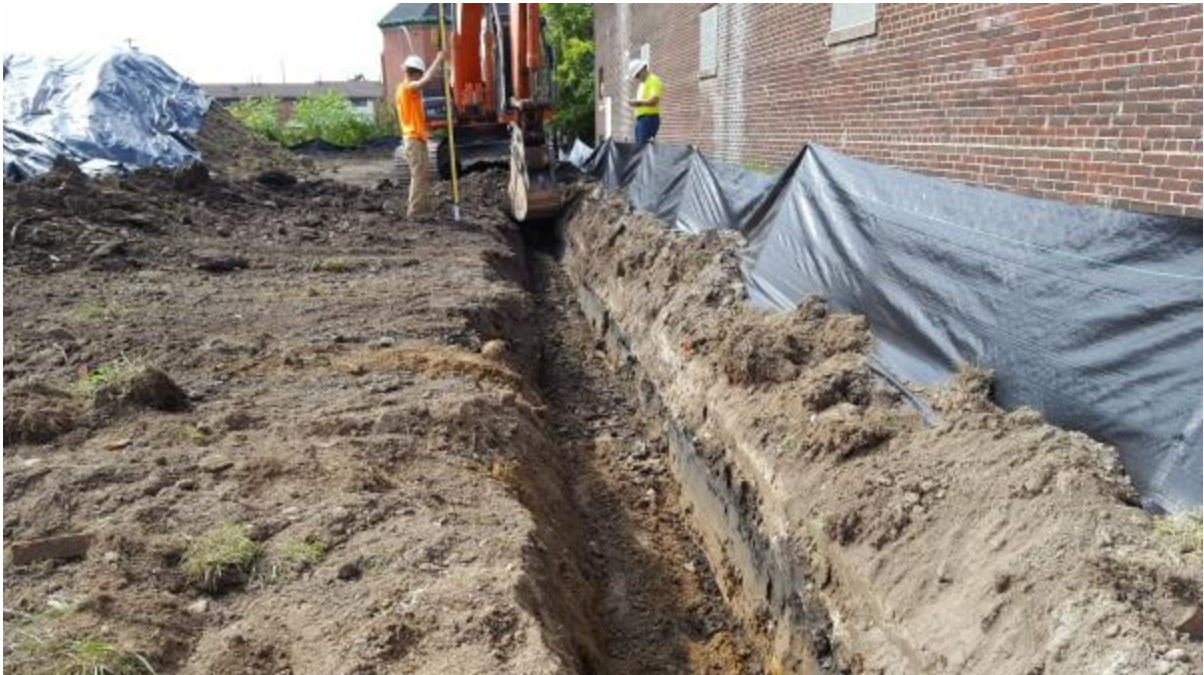
Photo 2 : Contractor excavating along alignment of drain on western side of site. Approximately 1.5 feet of fills underlain by native soils encountered in this area.

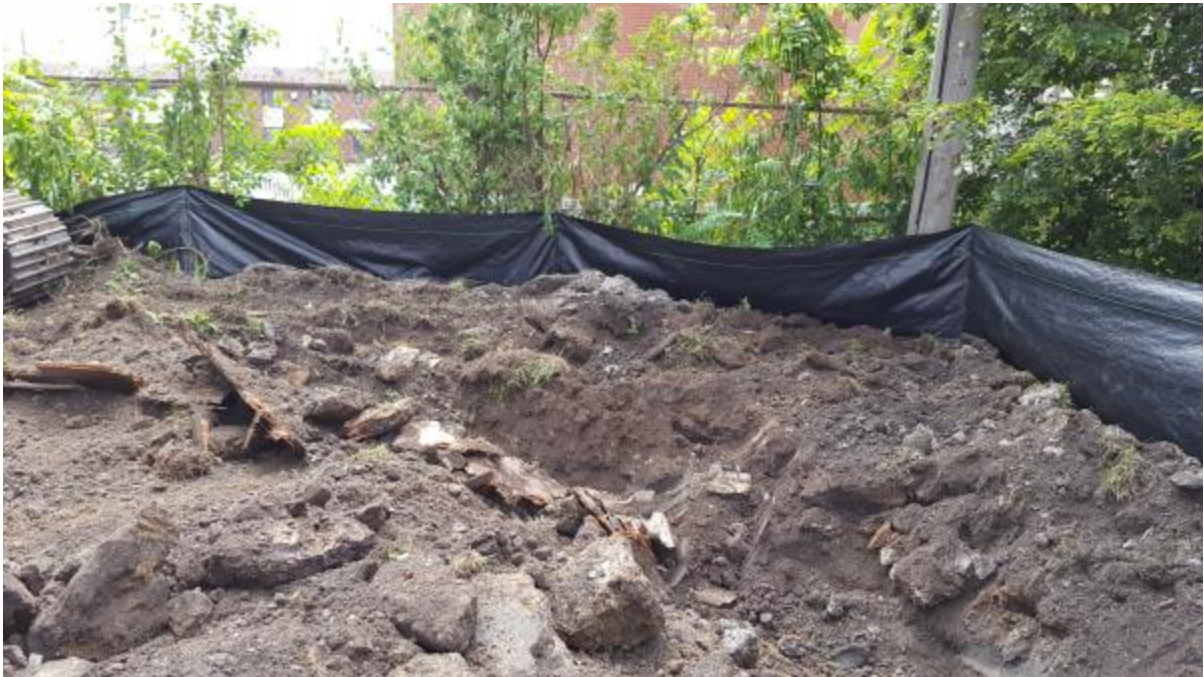
Photo 3 : Fills (predominantly C&D debris) encountered at southwestern corner of drain alignment.

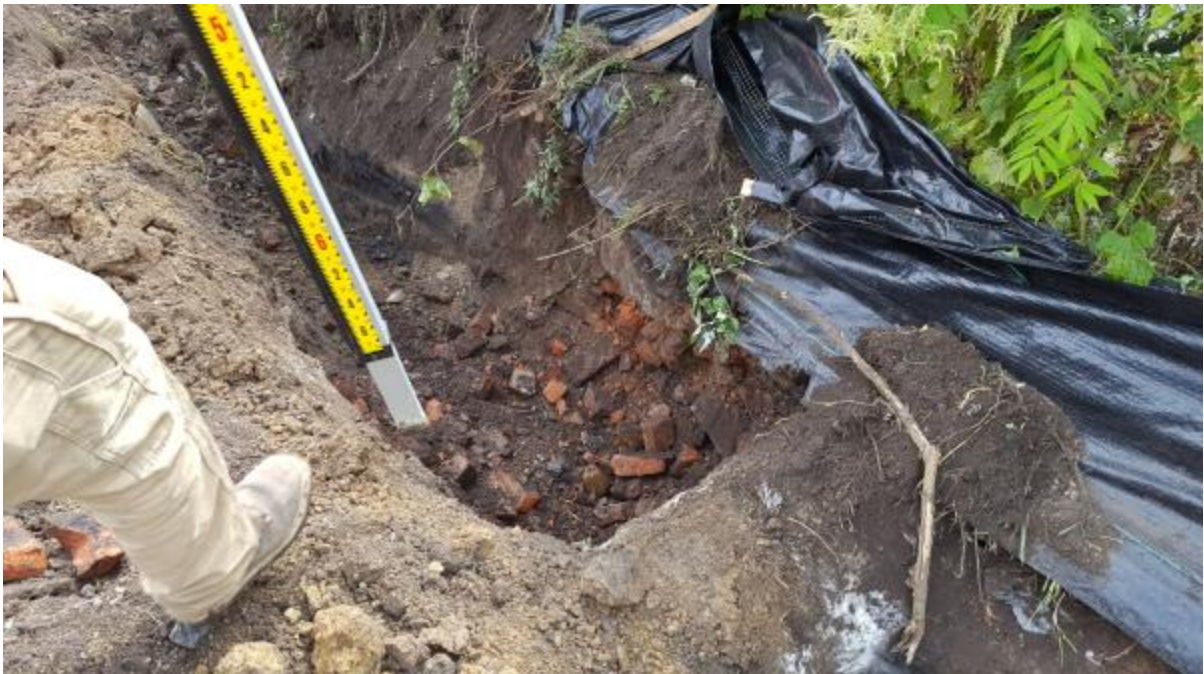
Photo 4 : Old footing and C&D fills encountered in drainage alignment – east of bend at southwestern corner of site.

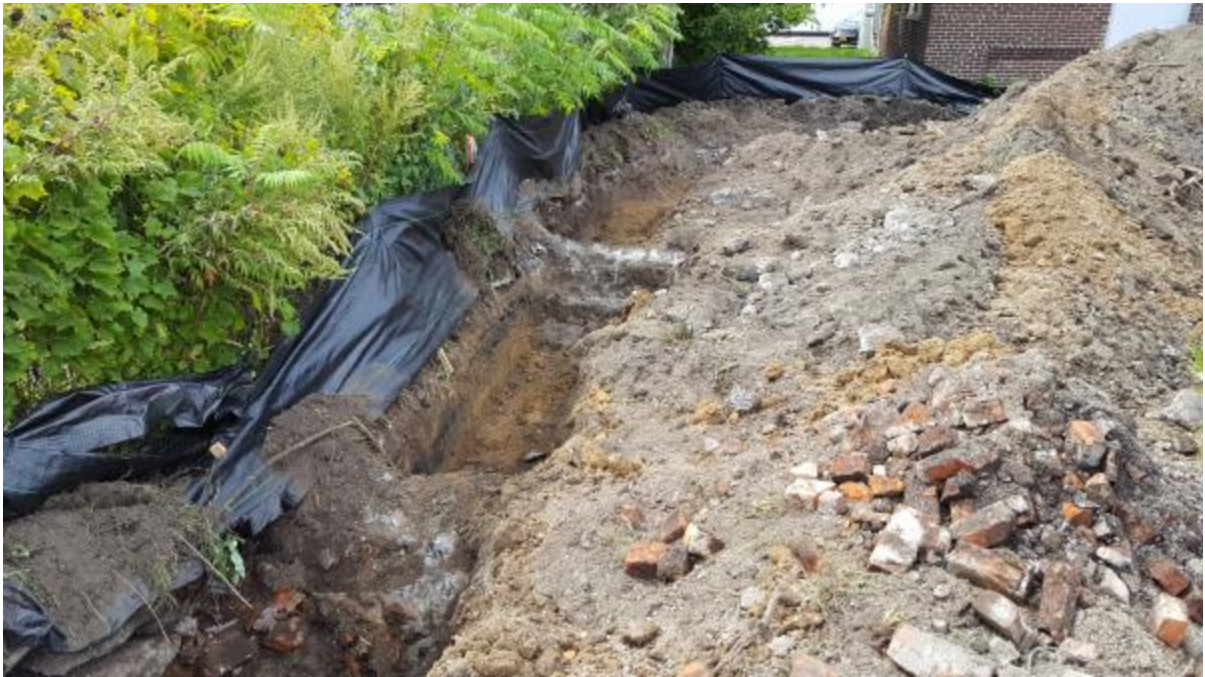
Photo 5 : Old footings and C&D fills – east of bend at southwestern corner

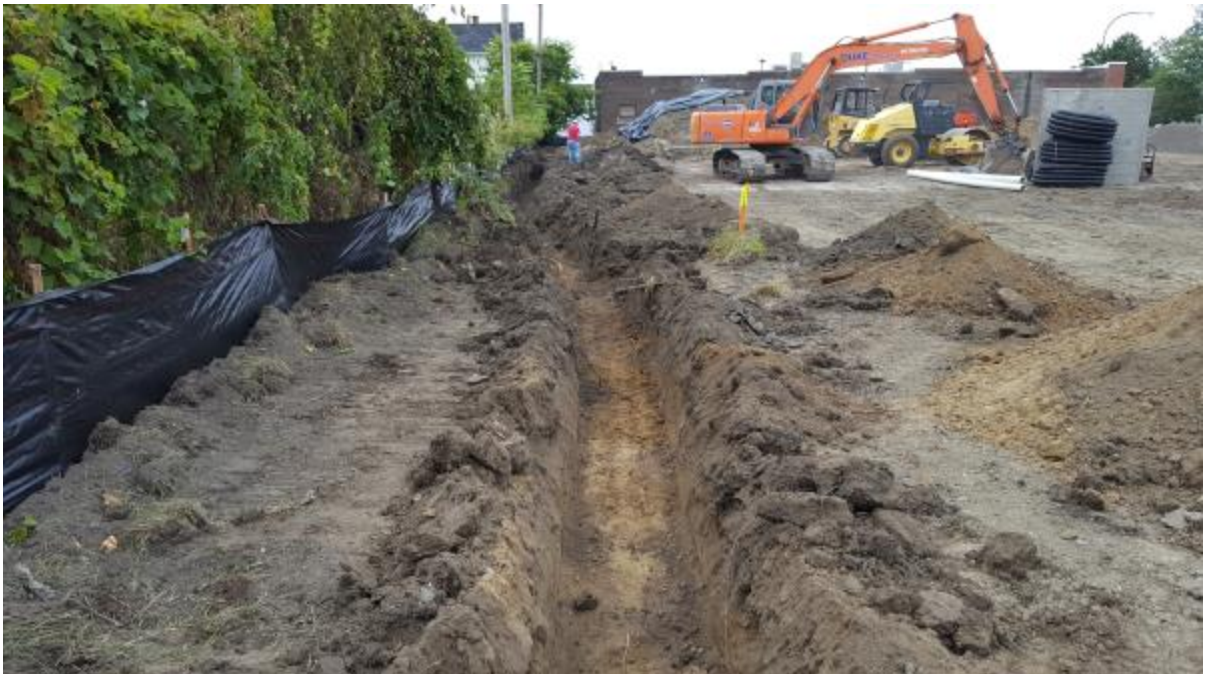
Photo 6 : Eastern portion of drainage alignment – minor amounts of surficial fills overlying native soils.

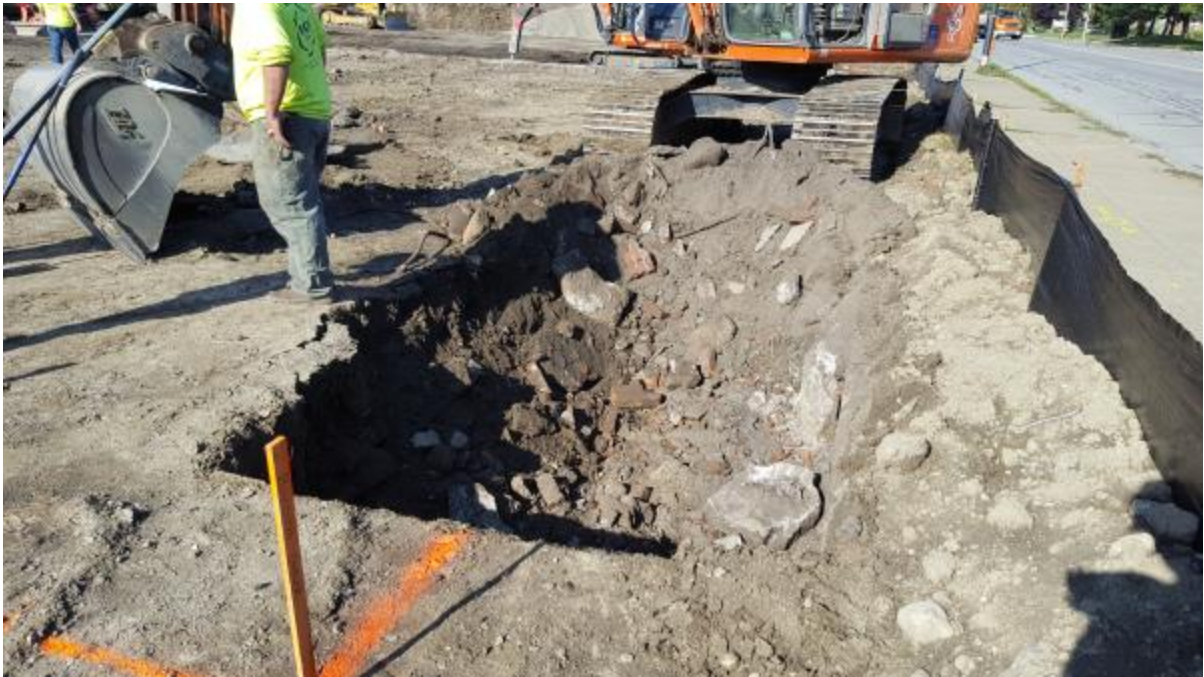
Photo 7 : Excavation for footings at northeastern corner of new building.

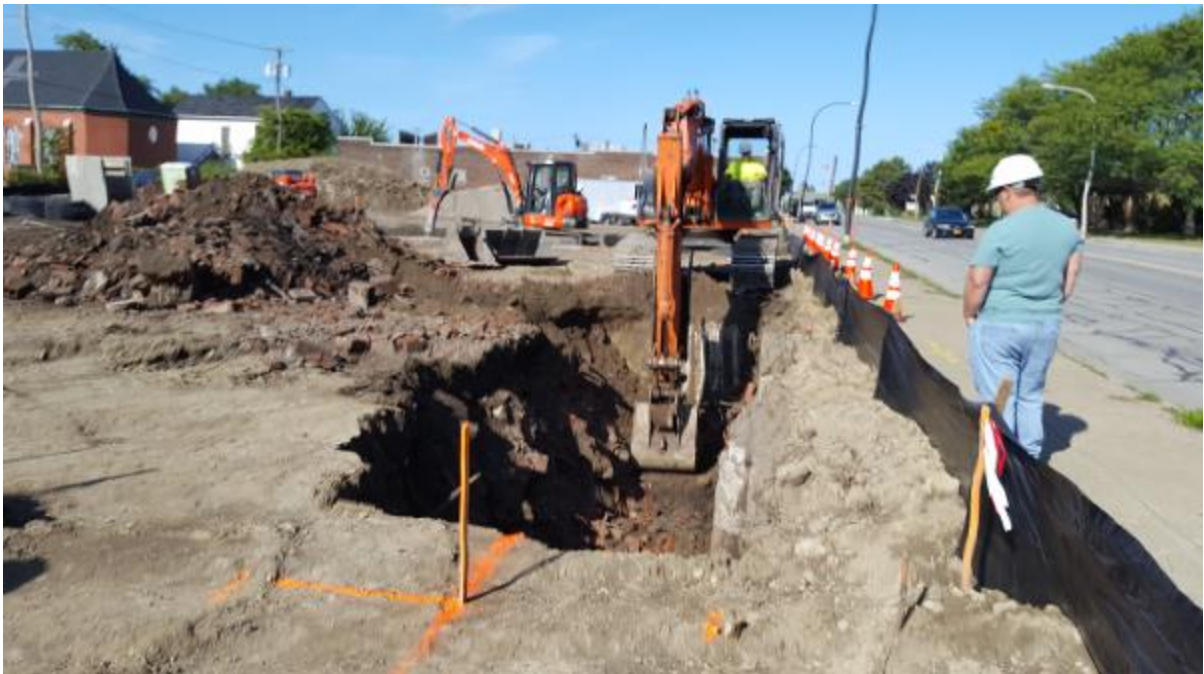
Photo 8 : Excavation at northeastern corner of new building – note C&D fills and old concrete foundation wall along right side of excavation (former basement likely encountered).

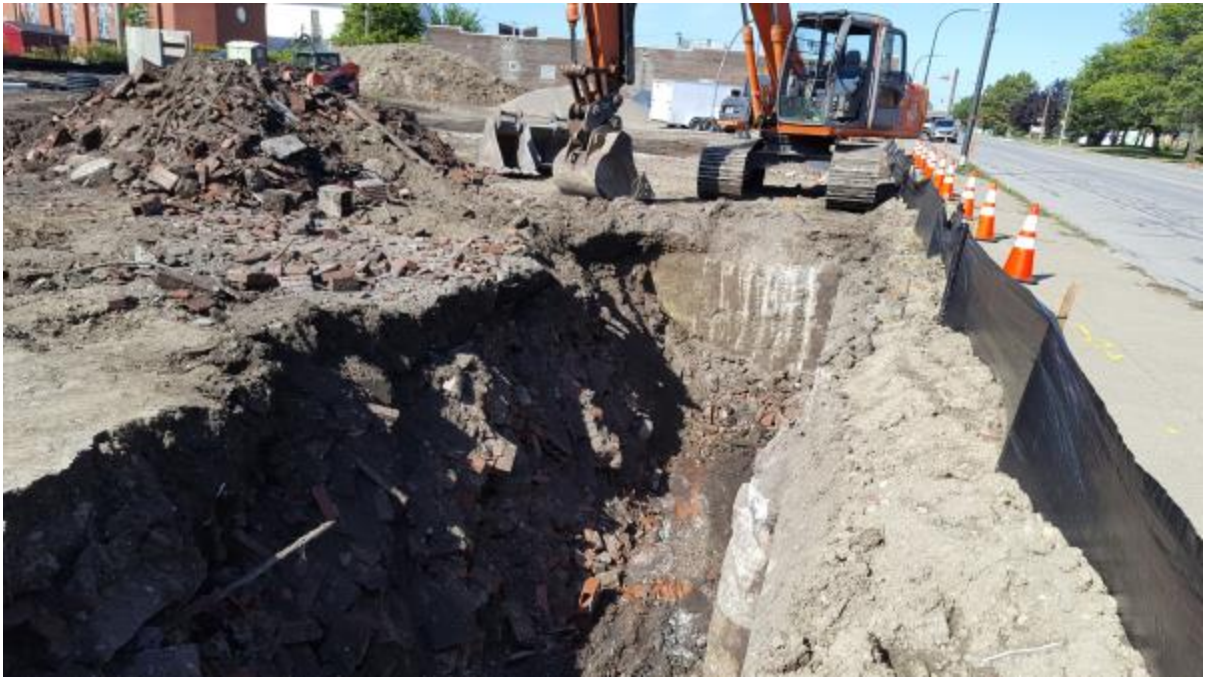
Photo 9 : Old basement wall encountered approximately 40' west of northeast building corner – Fill depth approximately 8.5 feet deep, with concrete slab at bottom.

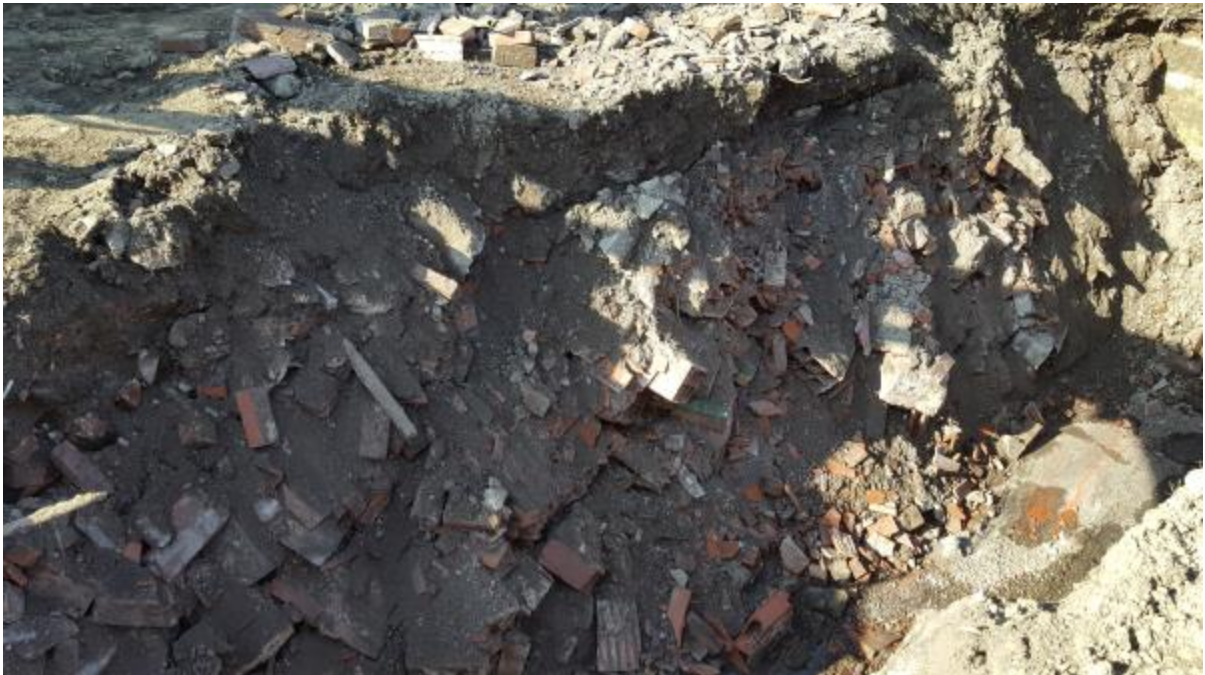
Photo 10 : C&D fills and old basement floor slab – Area “A” on site plan.

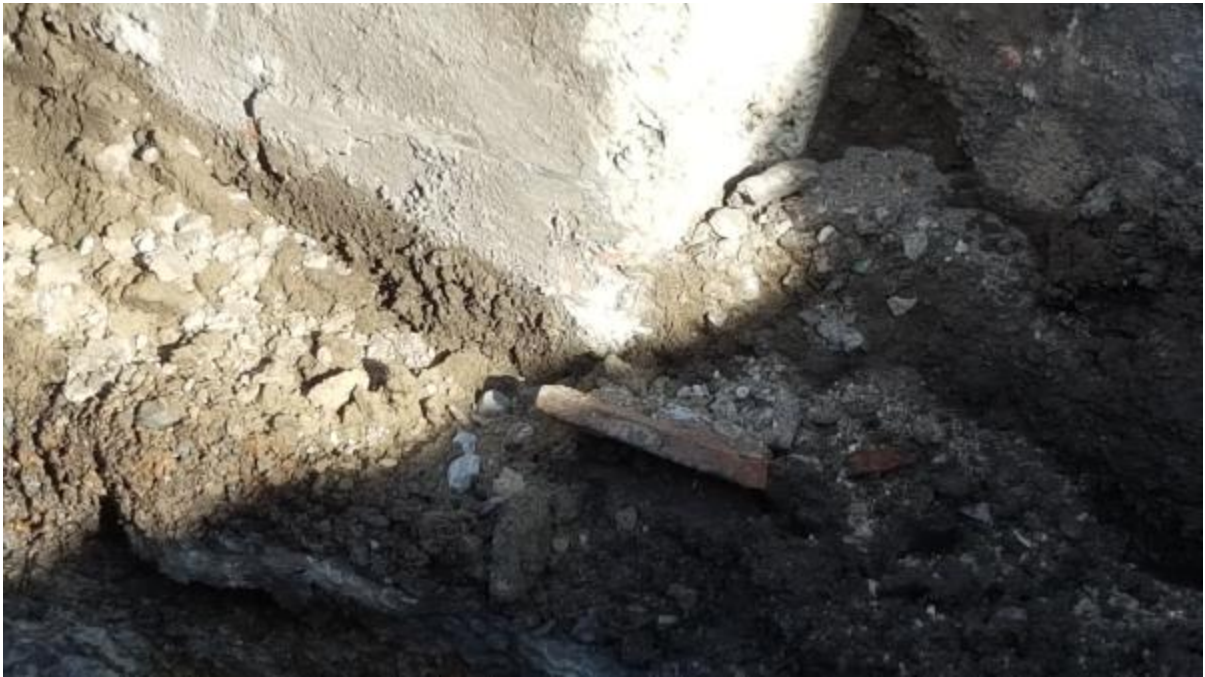
Photo 11 : Closeup of old basement floor slab thickness encountered in Area "A".

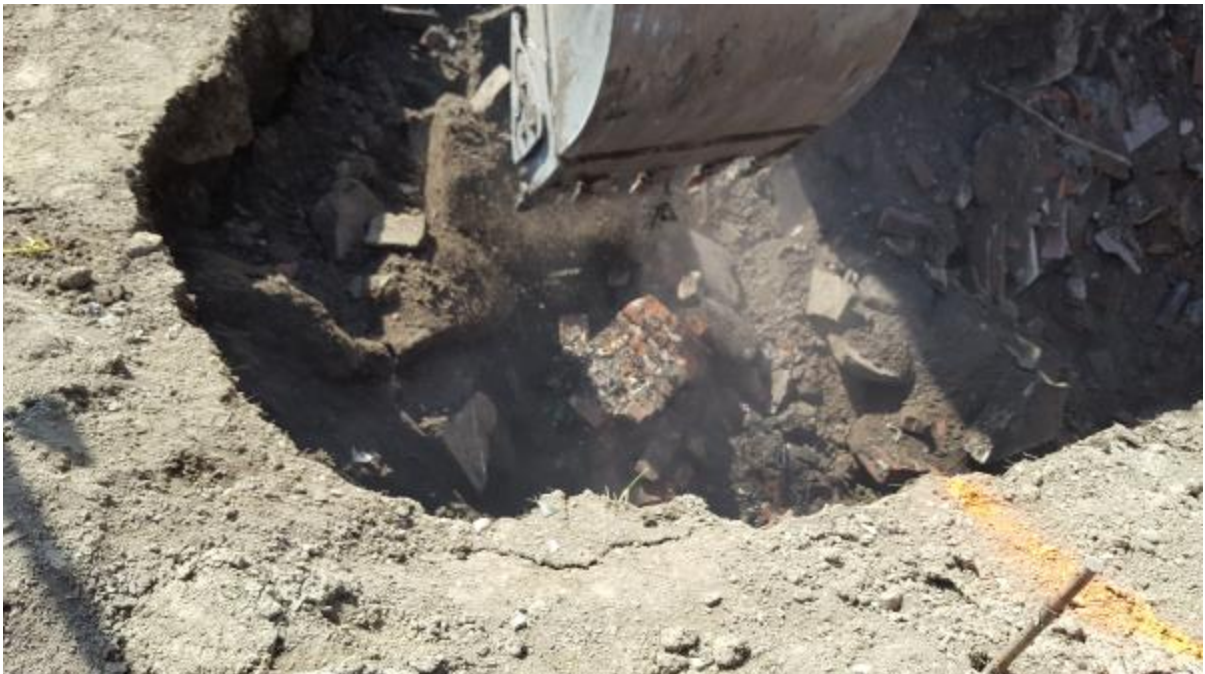
Photo 12 : Excavating south along eastern wall of new building – from northeastern corner.

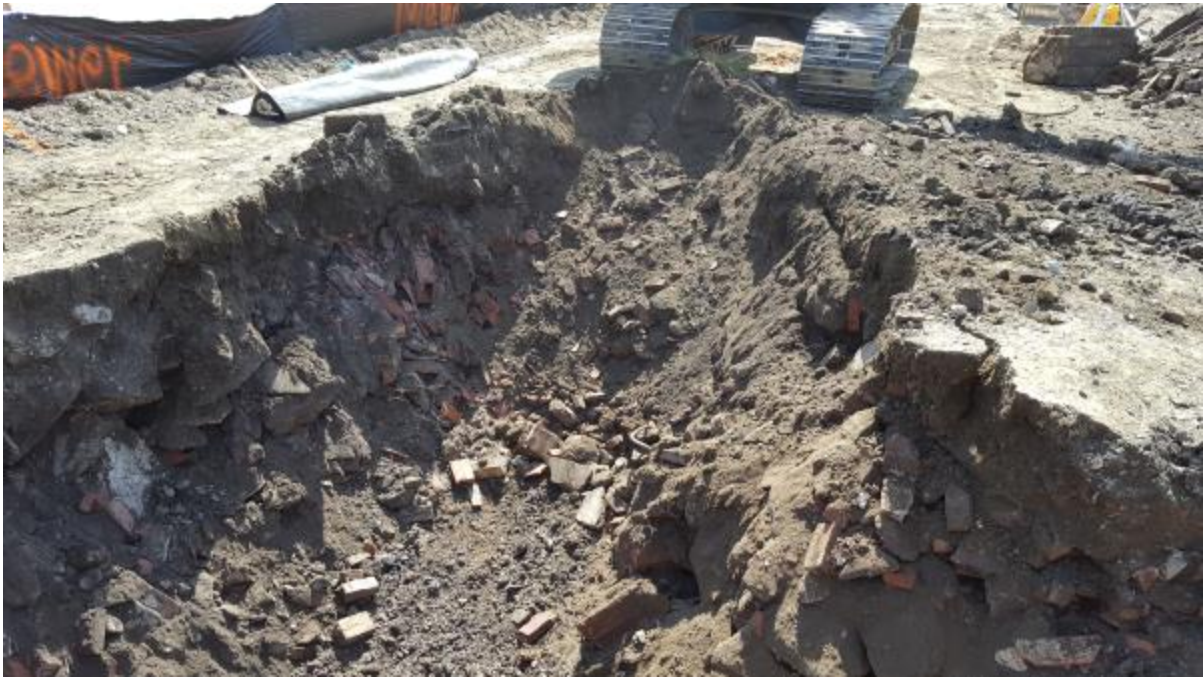
Photo 13 : Excavating south along eastern footing alignment of new building – from northeastern corner (Area “A”).

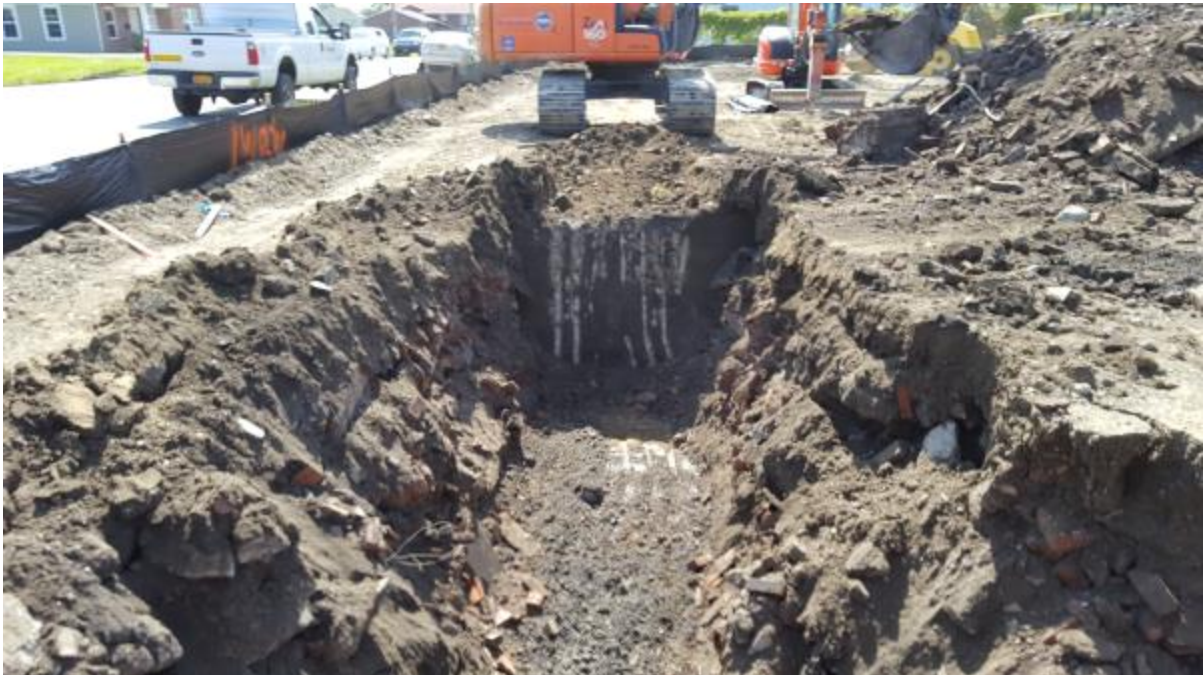
Photo 14 : Area “A” excavation – old wall encountered approximately 30 feet south of northeastern building corner – C&D fills overlying old basement floor slab.

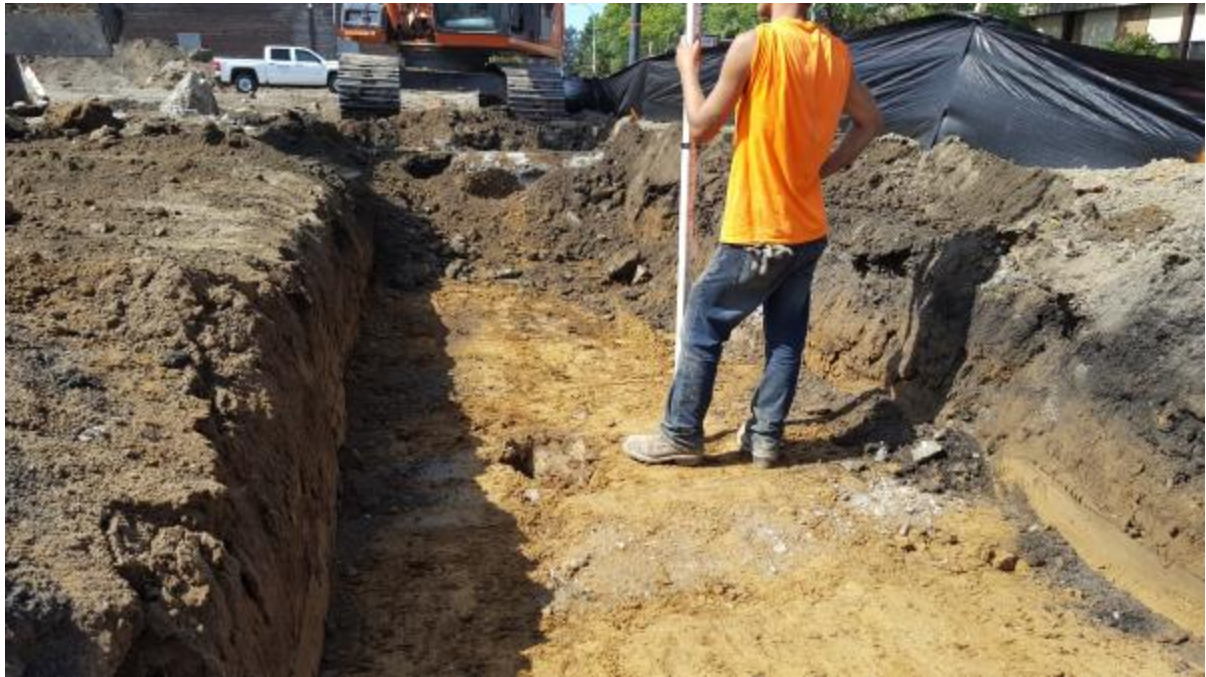
Photo 15 : Area "B" excavation – approximately 1.5 feet of fills underlain by firm native silty sands soils at bearing grade. Old footing wall encountered at end of trench by backhoe.

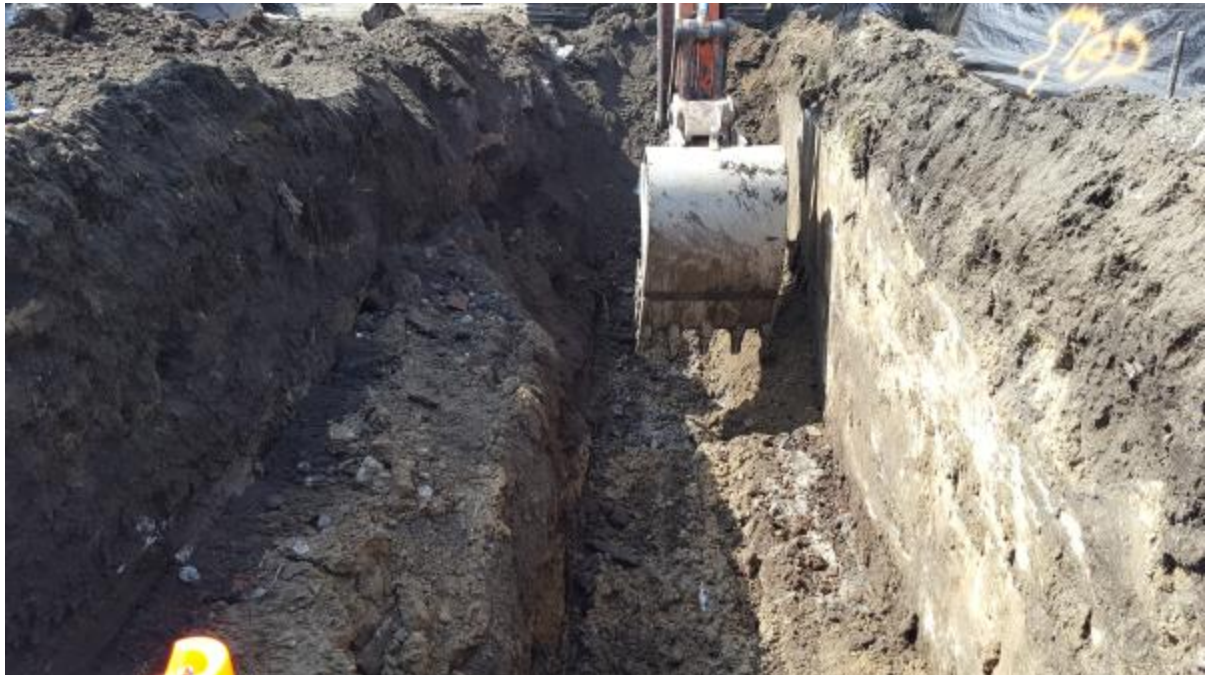
Photo 16 : Area "C" excavation – Native silty sands encountered at approximately 8.5 feet below grade – note old wall along right side of excavation.

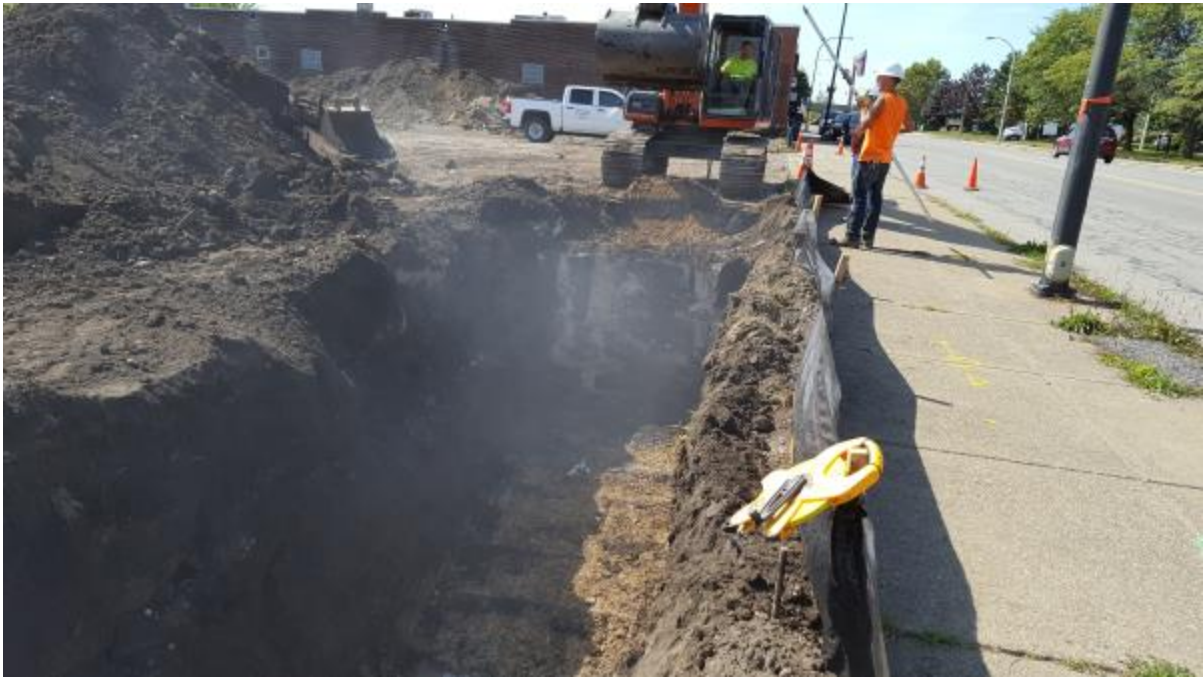
Photo 17 : Excavation of Area “C” – old wall encountered approximately 14 feet east of northwestern building corner of new building.

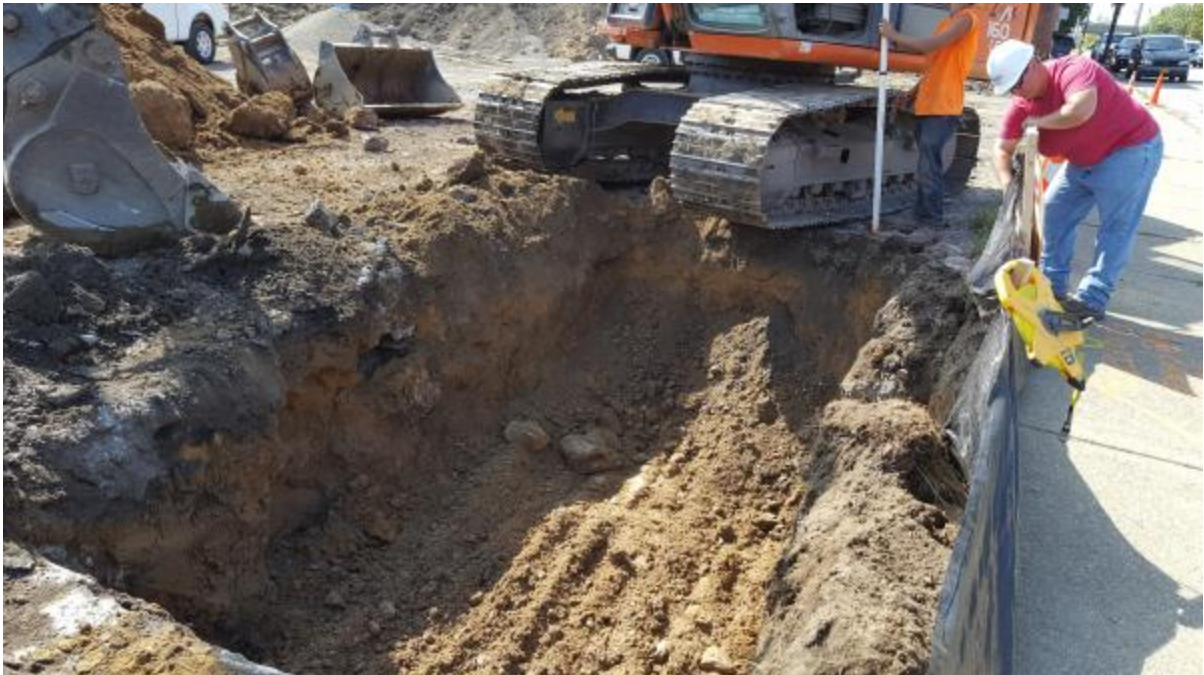
Photo 18 : Excavation of Area “D” at northwestern building corner.

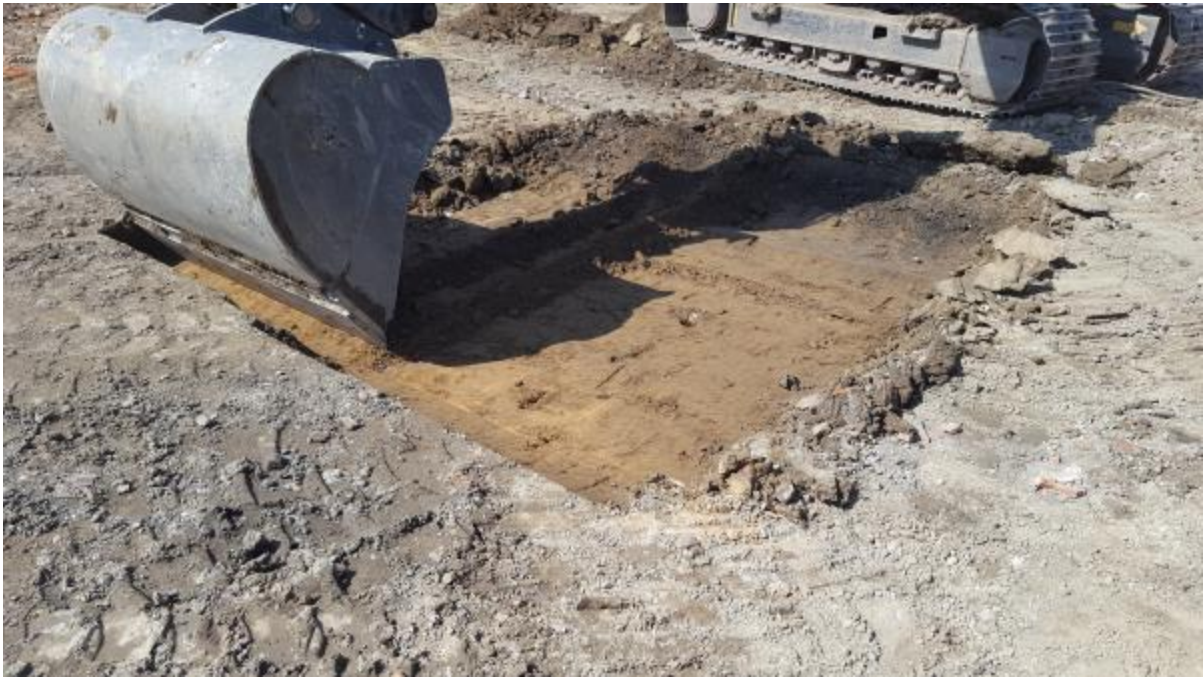
Photo 19 : Excavation of easternmost interior pier for new building.

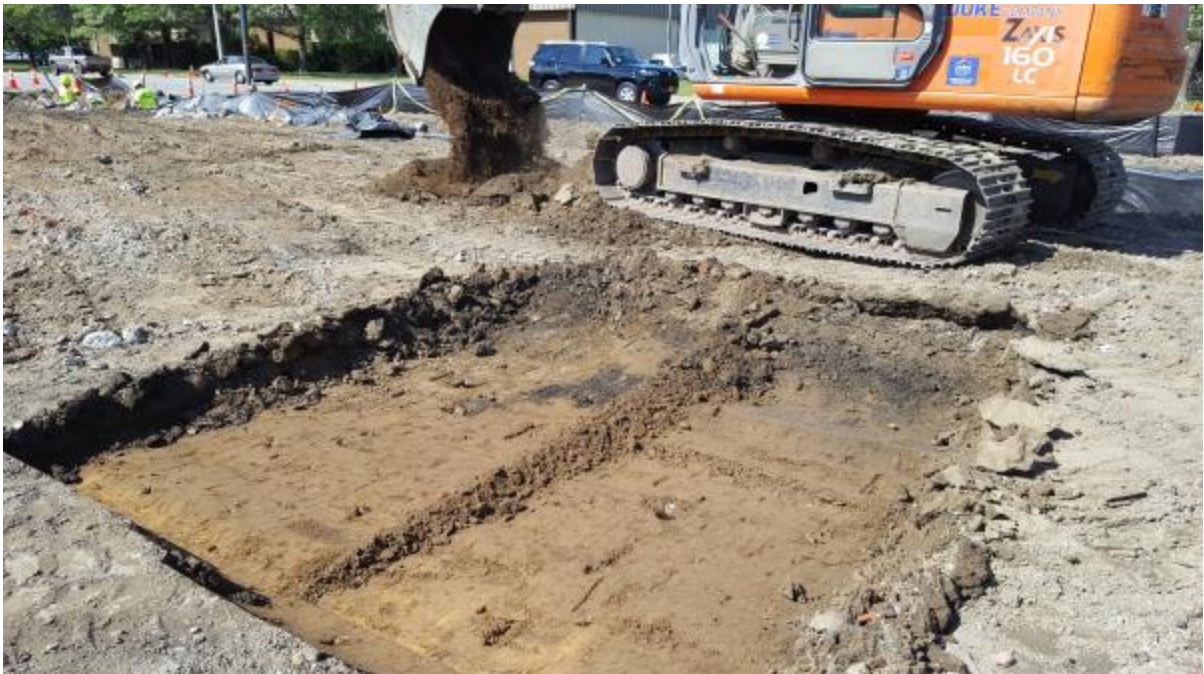
Photo 20 : Fills removed at easternmost pier – bearing on native silty sand soils.

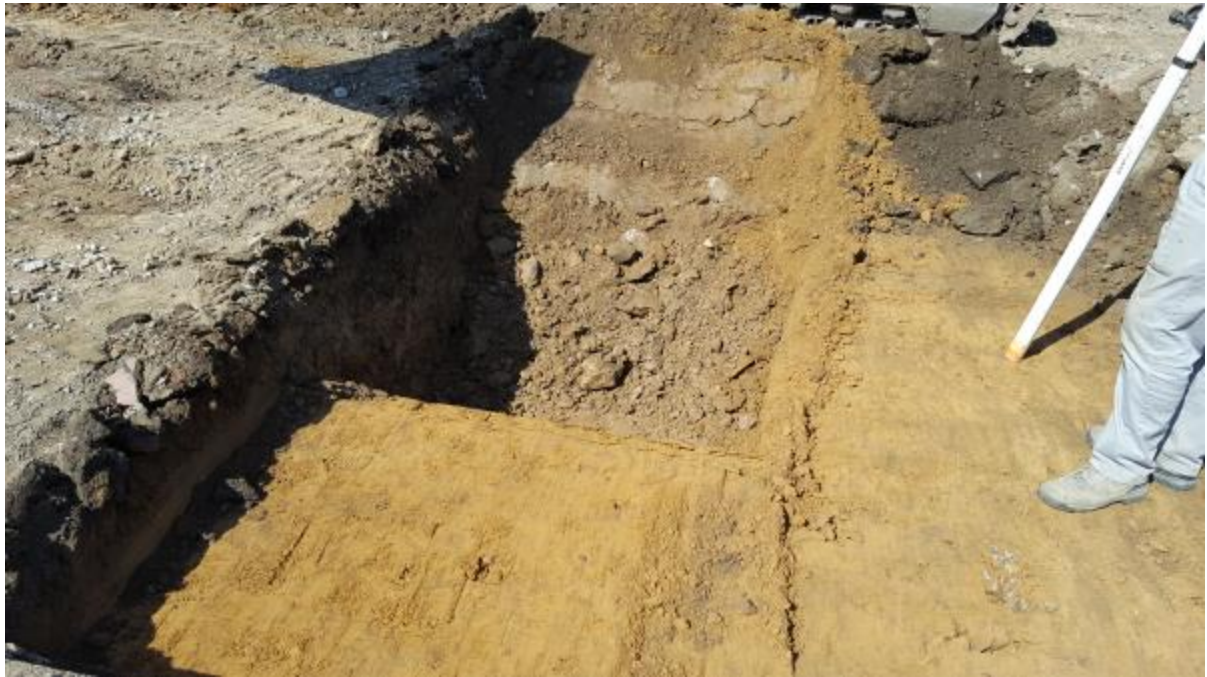
Photo 21 : Overexcavation at pier location due to organic and fills.

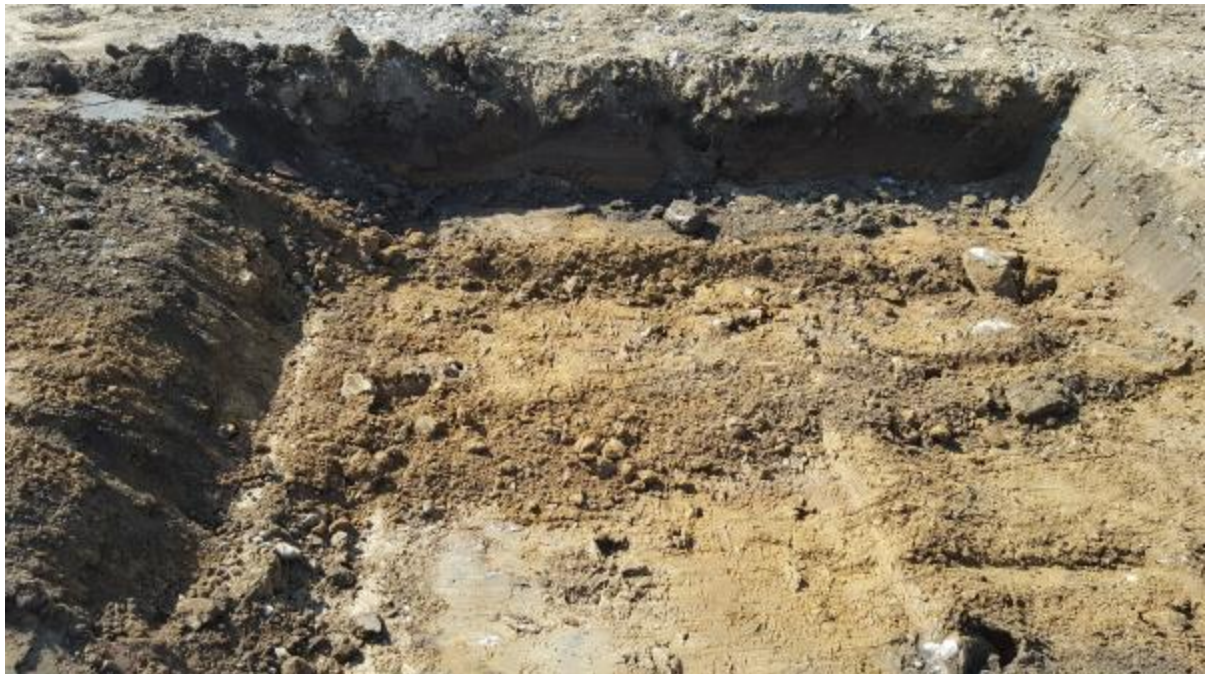
Photo 22 : Fills removed at pier location.

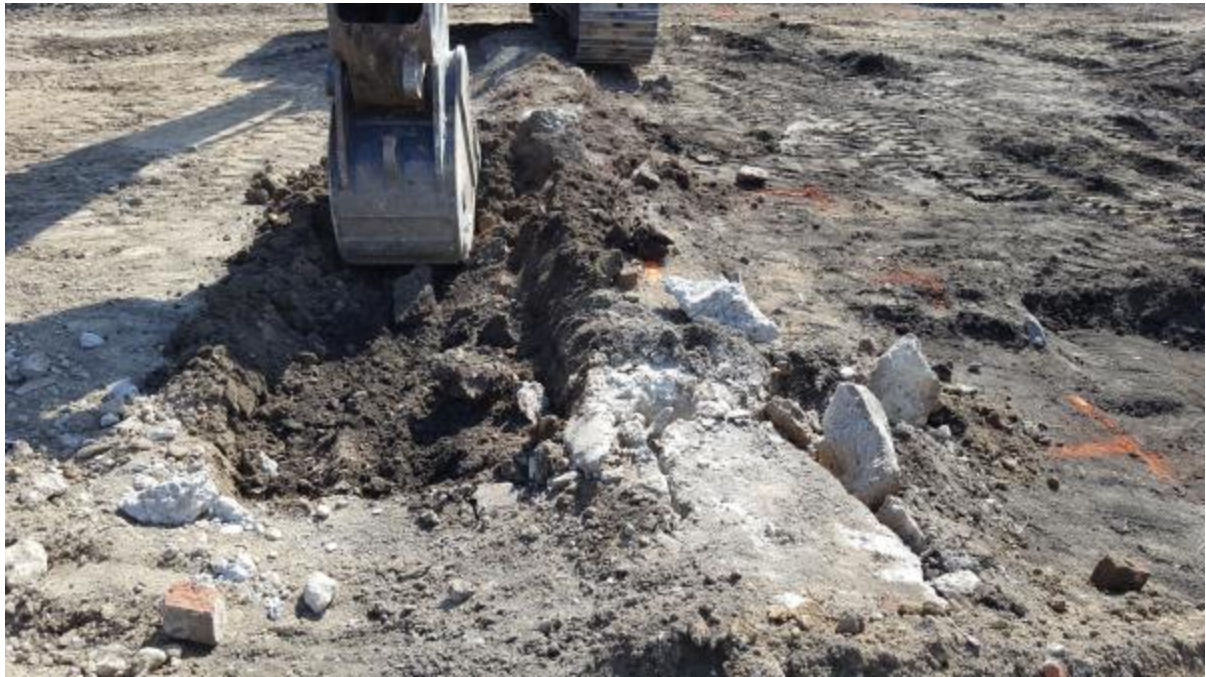
Photo 23 : Removing fills and old concrete walls at pier locations.

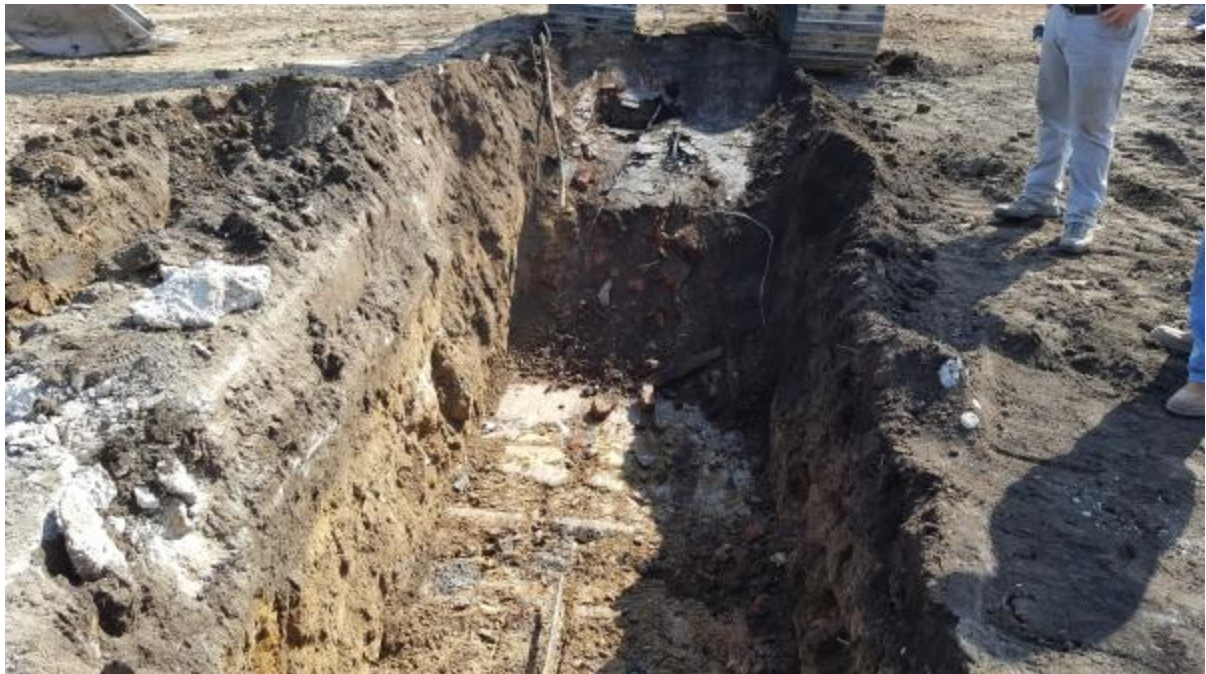
Photo 24 : Removing fills and old concrete walls at pier location.

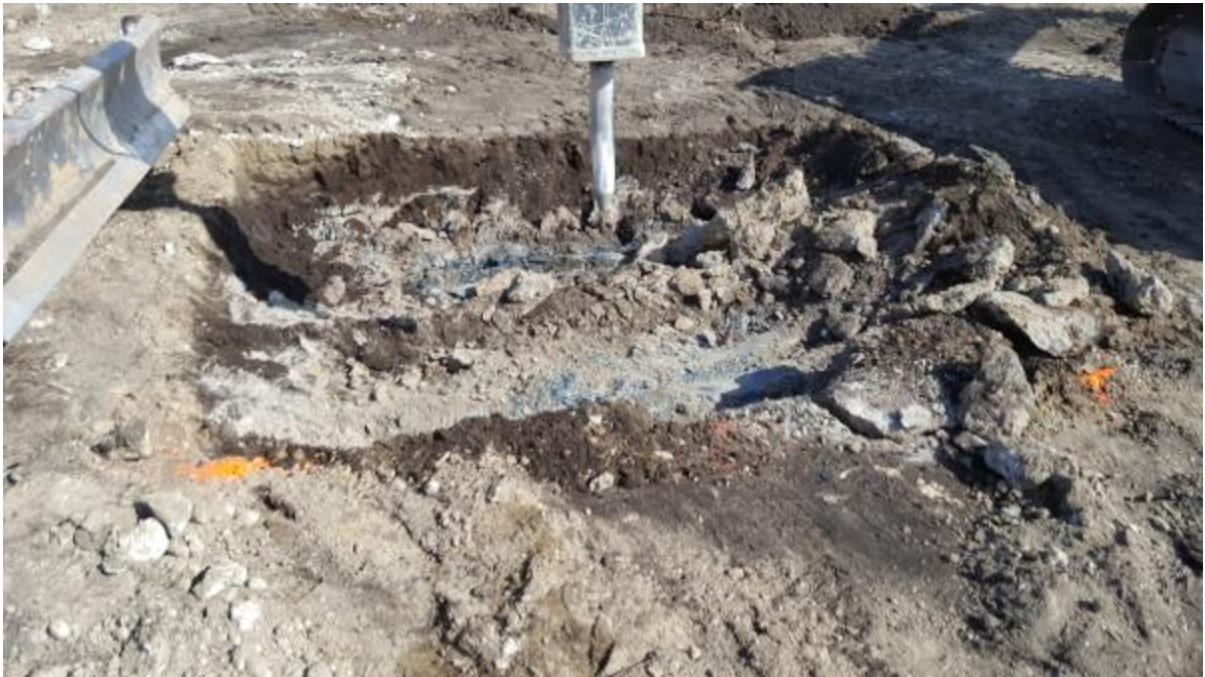
Photo 25 : Breaking out slag at westernmost pier.

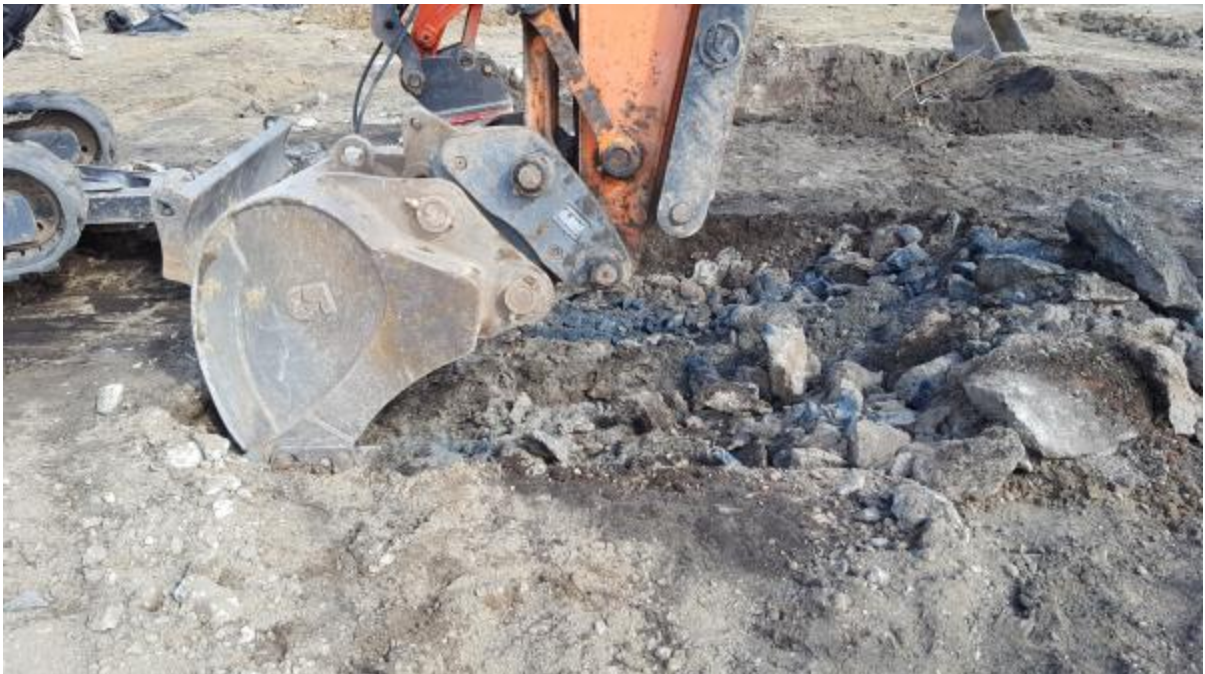
Photo 26 : Removing slag at westernmost pier.

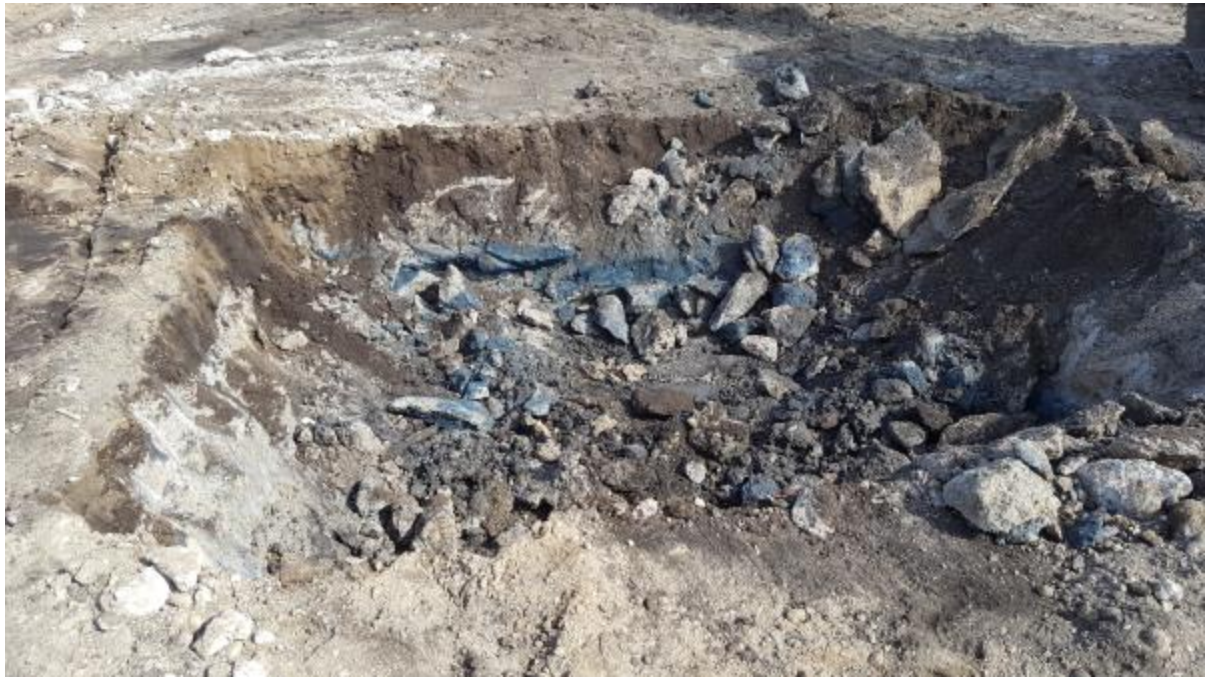
Photo 27 : Slag and debris fill at westernmost pier.
