EXCAVATION AND DISPOSAL COMPLETION AND FINAL ENGINEERING REPORT

121 Ridge Road
City of Lackawanna, Erie County, New York

June 1, 2018

Terracon Project No. J5171046
NYSDEC Site Number: E915188

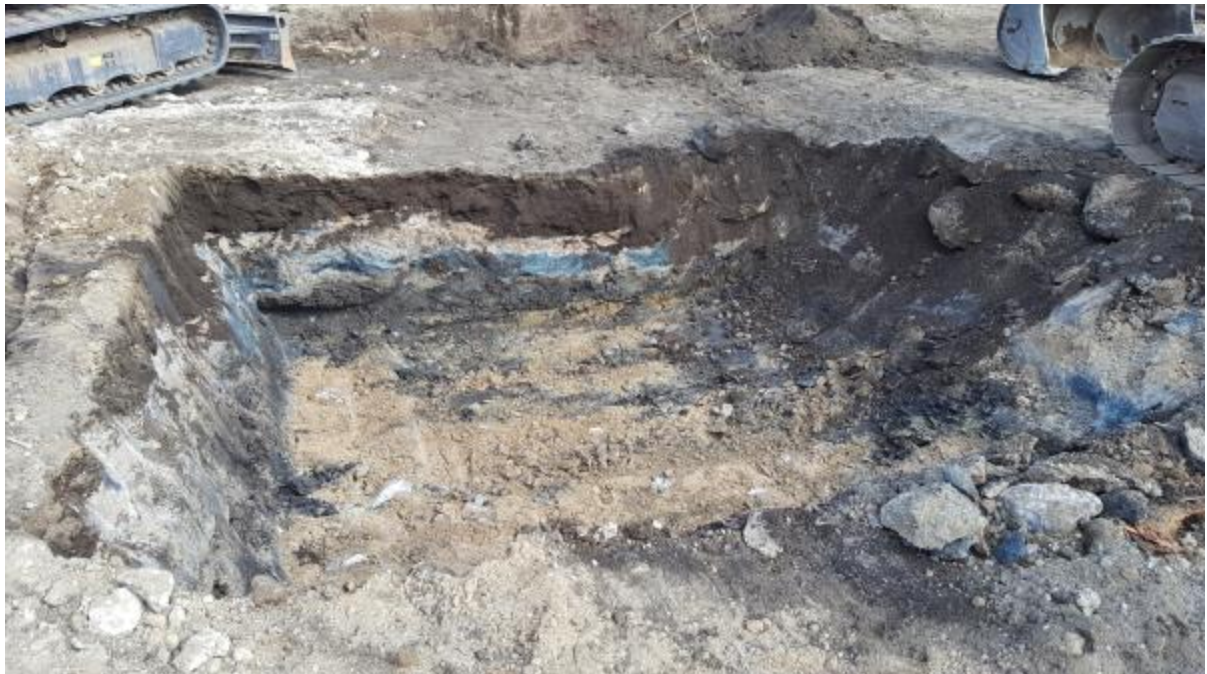
Photo 28 : Westernmost pier overexcavated to remove fills.

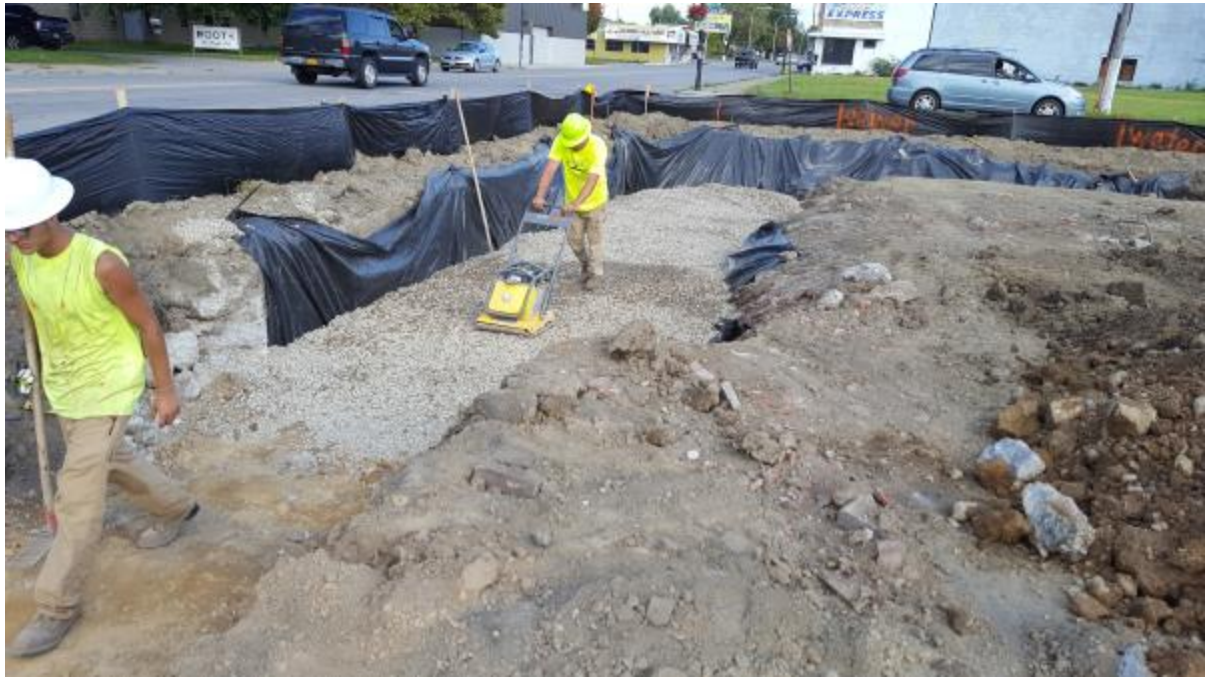
Photo 29 : Contractor compacting encapsulated stone fill placed at northeastern corner of building footing excavation.

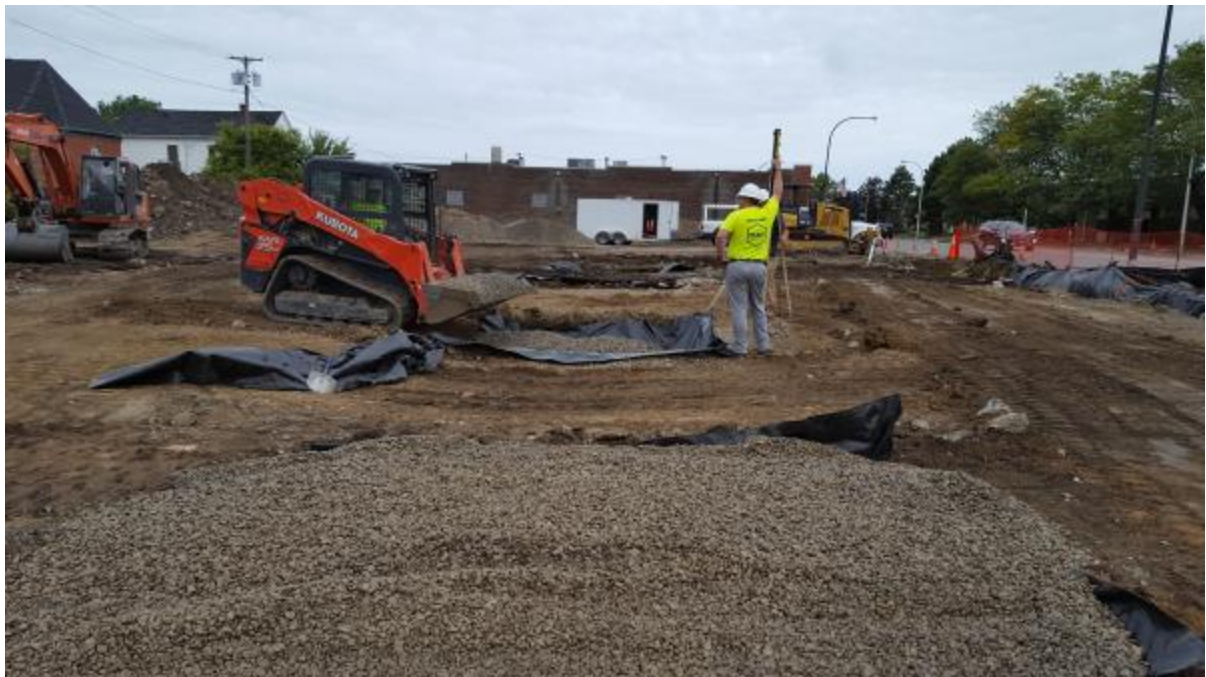
Photo 30 : Encapsulated stone fill being placed at center pier locations.

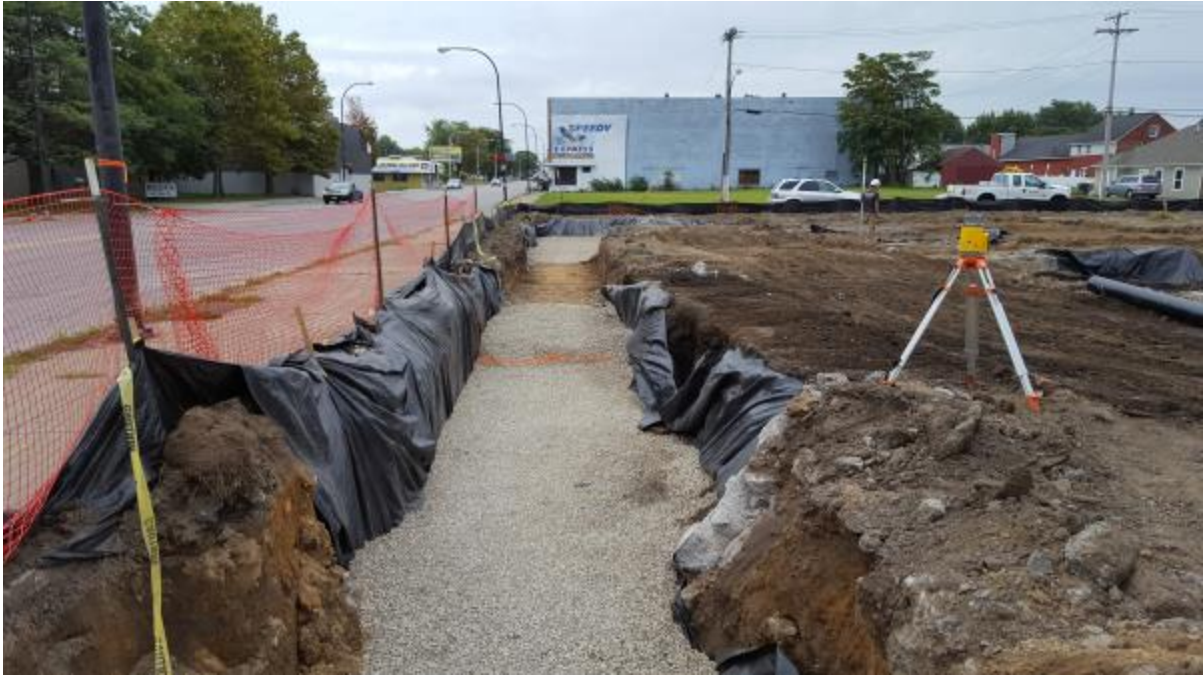
Photo 31 : View facing east from northwestern building corner – compacted stone to footing grade.

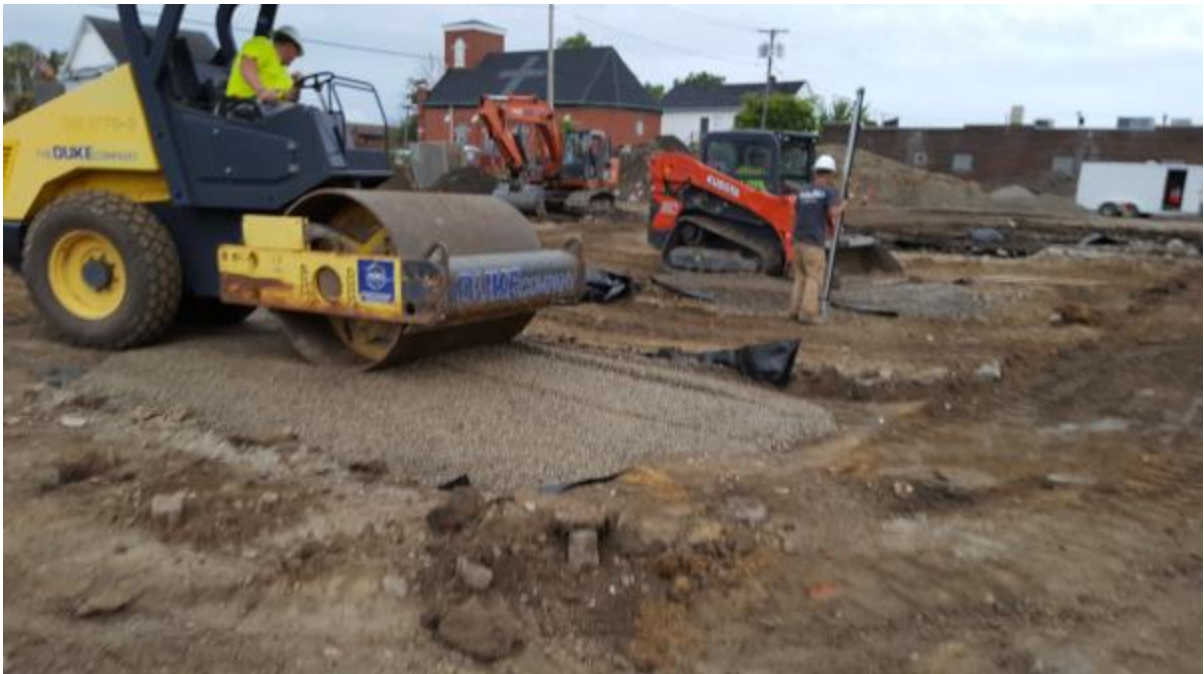
Photo 32 : Contractor compacting stone at piers.

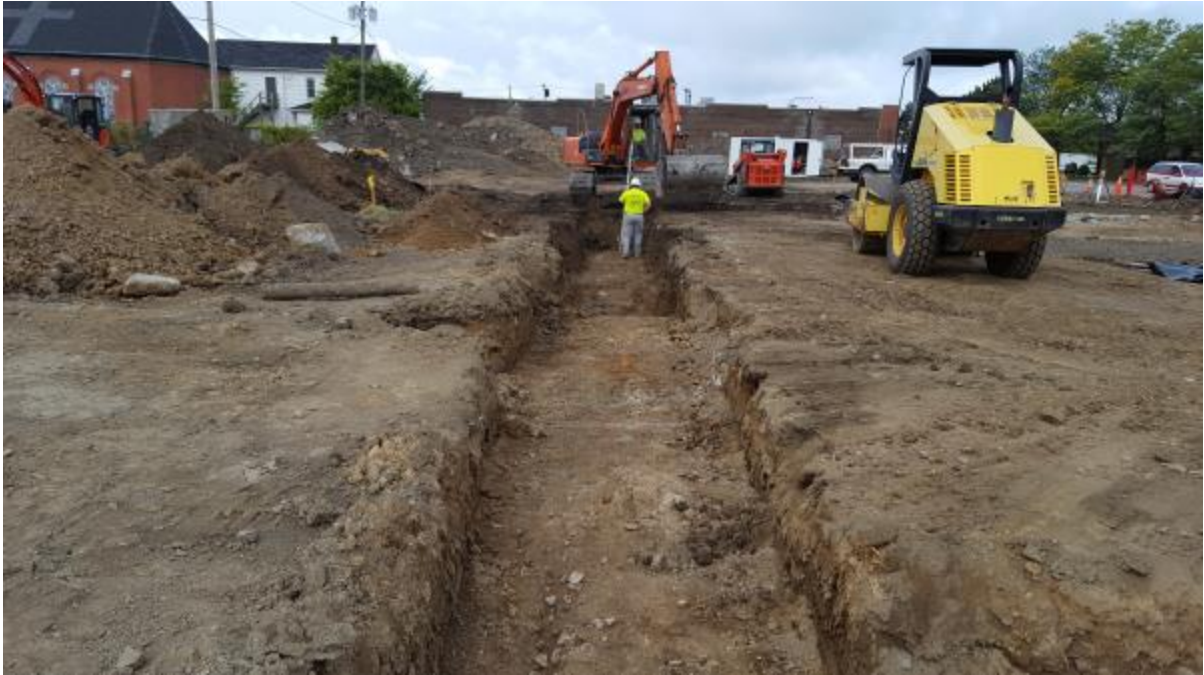
Photo 33 : Excavating for southern building footings. Minimal fills encountered in this area.

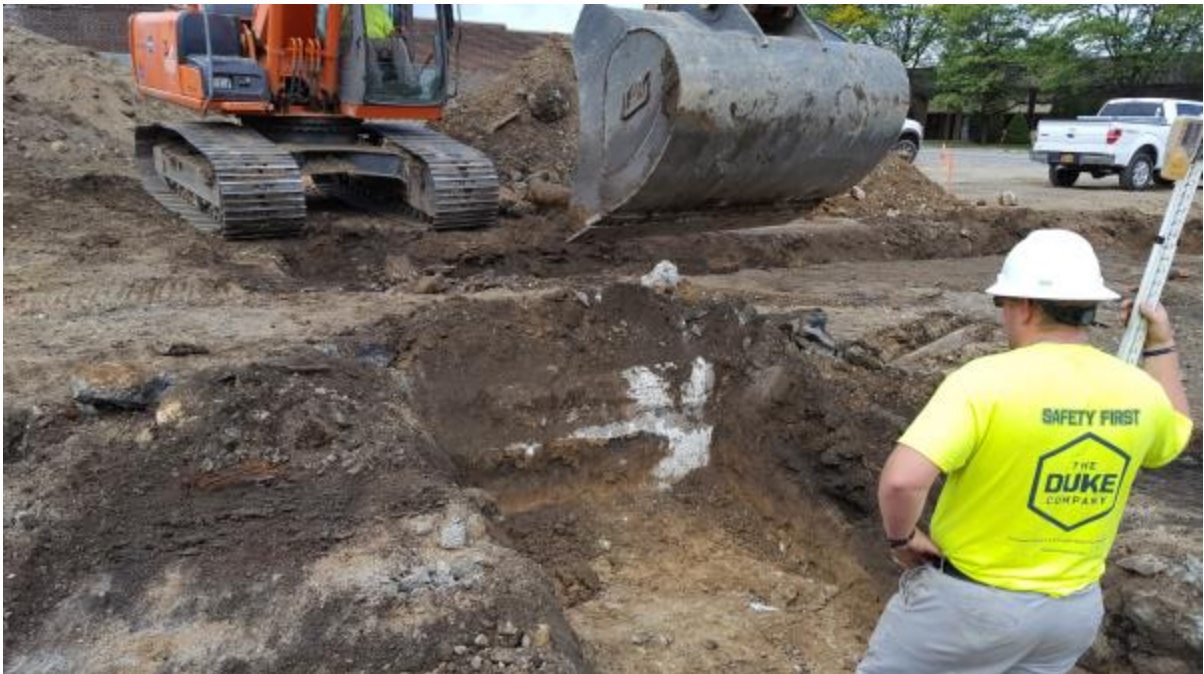
Photo 34 : Old footing encountered during excavation along southern building footing – approximately 5' east of southwestern building corner.

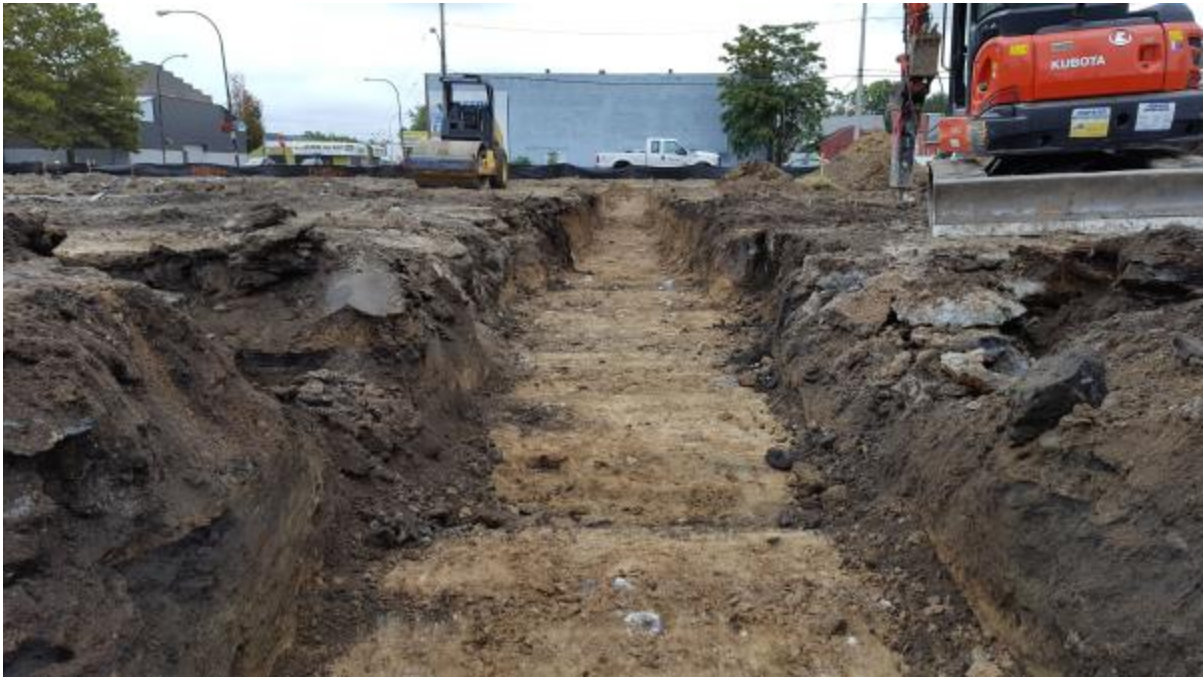
Photo 35 : View of excavation facing east from southwestern building corner.

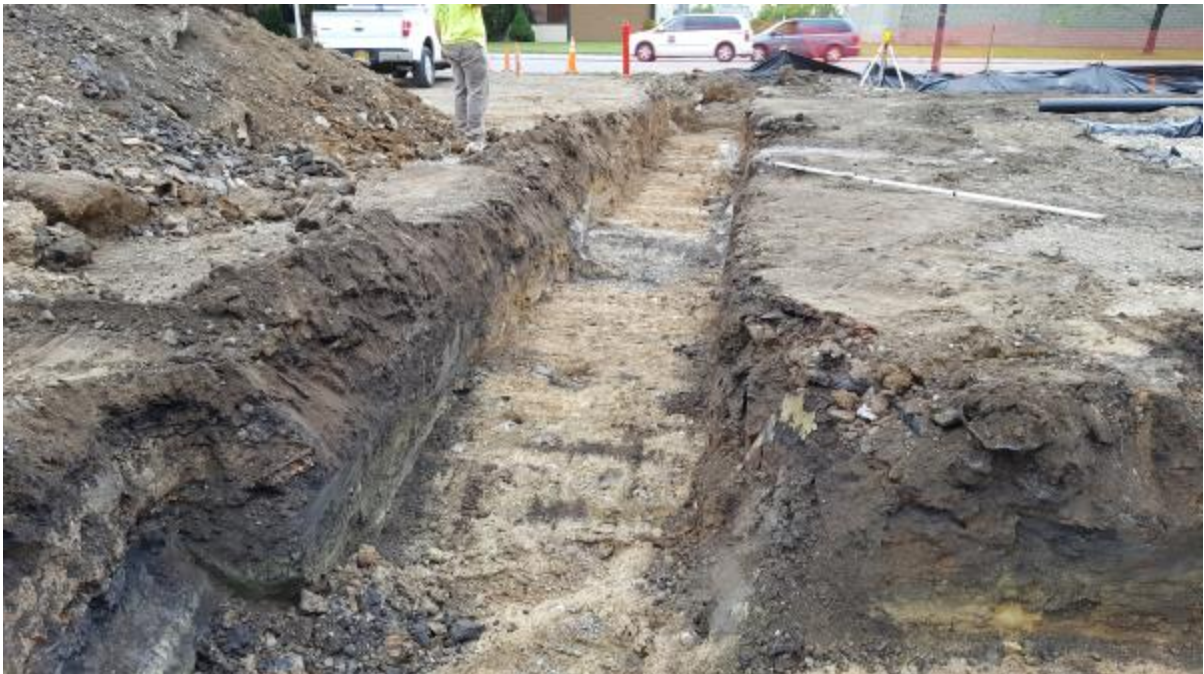
Photo 36 : View facing north from southwestern building corner – old footing in center.

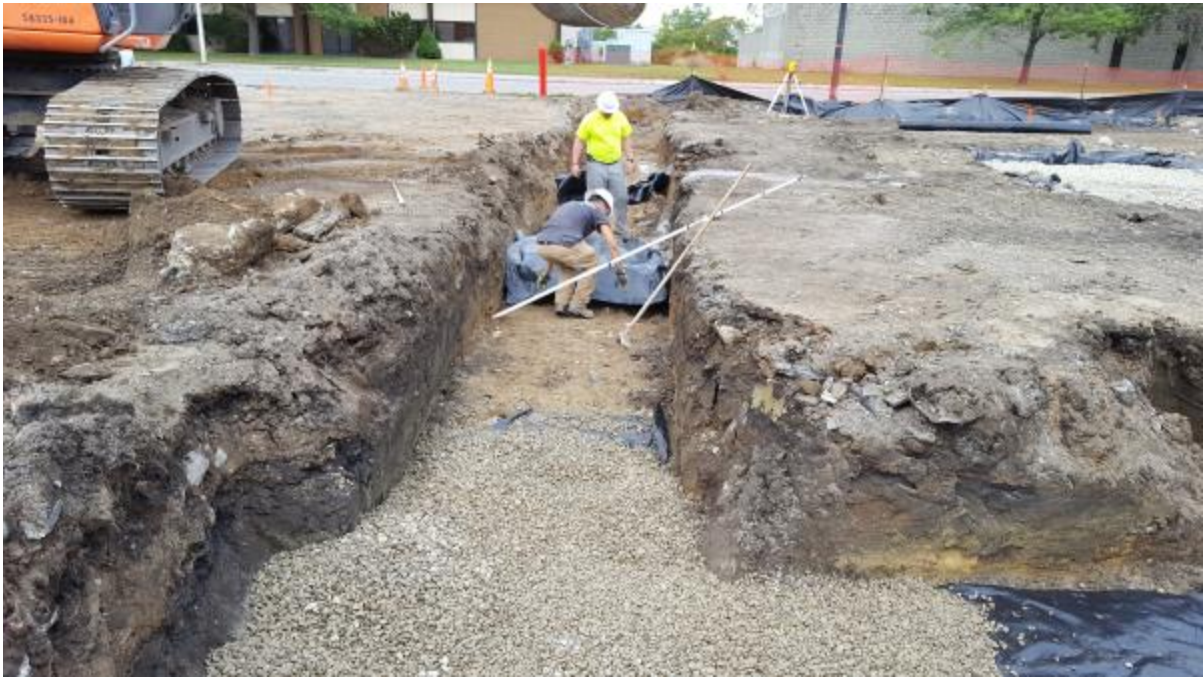
Photo 37 : Contractor placing fabric and stone in areas overexcavated due to fills and old concrete footings.

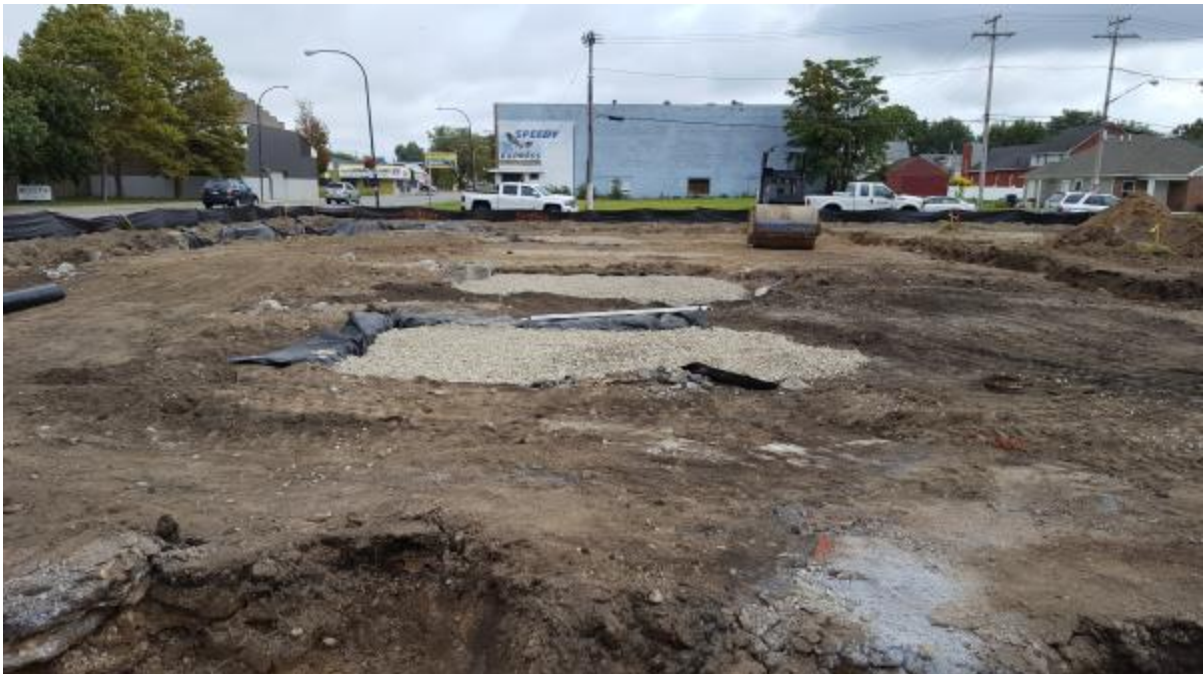
Photo 38 : Compacted center pier locations.

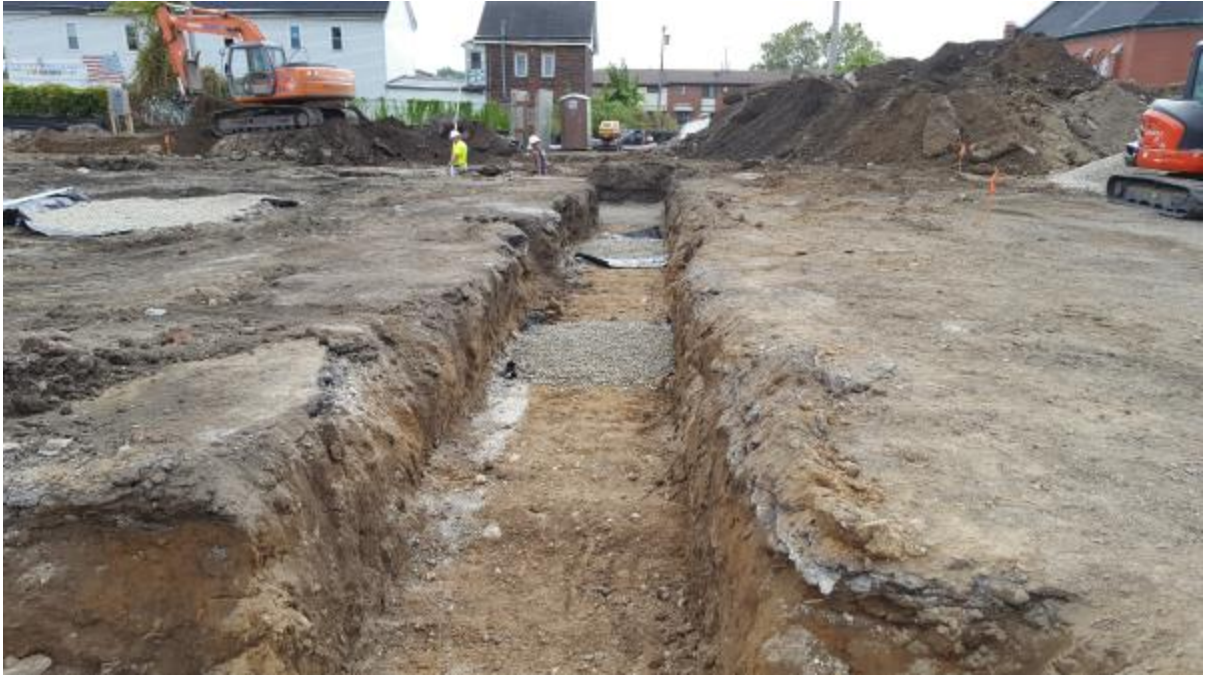
Photo 39 : View facing south from northwestern building corner.

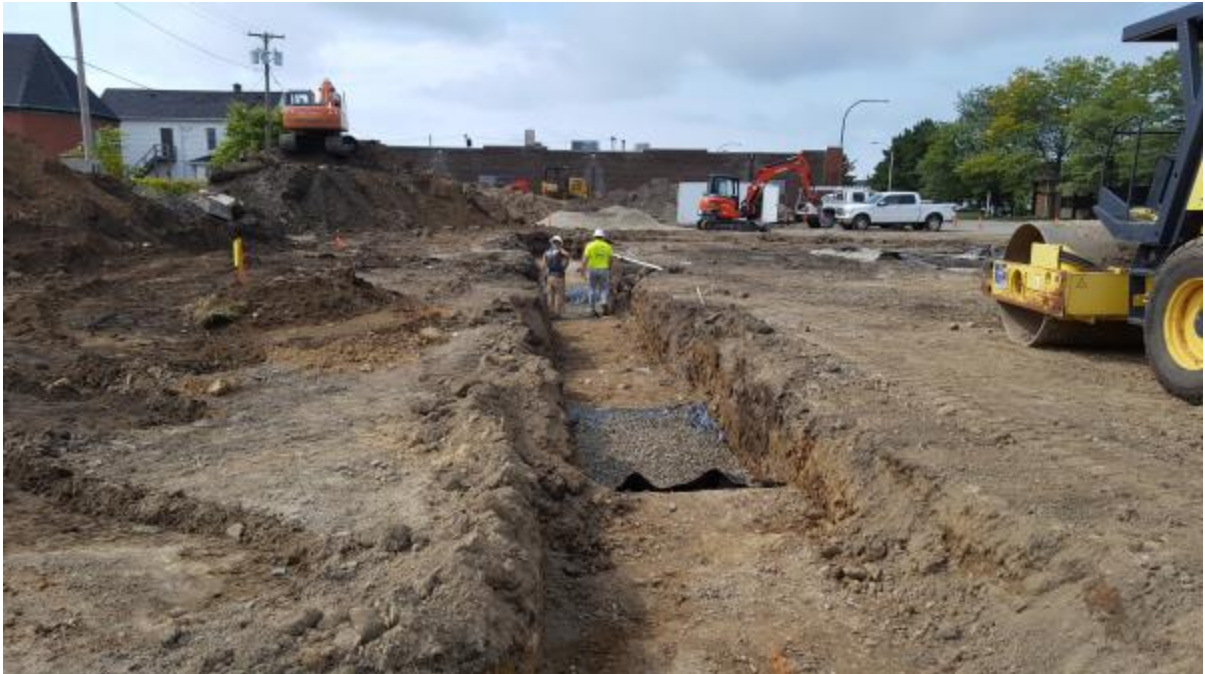
Photo 40 : View facing west from southeastern building corner – contractor placing fabric and stone in areas where old footings were removed.
