Re: Barrier Wall Phase II Construction Completion Report
Former Pratt Oil Works
Long Island City, New York
Consent Order Case No. D2-1002-12-07AM-2
NYSDEC Site No. S241115

BARRIER WALL PHASE II CONSTRUCTION COMPLETION REPORT

**ExxonMobil Former Pratt Oil Works (FPOW)
Long Island City, Queens, New York**

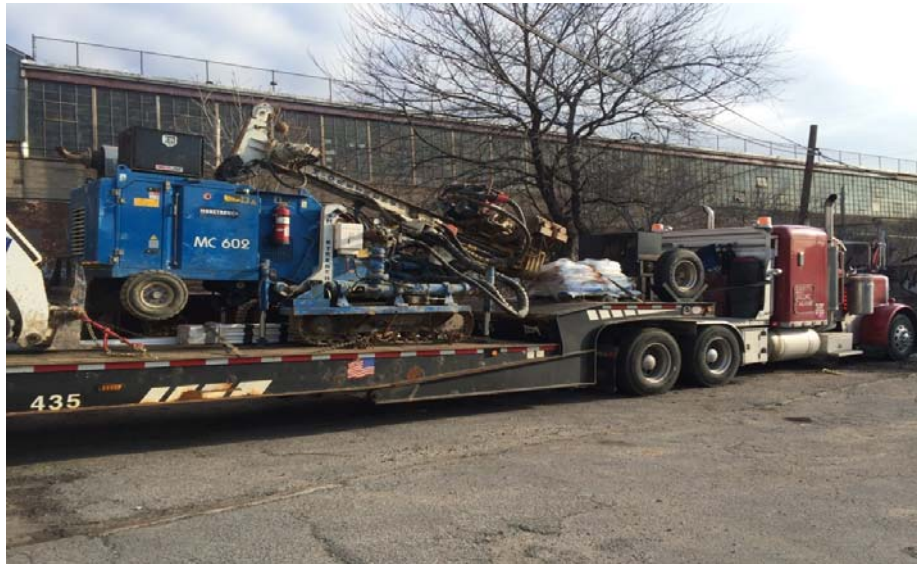
Photo 1: Mobilization of Comacchio drill rig, March 1, 2016

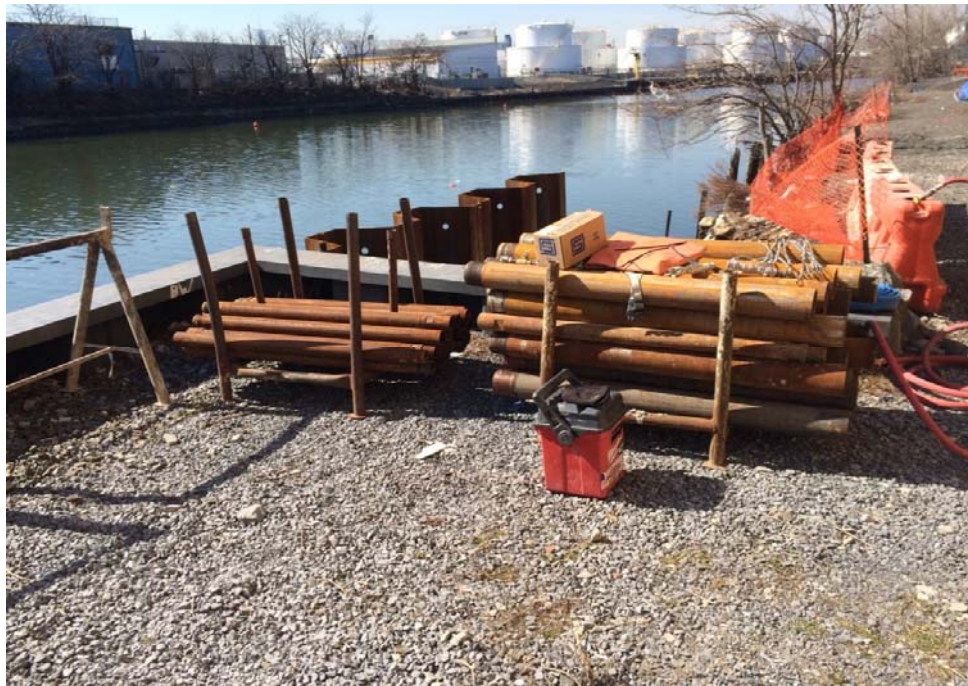
Photo 2: Looking southwest, drill casings for TAM pipe installation, March 1, 2016

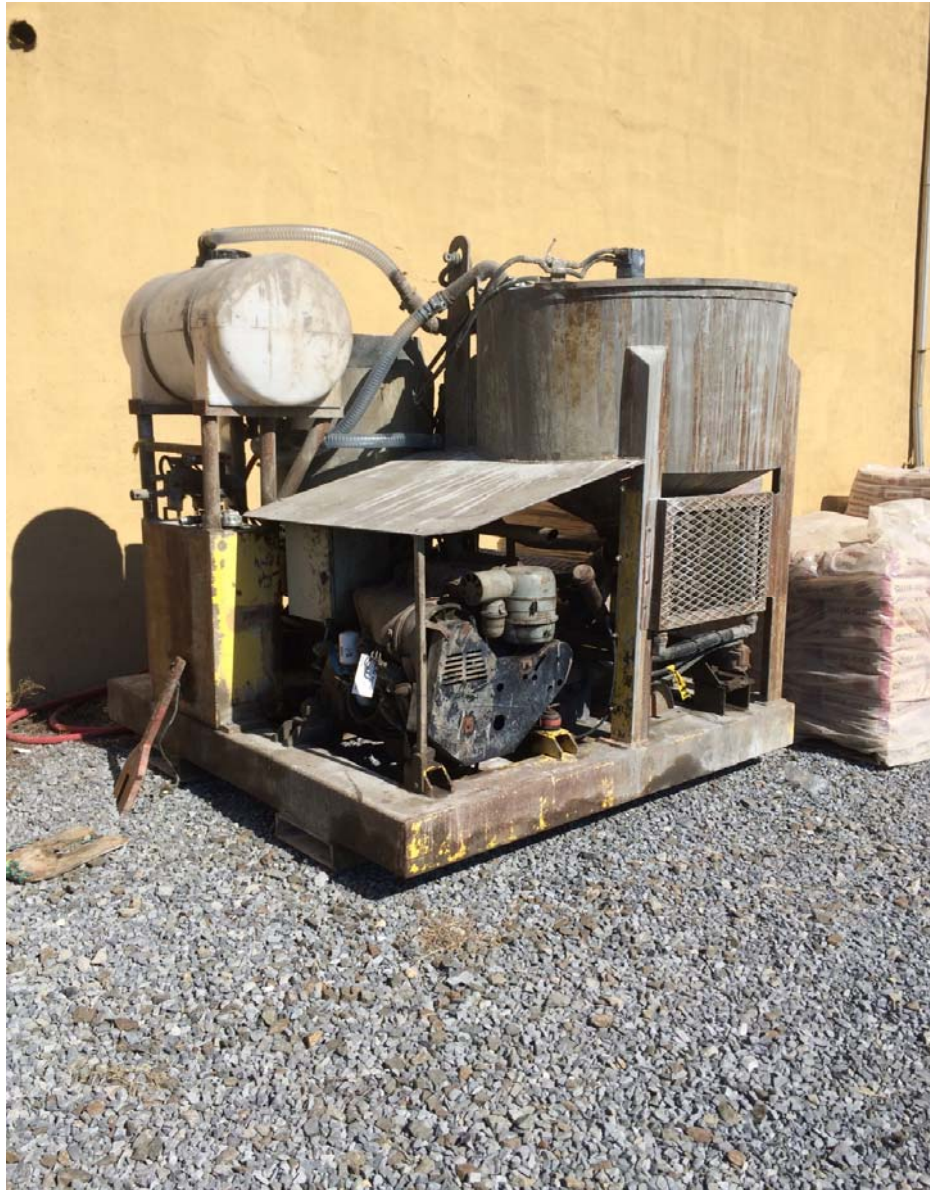
Photo 3: High shear grout mixer onsite, March 1, 2016

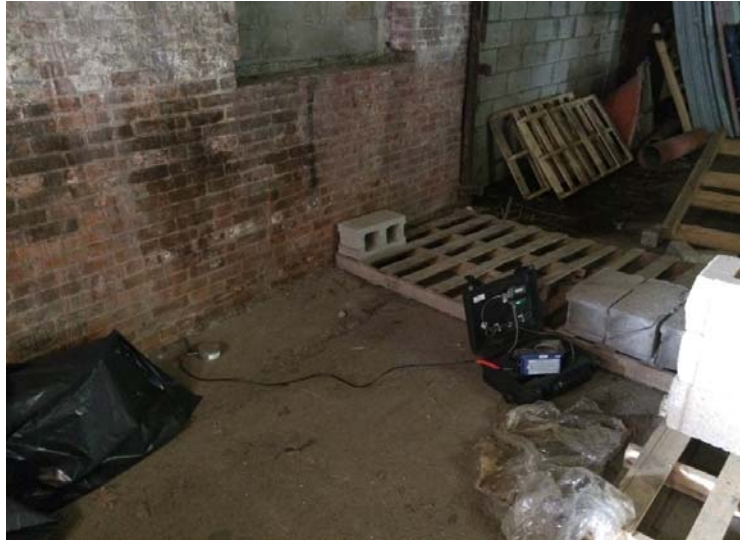
Photo 5: Vibration Monitor LI CITY #1 inside Parcel A warehouse, March 1, 2016

The VMSs were installed in two warehouse buildings, one at Parcel A and another at Parcel B. The equipment was stationed along the southern wall of each building, opposite the work area, in a location that was most practical. Photographs of the VMS equipment set-up can be found in Appendix A. The VMSs were labeled LI CITY #1 (Parcel A) and LI CITY #2 (Parcel B). The VMSs recorded at five-minute intervals on its internal memory and the data was uploaded to the remote server at the end of each day. There were exceedances detected on the systems, however, all were due to troubleshooting or accidental shifting of the equipment. The data, including the days the exceedances were detected, along with an explanation for each, are provided in Appendix F, with the exclusion of data collected on March 2, 2015. The vibration monitoring data collected on March 2, 2016 was not reported as tabulated data, and instead was summarized graphically. As seen in Appendix F, there were three vibration exceedances observed at LI CITY#2. The approximate maximum exceedance value, time, and reasoning for each exceedance observed at LI CITY#2 on March 2, 2016 are as follows:

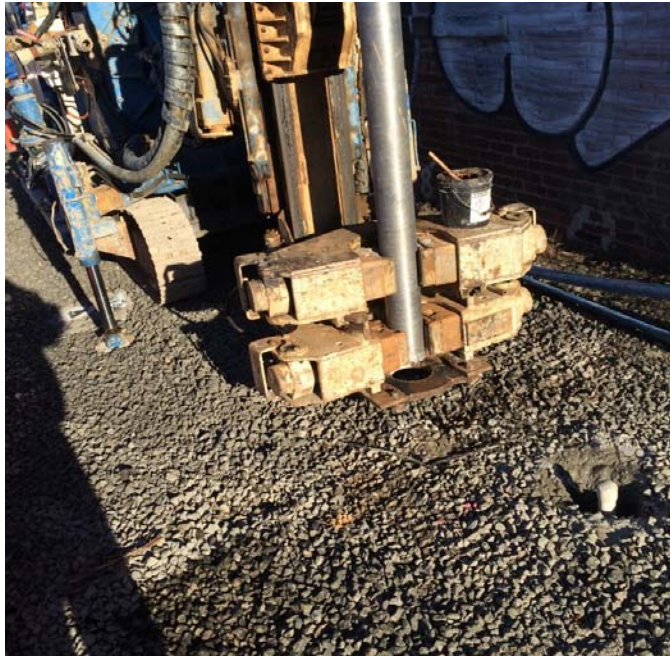
Photo 6: Drilling for TAM pipe installation, March 3, 2016

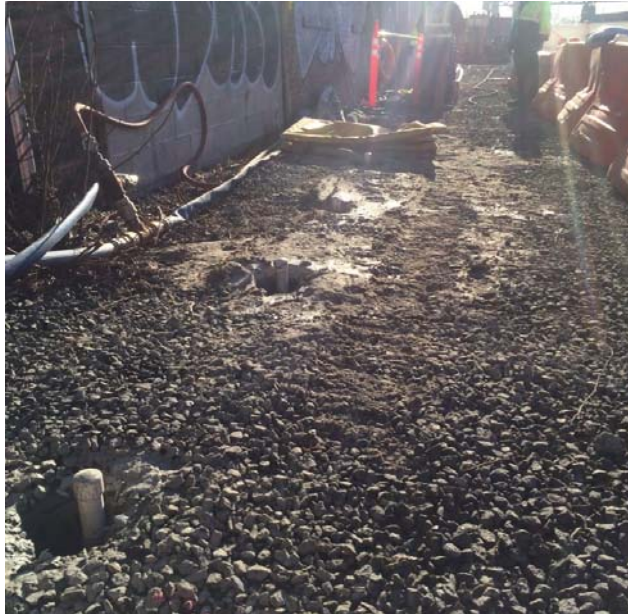
Photo 7: Looking east, view of installed TAM pipes TAM-1, TAM-2, and TAM-3; March 3, 2016

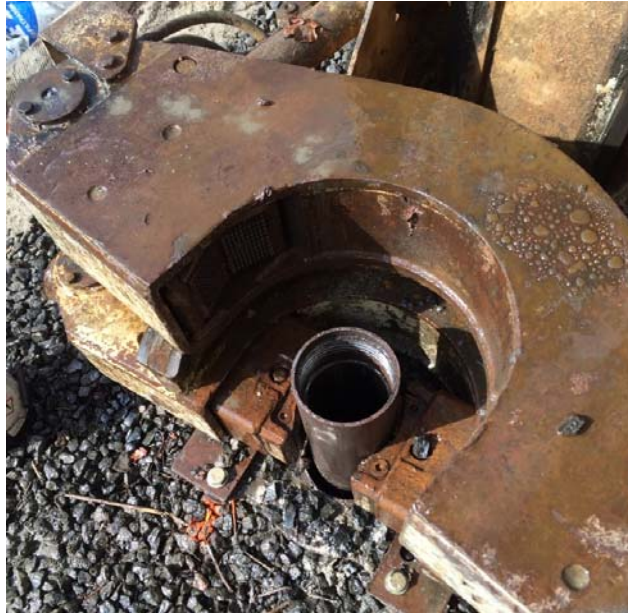
Photo 8: Drill rig with 5.5 inch drill casing, March 3, 2016

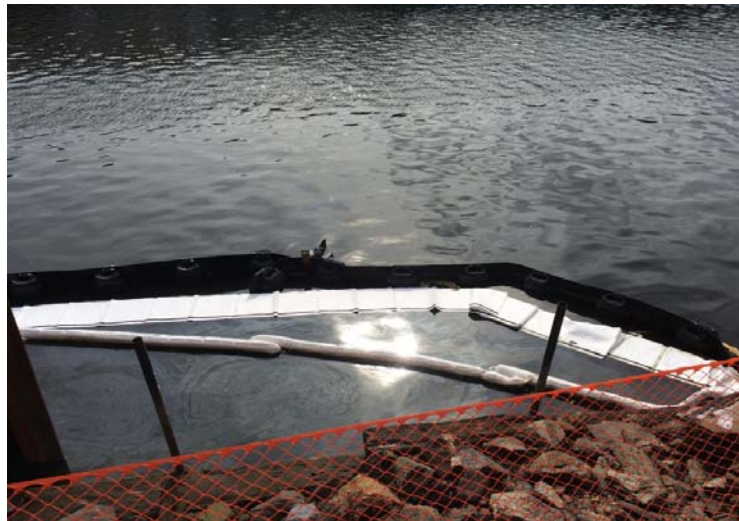
**Photo 9: Looking south, view of Newtown Creek with absorbent boom, absorbent pads and
PVC hard boom around work area, March 4, 2016**

For the duration of the Phase II work, Roux Associates contracted Atlantic Response, Inc. of East Brunswick, New Jersey (Atlantic Response) to provide emergency spill standby and monitor worker safety along the bulkhead. As a precautionary measure, Atlantic Response installed absorbent pads (“sweeps”) alongside the existing 5-inch absorbent boom in Newtown Creek to control any potential sheen to the extent observed during the course of the work. Neither grout nor sheen were observed penetrating the bulkhead during grout operations.

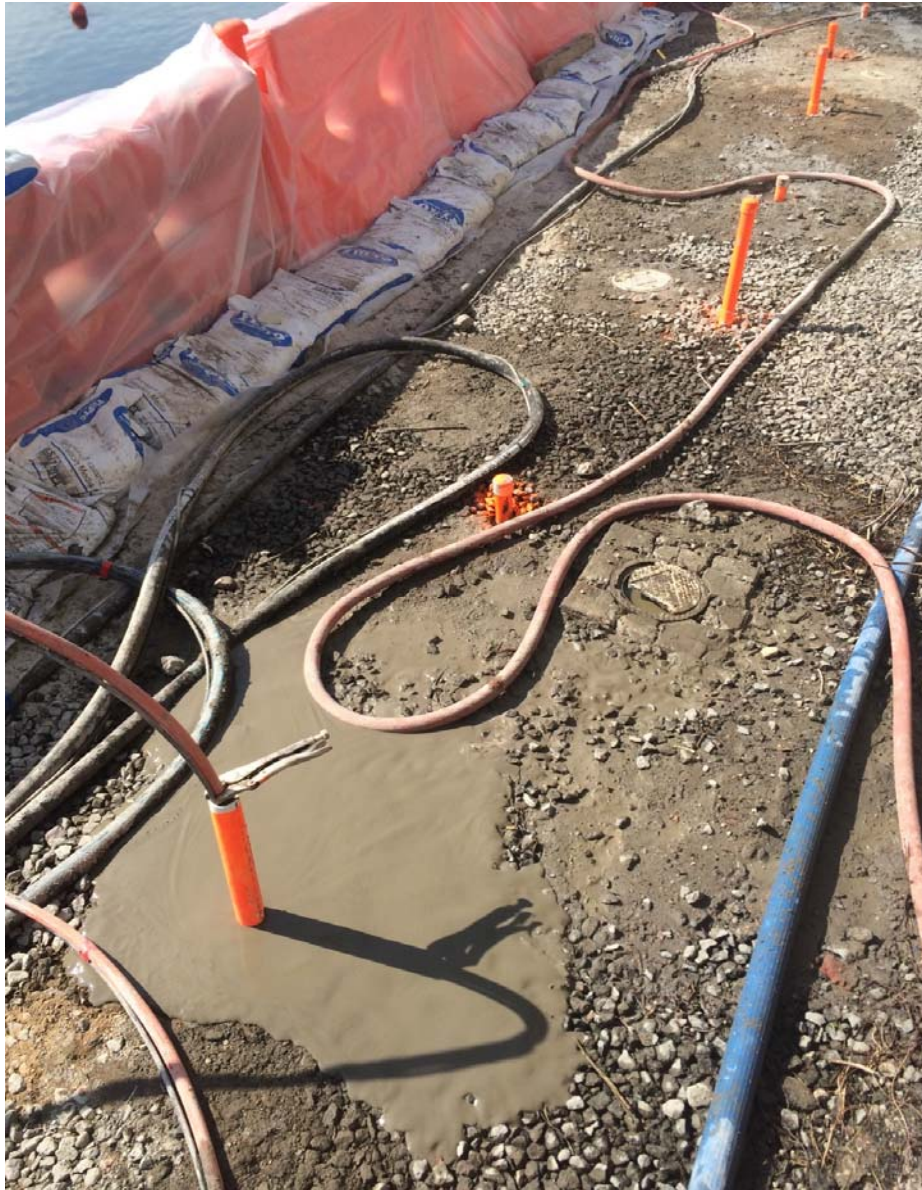
Photo 10: Looking west, hoses injecting grout in TAM-12, March 8, 2016

Grouting times, pressures, volume, and comments were noted in the Moretrench grouting logs, provided in Appendix C. Based on the logs, grouting pressures peaked at 200 psi and typically stayed in the range of 20 to 40 psi. Up to 200 psi was used for short periods of less than a minute to “crack” the existing grout and allow the injected grout to flow through. Between 47 and 186 gallons of grout were injected at a TAM pipe during one round. The total volume of grout injected was estimated at 3,715 gallons.

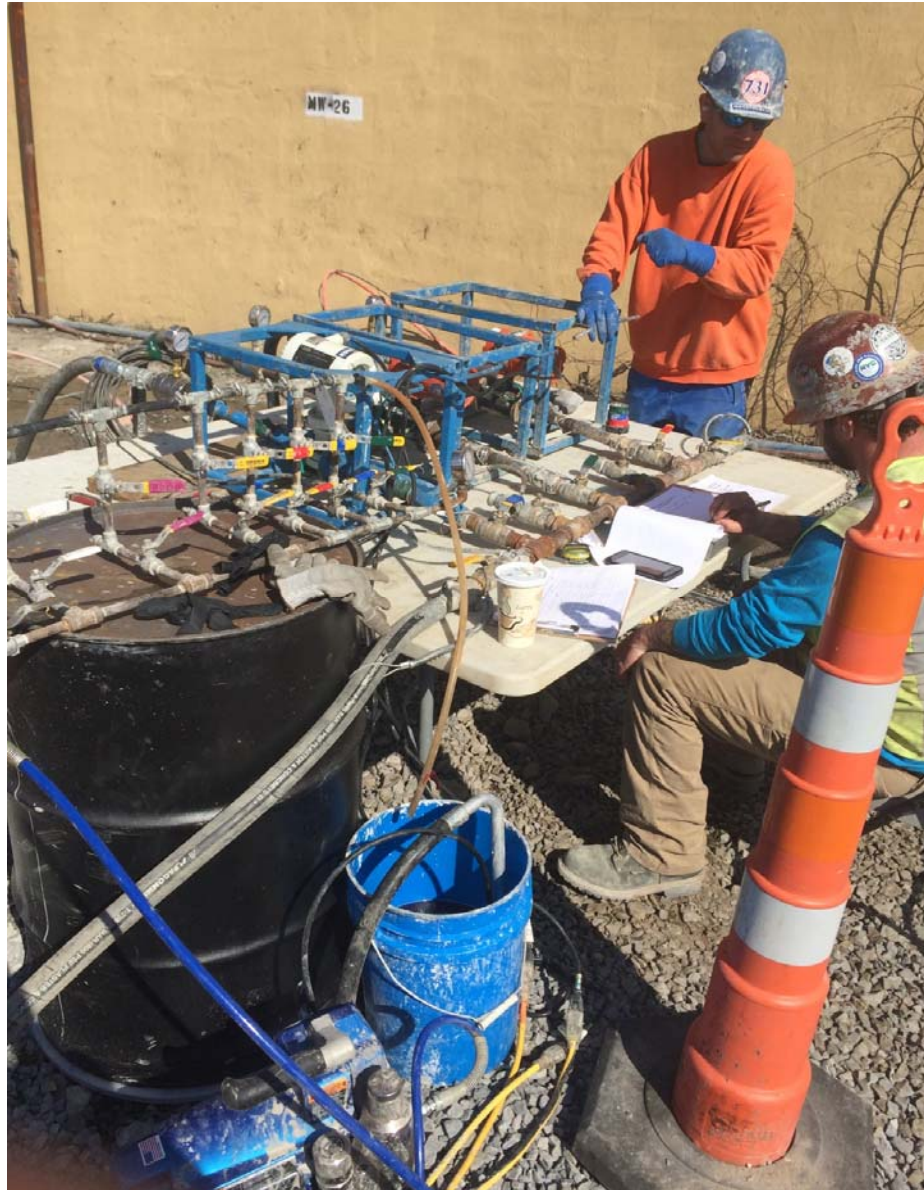
Photo 11: Grout manifold and monitoring set up, March 9, 2016

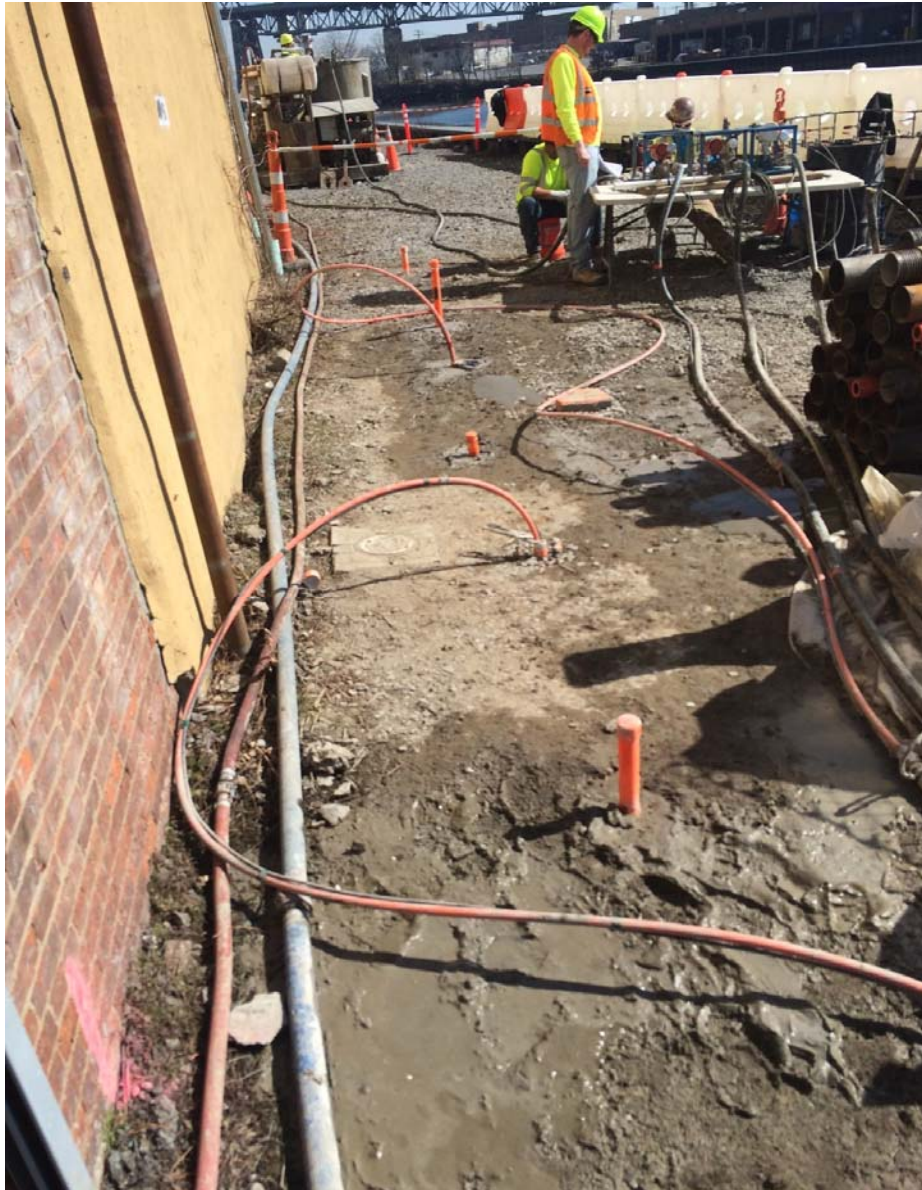
Photo 12: Hoses injecting grout in TAM-13 and TAM-15, March 9, 2016

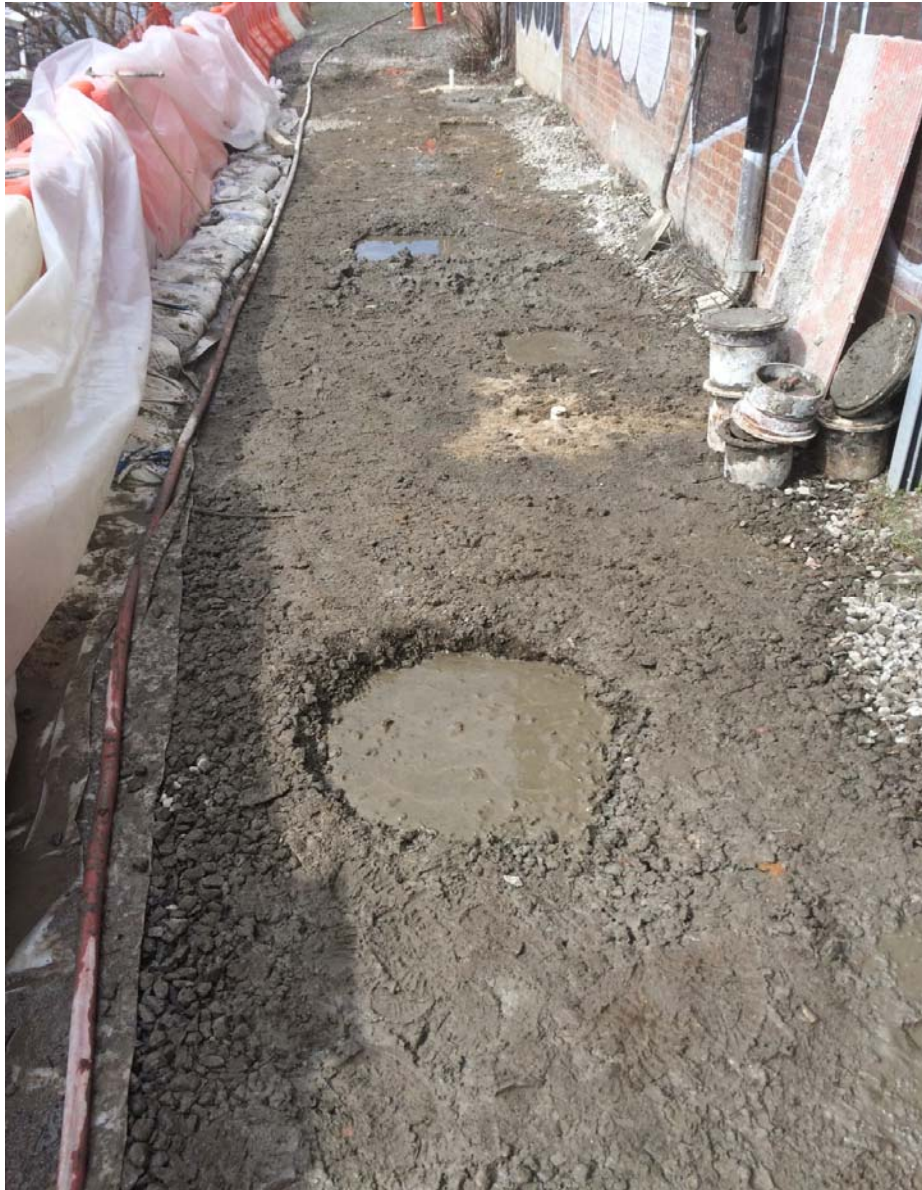
Photo 14: Looking west, abandonment of MW-25, PZ-2, and MW-32; March 11, 2016

Three monitoring wells within the work area, MW-25, MW-26, and MW-32, were observed to be filled with grout after injections were complete. On March 11, 2016, Moretrench abandoned these monitoring wells, along with the Phase I piezometer wells PZ-1, PZ-2, and PZ-3. Moretrench filled the monitoring wells with excess cement-bentonite grout from the injections and removed the casings and concrete pads. Photographs of the abandoned piezometers and monitoring wells are provided in Appendix A.

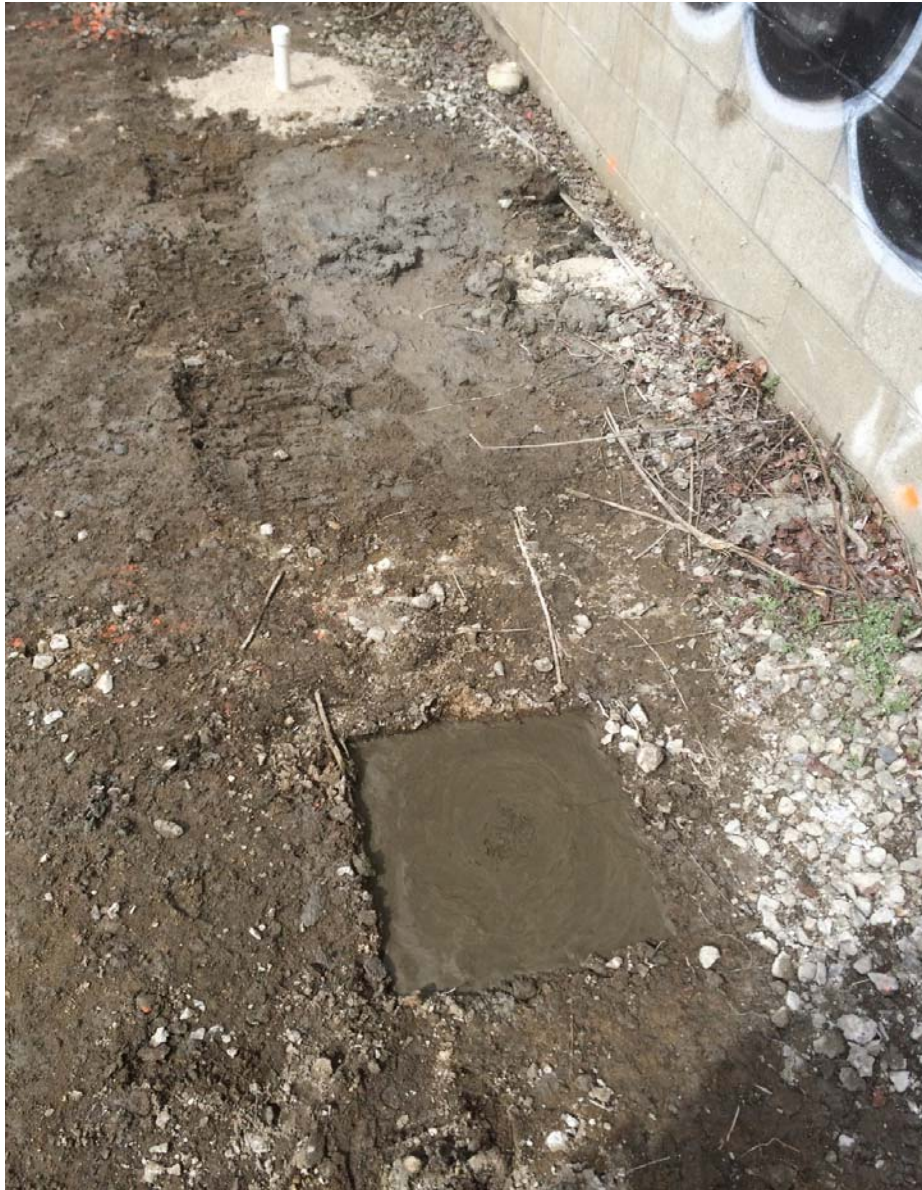
Photo 15: Abandonment of PZ-1, March 11, 2016

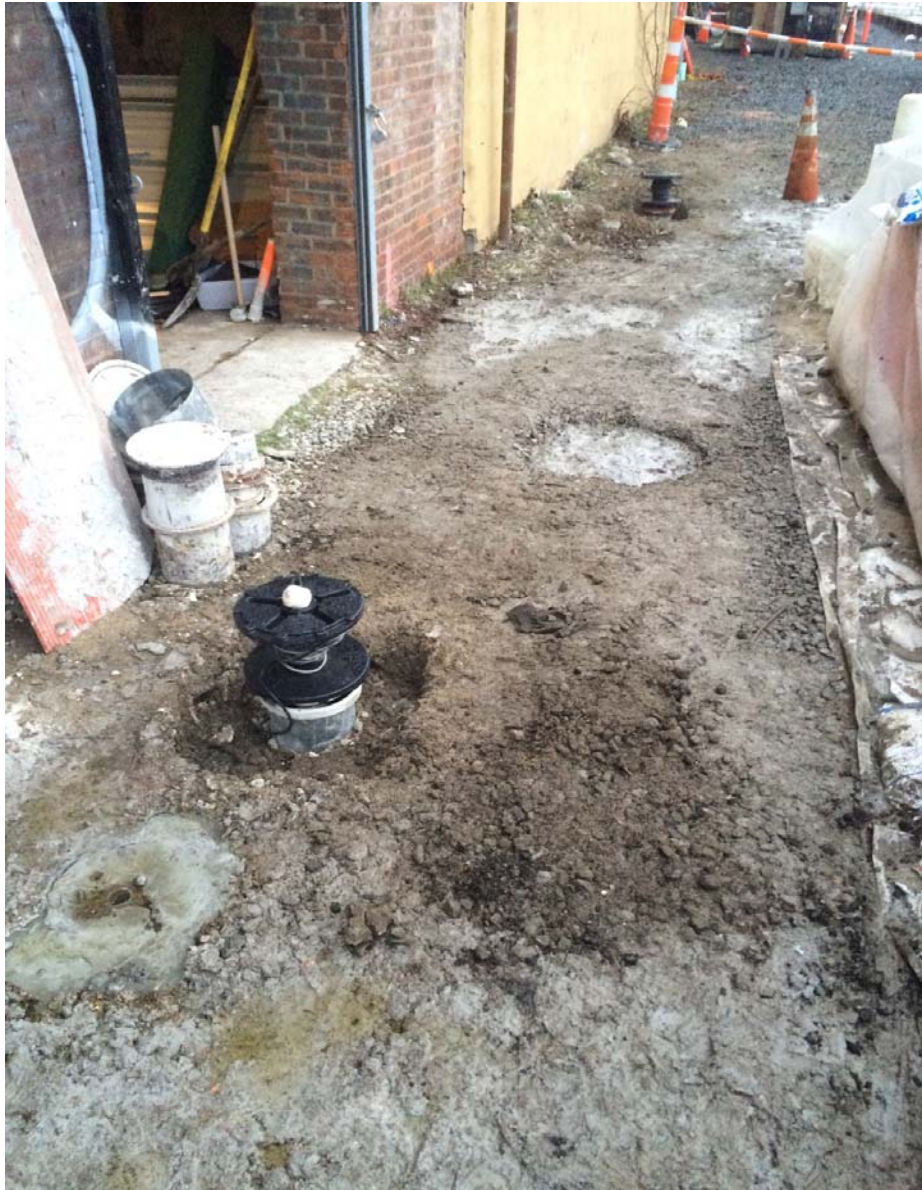
Photo 16: Looking east, image of abandoned wells and newly installed piezometers, March 14, 2016

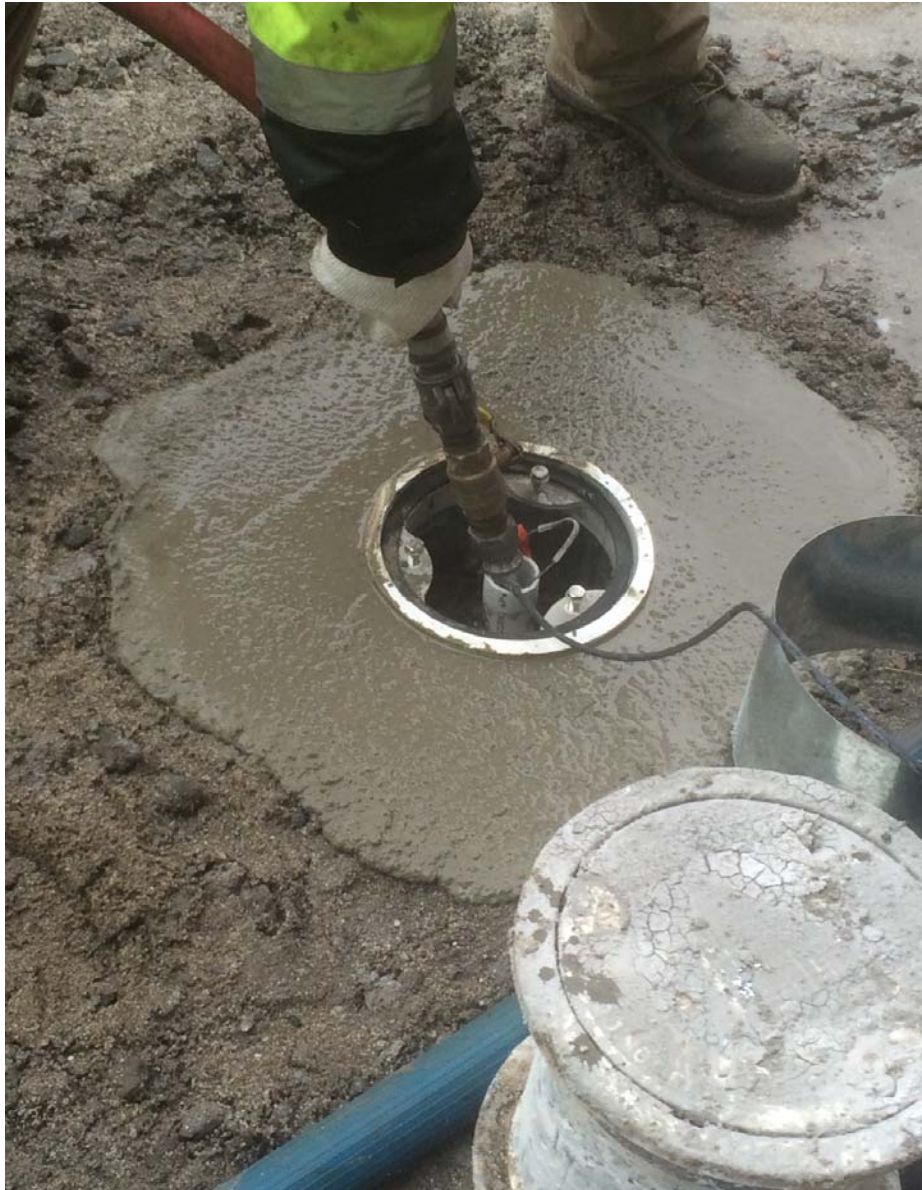
Photo 17: Slug Test being performed at PZ-4, March 14, 2016

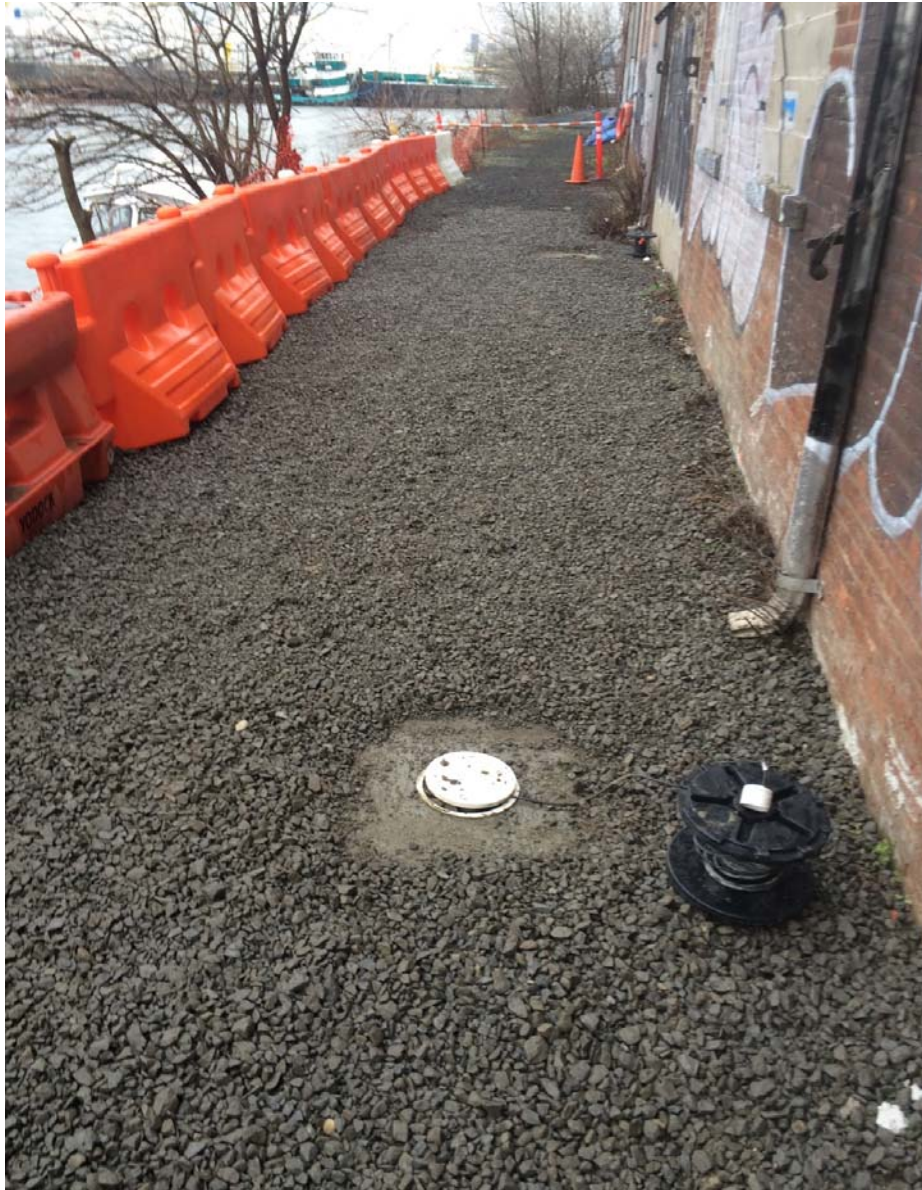
Photo 18: Looking west, site restored and regraded, March 15, 2016

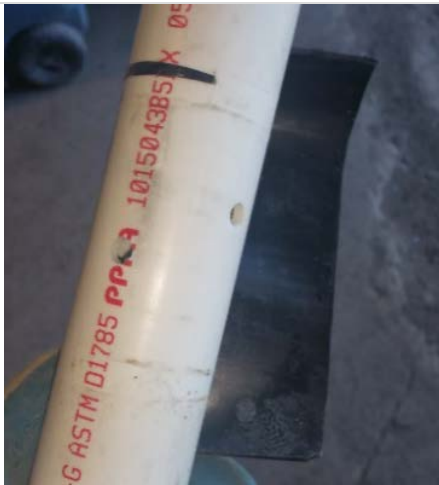
3/02/16- 1 1/2" dia PVC pipe with 1/4" dia. Drilled hole.

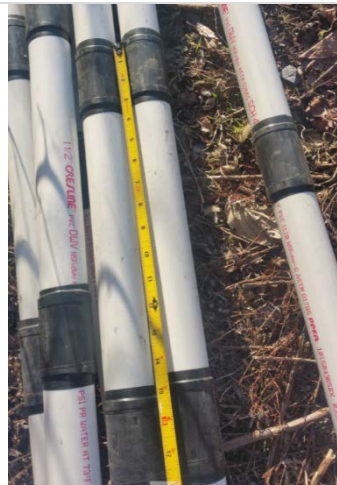
3/02/16-sleeve port located 15" apart.

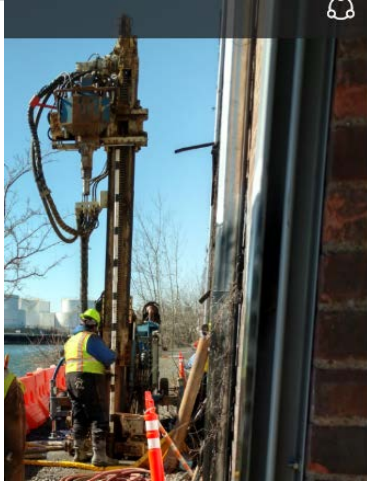
3/2/16- PVC pipe installation into borehole

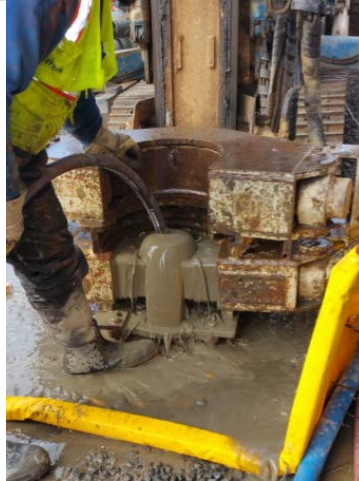
3/2/16- Grouting borehole.

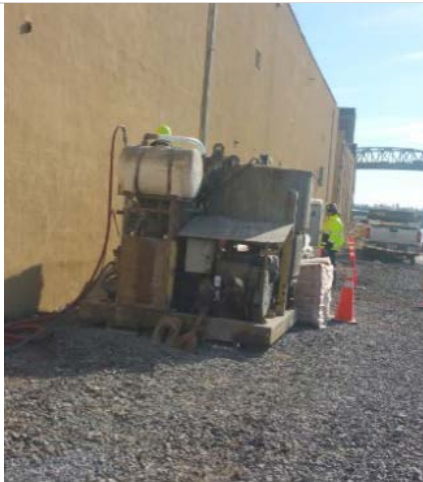
3/2/16- Mixer and pump.

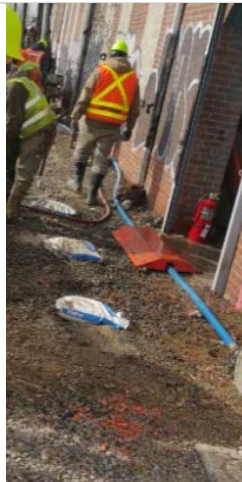
3/3/16- TAM pipe# 6,7,8,9,10,11 & 12 installed.

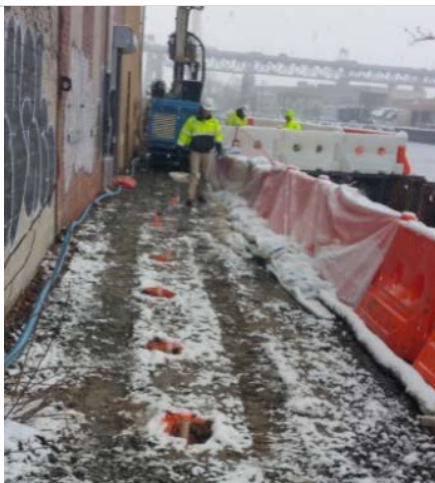
3/4/16- TAM pipe# 13,14,15,16 & 17 installed.

DATE OBSERVED	NON-CONFORMANCE ITEMS REQUIRING CORRECTION	SIGN OFF DATE
3/04/16	TAM pipe #16 depth below ground surface 14' 10" TAM pipe# 17 depth below ground surface 14' 0" (Required depth below ground surface +15 ft.) EOR to review and approve. Reviewed and found acceptable by; Dana M. Hignell, Senior Engineer Roux Associates, Inc. Brian P. Morrissey, PE Remedial Engineering PC Reference- letter dated June 1, 2016	6/03/16
3/10/16	Actual grout volume injected is less than target volume at numerous TAM piped due to grout surface return or high grout pressure. EOR to review Moretrench's detailed grouting reports and advise. Reviewed and found acceptable by; Dana M. Hignell, Senior Engineer Roux Associates, Inc. Brian P. Morrissey, PE Remedial Engineering PC Reference- letter dated June 1, 2016	6/03/16
3/10/16	Moretrench to submit 2 inch x 2 inch grout cubes test results for review and record. Reviewed and found acceptable by; Dana M. Hignell, Senior Engineer Roux Associates, Inc. Brian P. Morrissey, PE Remedial Engineering PC Reference- letter dated June 1, 2016	6/03/16

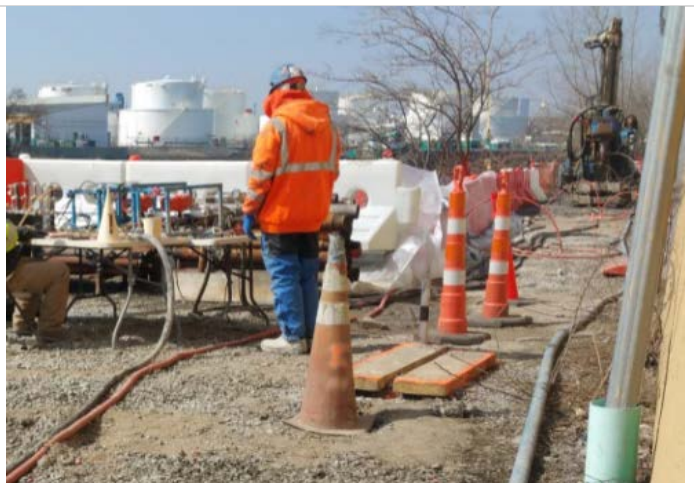
3/07/16- grout injection is in progress.

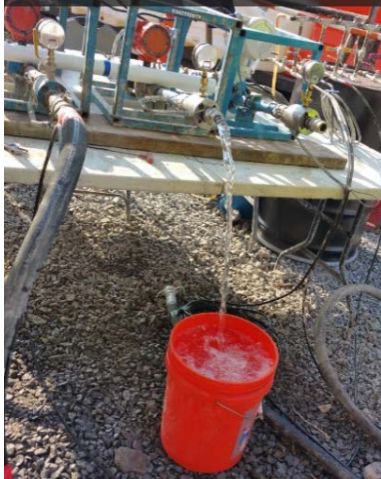
3/07/16 - Flowmeter calibration was checked by passing volume of water through the flowmeters.

3/07/16		
Grout Barrier wall cement Bentonite Grouting TAM pipe# 1, 2,3 4,5,6,7,8,9,10,11,12,13,14,15,16&17	1. Malfunctioning pressure gauge was replaced. 2. Flowmeter calibration was checked by passing volume of water through the flowmeters. 3. Grout consistency checked with marsh funnel. 4. 2 inchx2inch grout cubes were sampled by contractor. 5. Grout flow rate grout injection pressure were controlled by Moretrench field technician. 6. Grouting process witnessed and contractor logs were reviewed. 7. Grout return to surface was observed.	1st pass – is in progress (20 gallons each port)

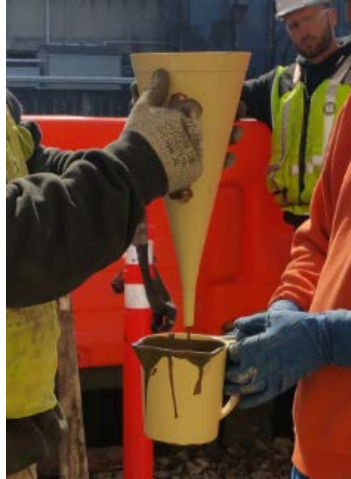
3/08/16 - Grout consistency checked with marsh funnel.

3/08/16		
Grout Barrier wall cement Bentonite Grouting TAM pipe#1, 2,3 4,5,6,7,8,9,10,11,12,13,14,15,16&17	<ol style="list-style-type: none"> 1. Grout consistency checked with marsh funnel- 41 second. 2. Grout sampled by contractor- 2 inchx2inch grout cubes. 3. Grout flow rate and grout injection pressure were controlled by Moretrench field technician. 4. Grouting process witnessed and contractor logs were reviewed. 5. Grout return to surface and existing observation well was observed. 	1st and 2nd pass is in progress (20 gallons each port)
3/09/16		
Grout Barrier wall cement Bentonite Grouting TAM pipe# 1, 2,3 4,5,6,7,8,9,10,11,12,13,14,15,16&17	<ol style="list-style-type: none"> 1. Grout consistency checked with marsh funnel- 42 second. 2. Grout sampled by contractor- 2 inchx2inch grout cubes. 3. Grout flow rate and grout injection pressure were controlled by Moretrench field technician. 4. Grouting process witnessed and contractor logs were reviewed. 5. Grout return to surface and existing observation well was observed. 	1st and 2nd pass is in progress (20 gallons each port) s

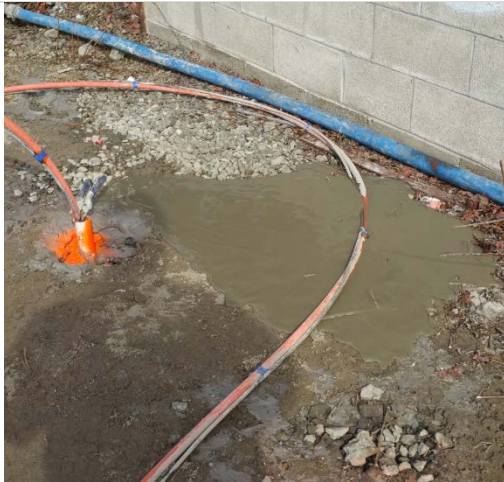
3/09/16 - Grout return to surface during injection.

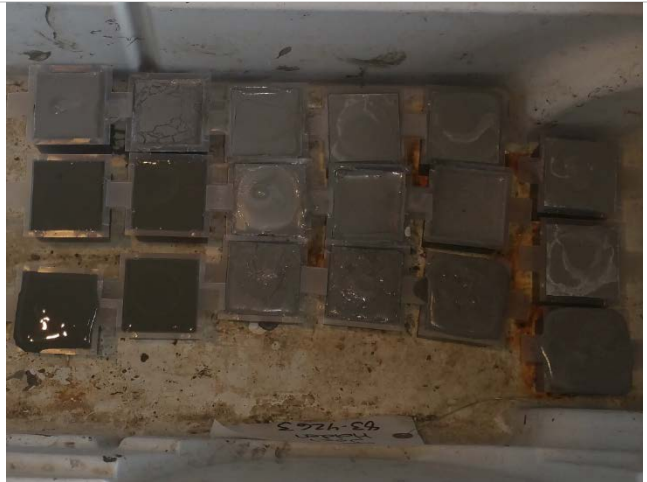
3/10/16- Grout sampled by contractor- 2 inchx2inch grout cubes.

3/10/16		
Grout Barrier wall cement Bentonite Grouting: TAM pipe# 1, 2,3 4,5,6,7,8,9,10,11,12,13,14,15,16&17	<ol style="list-style-type: none"> 1. Grout consistency checked with marsh funnel- 41 second. 2. Grout sampled by contractor- 2 inchx2inch grout cubes. 3. Grout flow rate and grout injection pressure were controlled by Moretrench field technician. 4. Grouting process witnessed and contractor logs were reviewed. 5. Grout return to surface and existing observation well was observed. 	Accepted, Except as noted NCR on page 2. 6/3/16 Accepted

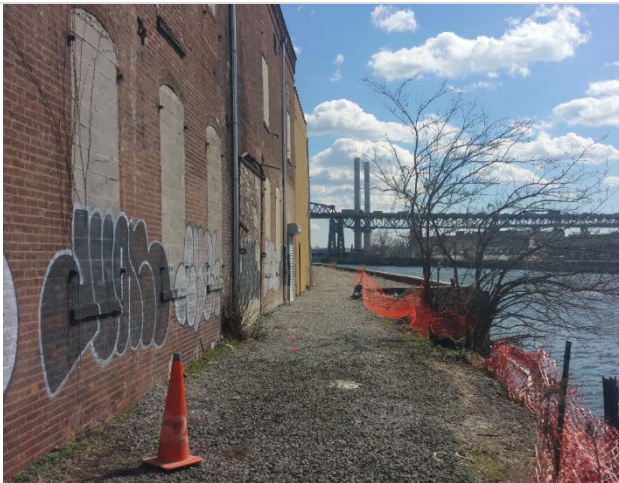
3/18/16 - (17) Tube –A - Manchette (TAM) were installed just north of Phase 1 high slump grouting elements
