October 4, 2019

Reference No. 11137172

**Re: Supplemental Investigation Work Plan - Southern Terminals
Cold Springs Terminal Site, Hillside Road, Lysander, New York
NYSDEC Spill No. 89-04923**

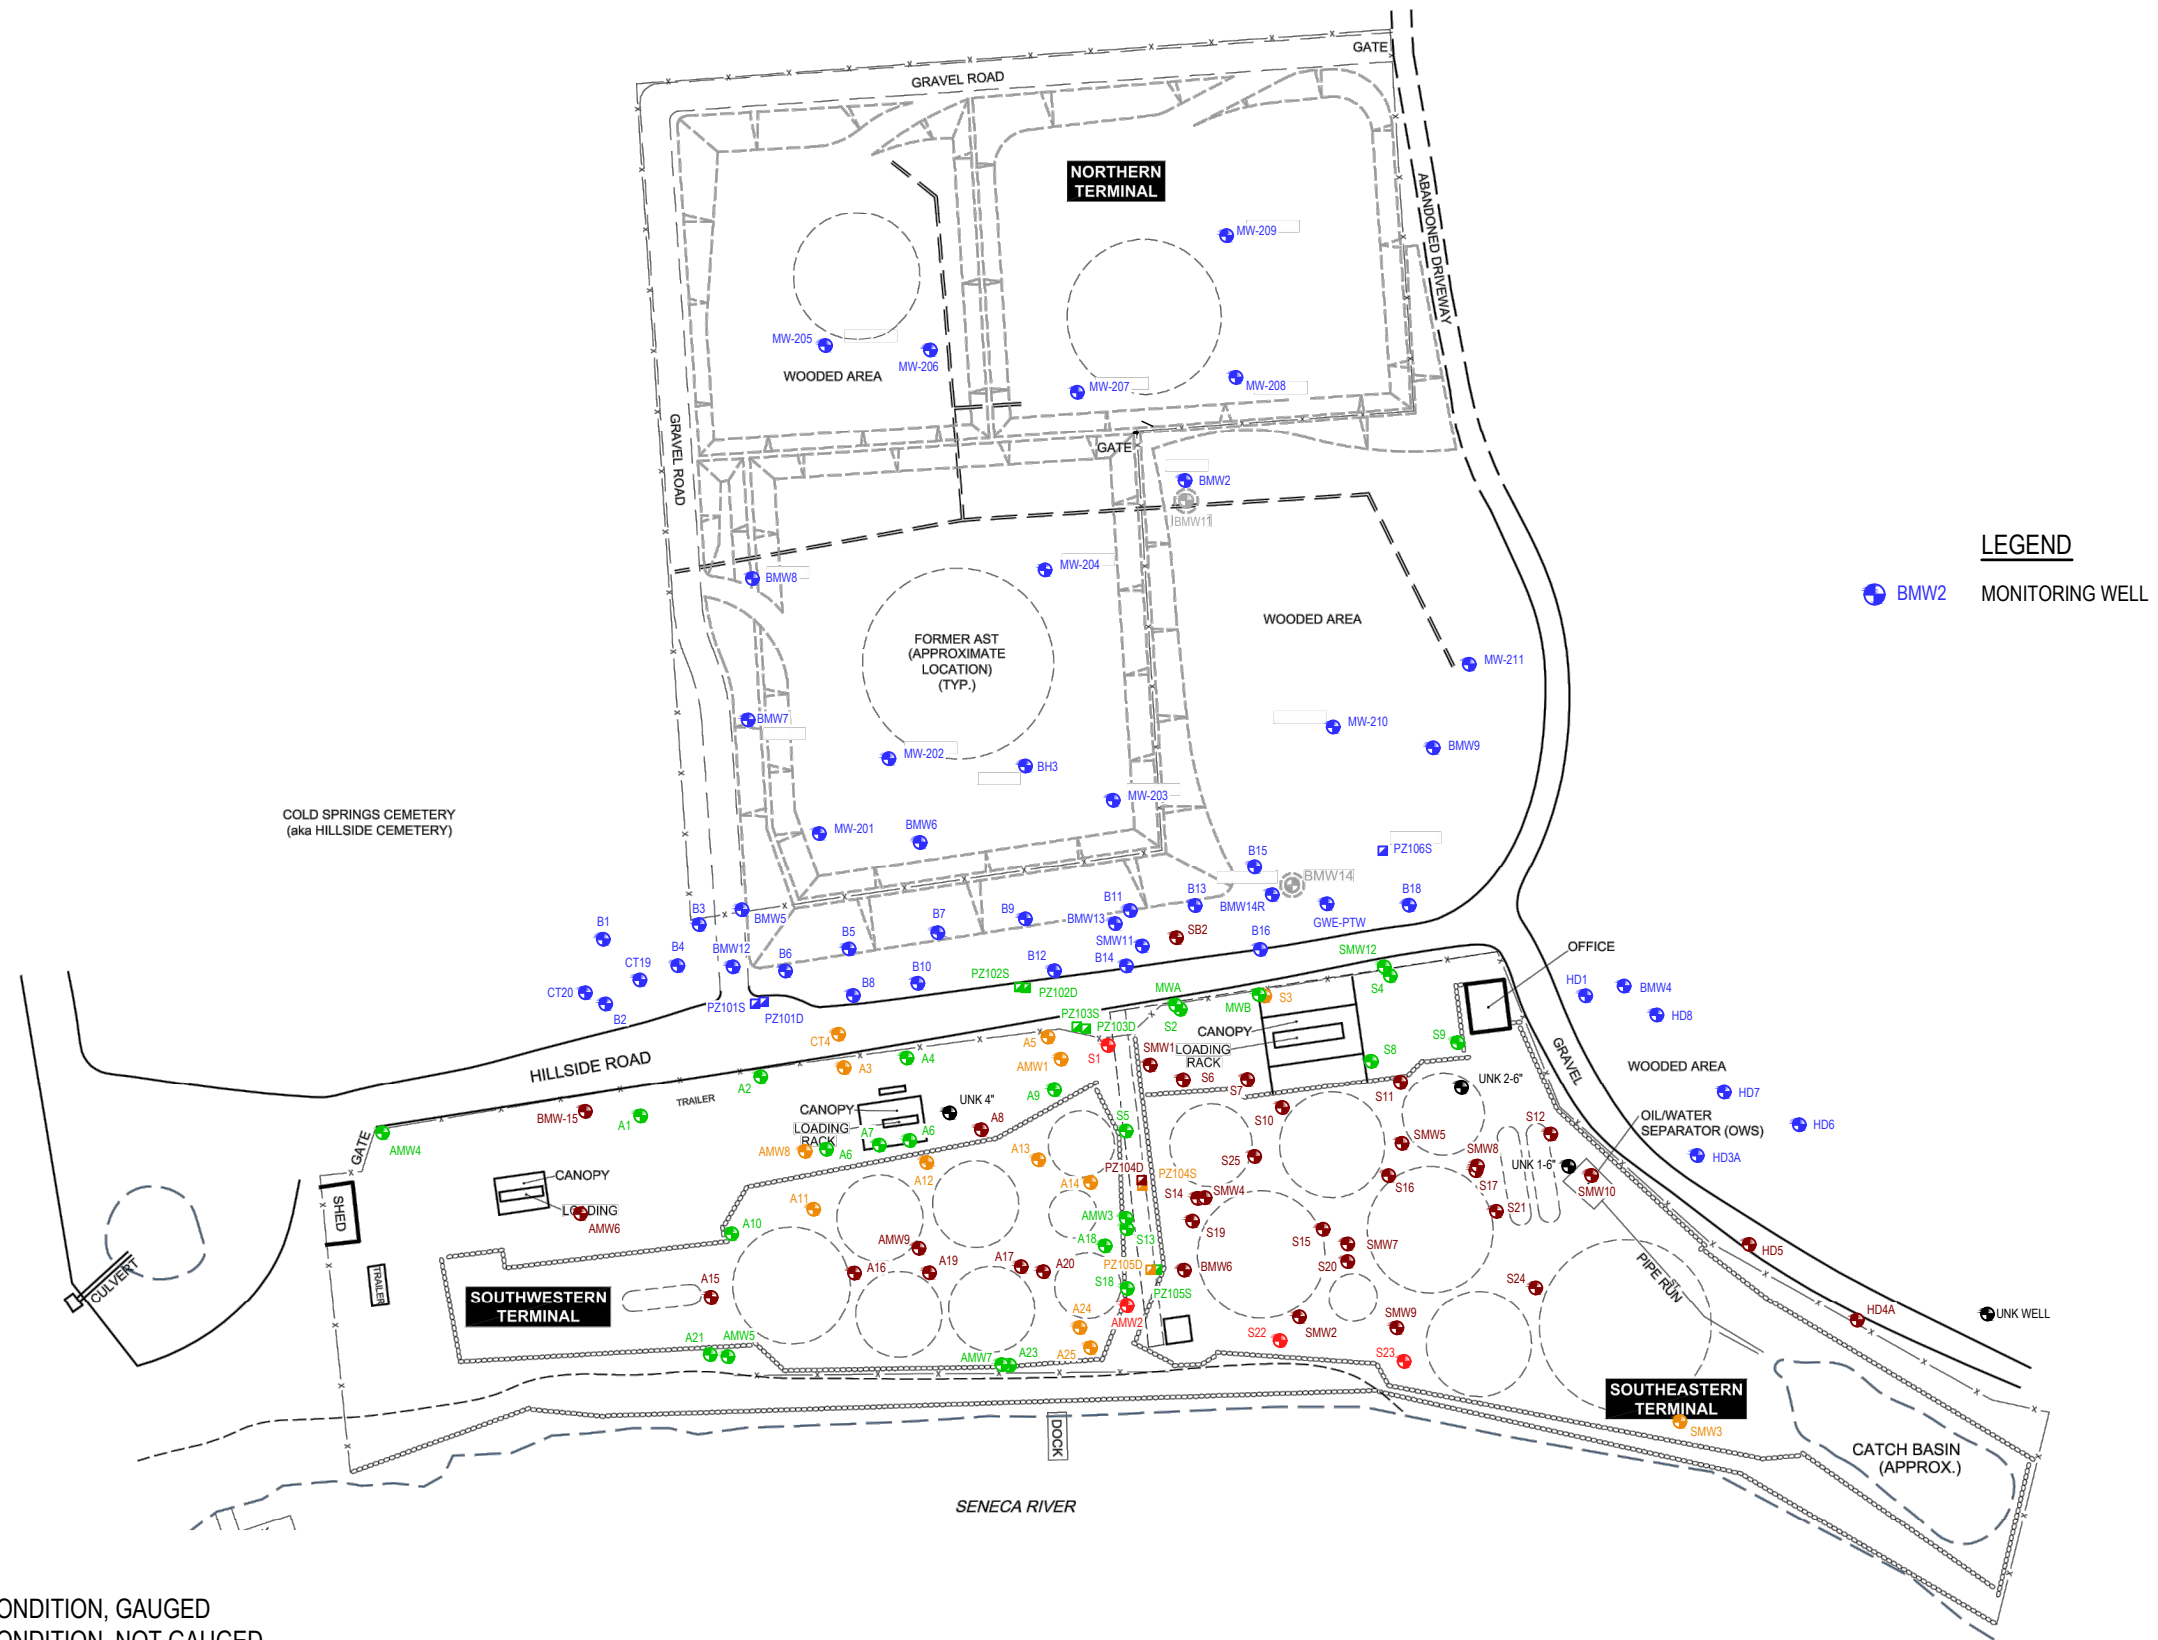
FIGURE 3

**SOUTHERN TERMINALS GROUP
COLD SPRINGS TERMINAL SITE
HILLSIDE ROAD, LYSANDER, NEW YORK
WELL ASSESSMENT SUMMARY**

In June 2019 and pursuant to authorization from NYSDEC, GHD performed a limited Monitoring Well Assessment and LNAPL Gauging Event (GHD, 2019). The purpose of GHD's evaluation was to assess the Site and current monitoring well network conditions. While the majority of NT wells were located, only 49 of the 84 anticipated monitoring wells on the ST property were located. Of those, four monitoring wells could not be gauged as a result of damage and an additional nine wells were observed to be in poor condition. Overall, LNAPL was measured in thicknesses varying from approximately 0.01 feet at S5 to 3.48 feet at A10. The apparent extent of LNAPL is generally consistent with historical observations; however, monitoring wells in several areas of historically observed LNAPL could not be located and/or gauged. As such, GHD has identified a number of monitoring wells for replacement or repair. Summaries of monitoring well conditions and LNAPL measurements collected during the event are included as Tables 1 and 2 and are presented on Figures 3 and 4, respectively.

GHD will repair three ST monitoring wells (A3, A12, A14) identified as damaged during 2019 monitoring well assessment activities. A total of ten nested monitoring well pair locations will be installed in central portions of the Southwestern and Southeastern terminals intended to replace remedial system performance wells (as identified in the NYSDEC-approved RAWP) and/or monitoring wells that historically contained greater than 1 foot of LNAPL that could not be located or were determined to be heavily damaged during the 2019 monitoring well assessment. These wells will also be used to fill in data gaps regarding LNAPL distribution. Five large-diameter wells will be installed for use in conjunction with LNAPL recovery activities.

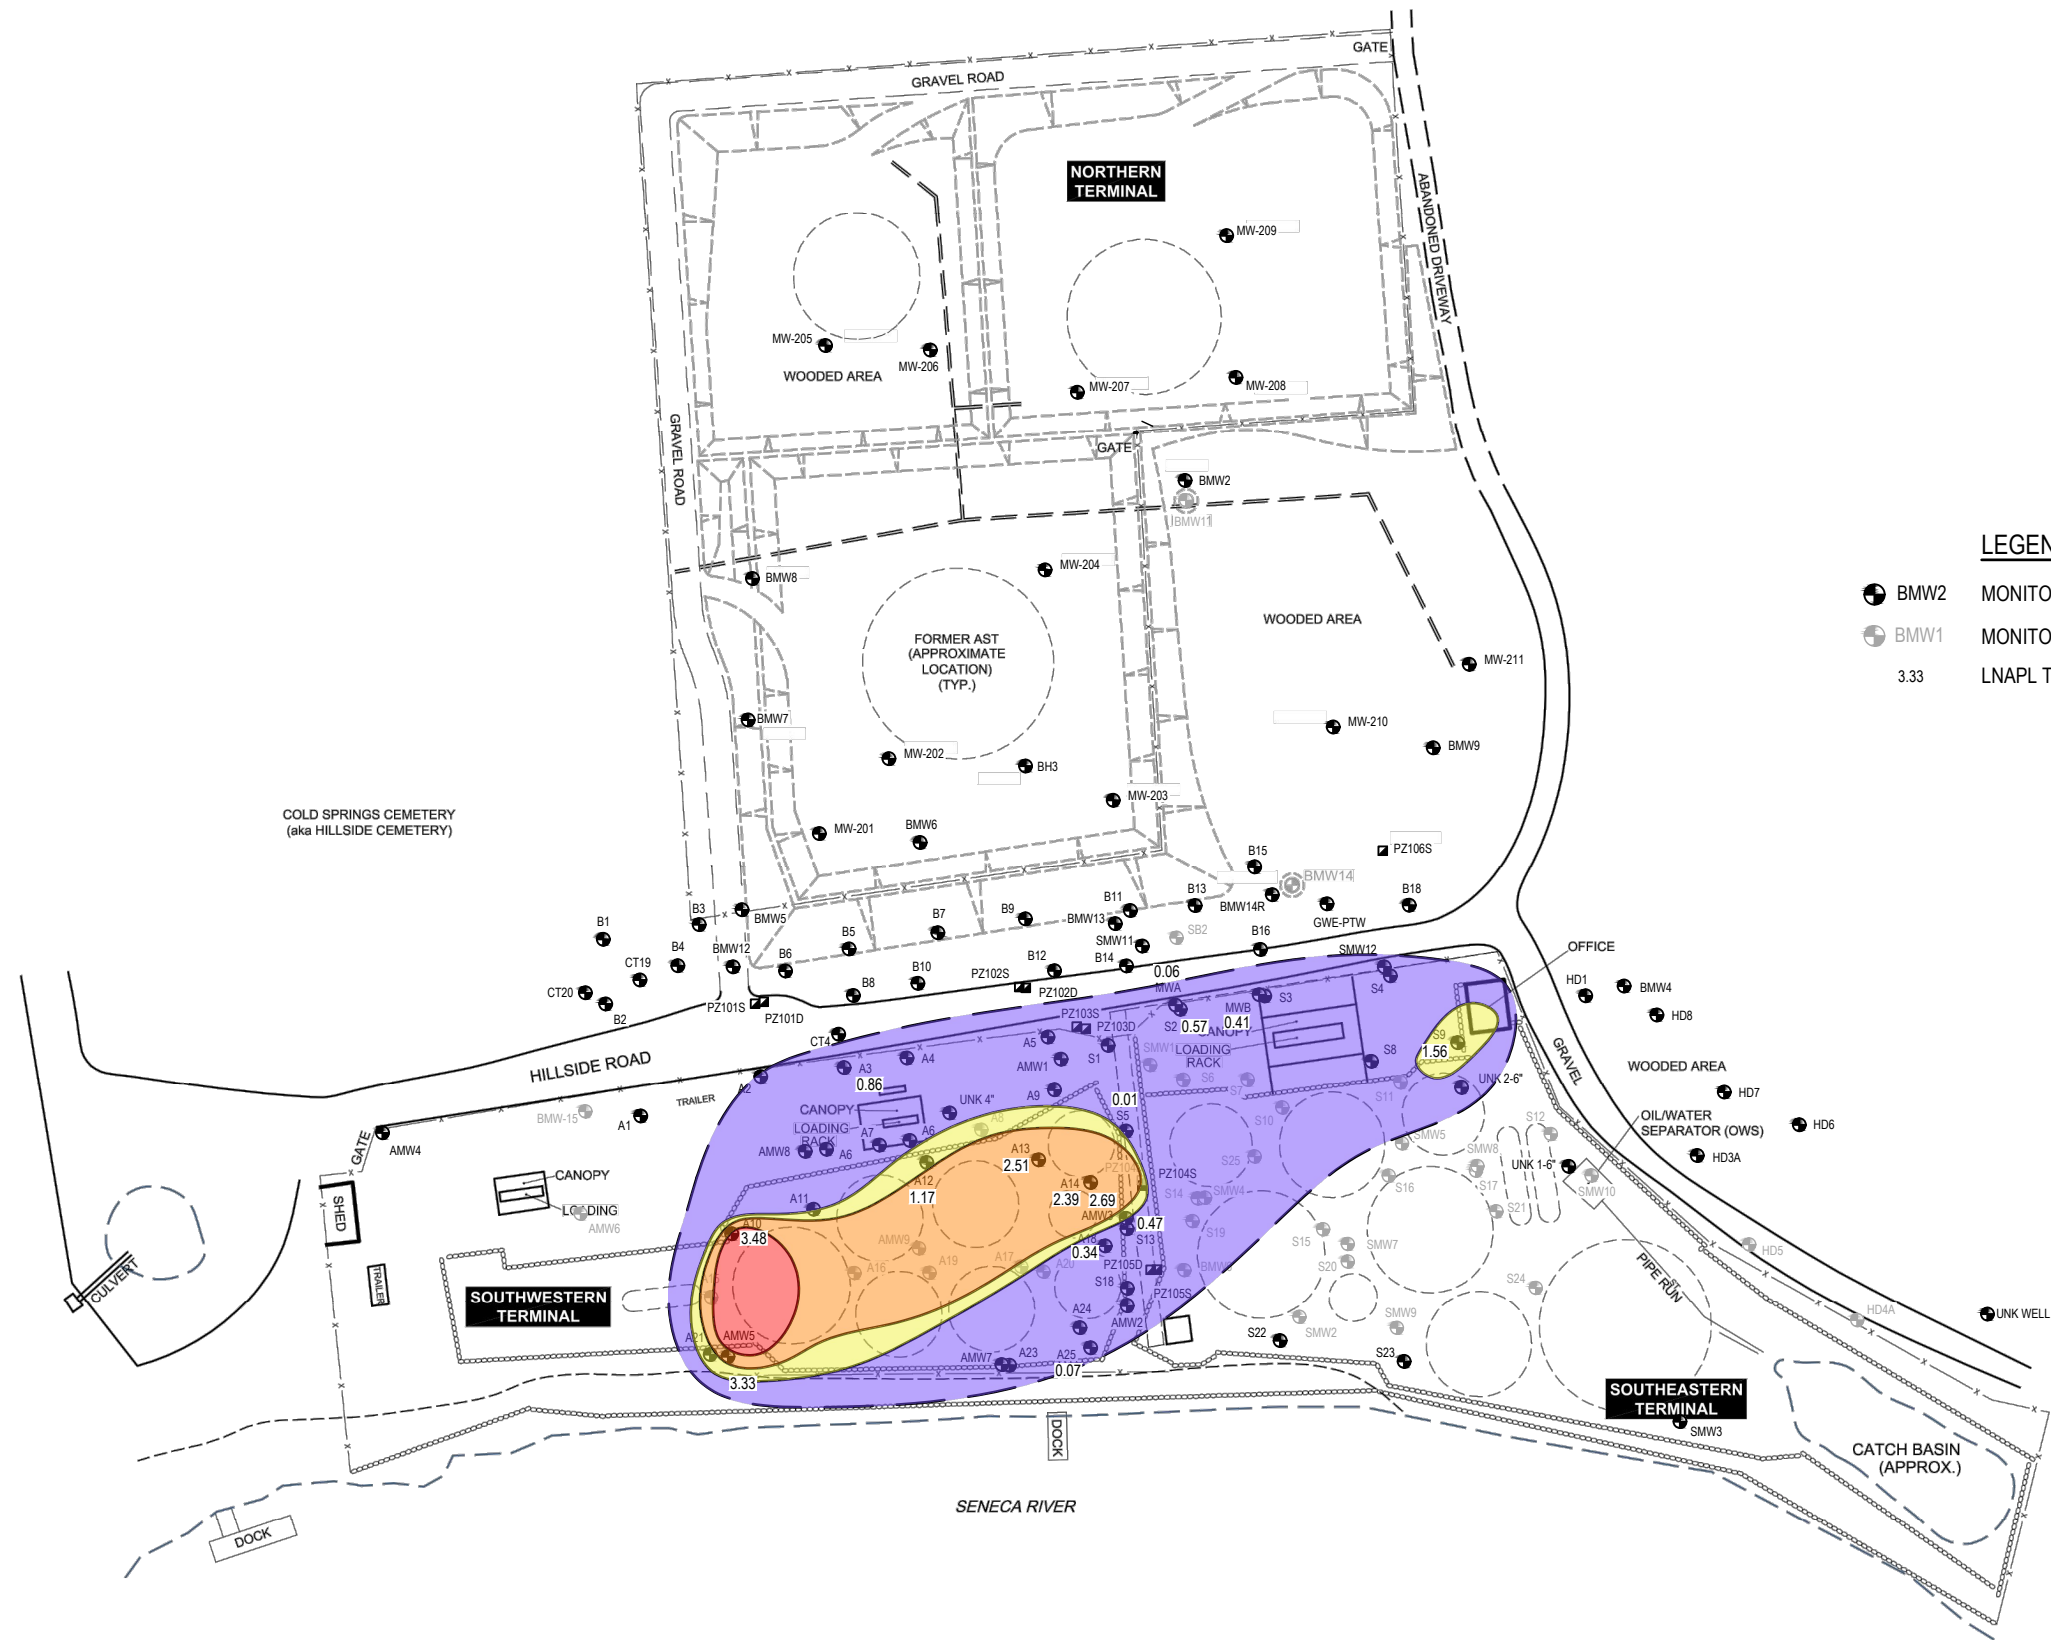
FIGURE 4

**SOUTHERN TERMINALS GROUP
COLD SPRINGS TERMINAL SITE
HILLSIDE ROAD, LYSANDER, NEW YORK
APPARENT LNAPL THICKNESS
JUNE 6-7, 2019**

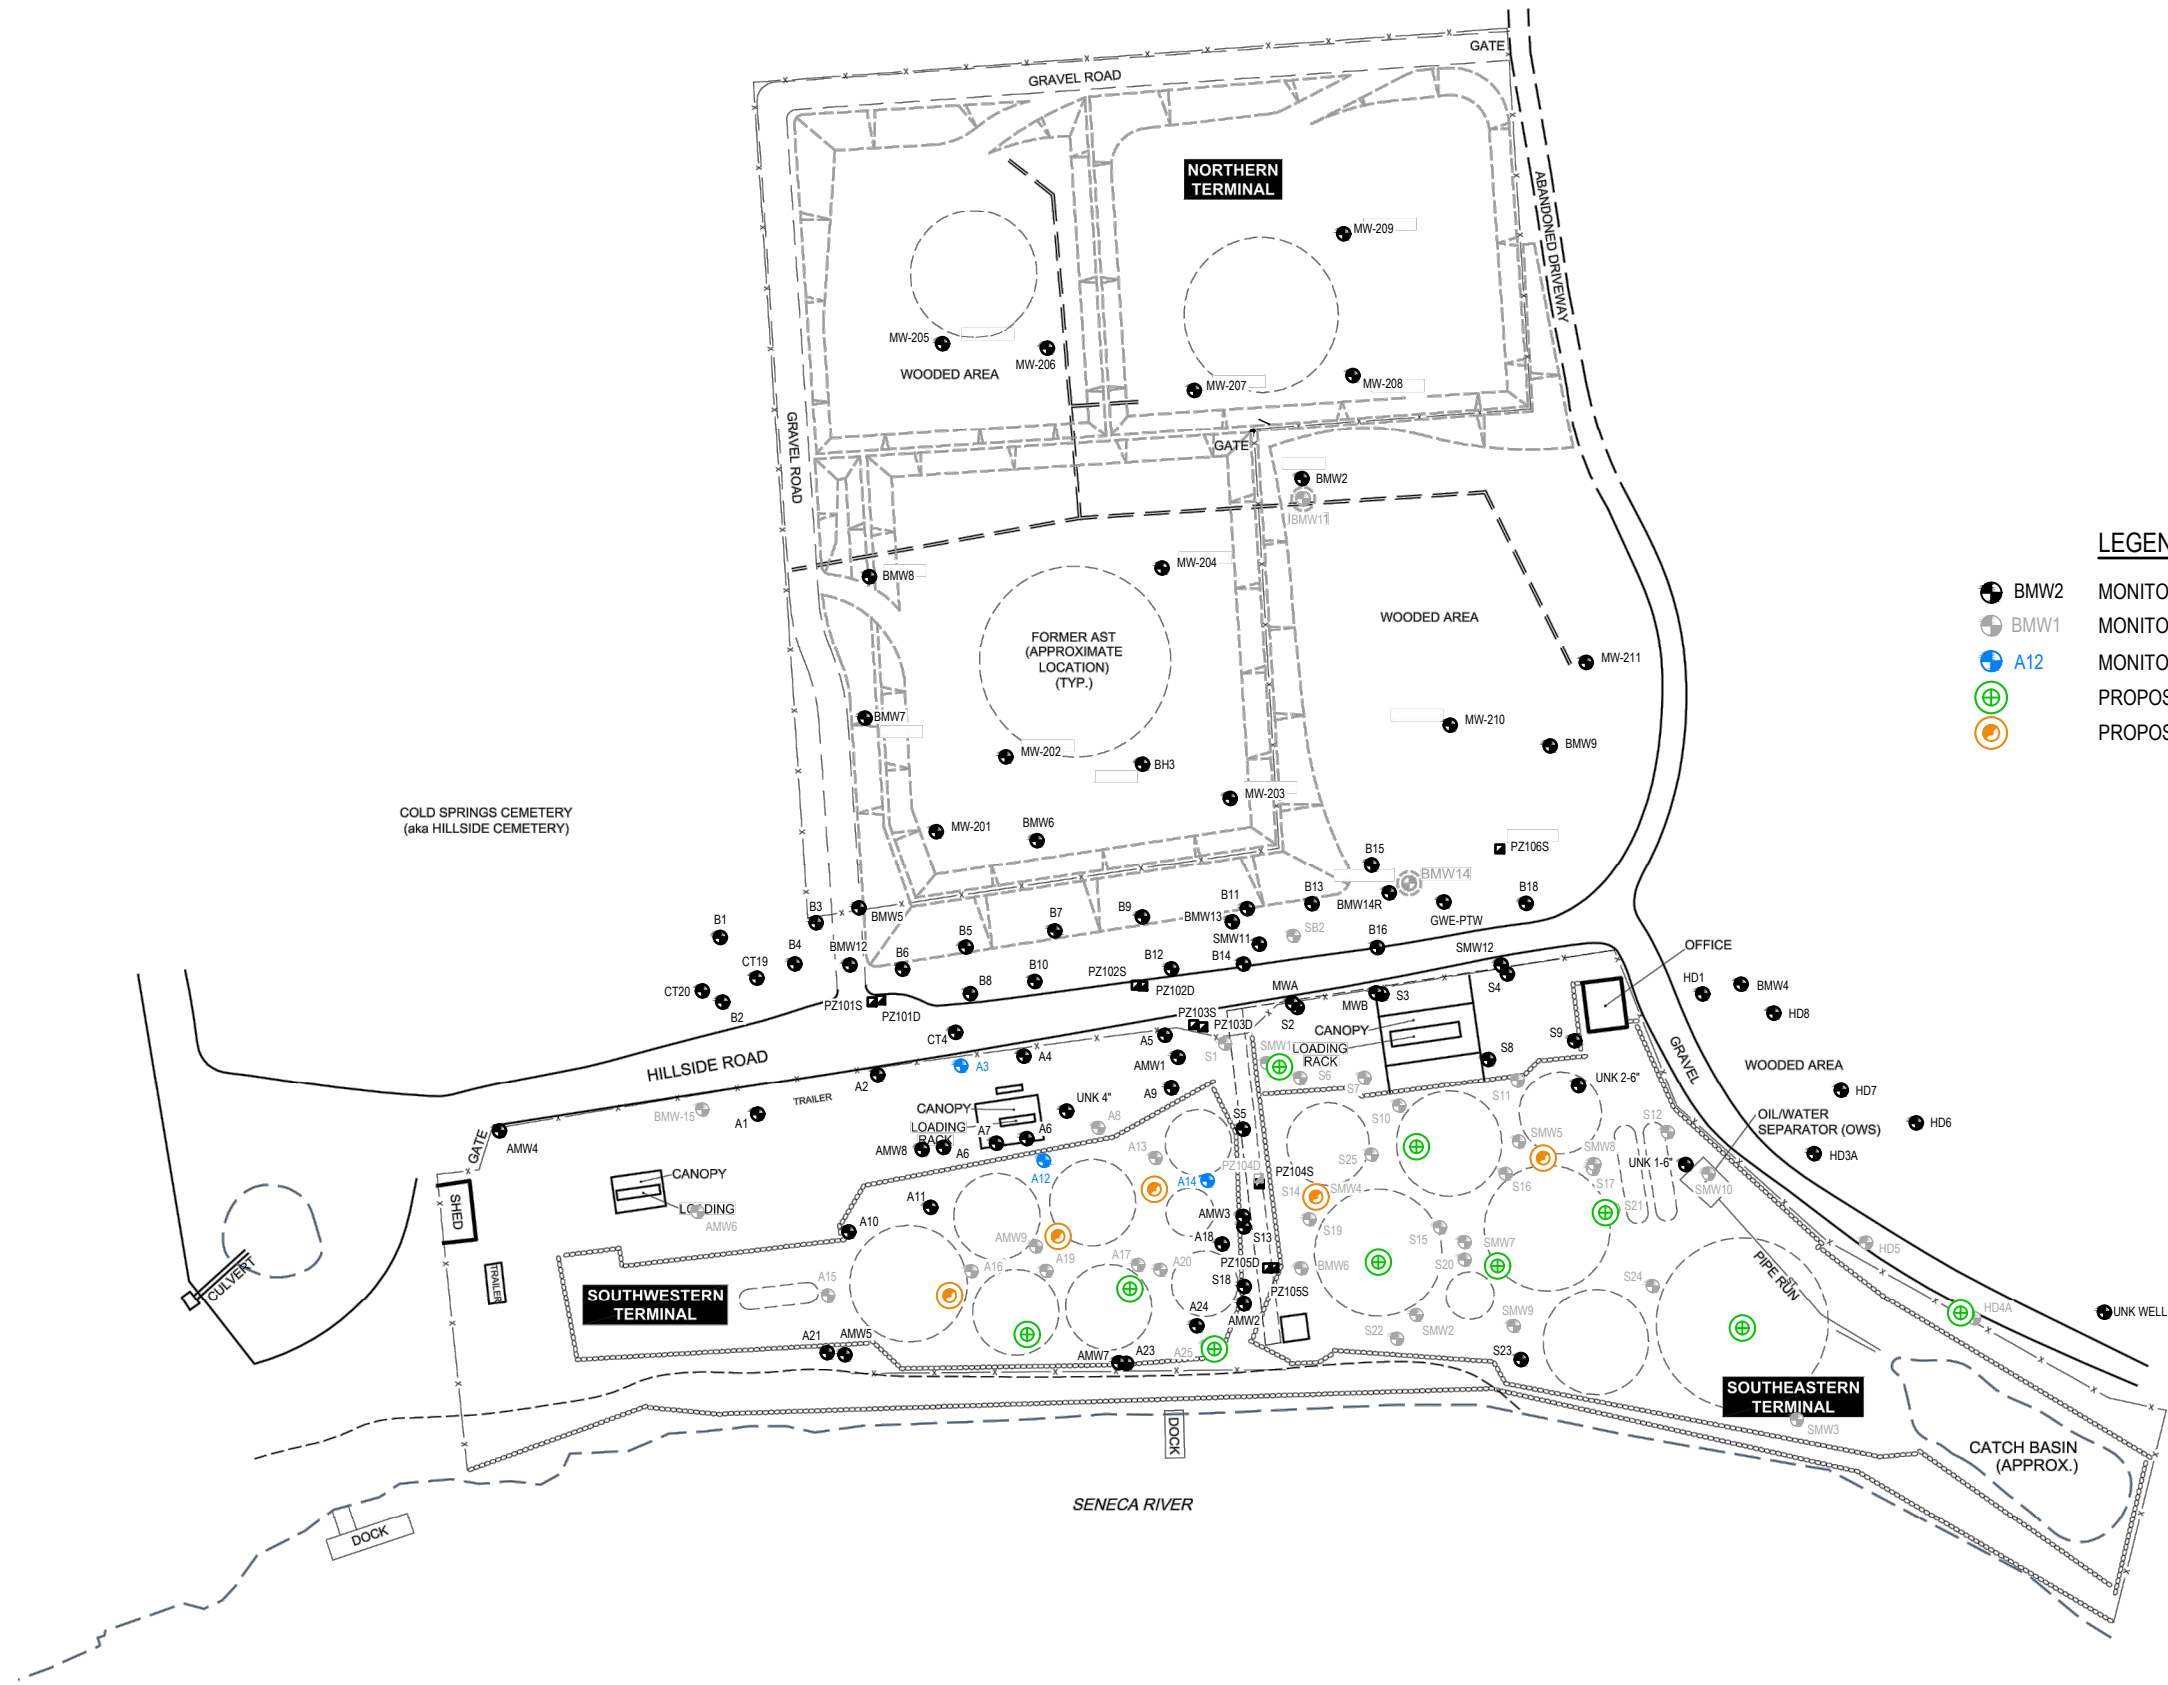
FIGURE 5

**SOUTHERN TERMINALS GROUP
COLD SPRINGS TERMINAL SITE
HILLSIDE ROAD, LYSANDER, NEW YORK
PROPOSED MONITORING WELL AND
RECOVERY WELL LOCATIONS**

Recovery wells will be constructed of a minimum of 6-inch schedule 80 PVC with 10 feet of 10-slot screen spanning the water table and LNAPL zone. Annular space will be backfilled with #00N sand to the top of the well screen, followed by a minimum of one foot of bentonite, and grouted to the surface. Each recovery well will be finished at the surface with a flush-mount well box or manhole, dependent on well size.

A summary of proposed monitoring and recovery wells to be installed is included as Figure 5. Recovery wells on the Southeastern Terminal are contingent on field observations and determinations; however, 2-inch PVC monitoring wells will be installed, at a minimum.
