BAUSCH & LOMB PROJECT SITE

WORK PLAN
SOIL INVESTIGATION AT THE SPEEDY'S CLEANERS SITE

**PHASE II
SITE CHARACTERIZATION REPORT**

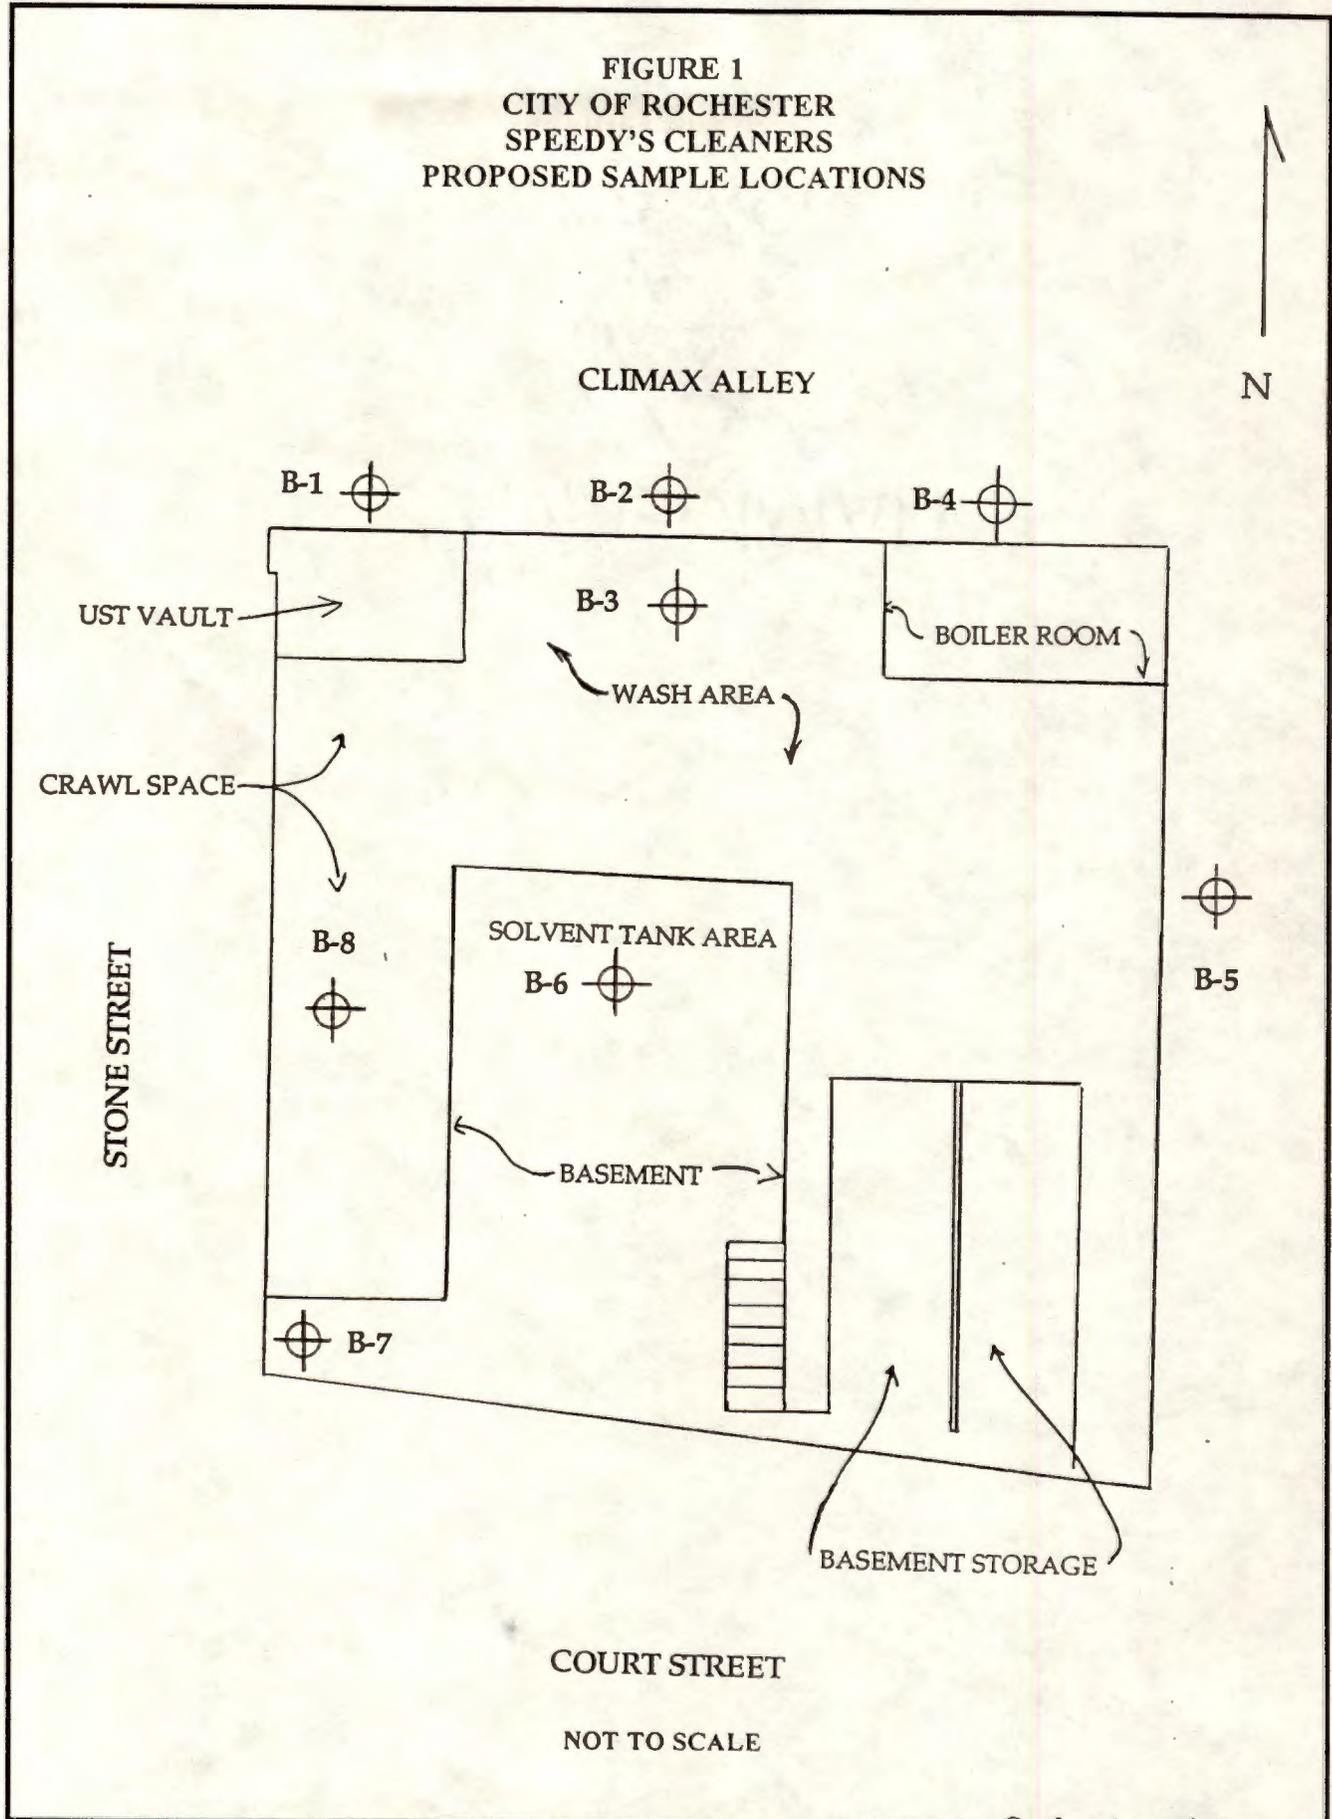
FIGURE 1
CITY OF ROCHESTER
SPEEDY'S CLEANERS
PROPOSED SAMPLE LOCATIONS

The proposed locations for sampling are present on Figure 1. A total of 8 boreholes will be advanced for sampling. Table 1 was developed to identify the proposed depths of each borehole. These depths were based on the proposed depth of excavation and the need to determine if the soils are a hazardous waste. Boreholes to be advanced within the Speedy's building and basement will require unconventional sampling techniques, because of restricted access and ceiling height. Boreholes located in the building may not achieve their planned depth because of the restrictions imposed by the building.

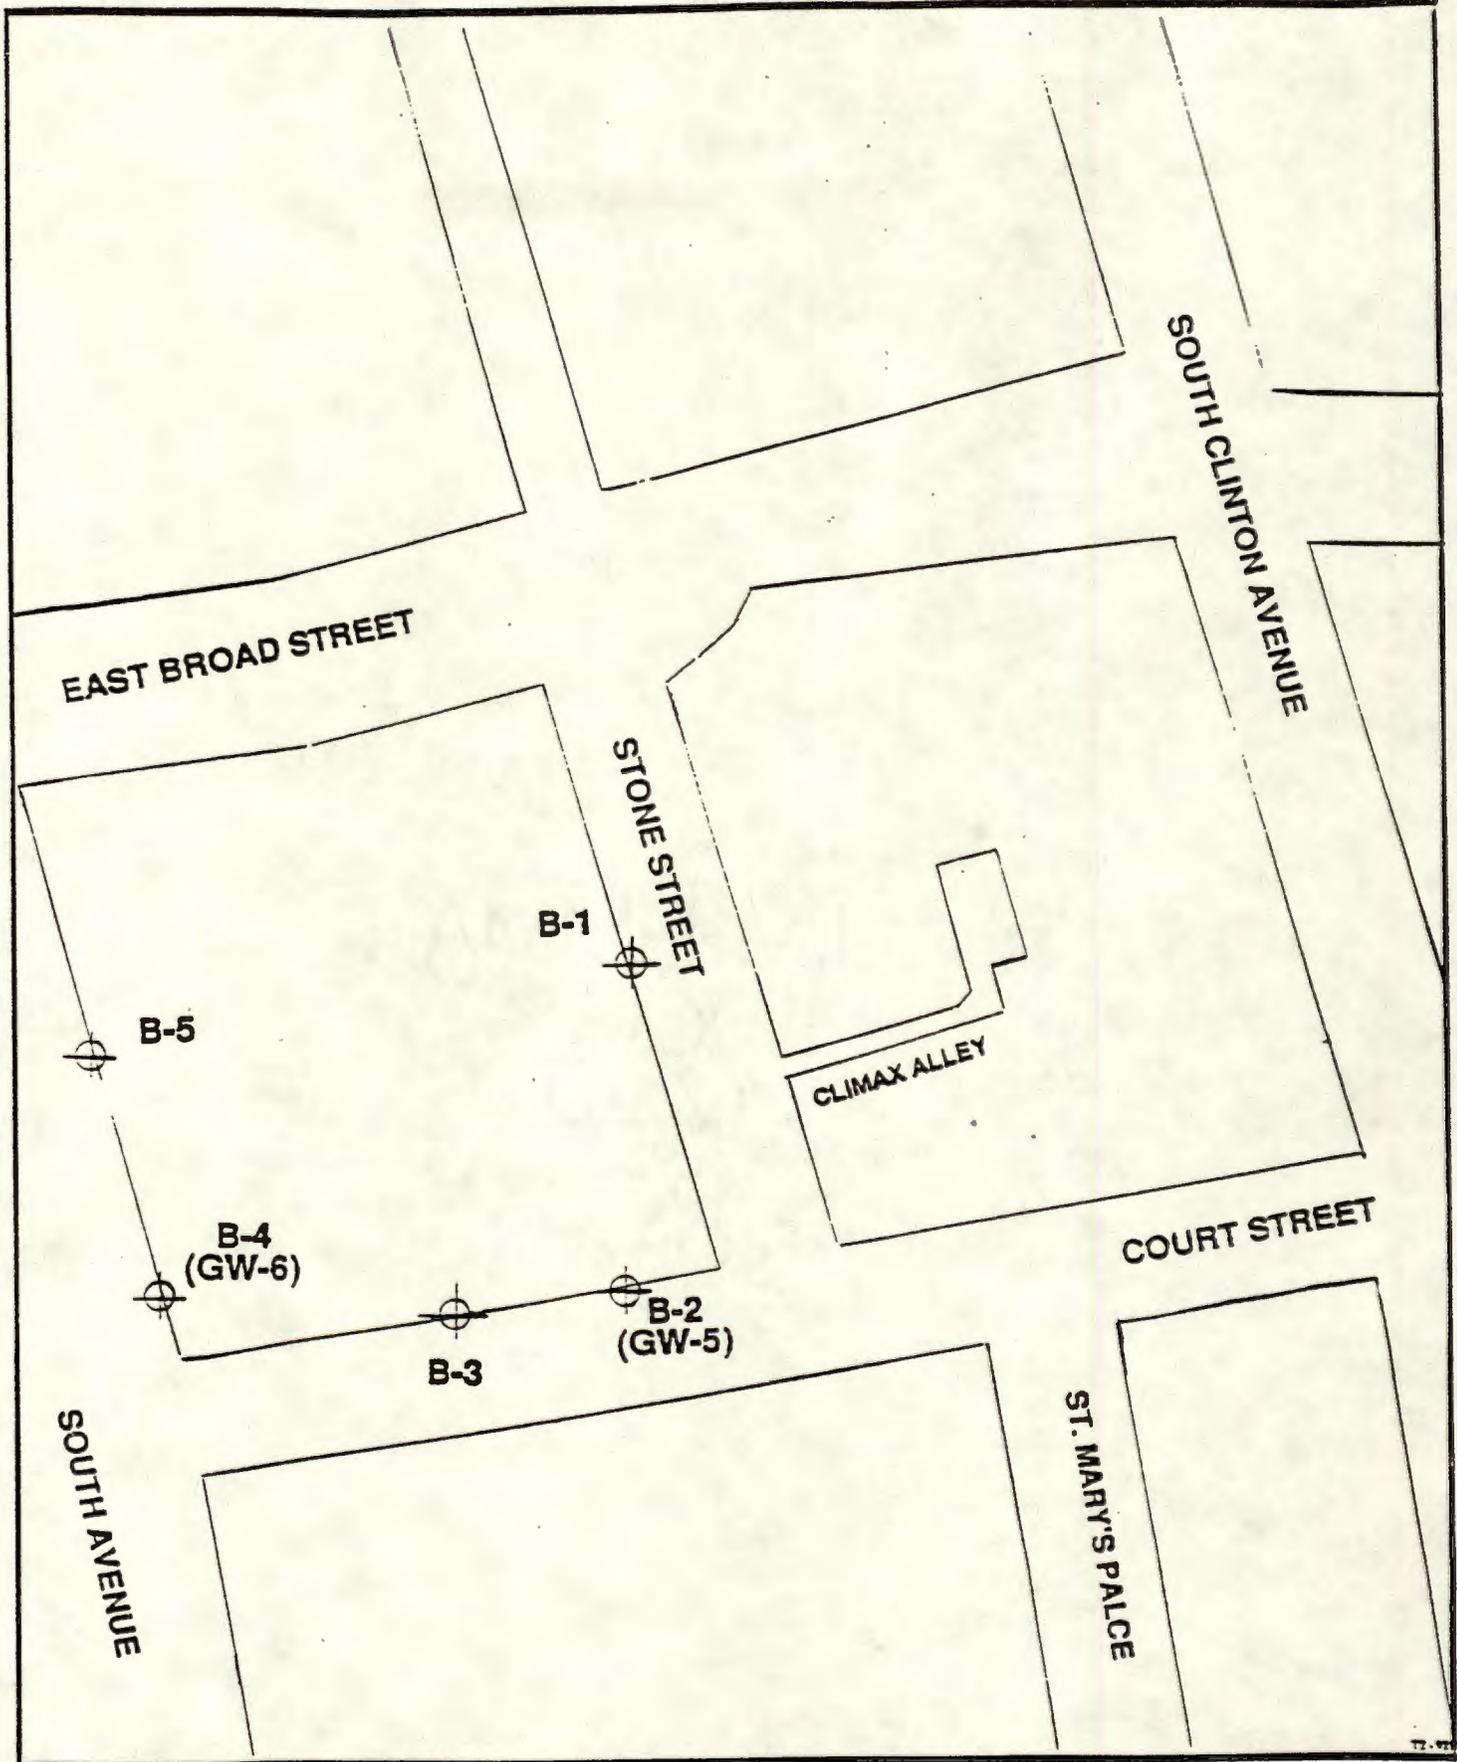
FIGURE 4
TEST BORING LOCATIONS

Test borings were drilled by advancing a 4 1/4 inch I.D. hollow-stem auger following the split spoon sample. Split spoon samples were taken continuously throughout the boring program. The Project Geologist visually identified the soil, collected samples, and then prepared boring logs describing the subsurface conditions encountered at each location. In addition, the headspace of each soil sample was monitored with a Hnu PID. No PID readings above background were noted, however, a slight odor was noted in samples at B-2 and B-4.

A petroleum odor was noted in soil samples at the 12-14 foot level at boring B-2. No staining or visible signs of petroleum were observed at this location.

Soil samples at boring B-4 revealed a wet black sandy material at the 13 -15 foot level. A slight petroleum odor was noted in this sample. Sample volumes recovered were not sufficient to send to the laboratory for analysis.

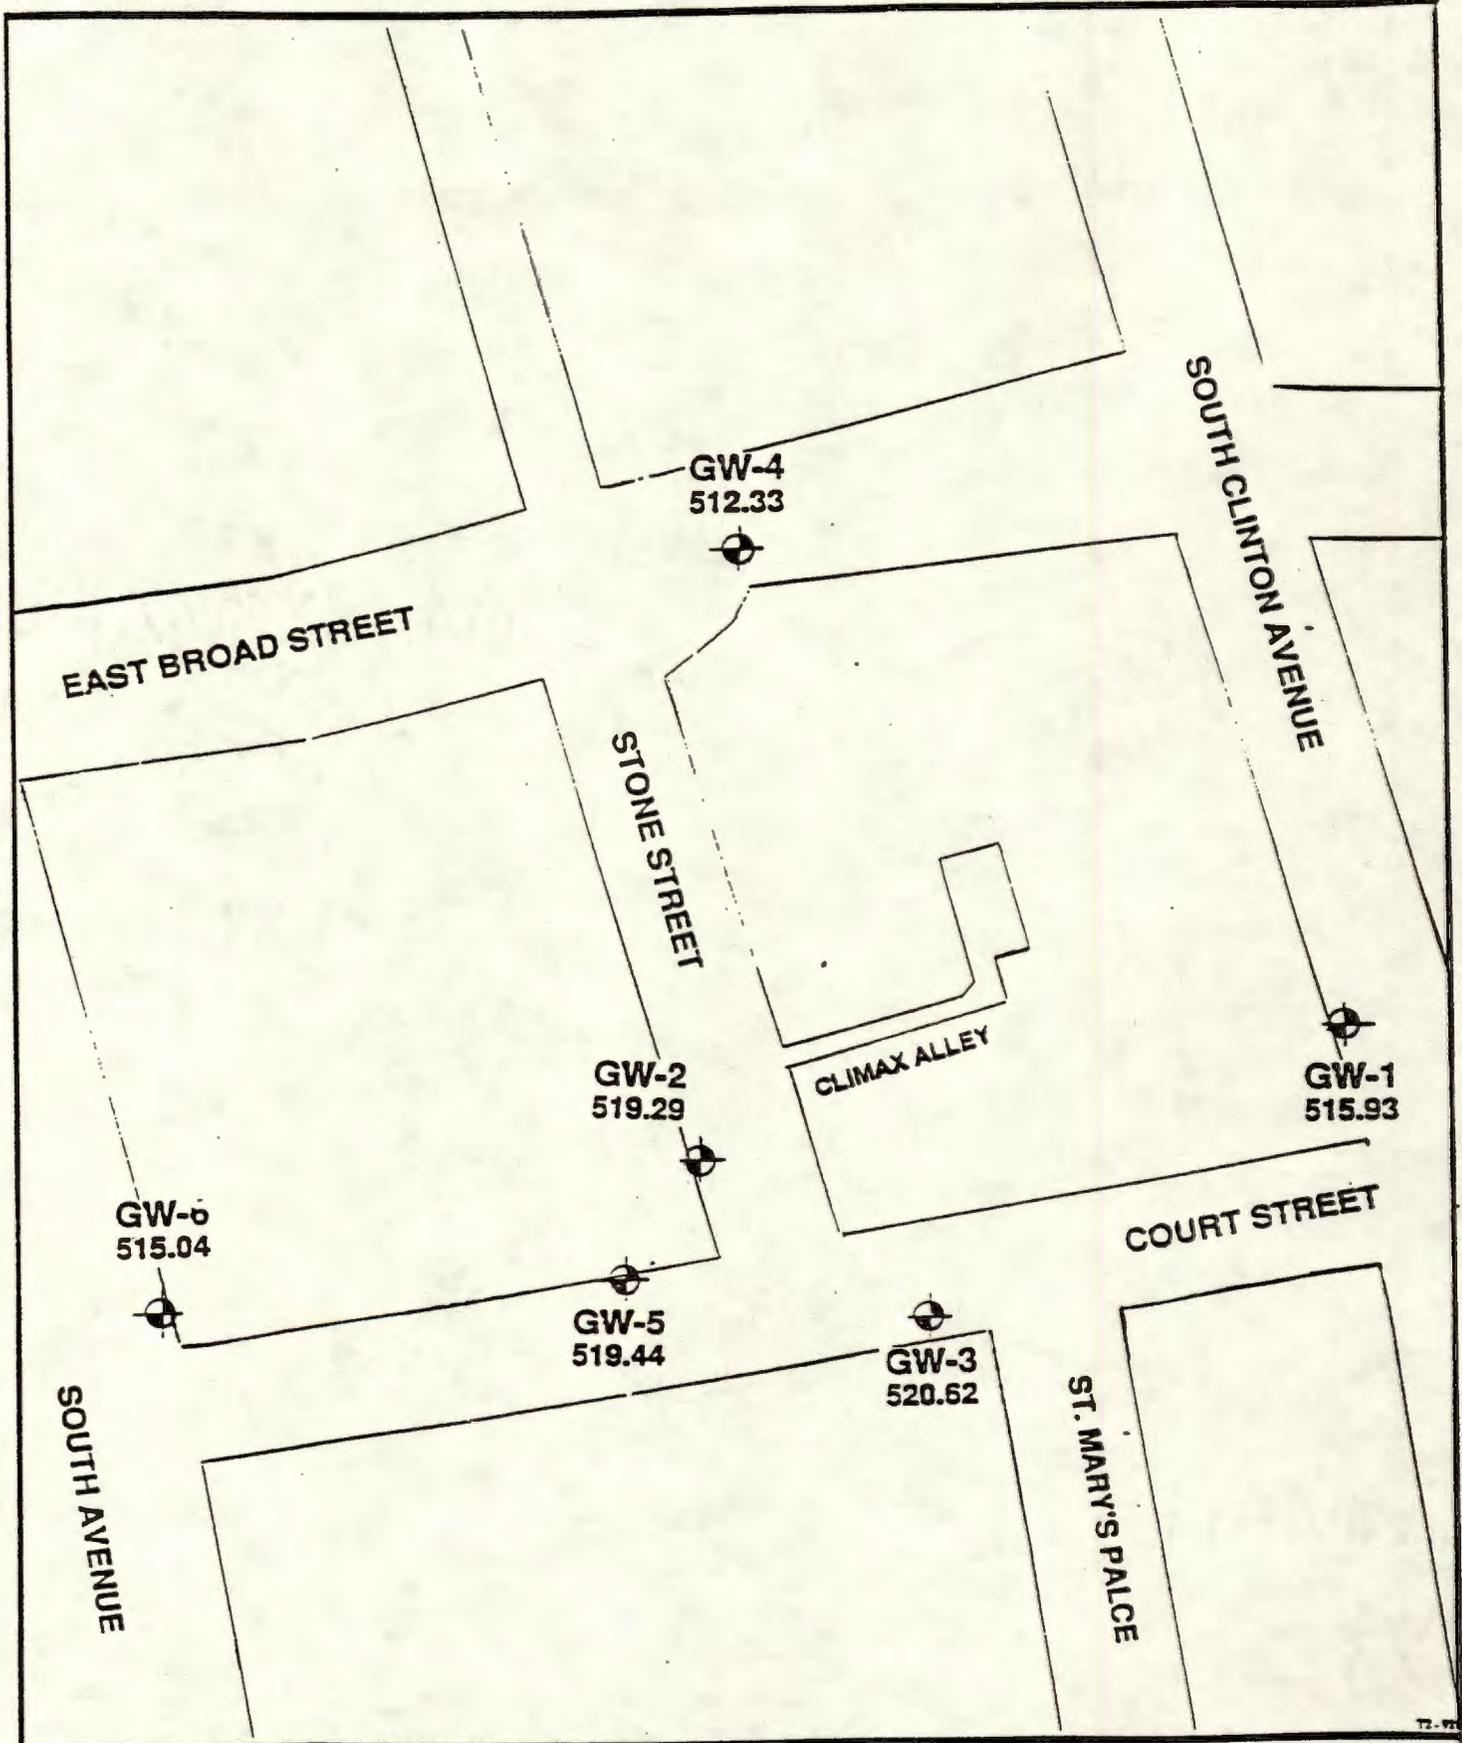
FIGURE 5
GROUNDWATER ELEVATION MAP

Horizontal groundwater flow at the time of water level measurement appeared to be to the north. As regional groundwater flow in this area is westerly toward the Genesee River, it can be logically assumed that local groundwater flow is being influenced by man-made conditions (i.e. basements, underground parking garages) in the immediate vicinity of the site.

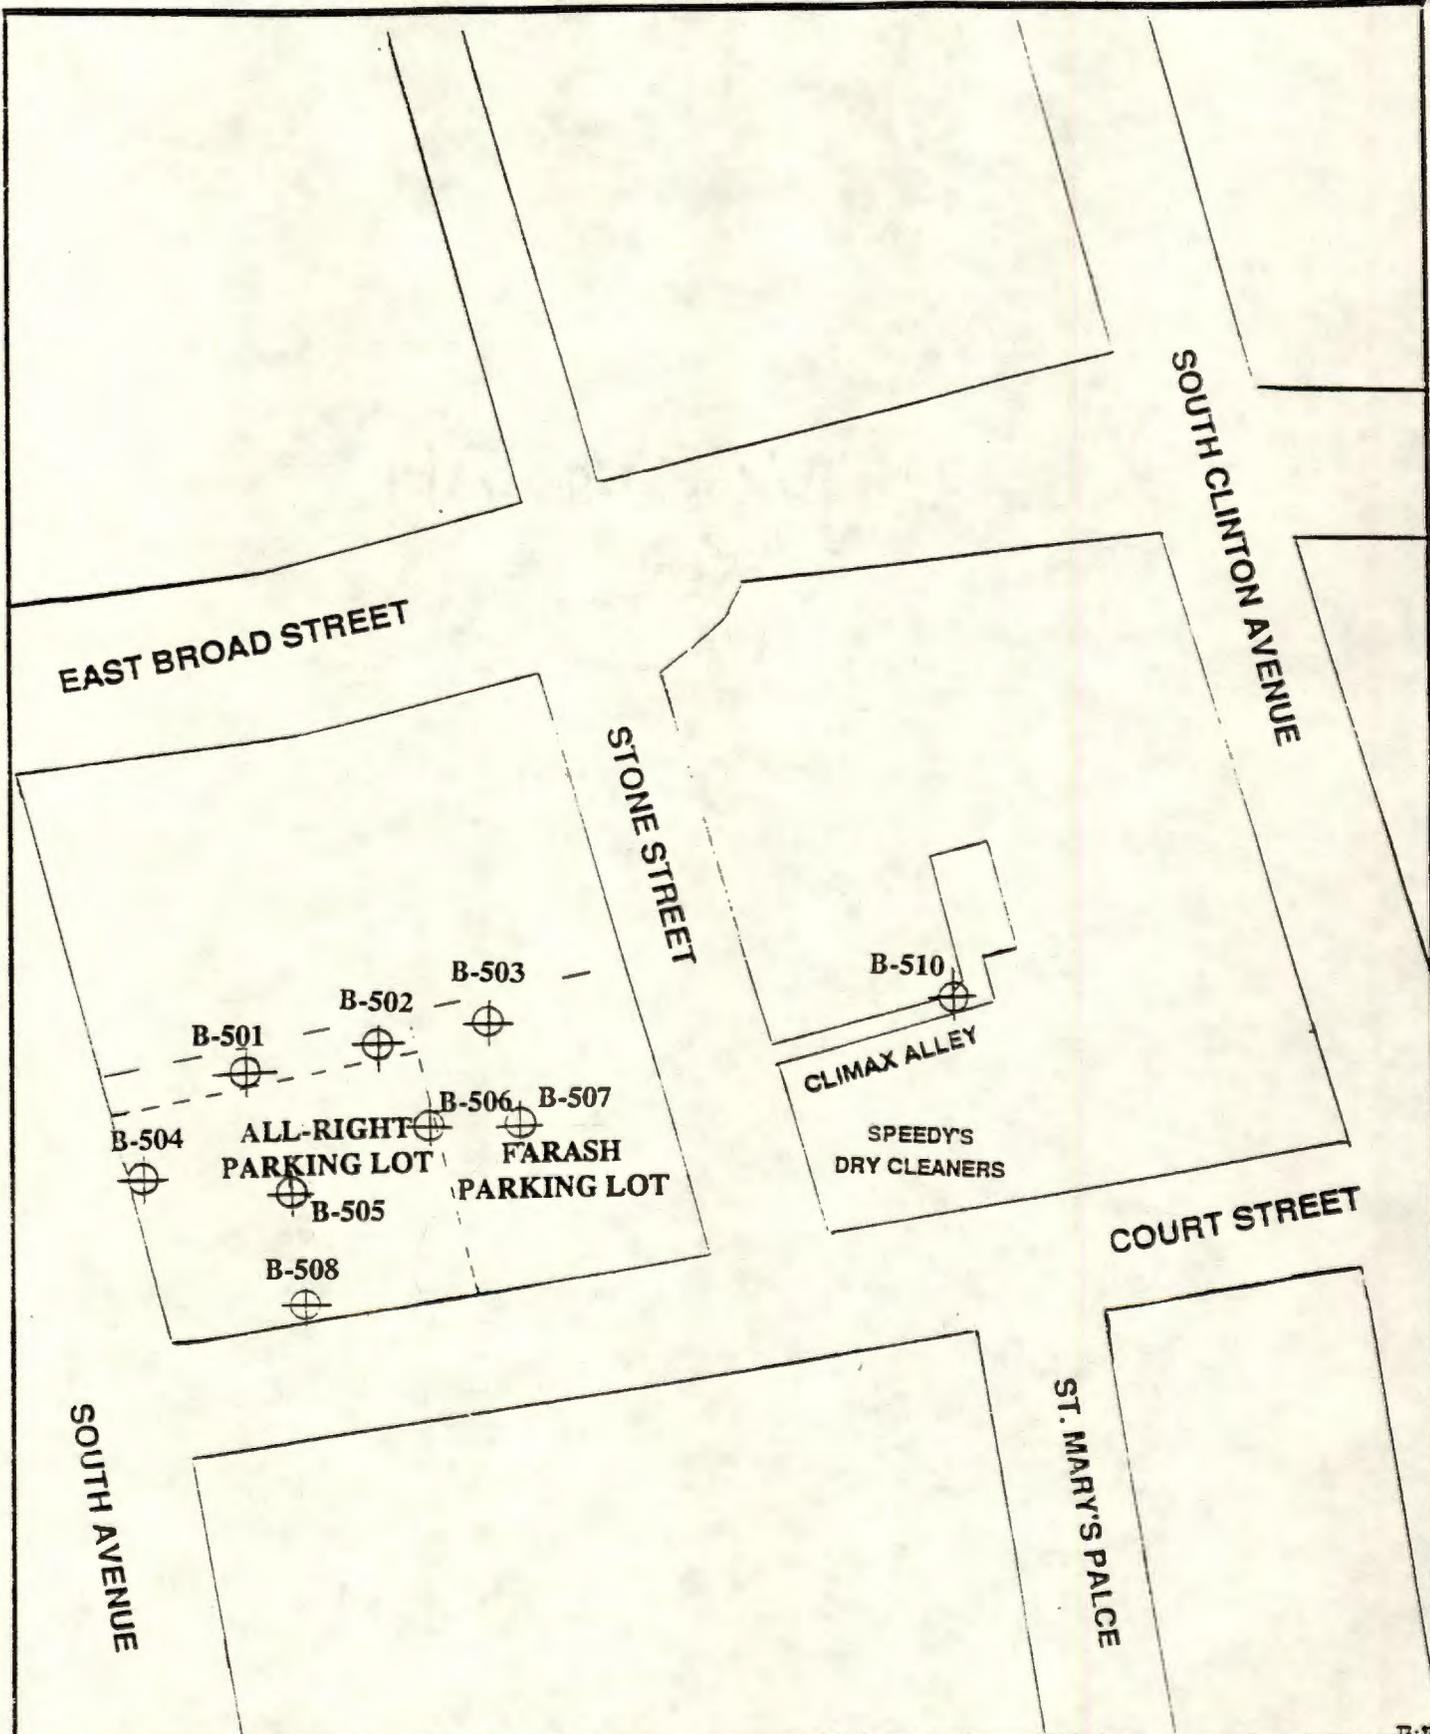
FIGURE 3

2. Soil borings performed for geotechnical purposes by Huntingdon-Empire were observed by a LaBella Associates geologist. The geologist was present to observe the soil borings, to monitor the head space of the soil samples collected using a HNu photoionization detector (PID), and to collect samples for laboratory analysis if deemed appropriate. Soil boring locations are identified on Figure 3.

Evidence of fill material (bricks, concrete, etc.) was encountered at most locations. Soils with a black stain and petroleum type odor were observed at 15.5 feet below grade at boring B-507 in the Farash lot. PID readings of 3 parts per million (ppm) were noted. A sample of the soil was collected and analyzed for volatile organic compounds (VOC's). Compounds identified in the sample are noted below:

TEST BORING LOCATIONS

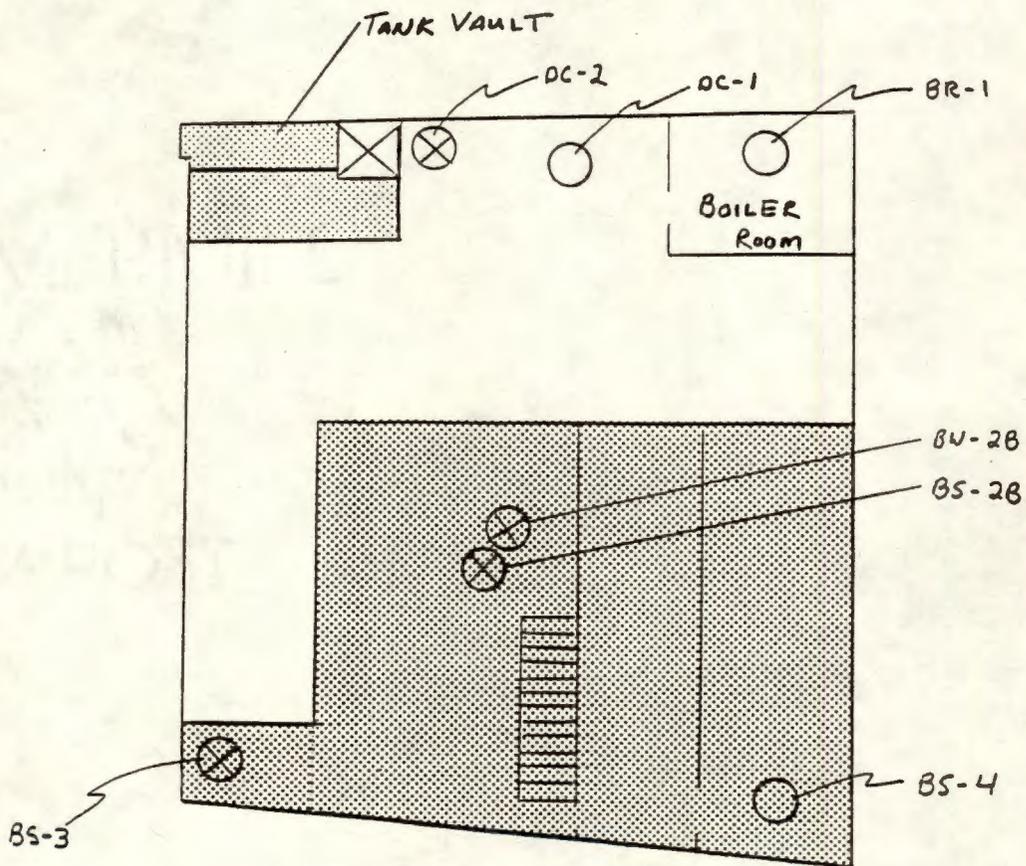
FIGURE 5

3. An additional boring was added to the Huntingdon-Empire drilling program in Climax Alley behind Speedy's and observed by a LaBella geologist.
4. Soil samples were collected from beneath the concrete floors inside the Speedy's building. Samples S-1 and S-2 were obtained from beneath the concrete slab on the main floor and sample BSMT-1 was obtained from beneath the floor in the basement. Sample BSMT-1 was analyzed for volatile organic compounds (VOC's) and total petroleum hydrocarbons (TPH). Sample locations are identified on a floor plan sketch of the Speedy's building included as Figure 4.

- GROUND LEVEL
- BASEMENT
- X HIGH CONCENTRATION RESULTS
- LOW CONCENTRATION RESULTS

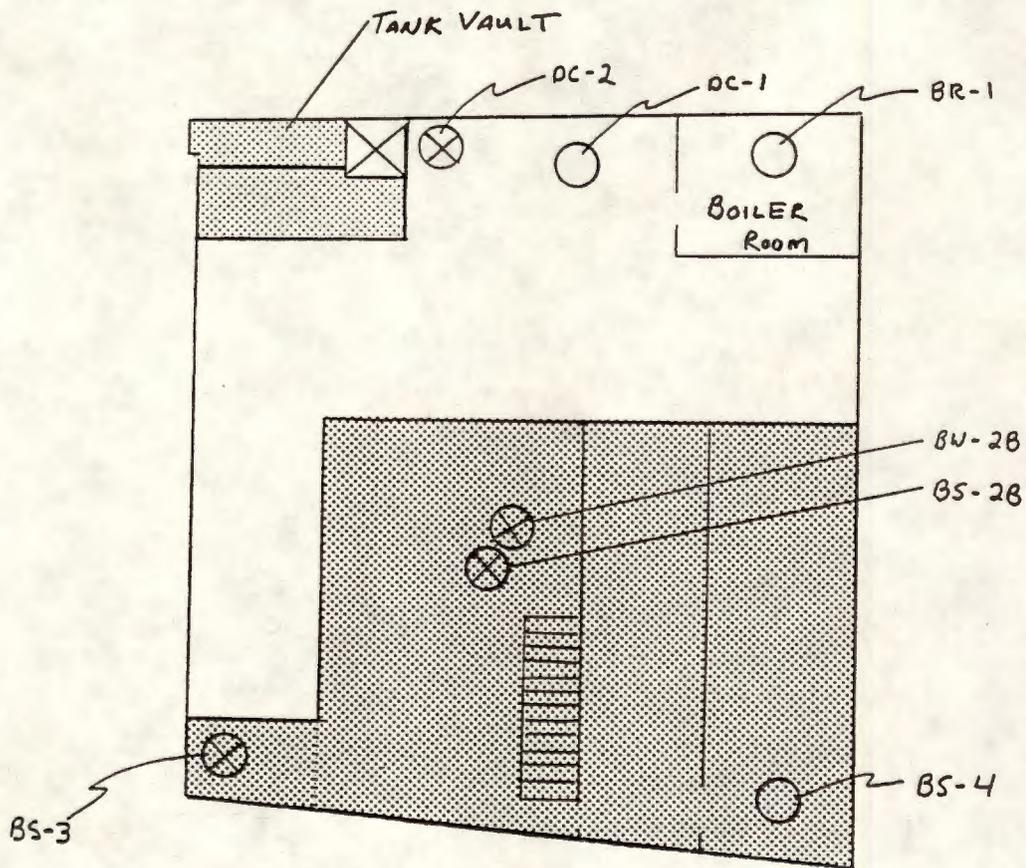
APPENDIX C
SAMPLE LOCATION MAP

6. Additional sampling of soils beneath the slab of the Speedy's building performed by Monroe Monitoring and Analysis (MMA) on behalf of Speedy's was observed by a LaBella Associates geologist. This sampling took place in August, 1993 after results of the initial sampling had been reviewed.

- GROUND LEVEL
- BASEMENT
- HIGH CONCENTRATION RESULTS
- LOW CONCENTRATION RESULTS
