Re: *General Cable Site*  
*- Rod Mill Parcel Closure Report*

**ROD MILL PARCEL**

**REMEDIAL ACTION  
CLOSURE REPORT**

**(Amendment to  
Environmental Remediation Closure Report  
April 26, 2001 )**

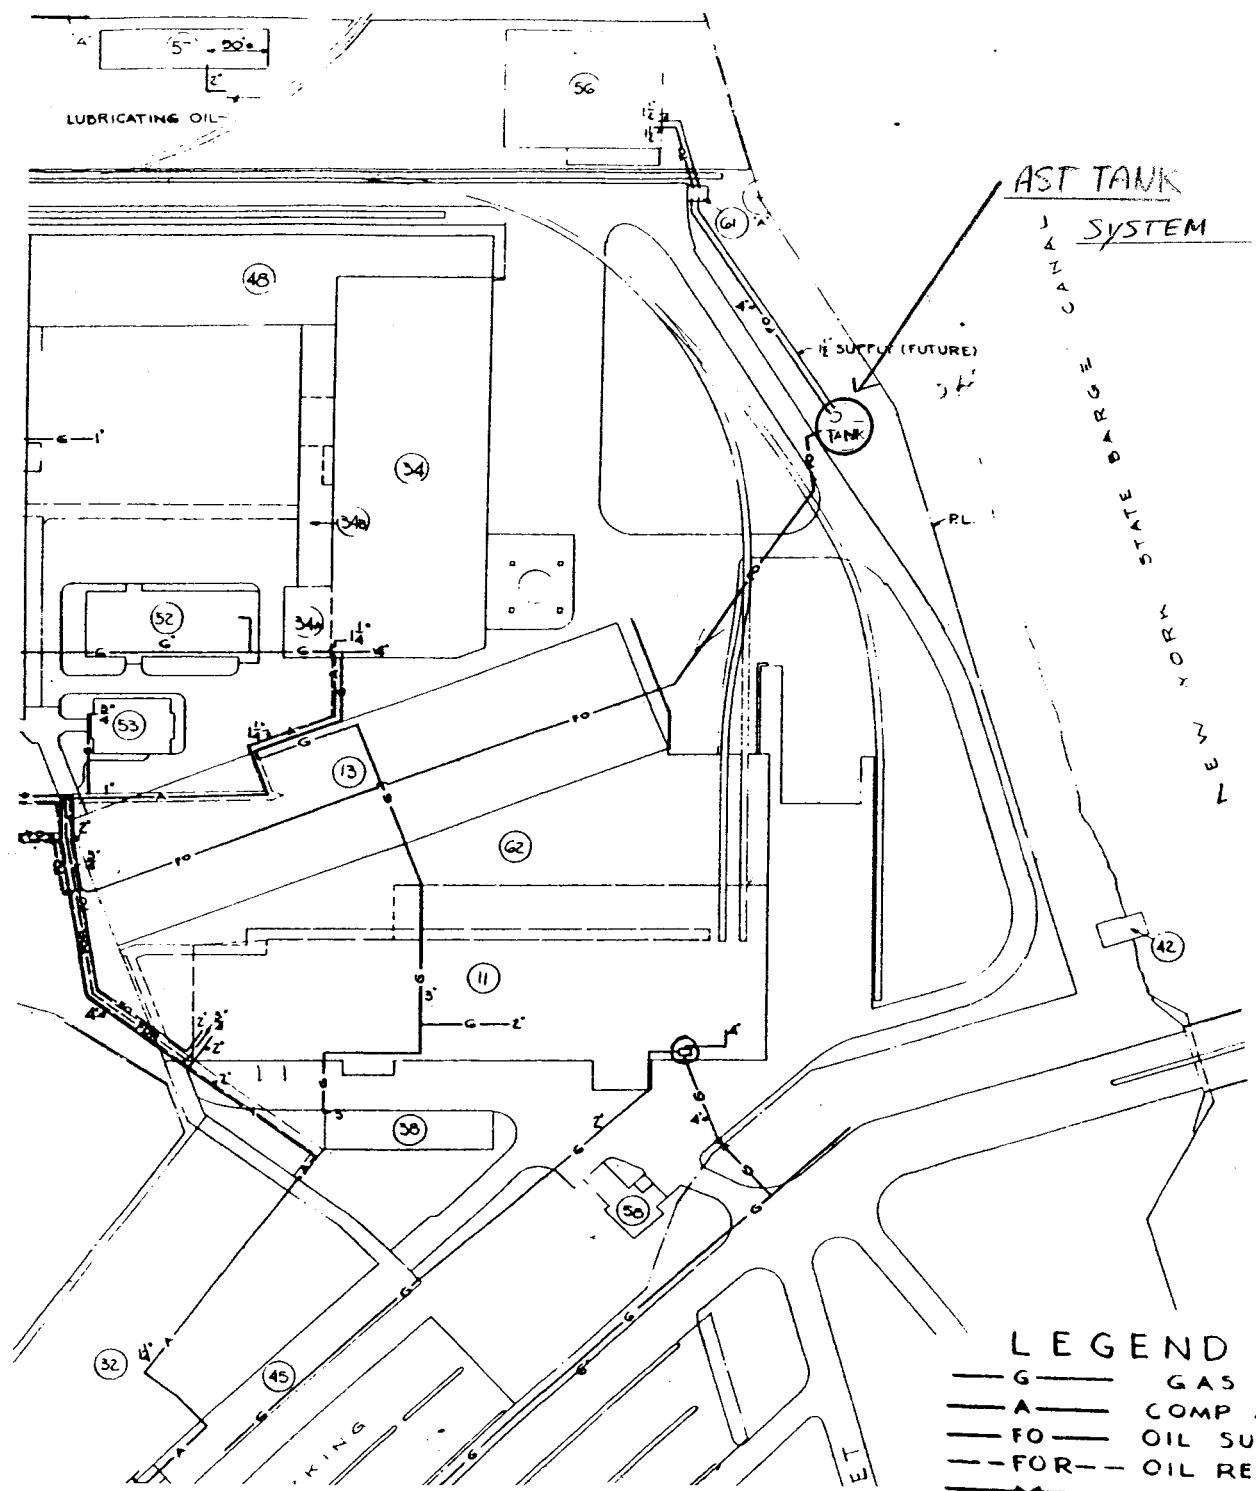
Figure 5

Review of a 1945 General Cable Corp., Utilities Survey, Gas, Comp Air & Oil, shows the tank with fuel oil supply lines (see Figure 5). The fuel oil lines shown on Figure-5 were uncovered during the remedial excavation. Petroleum contamination was discovered at a union in the fuel-oil piping that went in the north direction toward the former boiler plant. The fuel oil pipe was a 4-inch diameter, steel pipe and was buried 3-feet below grade surface. This pipe originated inside the tank's concrete foundation wall, went through the wall and proceeded northward to the boiler plant.

Two other fuel oil pipes were uncovered during the excavation. These pipes include a 4-inch and 1.5-inch steel pipes that were buried within a single clay-tile pipe. These pipes were noted to go from the tank outward in an eastward direction as shown on Figure-5.

Above ground Tank System Plan  
(Copied from 1945 General Cable Corp. Utility Survey)

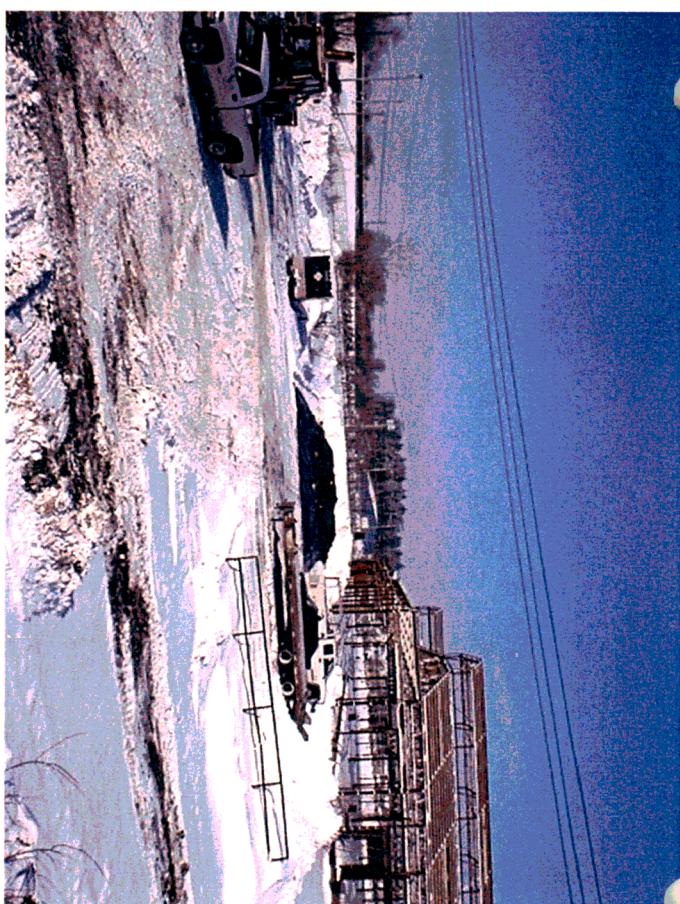
24

- 24.) Looking northeast at FOL and oil stained soils.
- 25.) Looking northwest at excavation.
- 26.) Looking east at FOL and stained soil on excavation walls and on surface of groundwater.

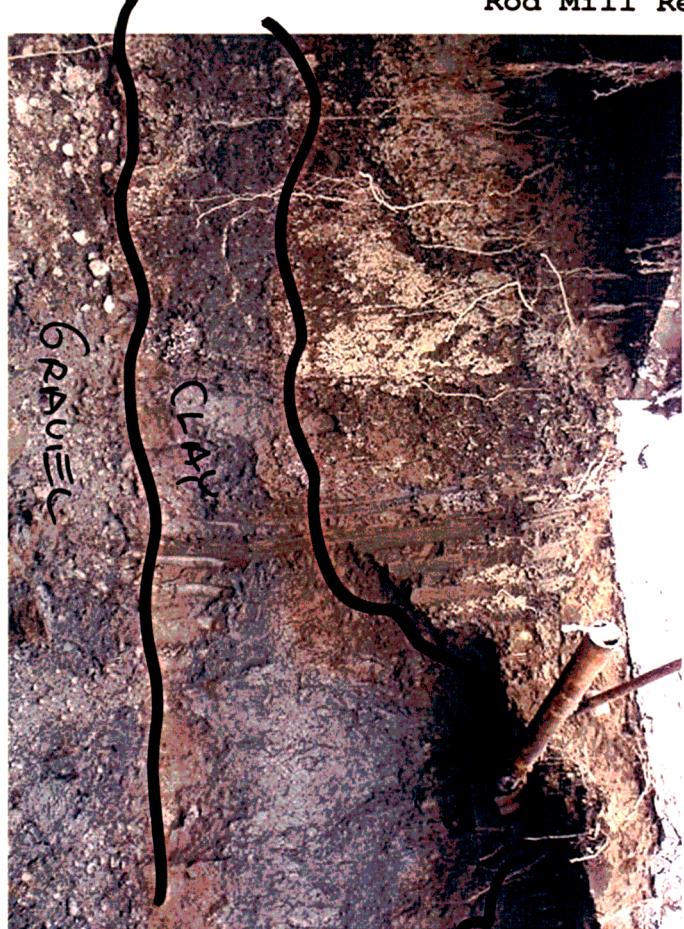
43

- 40.) Looking northeast at oil impacted soil on sidewall of excavation, note pattern of impact originating from FOL.
- 41.) Oil being soaked up and pumped from excavation.
- 42.) Oil being soaked up and pumped from excavation.
- 43.) Looking northeast at oil impacted soil on sidewall of excavation, note pattern of impact originating from FOL.
- 44.) Oil being soaked up and pumped from excavation.
- 45.) Looking north at FOL, note oil stained soils.
- 46.) Looking north at FOL, note oil-stain on pipe.
- 47.) Looking north at oil stained soils.
- 48.) Looking north on to north side of excavation wall.
