**VOLUNTARY CLEANUP AGREEMENT
CLOSURE REPORT**

**ROD MILL PARCEL
OLD GENERAL CABLE SITE
ROME, NEW YORK**

**VCA INDEX NO. D6-0001-97-07
NYSDEC SPILL NOS. 02-12777 & 02-12778**

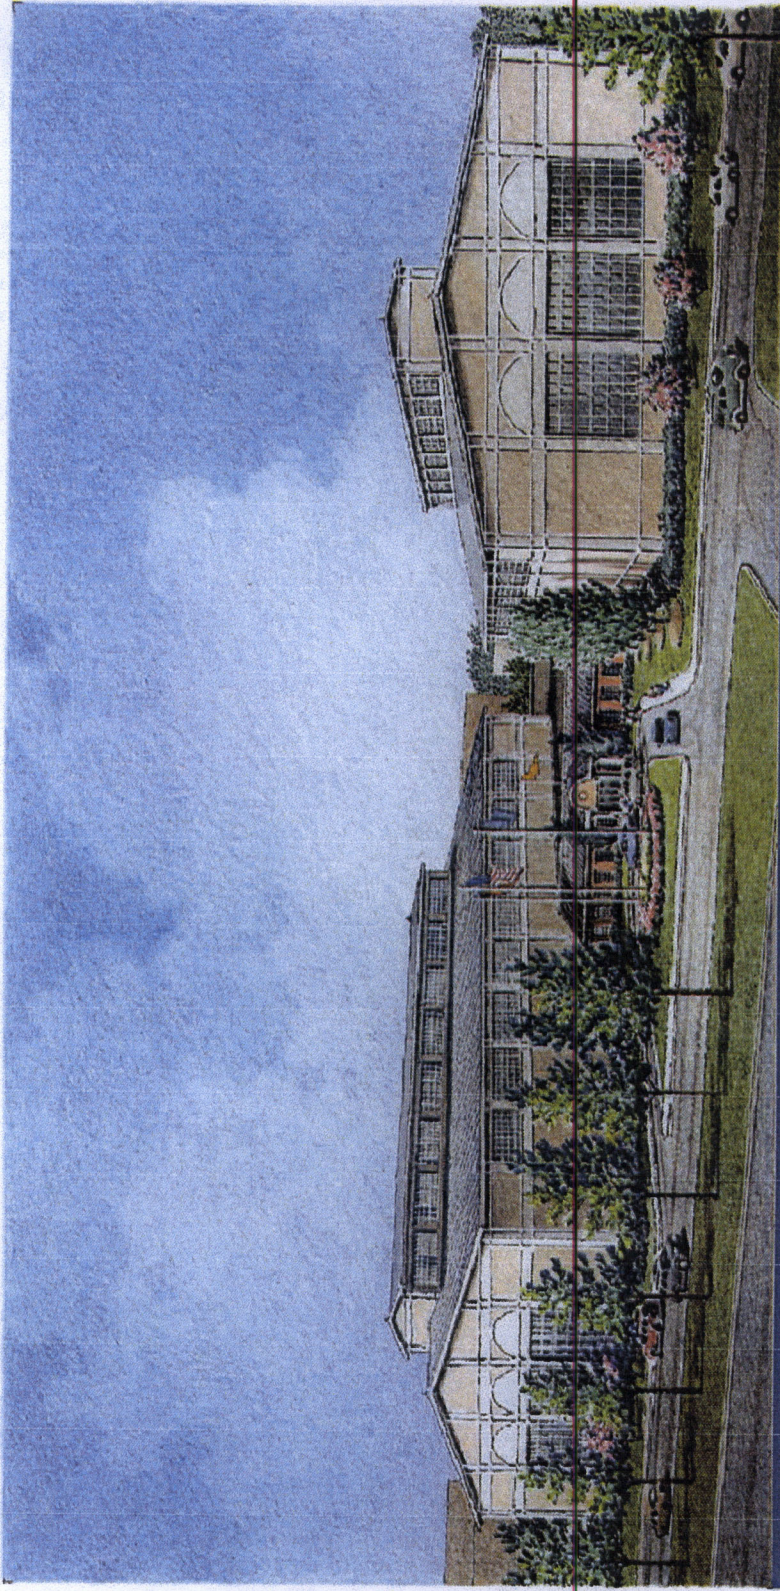
Artist's Concept of Indoor Facilities (View from Dominick Street)

BUILDING COMPONENTS
 Ice Rink (Future 2nd Sheet Possible)
 2 Indoor Soccer Fields
 Amenities & support incl. rest rooms, lockers, storage, ticketing, offices, concession, mechanical & maintenance
 Possible additional spaces: Health & Fitness Center, Basketball/Volleyball Gymnasium, Aerobics Training, Batting cages, Bullpens, Game room, Additional meeting room(s) (2 levels possible)
