FINAL ENGINEERING REPORT

FORMER “SAKMANN RESTAURANT CORP.” PROPERTY

**LOCATED AT U.S. ROUTE 9W
TOWN OF HIGHLANDS
ORANGE COUNTY, NEW YORK**

**NYSDEC Voluntary Cleanup Site Number: V-00083-3
(Index Number: W3-0962-03-07)**

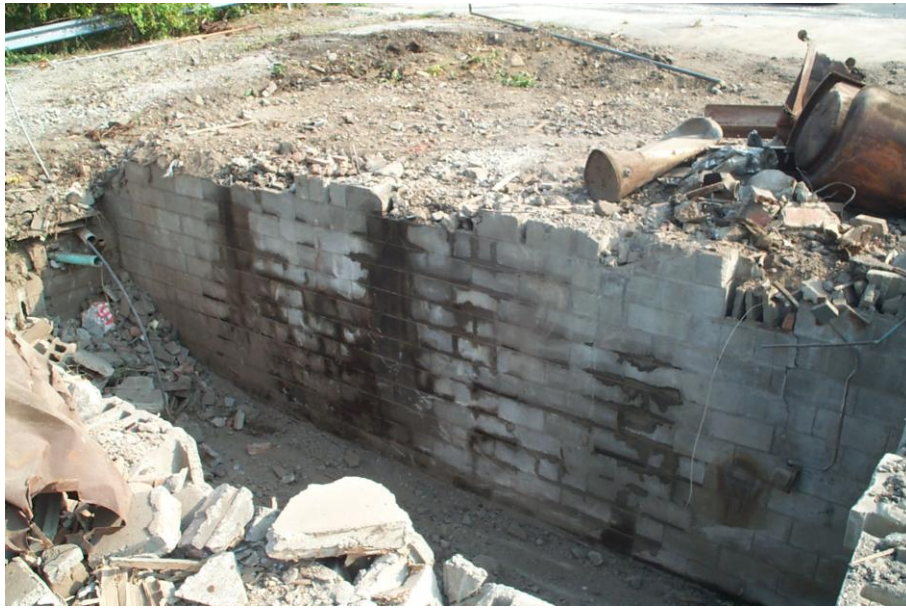
- 1. Former garage basement wall, exposed following building demolition (seen from northwestern corner, looking southeast)**

Above-grade portions of the Garage were demolished on September 13, 2005. The concrete slab (covering contaminated soil) in the former repair bays, and the concrete-block basement wall, were removed on September 14, 2005. All aerial portions of the building, and demolished foundation components, were placed in refuse containers, which were subsequently hauled from the Site for proper off-site disposal. Portions of the concrete basement walls and footings were left in place, except for any foundation components that were stained, which were stockpiled along with contaminated soil (see Section 2.4.4, below), pending off-site disposal.

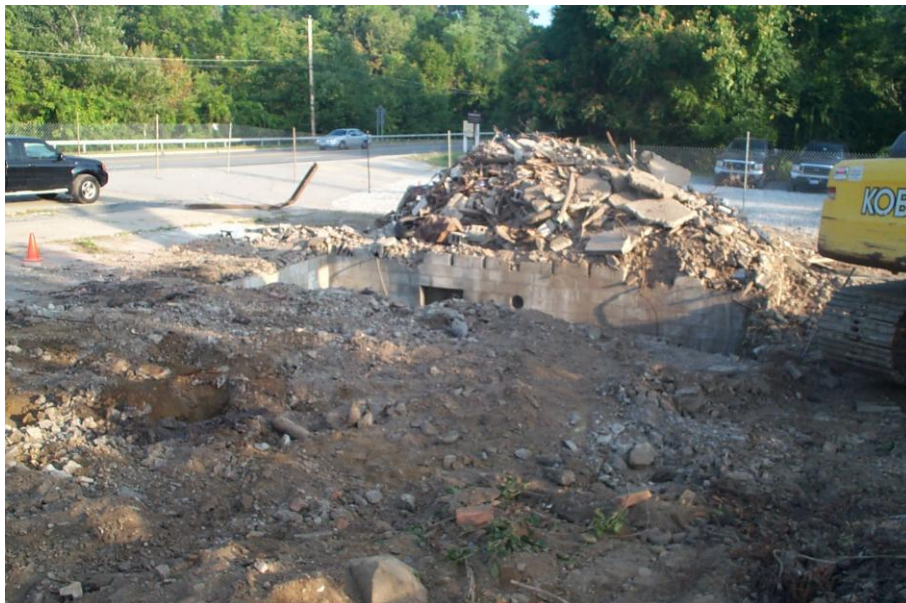
- 2. Area of PCE-contaminated soil at southern end of former garage (area of repair bays), exposed following building demolition (seen from southeastern corner, looking northwest)**

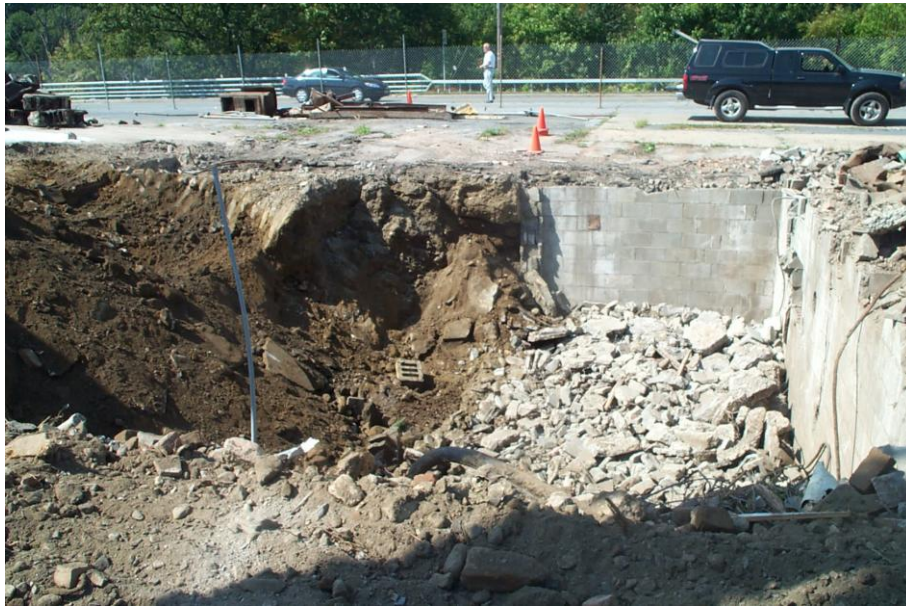
3. Excavation of PCE-contaminated soil at former repair bays (looking west)

Soil beneath the former repair bay building slab were excavated on September 14, 2007. Sandy fill exhibiting evidence of petroleum contamination (staining, mild odors, and PID readings below 20 ppm) was encountered in the vicinity of the closed northern floor drain, the area previously identified as the source of subsurface discharges of petroleum and chlorinated solvents. Overtly contaminated soils were limited to an approximately 4' by 4' by 3' deep area. No field evidence of contamination was observed at the location of the closed southern floor drain. Both drains appeared to have discharged directly to the subsurface. Based on existing data, an area measuring approximately 8' by 25' by 8' deep was excavated in order to remove all potentially contaminated soils (including concrete blocks from the base of the southern basement wall).

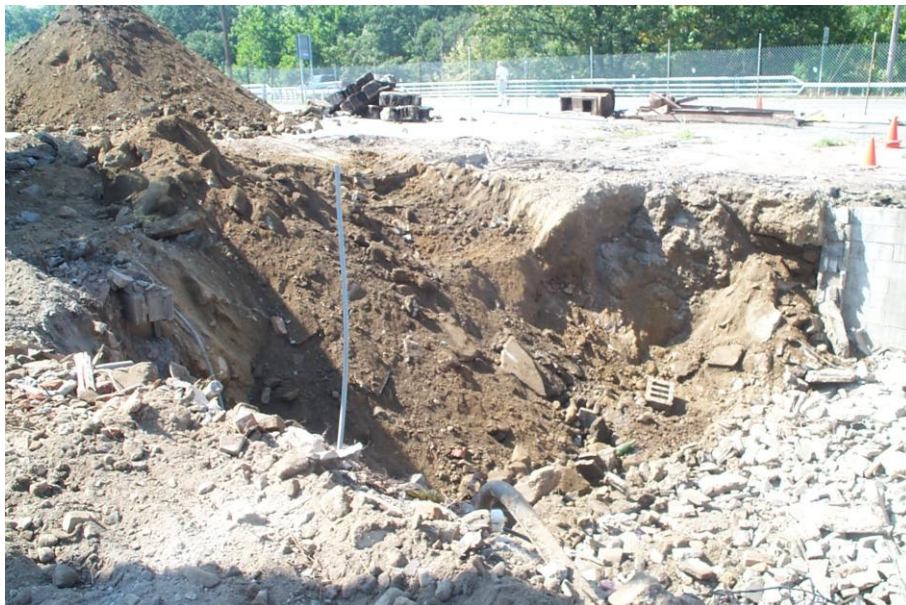
4. Excavation of PCE-contaminated soil at former repair bays (looking southwest)

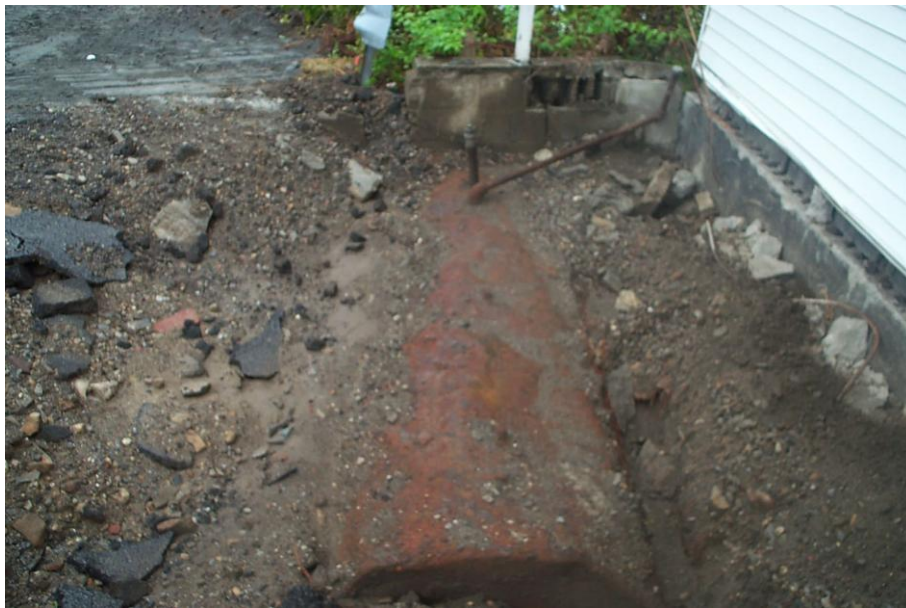
5. **Former fuel oil underground storage tank at western side of restaurant**

The top of the UST was exposed on September 15, 2006 and the tank was excavated, pumped of residual product (approximately 170 gallons of oily water and sludge), and removed from the ground on September 16. The UST was found to be a single wall, steel tank with an estimated capacity of 1,000 gallons (approximately 4' in diameter by 11' long). The body of the tank was sound, with the exception of several small holes at the bottom of the northern end.

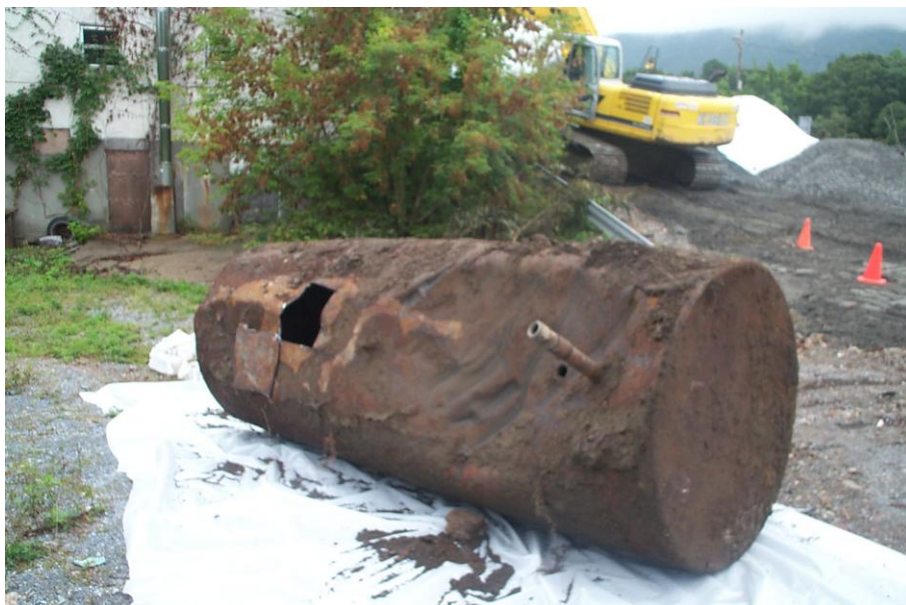
6. **Former fuel oil underground storage tank, stored on plastic prior to off-site disposal**

Based on field conditions and laboratory data, spill number 0507282 was subsequently reported to the NYSDEC. The former UST, along with the excavated hydraulic lift and an abandoned 275-gallon fuel oil tank, were removed from the Site on March 30, 2006. The spill was subsequently closed by the NYSDEC on October 21, 2008. Tank and waste disposal documentation is included in Appendix E.

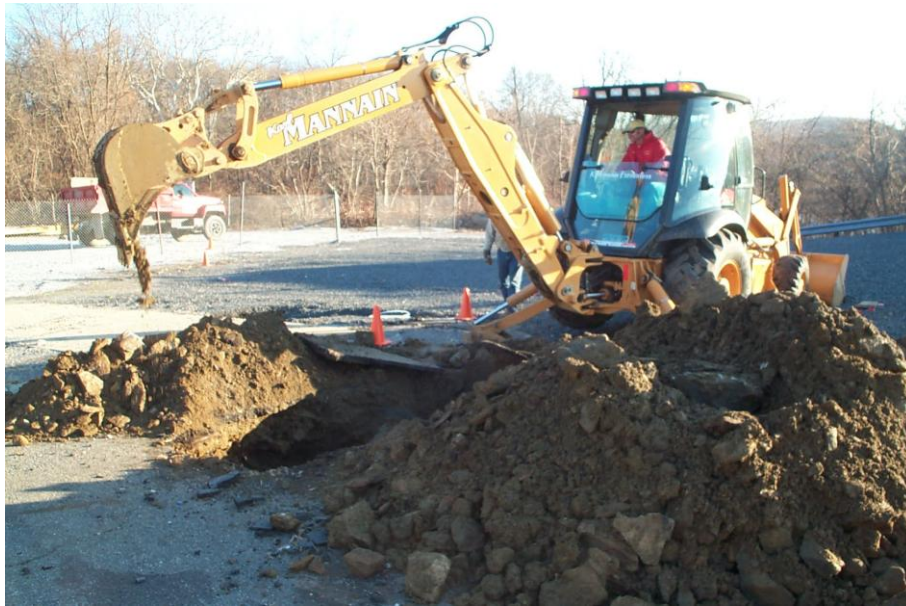
- 7. Extension of test pits at western side of Site near former fuel-pump island and concrete pads**

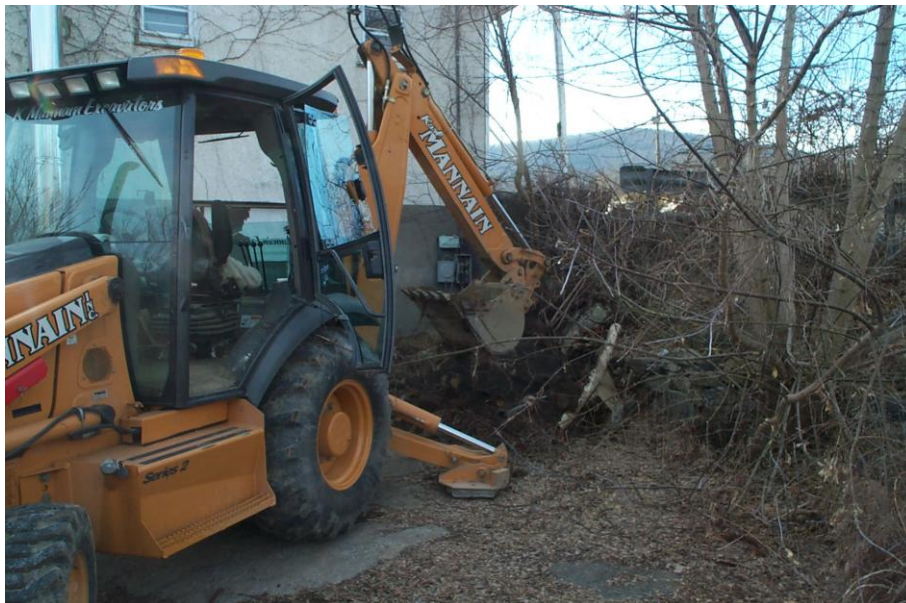
- 8. Extension of test pit at southwestern corner of restaurant, near former fuel oil underground storage tank**

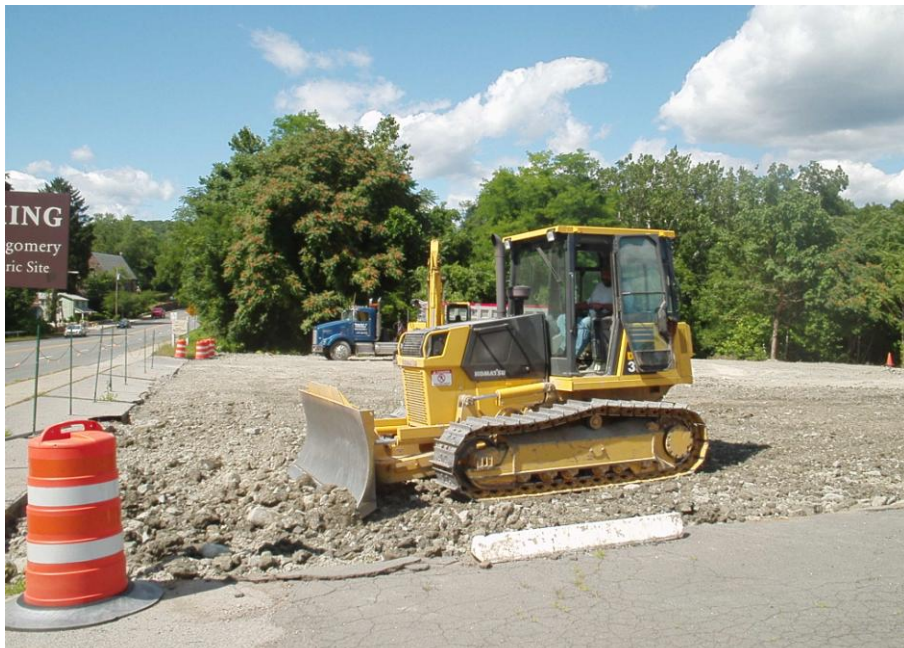
9. Installation of final soil barrier layer at western portion of Site

use as the final cover. Previously imported materials were regraded and covered with a marker layer, the barrier layer was installed to a minimum thickness of 18 inches, and the surface was seeded and secured with biodegradable landscaping materials. A full layer of vegetation had been established by the fall of 2007. Minor breaks in the cut edge of the surrounding asphalt pavement were repaired following the completion of construction activities.

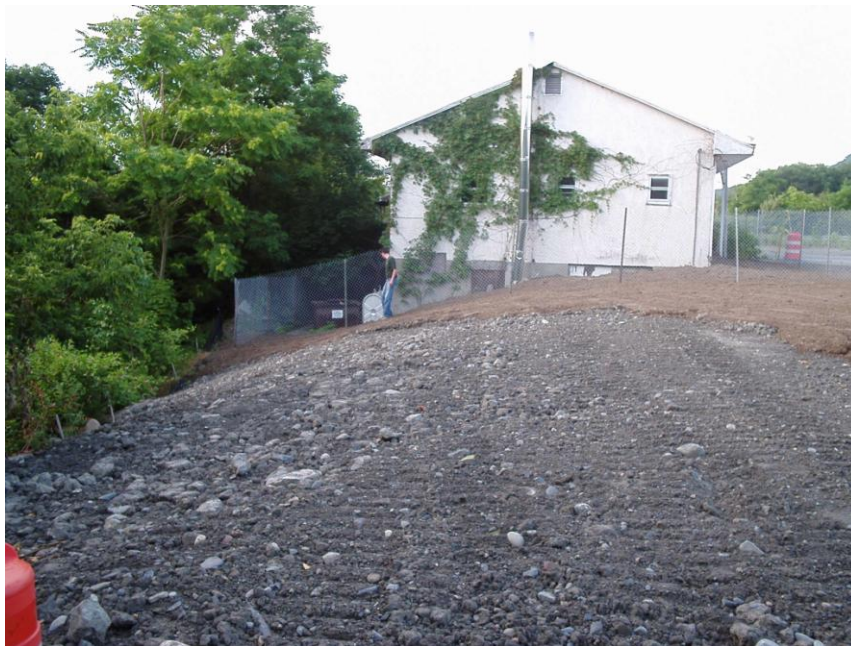
10. Installation of final soil barrier layer at eastern portion of Site

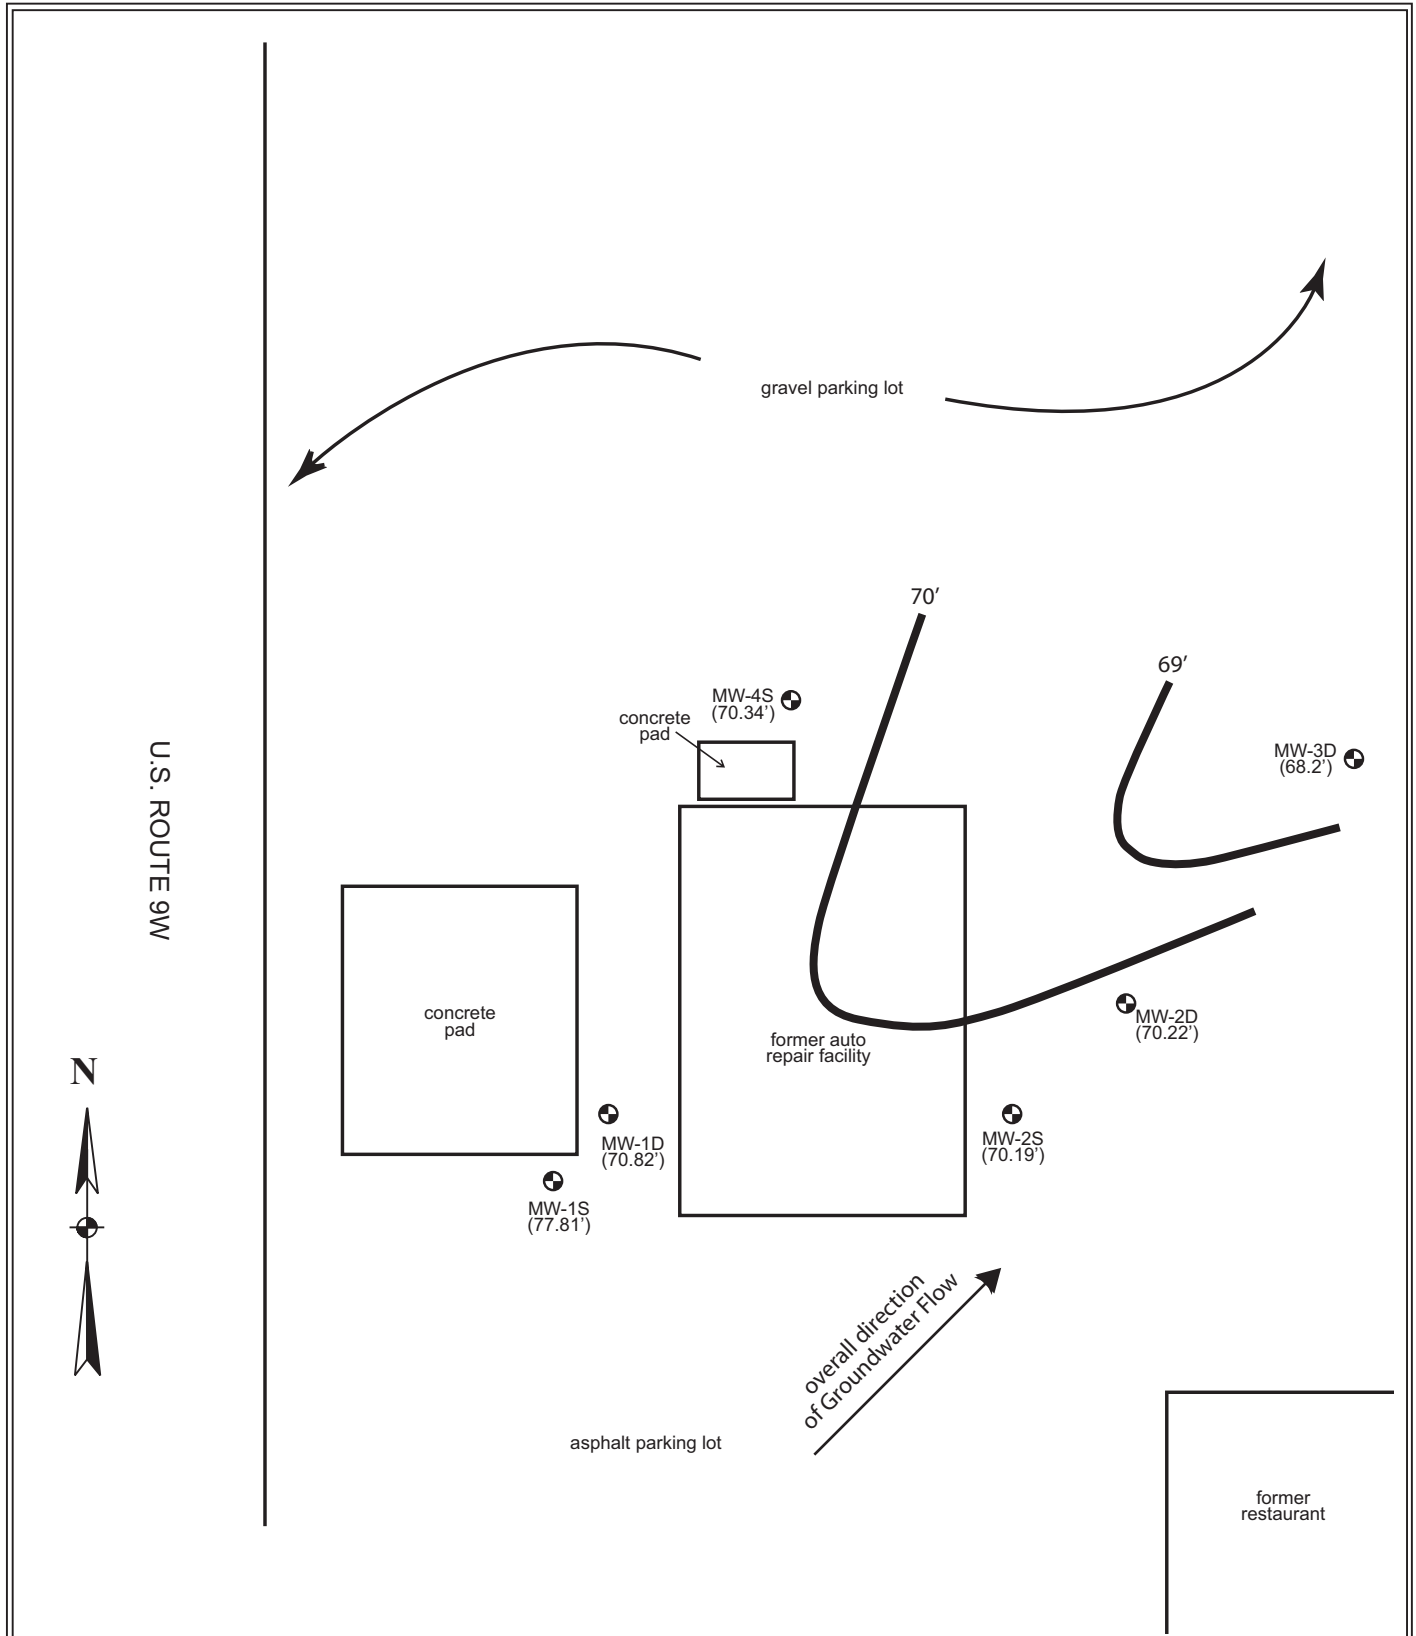
<p>Groundwater Flow Map June 2006 Former Sakmann Property U.S. Route 9W Town of Highlands Orange County, New York</p>	<p>Legend:

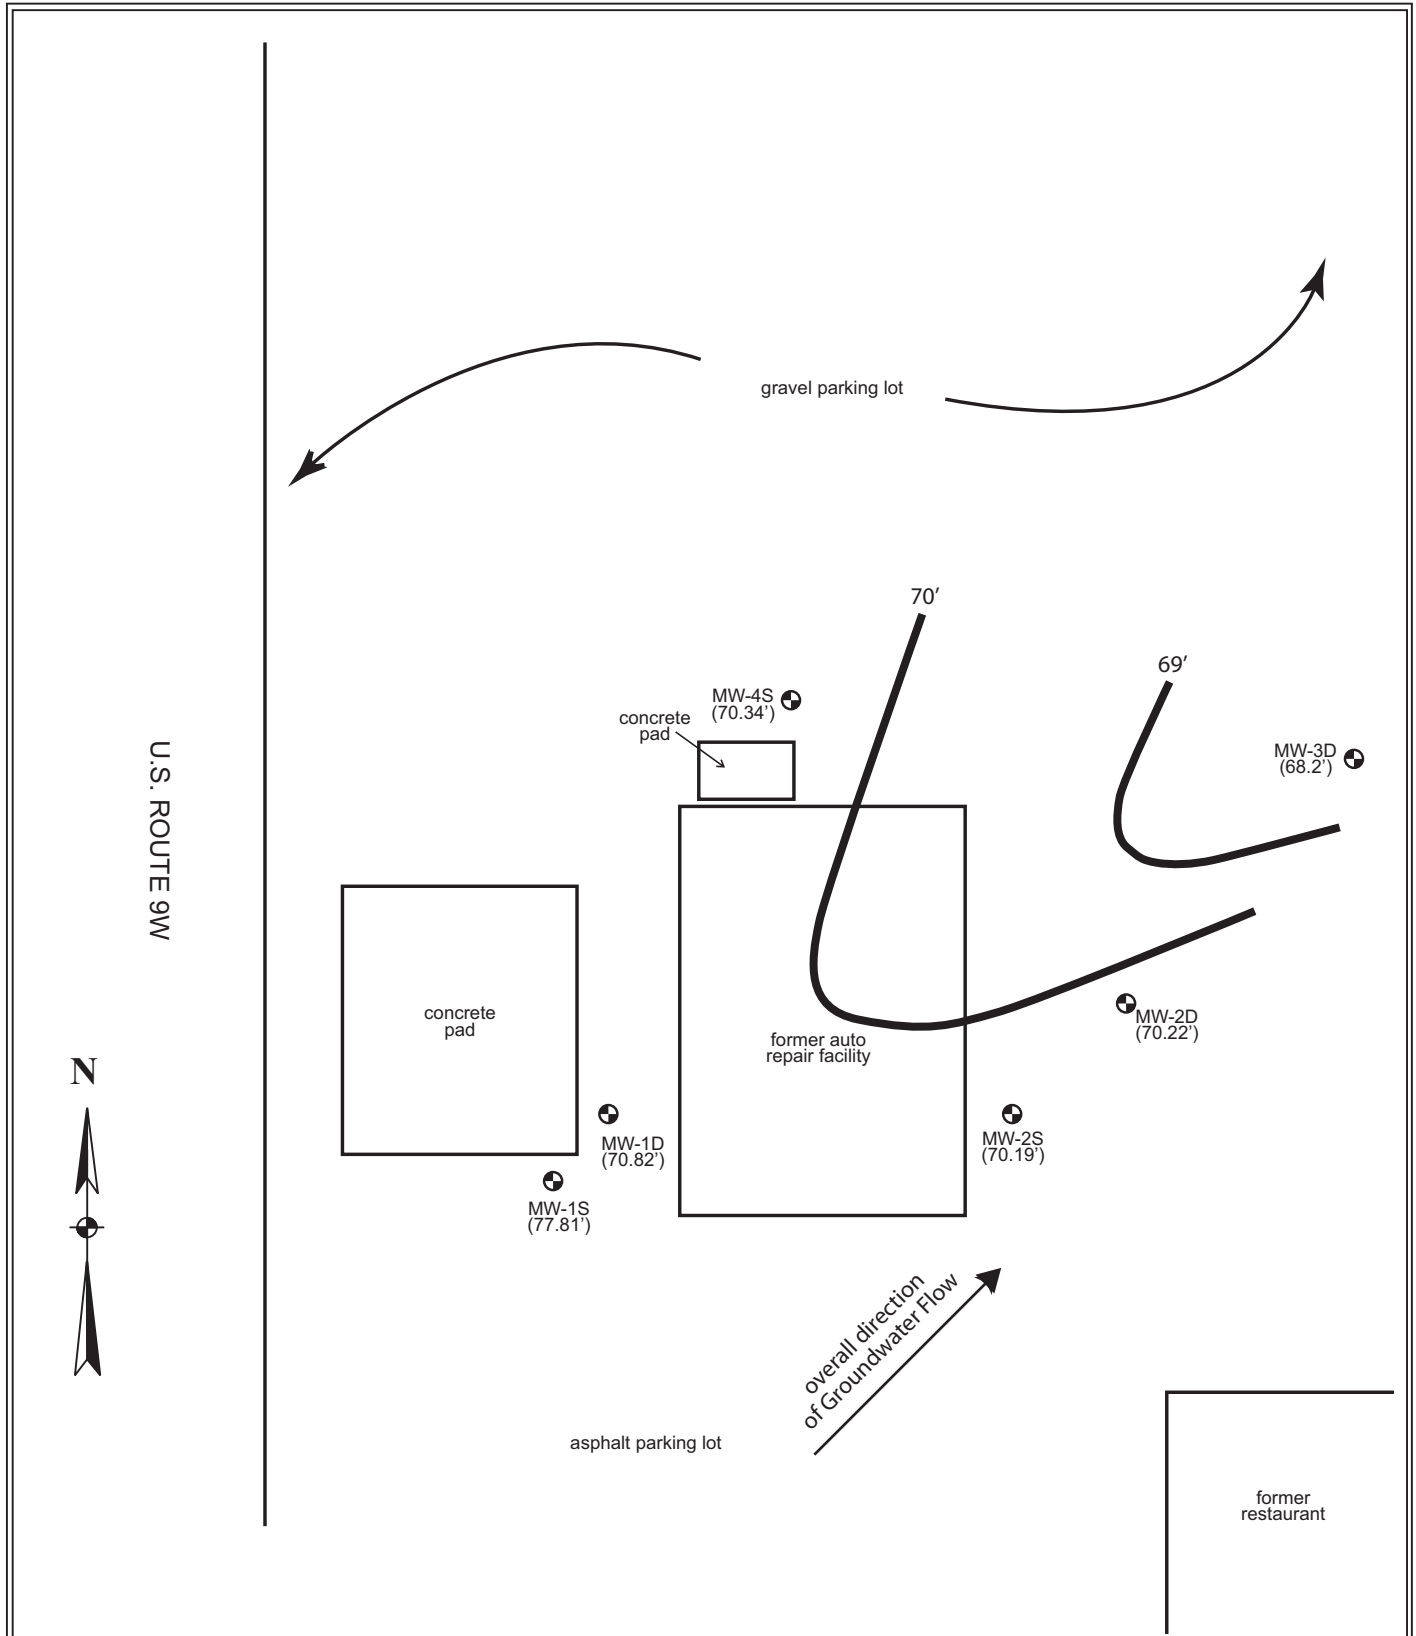
<p>Groundwater Flow Map June 2006 Former Sakmann Property U.S. Route 9W Town of Highlands Orange County, New York</p>	<p>Legend:

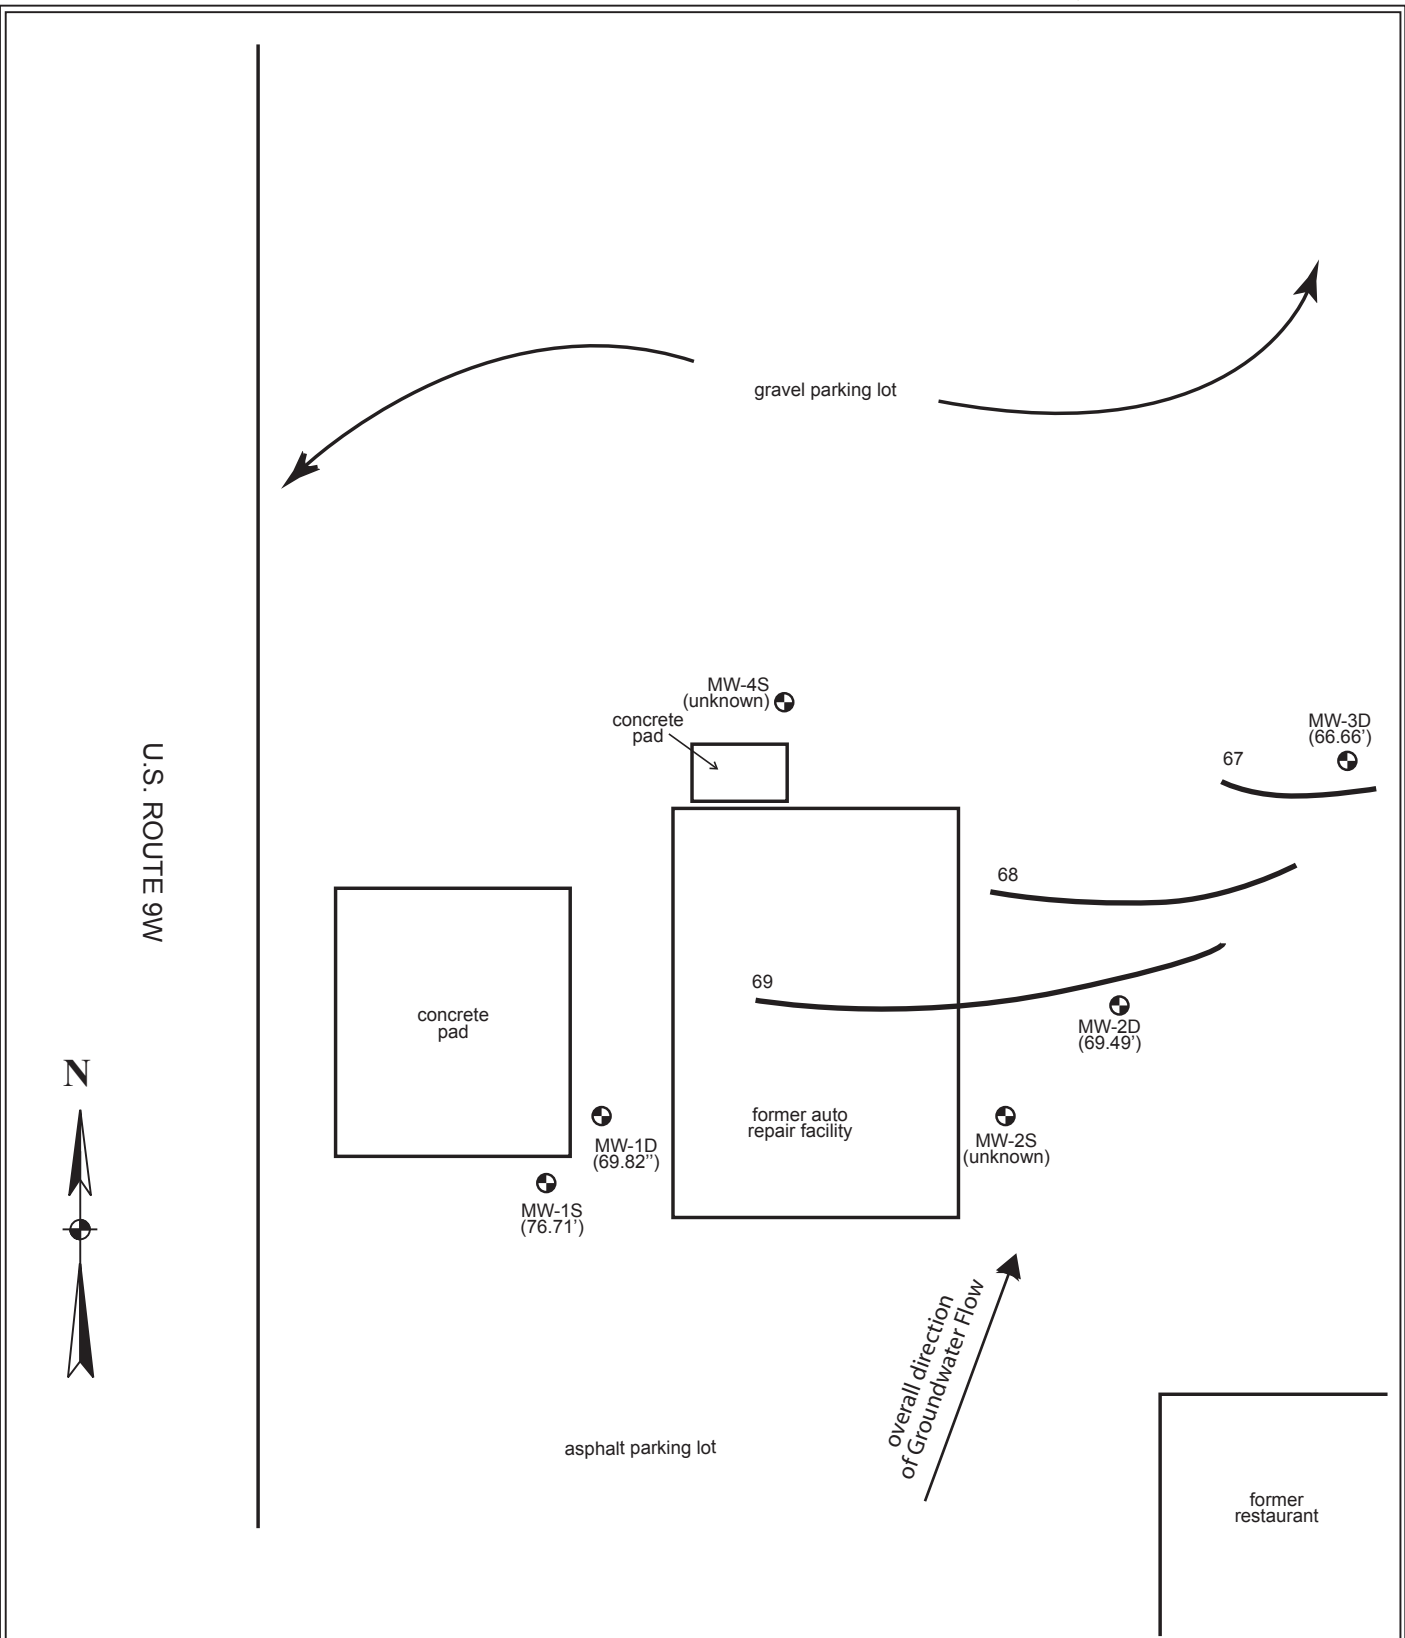
<p>Groundwater Flow Map July 2003 Former Sakmann Property U.S. Route 9W Town of Highlands Orange County, New York</p>	<p>Legend:

monitoring well with groundwater elevation noted parenthetically MW-1S (76.67')</p>	<p>ESI File: SF01123.60</p>
		<p>January 2009</p>
		<p>Not to Scale</p>
		<p>Appendix H</p>

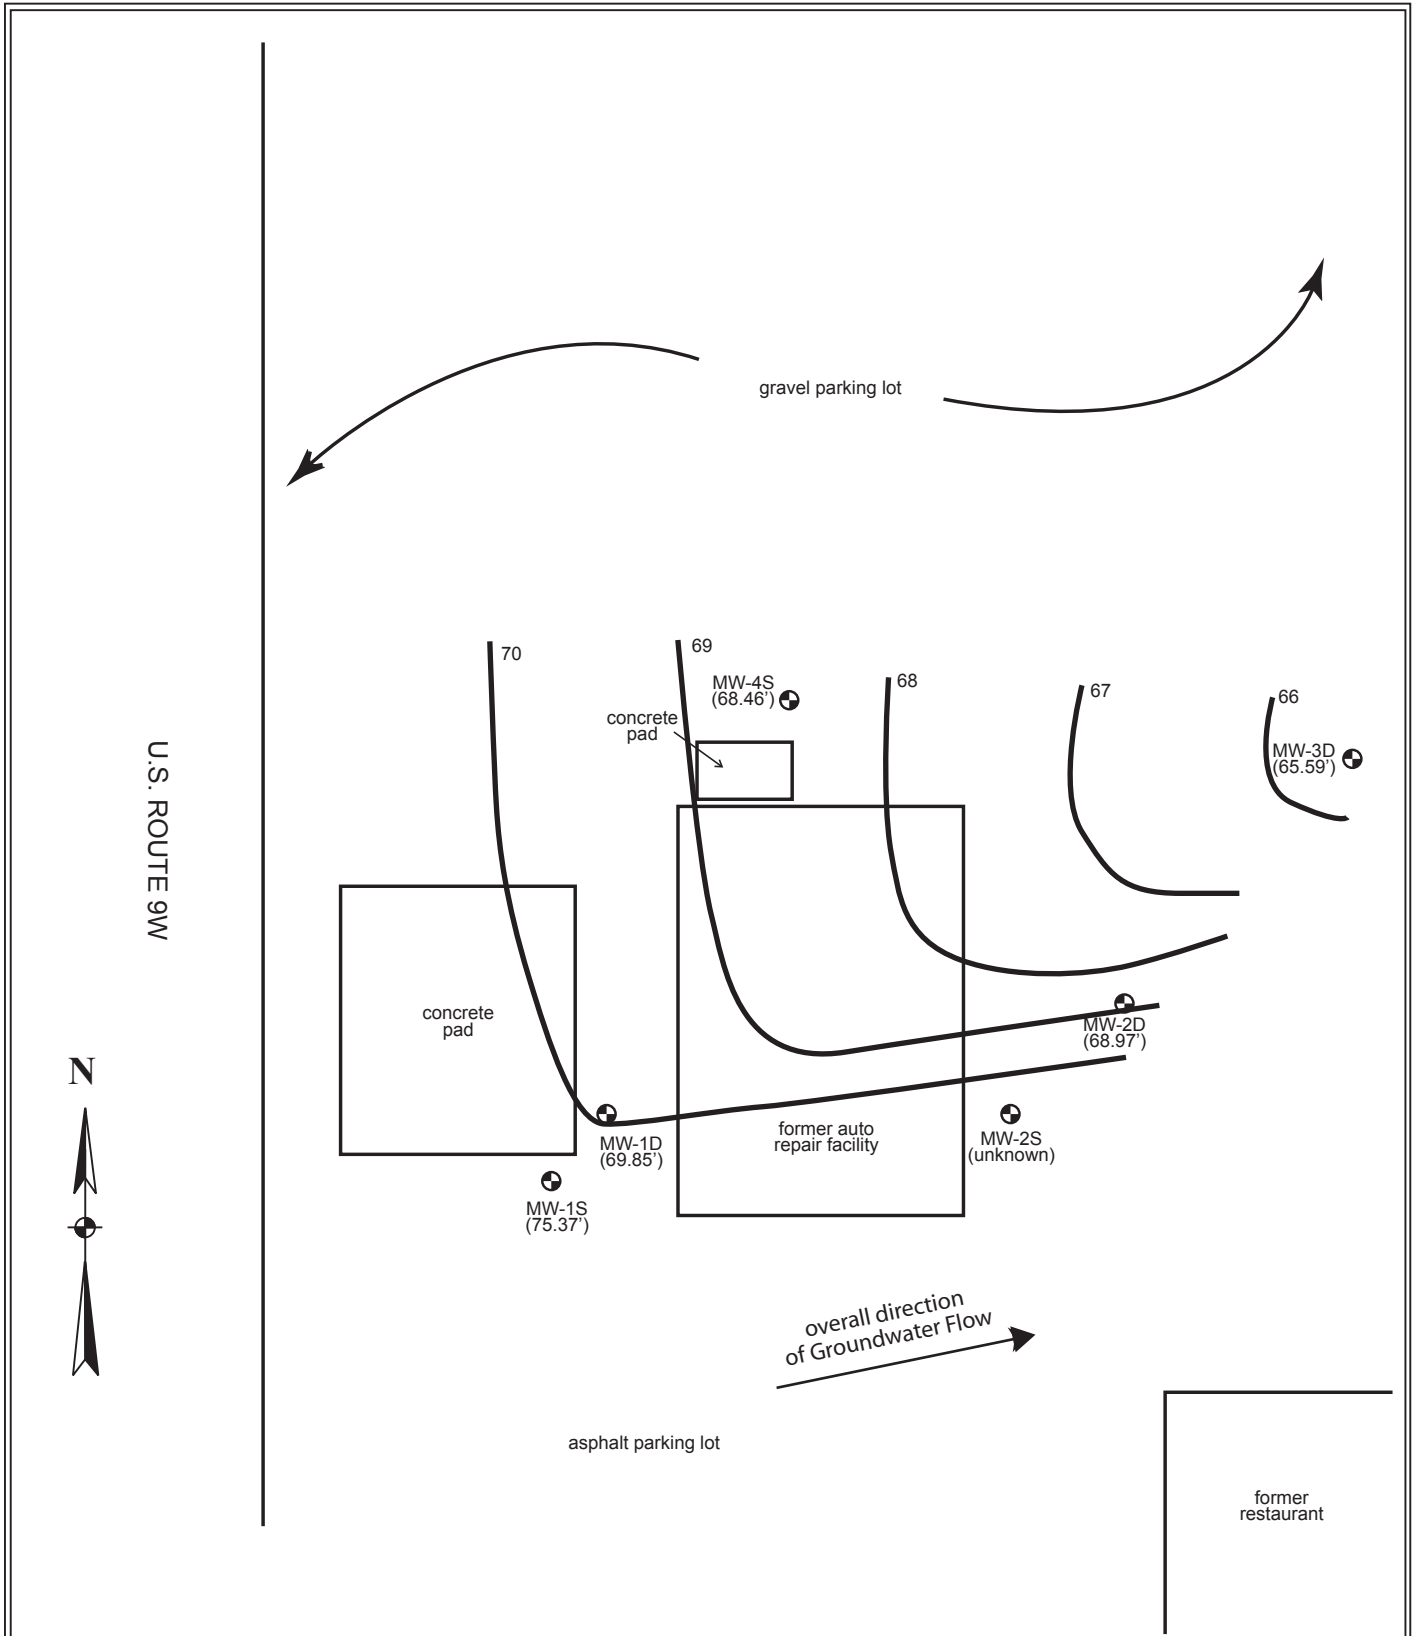
<p>Groundwater Flow Map February 2004 Former Sakmann Property U.S. Route 9W Town of Highlands Orange County, New York</p>	<p>Legend:

monitoring well with groundwater elevation noted parenthetically MW-1S (76.67')</p>	<p>ESI File: SF01123.60</p>
		<p>January 2009</p>
		<p>Not to Scale</p>
		<p>Appendix H</p>

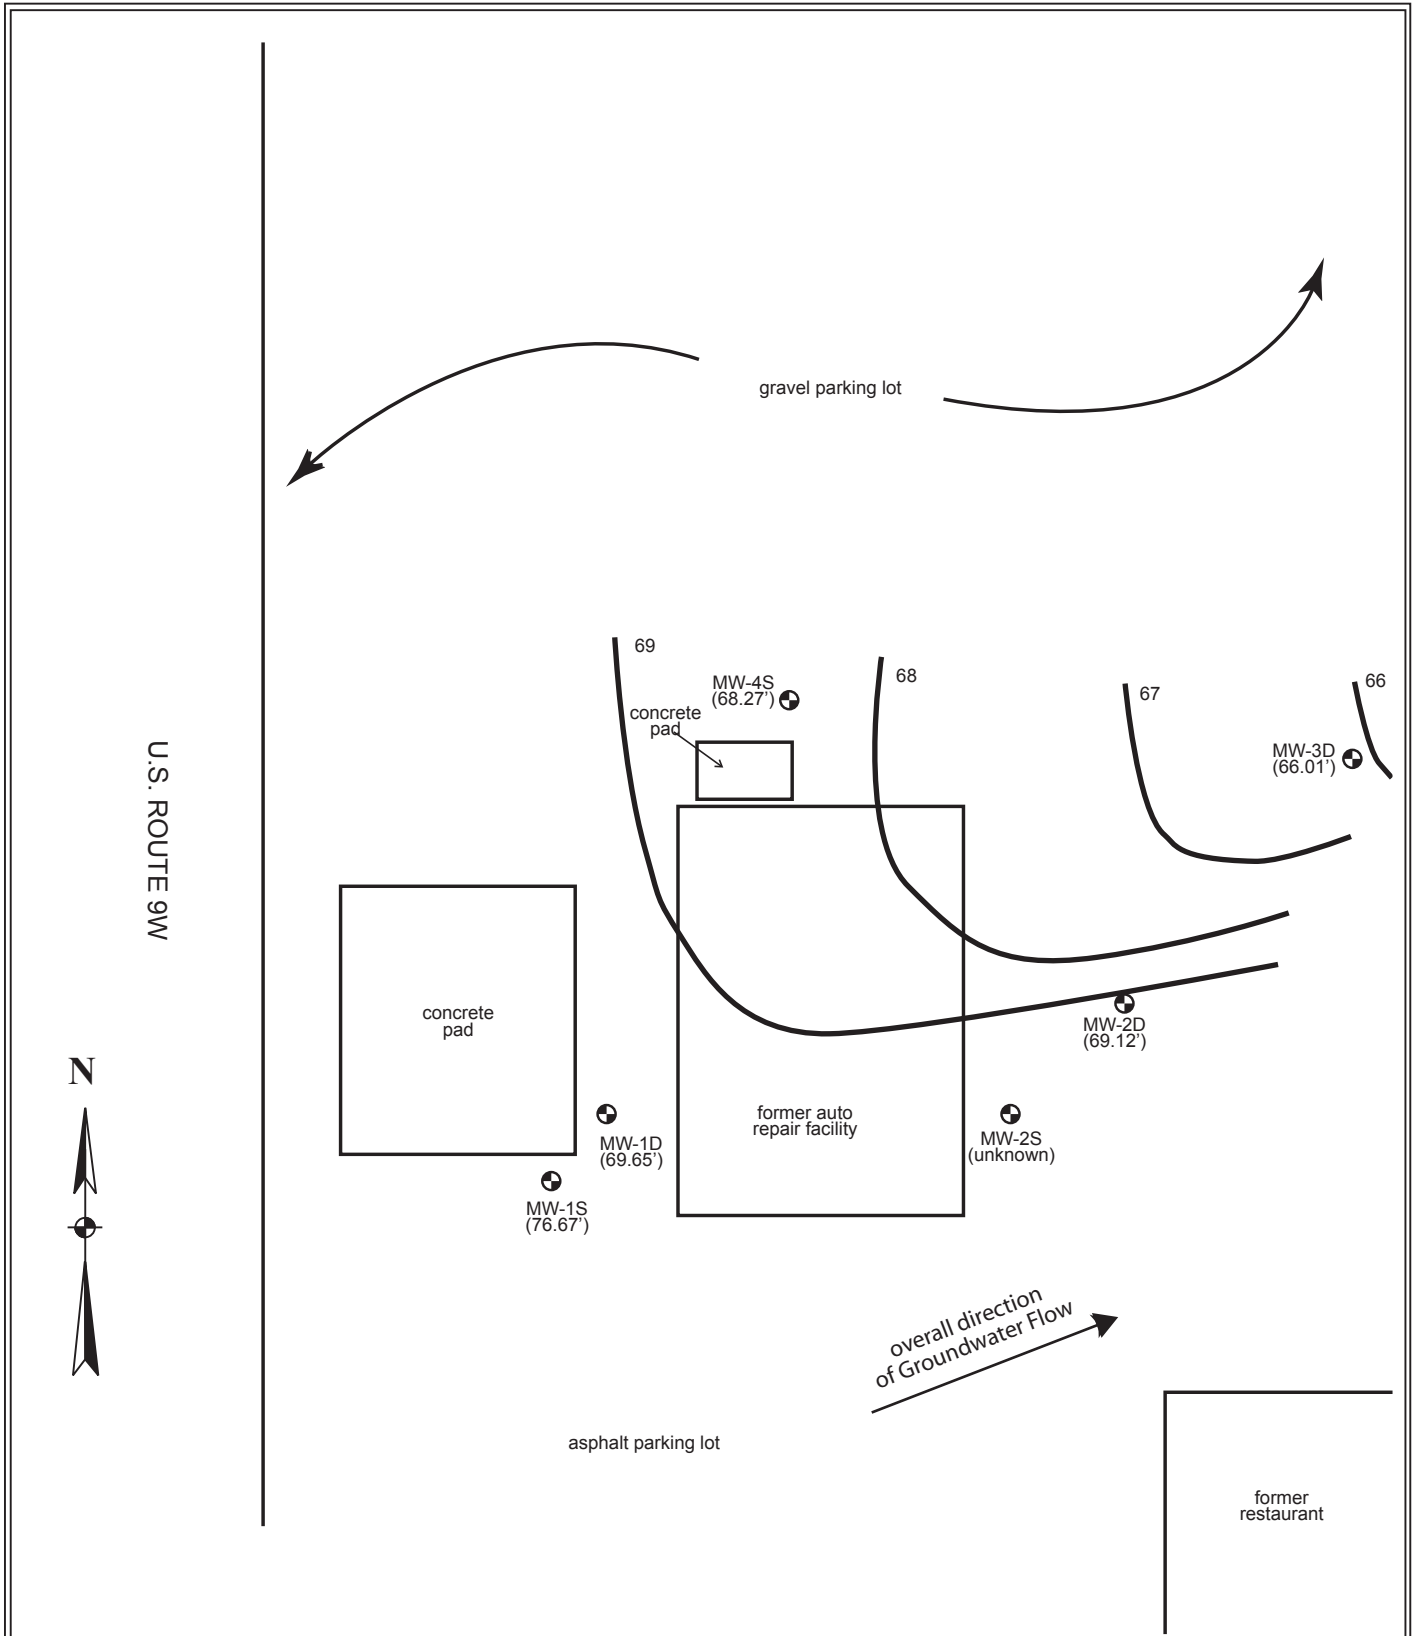
<p>Groundwater Flow Map August 2004 Former Sakmann Property U.S. Route 9W Town of Highlands Orange County, New York</p>	<p>Legend:

monitoring well with groundwater elevation noted parenthetically MW-1S (76.67')</p>	<p>ESI File: SF01123.60</p>
		<p>January 2009</p>
		<p>Not to Scale</p>
		<p>Appendix H</p>

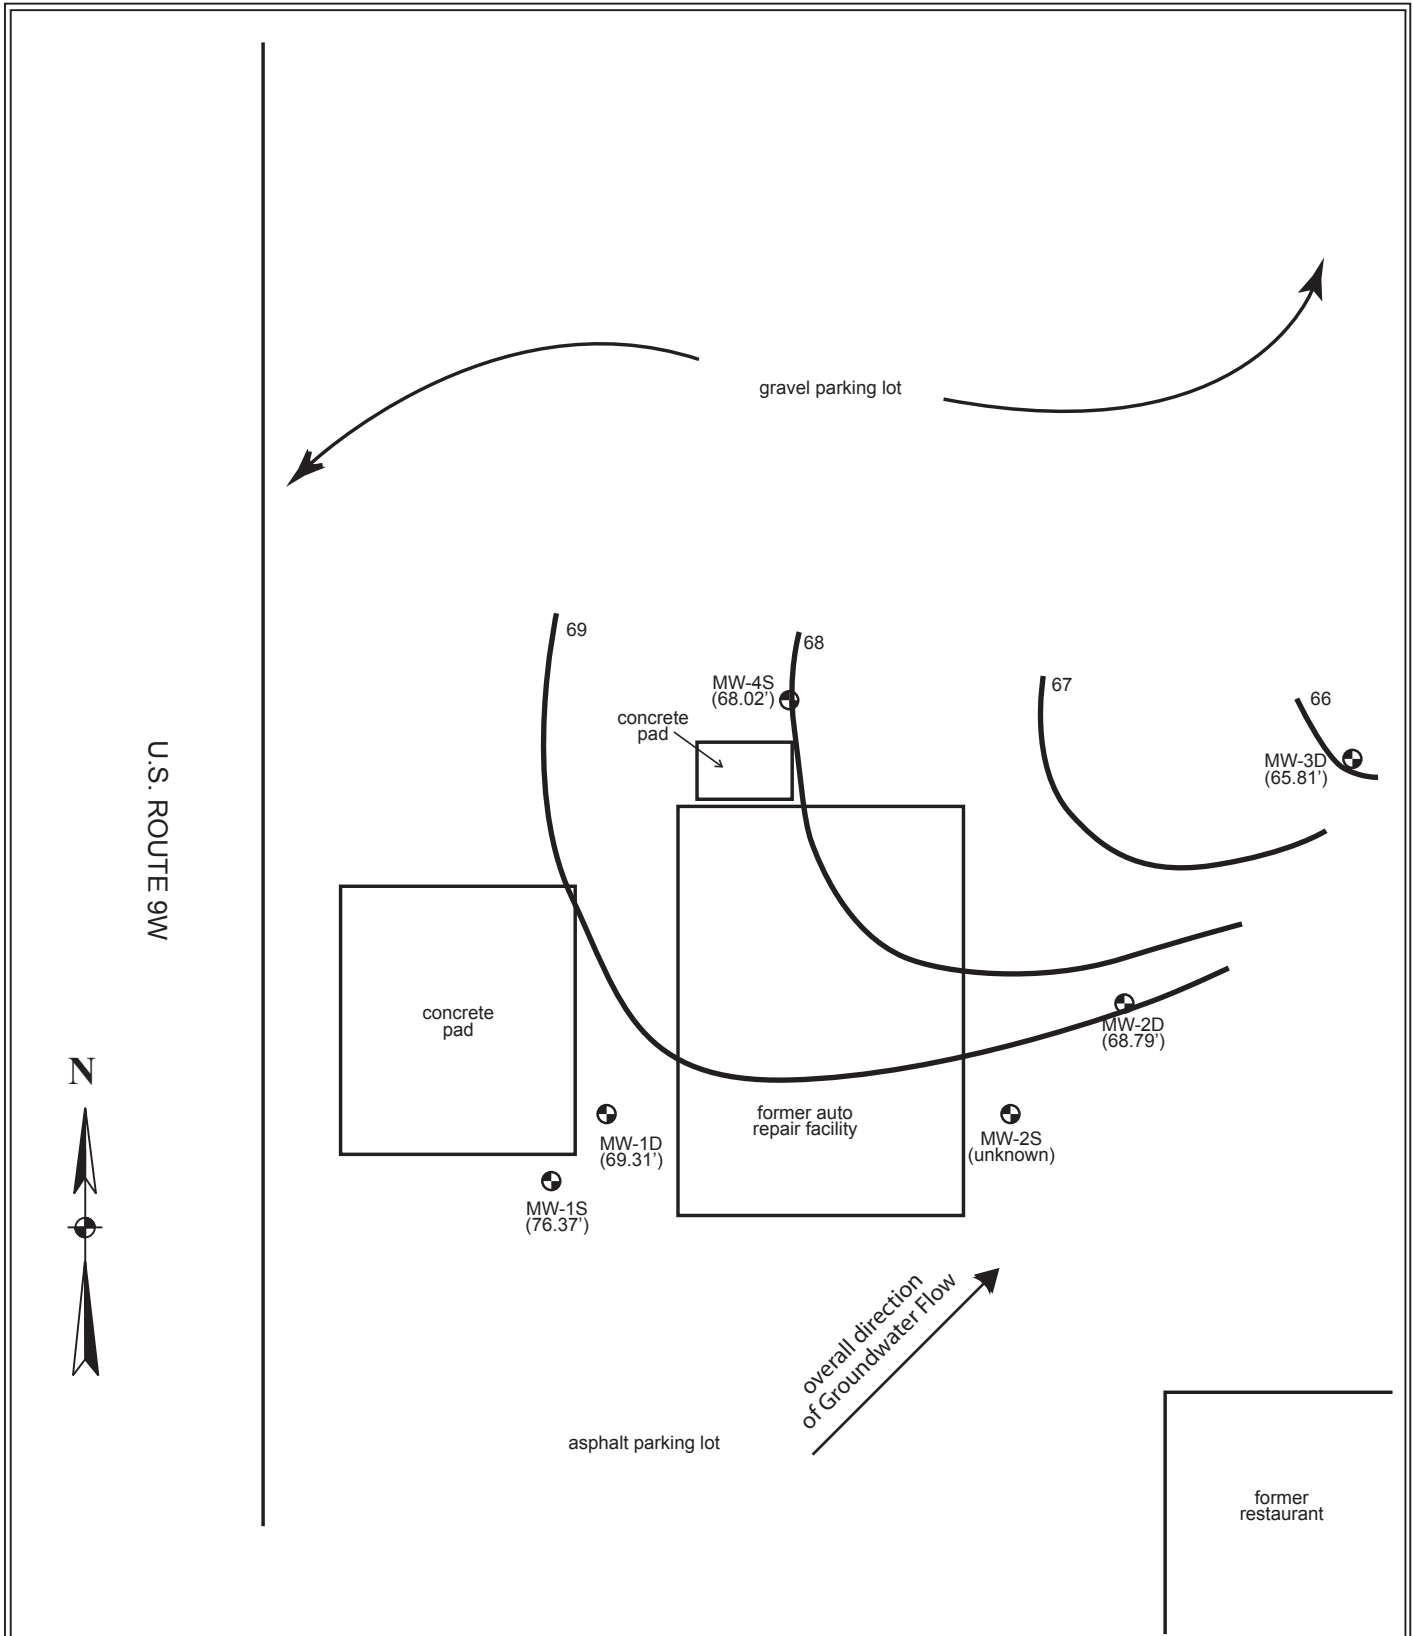
<p>Groundwater Flow Map May 2004 Former Sakmann Property U.S. Route 9W Town of Highlands Orange County, New York</p>	<p>Legend:

monitoring well with groundwater elevation noted parenthetically MW-1S (76.67')</p>	<p>ESI File: SF01123.60</p>
		<p>January 2009</p>
		<p>Not to Scale</p>
		<p>Appendix H</p>
