FINAL ENGINEERING REPORT

FORMER “SAKMANN RESTAURANT CORP.” PROPERTY

**LOCATED AT U.S. ROUTE 9W
TOWN OF HIGHLANDS
ORANGE COUNTY, NEW YORK**

**NYSDEC Voluntary Cleanup Site Number: V-00083-3
(Index Number: W3-0962-03-07)**

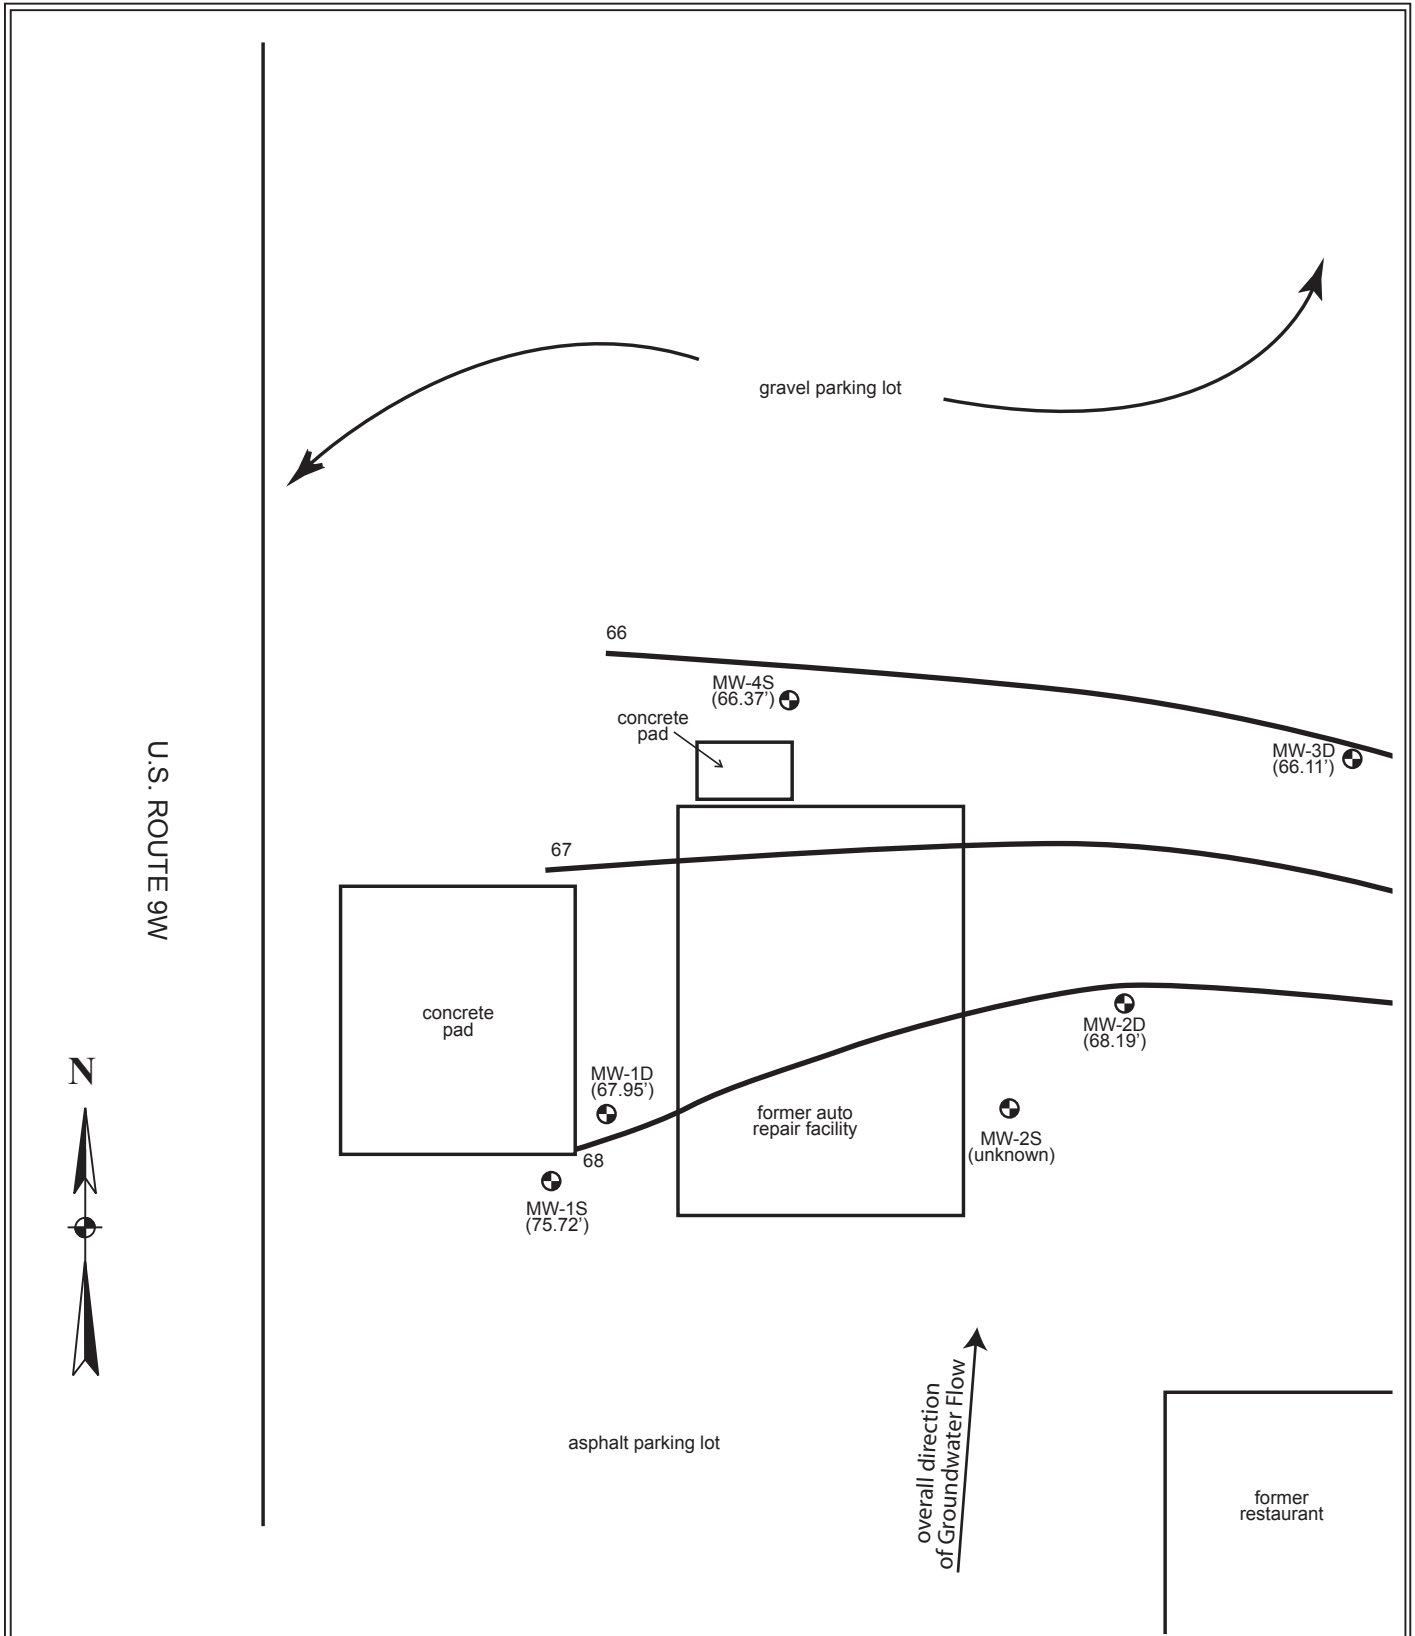
<p>Groundwater Flow Map January 2005 Former Sakmann Property U.S. Route 9W Town of Highlands Orange County, New York</p>	<p>Legend:

monitoring well with groundwater elevation noted parenthetically MW-1S (76.67')</p>	<p>ESI File: SF01123.60</p>
		<p>January 2009</p>
		<p>Not to Scale</p>
		<p>Appendix H</p>

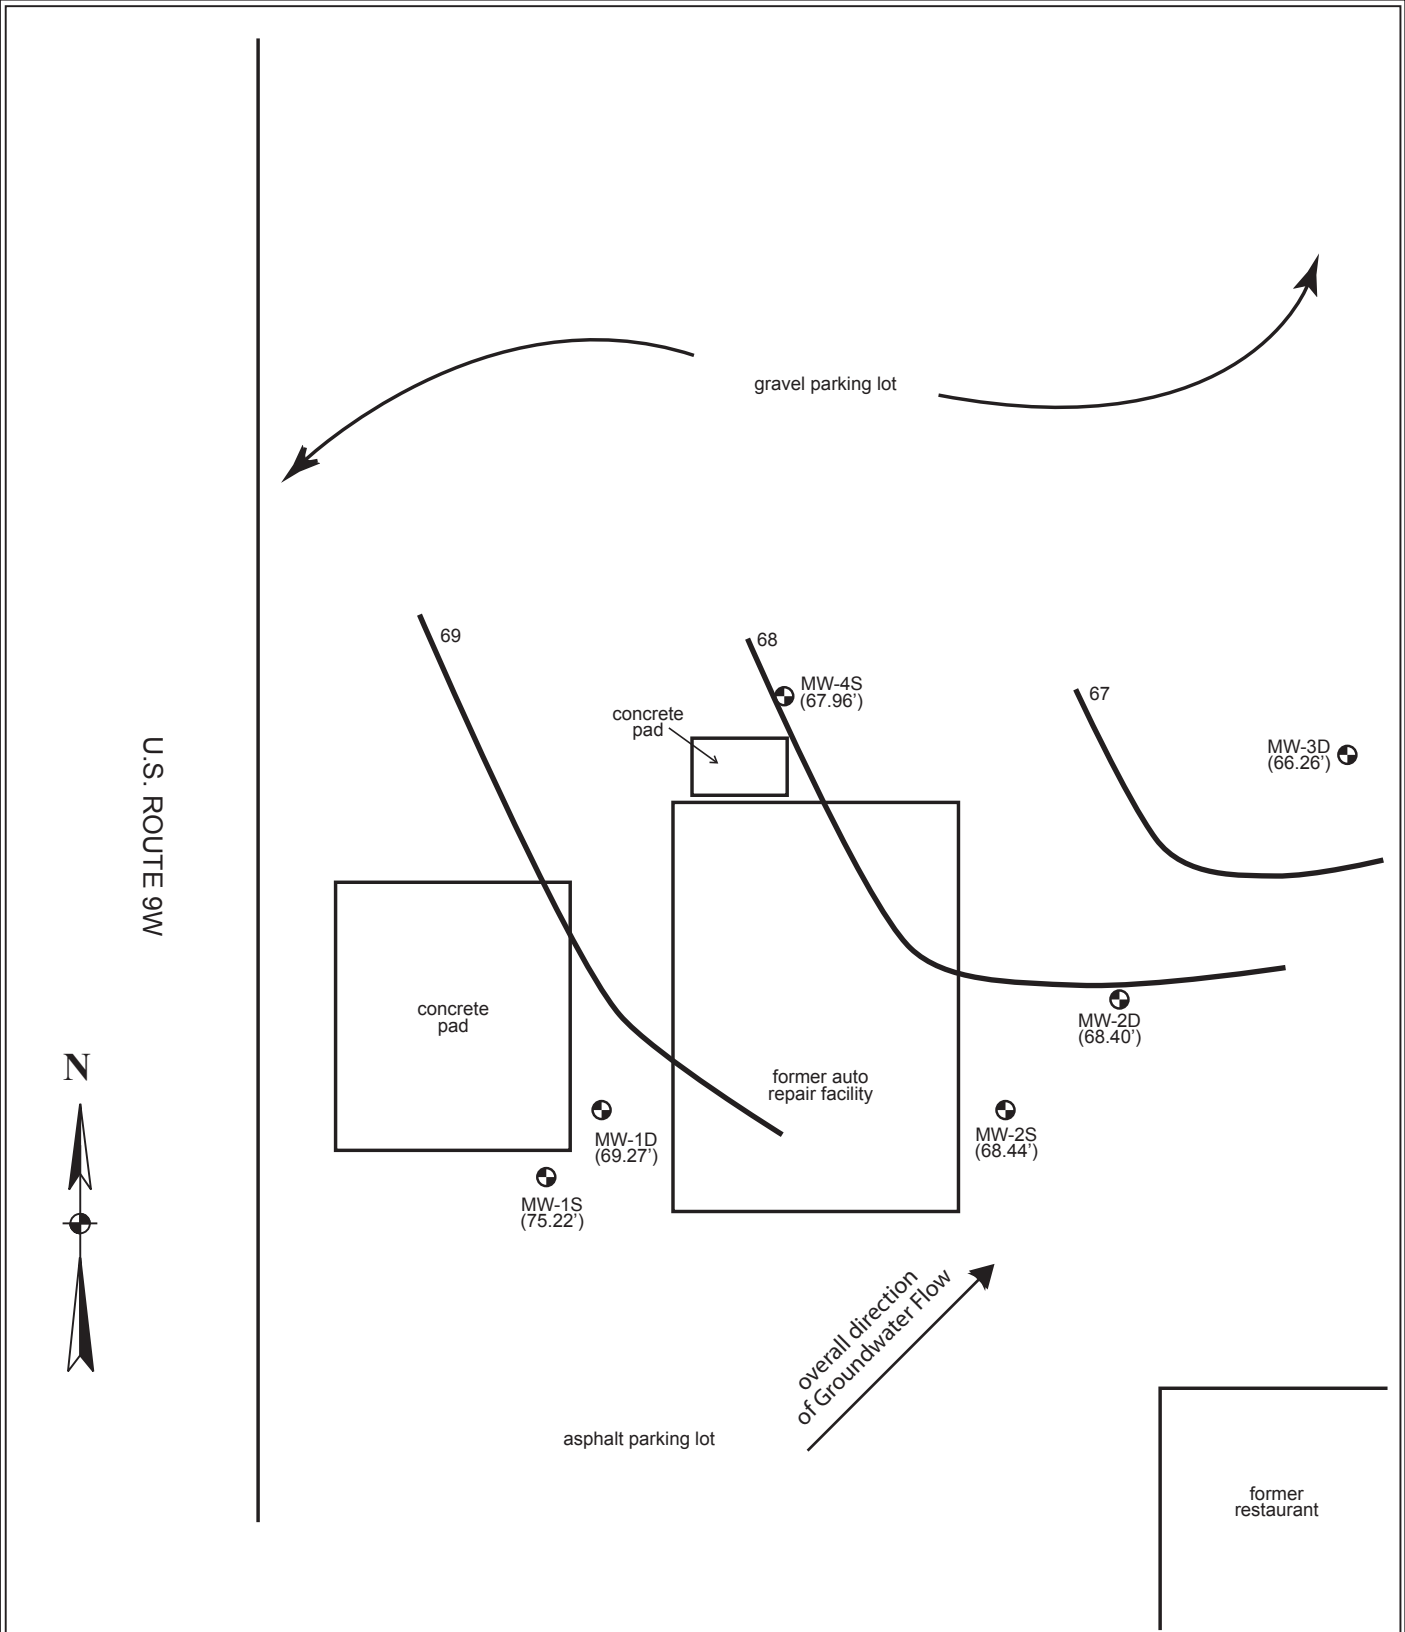
<p>Groundwater Flow Map June 2005 Former Sakmann Property U.S. Route 9W Town of Highlands Orange County, New York</p>	<p>Legend:

monitoring well with groundwater elevation noted parenthetically MW-1S (76.67')</p>	<p>ESI File: SF01123.60</p>
		<p>January 2009</p>
		<p>Not to Scale</p>
		<p>Appendix H</p>

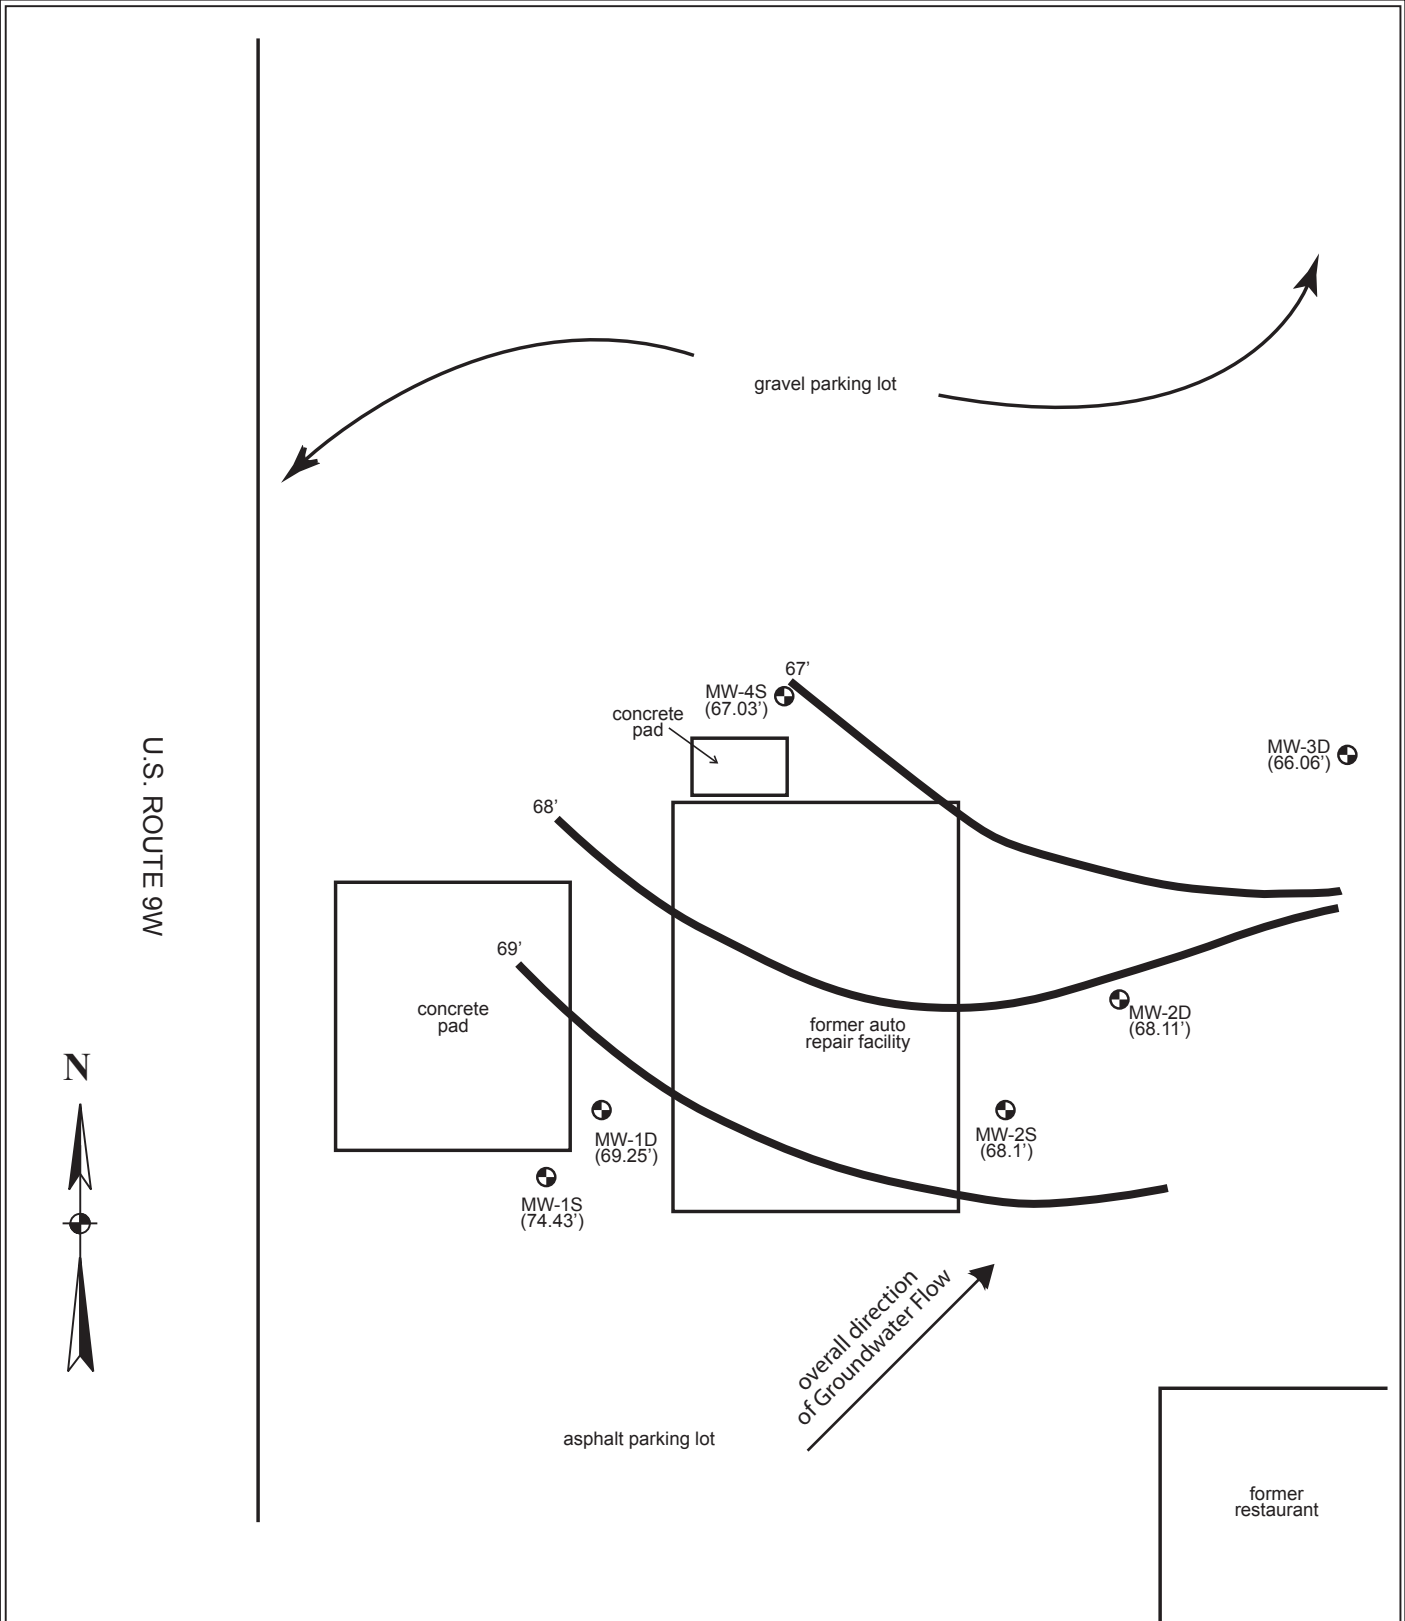
<p>Groundwater Flow Map March 2006 Former Sakmann Property U.S. Route 9W Town of Highlands Orange County, New York</p>	<p>Legend: monitoring well with groundwater elevation noted parenthetically MW-1S</p>	<p>ESI File: SF01123.60</p>
		<p>January 2009</p>
		<p>Not to Scale</p>
		<p>Appendix H</p>

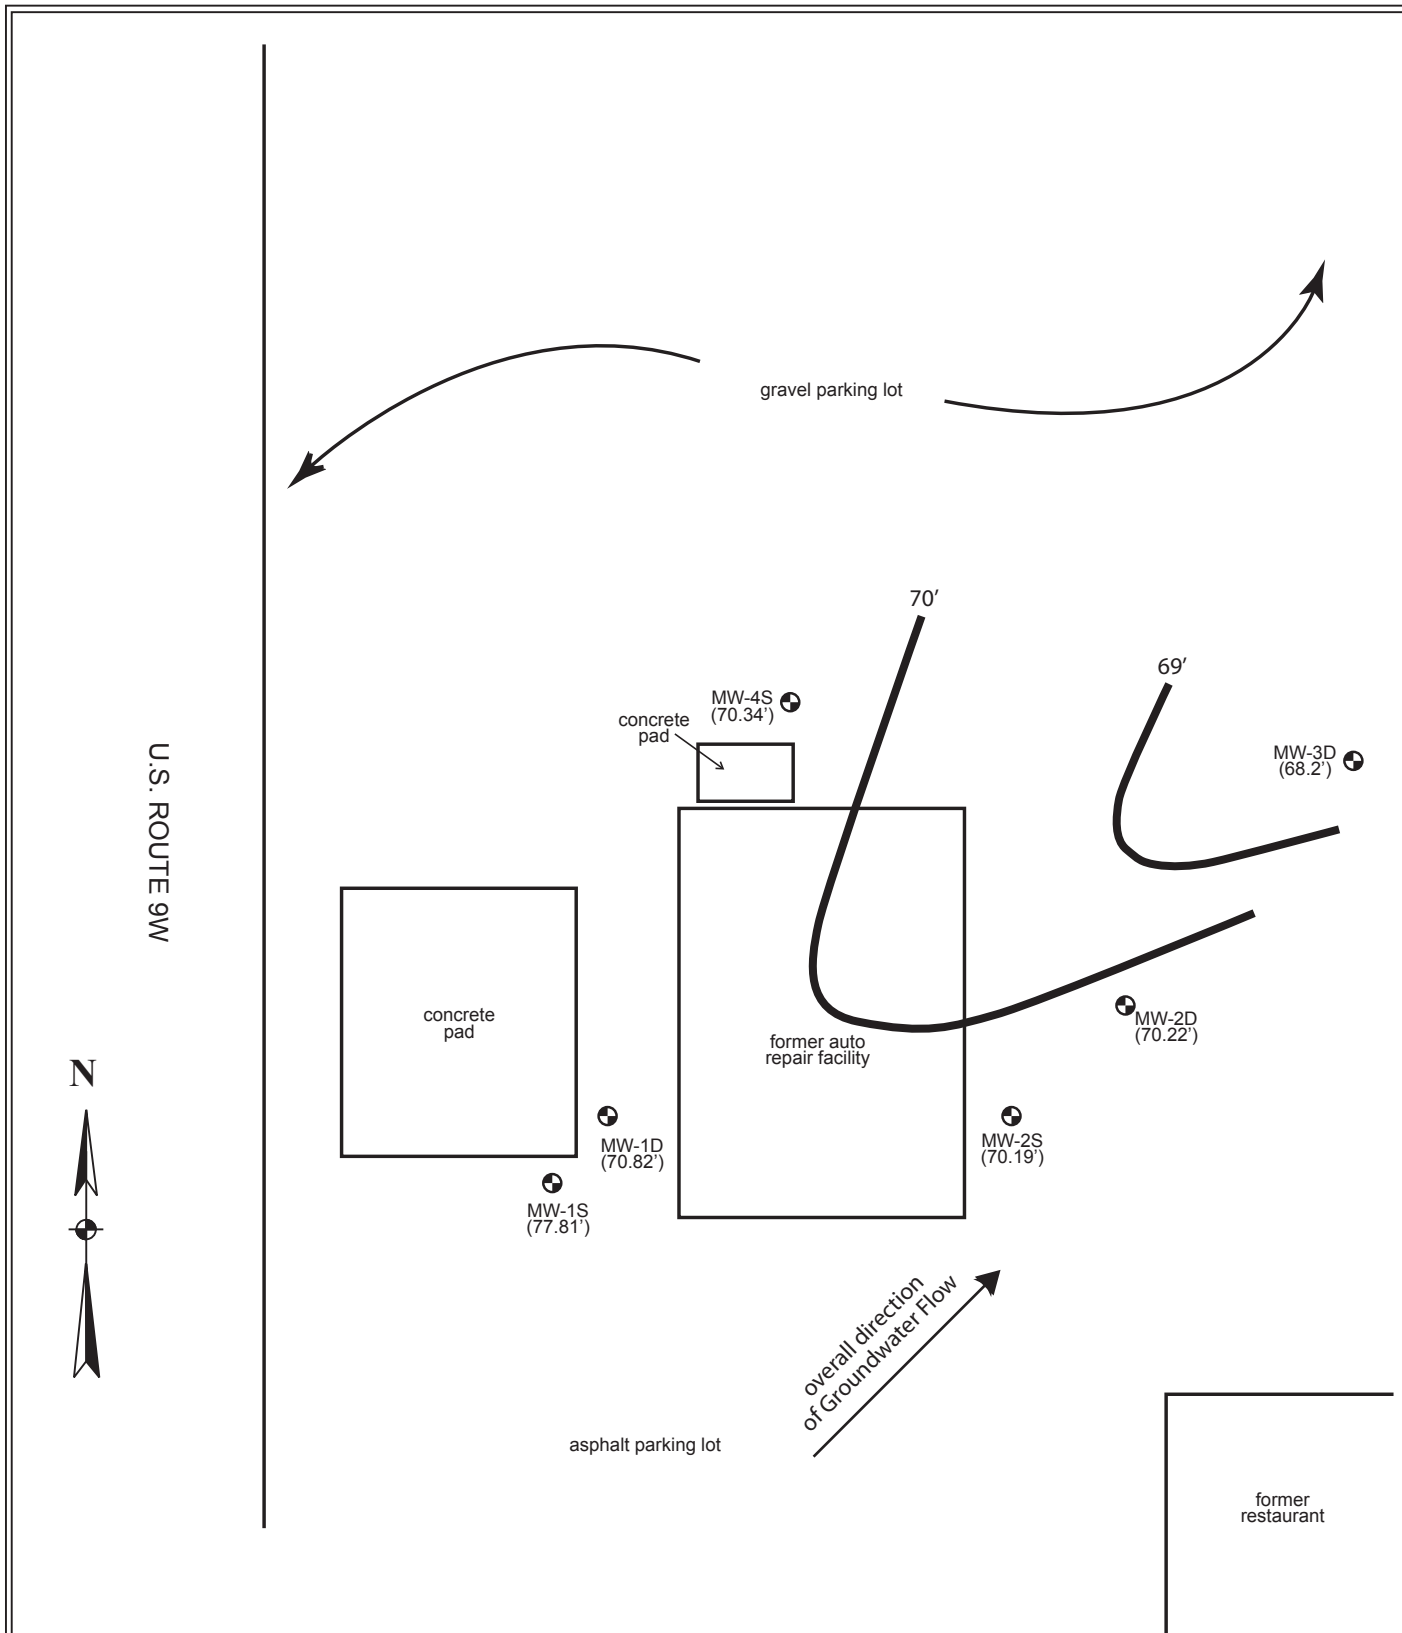
<p>Groundwater Flow Map June 2006 Former Sakmann Property U.S. Route 9W Town of Highlands Orange County, New York</p>	<p>Legend:
