**PERIODIC REVIEW REPORT  
October 30, 2013 – October 30, 2014  
New Paltz Plaza VCP Site**

**Town of New Paltz  
Ulster Co., New York  
VCP Site #V00087**

Sterling Environmental Engineering, P.C.  
24 Wade Road  
Latham, New York 12110

March 11, 2015

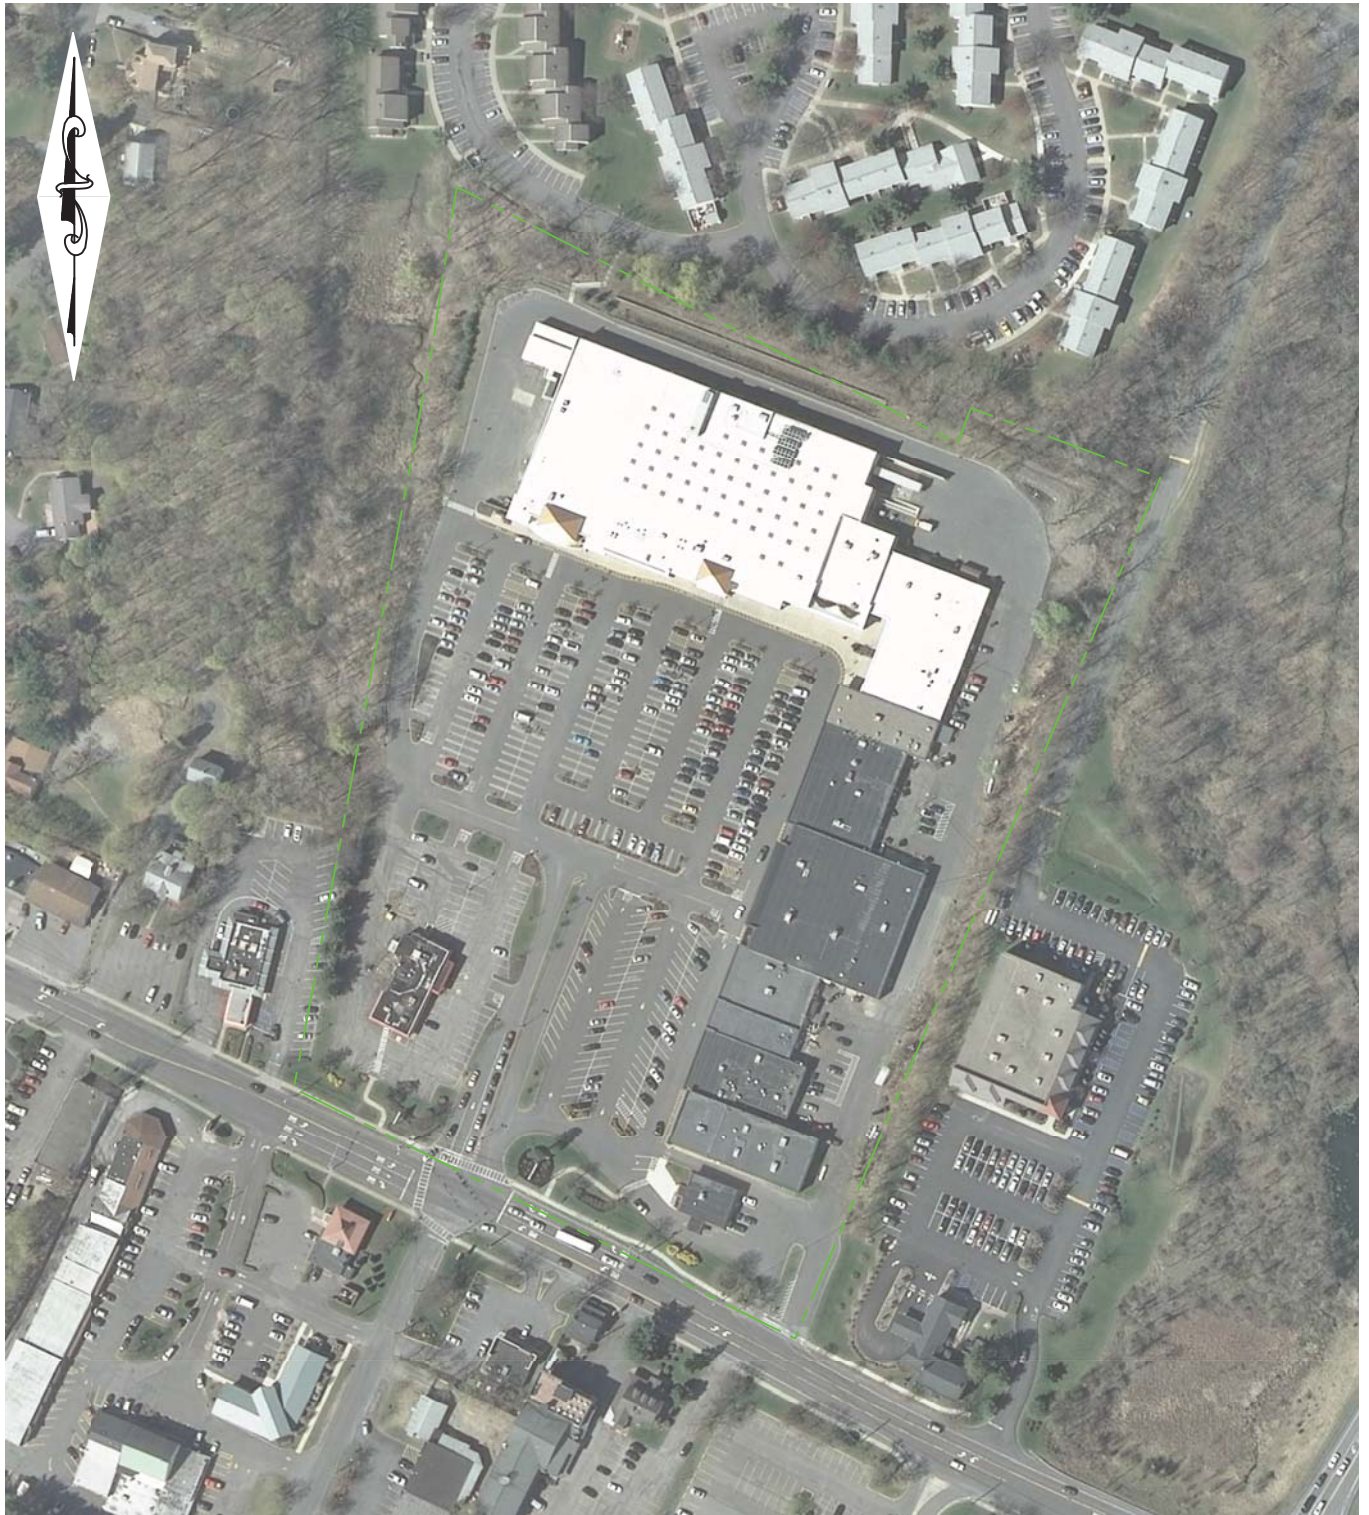
| PROJ. No.: 2014-45 | DATE: 1/7/15 | SCALE: 1" = 200' | DWG. NO. 2014-45002 | FIGURE 2 |

Figure 2 is a map showing the location of the components of the selected remedy for the site, including the SSDS, phytoremediation area, HRC injection area, and area where soil and impacted groundwater removal was performed.
