**Re: Soil Vapor Intrusion Investigation Summary
Carmel ShopRite Plaza
180 Gleneida Avenue
Carmel, New York
NYSDEC Site #V00104**

Soil Vapor Intrusion Investigation Summary (Part 1)

Carmel ShopRite Plaza
180 Gleneida Avenue
Carmel, New York
NYSDEC Site Number V00104

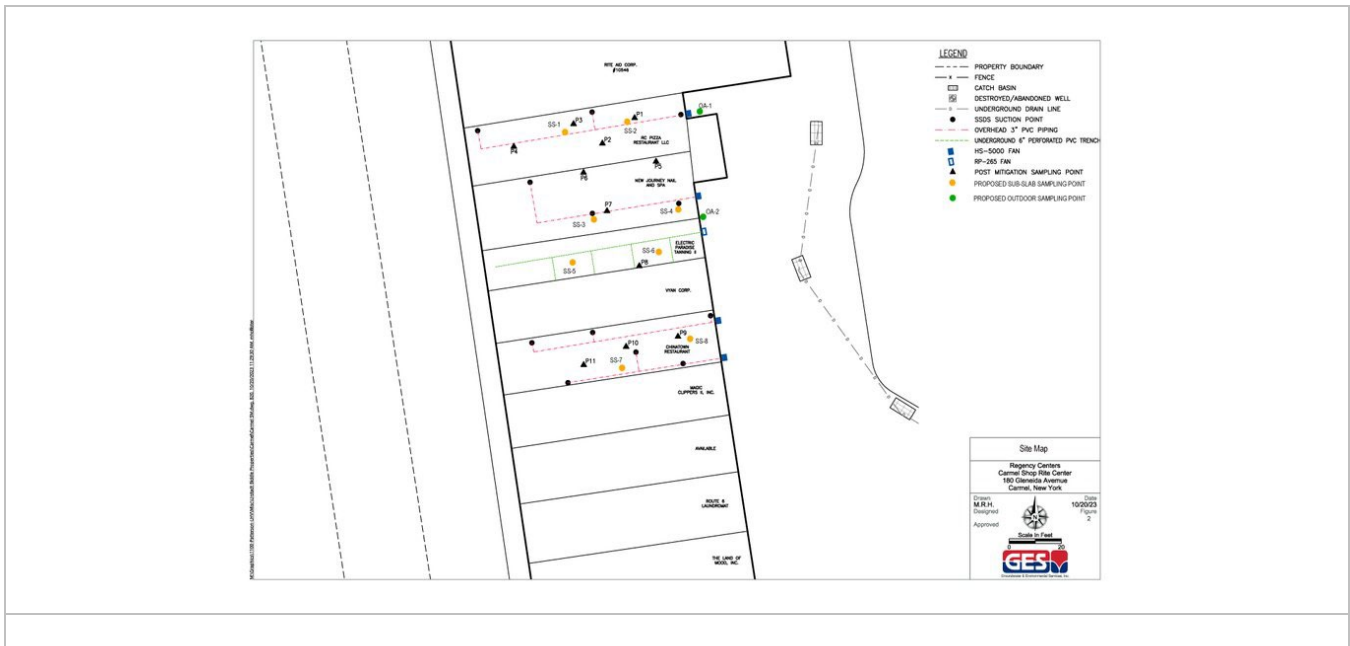
First Floor:

Draw a plan view sketch of the basement and first floor of the building. Indicate air sampling locations, possible indoor air pollution sources and PID meter readings. If the building does not have a basement, please note.

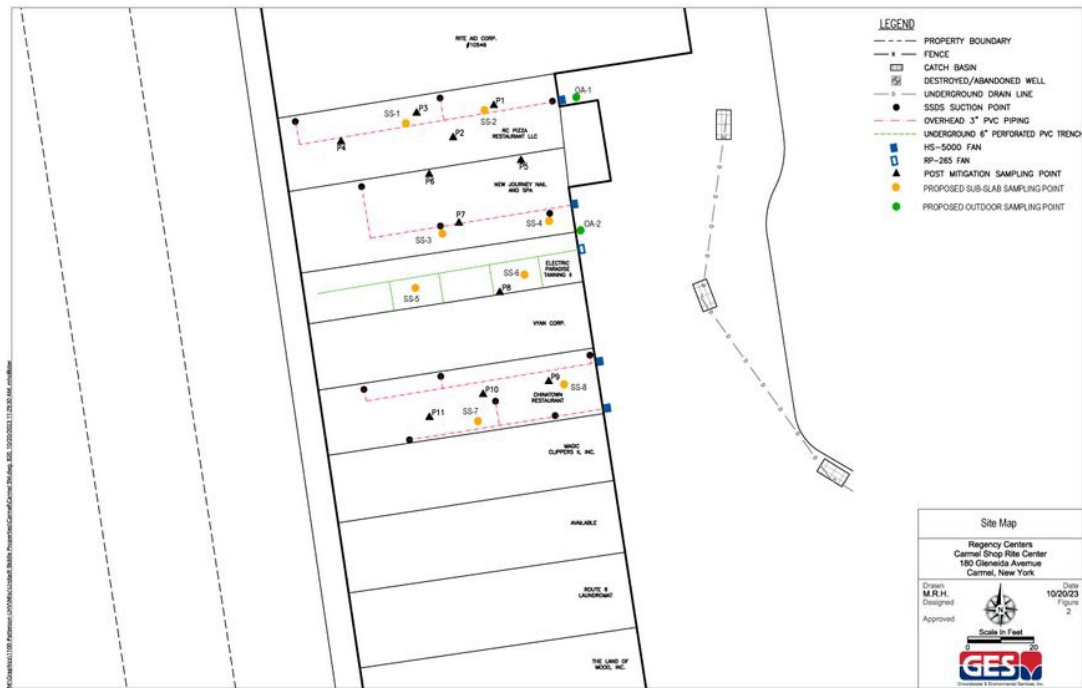
12. OUTDOOR PLOT

Draw a sketch of the area surrounding the building being sampled. If applicable, provide information on spill locations, potential air contamination sources (industries, gas stations, repair shops, landfills, etc.), outdoor air sampling location(s) and PID meter readings.

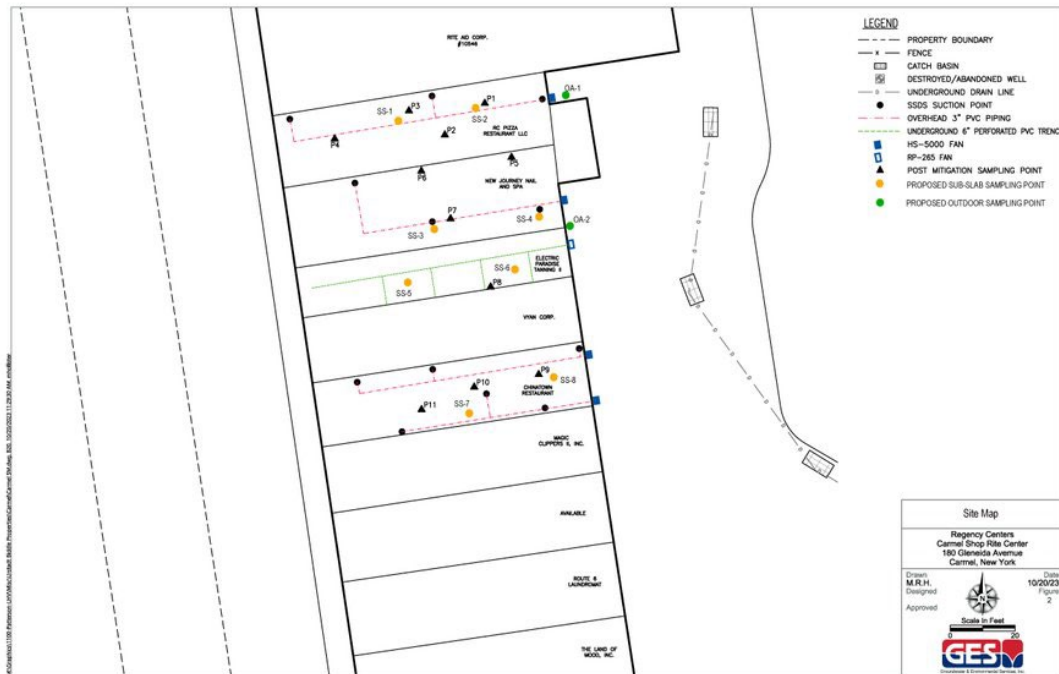
12. OUTDOOR PLOT

Draw a sketch of the area surrounding the building being sampled. If applicable, provide information on spill locations, potential air contamination sources (industries, gas stations, repair shops, landfills, etc.), outdoor air sampling location(s) and PID meter readings.

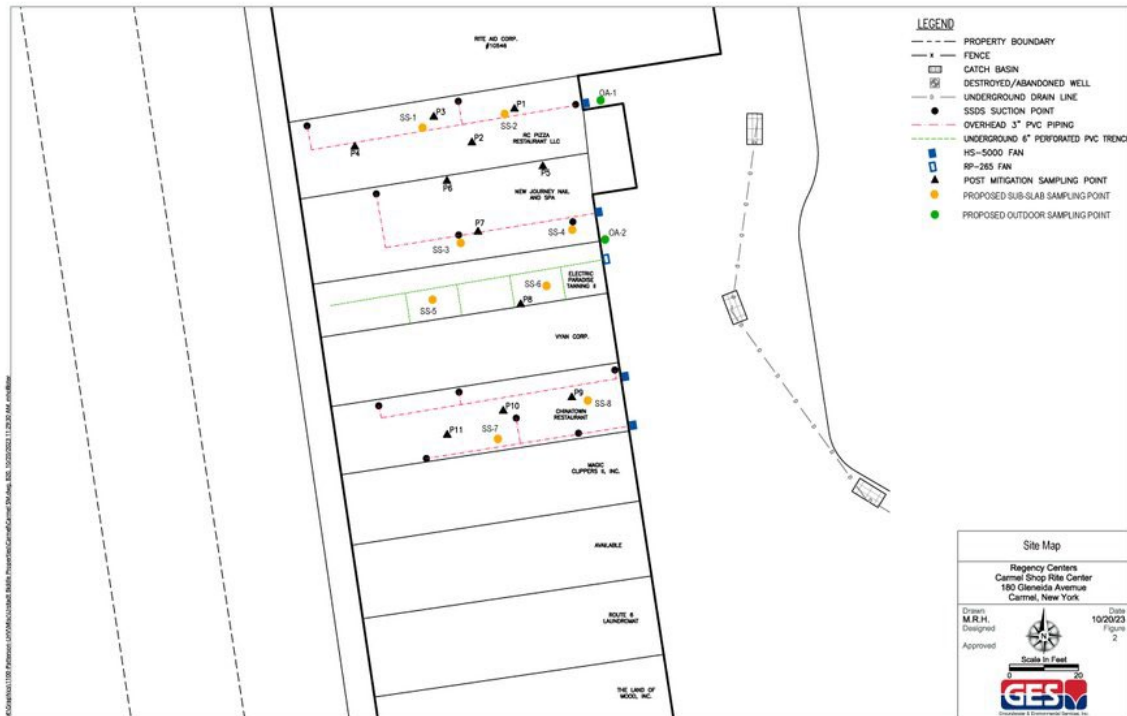
12. OUTDOOR PLOT

Draw a sketch of the area surrounding the building being sampled. If applicable, provide information on spill locations, potential air contamination sources (industries, gas stations, repair shops, landfills, etc.), outdoor air sampling location(s) and PID meter readings.
