# Remedial Action Work Plan

**PELHAM PLAZA  
PELHAM, NEW YORK  
SITE No. V00110-3**

**Volunteer: Levin Properties, L.P.  
North Plainfield, New Jersey**

**Prepared by  
MALCOLM PIRNIE, INC.  
17-17 Route 208 North  
Fair Lawn, NJ 07410**

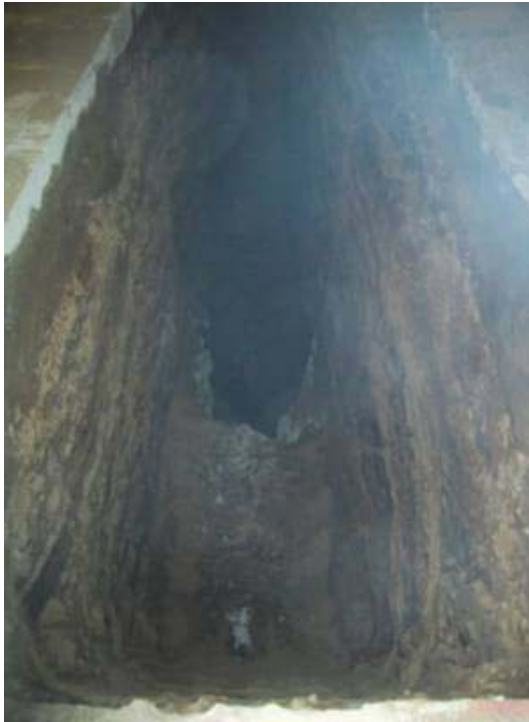
Photograph 1: Concrete slab at 7 to 7.5 feet bgs in TP-12, located at eastern edge of former 350,000 ft<sup>3</sup> relief holder footprint.

- A concrete slab at approximately 7 feet bgs was observed in test pits TP-12, TP-12B, TP-13 and TP-14, in an area associated with relief holder foundation. The slab was approximately six inches to one foot thick. A dried tar-like material was mottled in soils above the slab and present as a thin layer immediately above the slab.

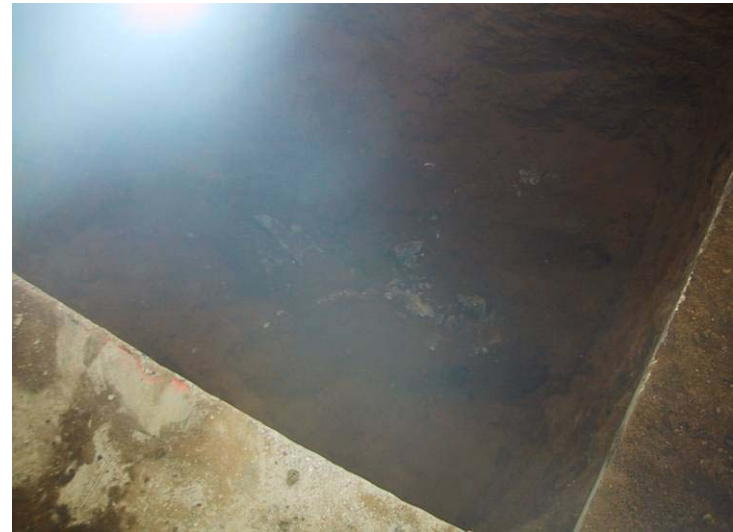
Photograph 2: Concrete slab at 7 to 8 feet bgs in TP-12B, located in center of former 350,000 ft<sup>3</sup> relief holder footprint.

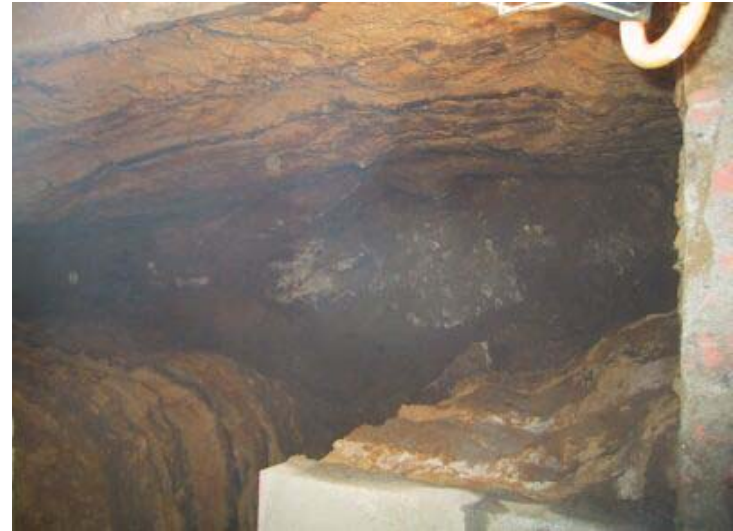
Photograph 4: Concrete slab at 7 feet bgs in TP-14, located at northern edge of former 350,000 ft<sup>3</sup> relief holder footprint.

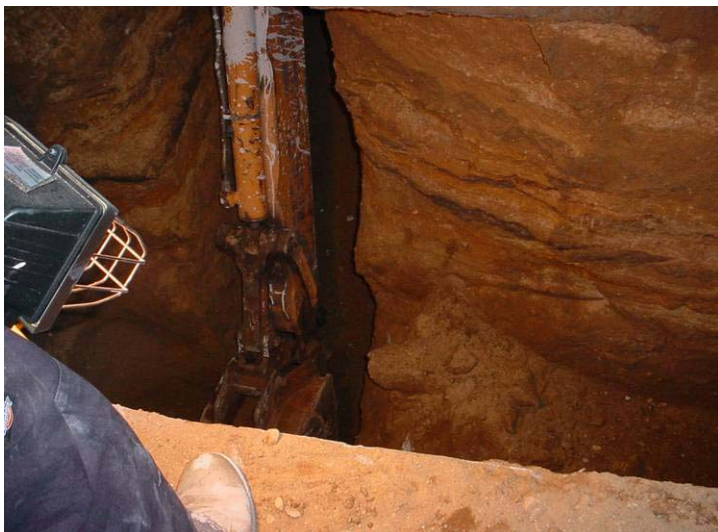
Photograph 5: Sidewall of TP-14, located at northern edge of former 350,000 ft<sup>3</sup> relief holder footprint.

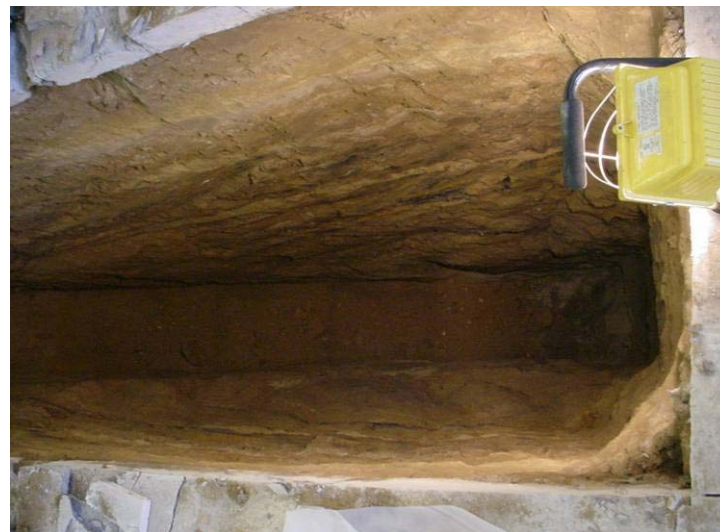
Photograph 6: Bottom of test pit at 12.5 feet bgs in TP-15, located within former purifier house footprint.

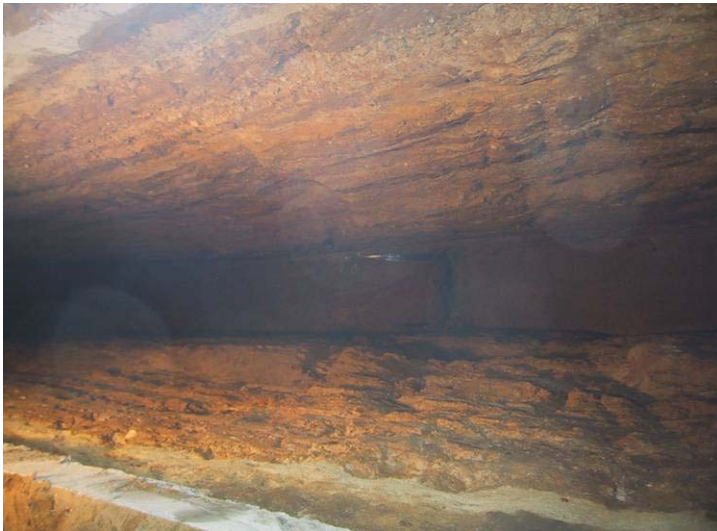
Photograph 7: Bottom of test pit at 13.5 feet bgs in TP-16, located in footprint of former purifier house.

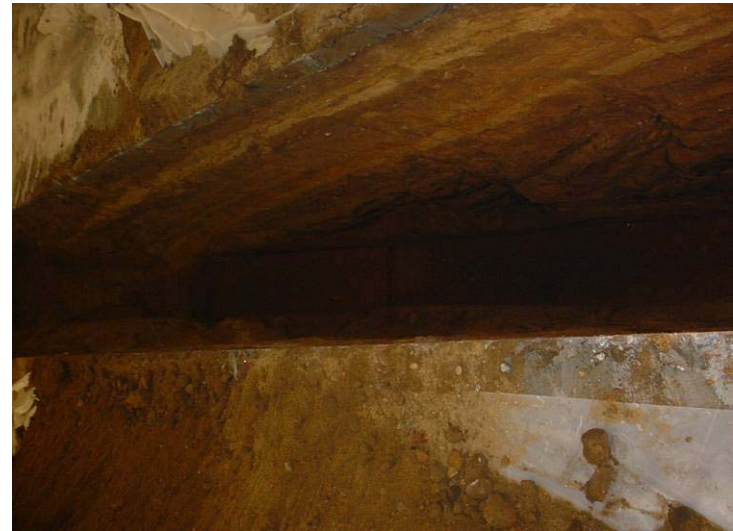
Photograph 8: Bottom of test pit at 13 feet bgs in TP-17, located within footprint of former purifier house.

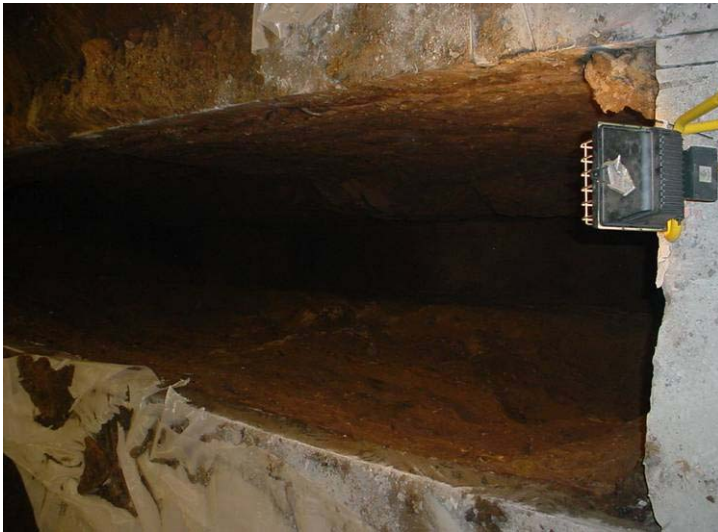
Photograph 9: Bottom of test pit at 12 feet bgs in TP-18, located at northern edge of former 1 million ft<sup>3</sup> gas holder footprint.

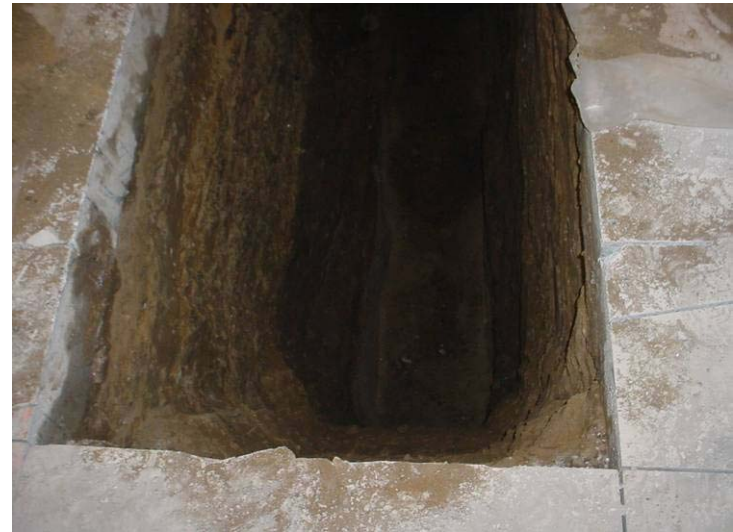
Photograph 10: Bottom of test pit at 12 feet bgs in TP-19, located at western edge of former 1 million ft<sup>3</sup> gas holder footprint.

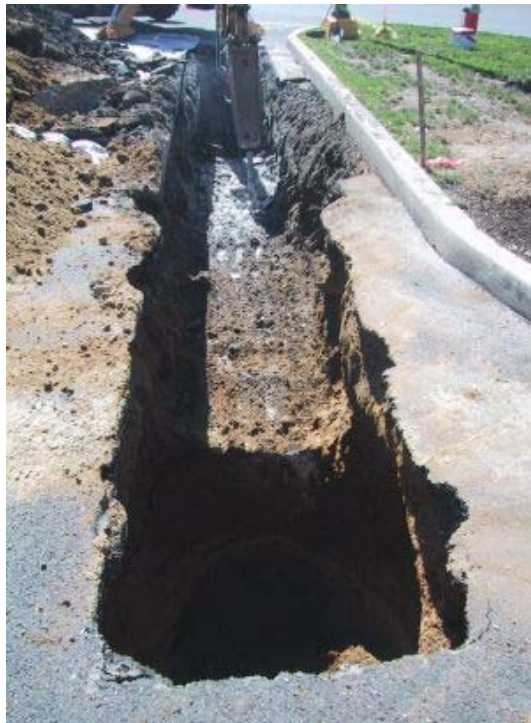
Photograph 11: Concrete pad at 5.5 to 6.5 feet bgs in TP-20, located at northern edge of former 3 million ft<sup>3</sup> gas holder footprint.

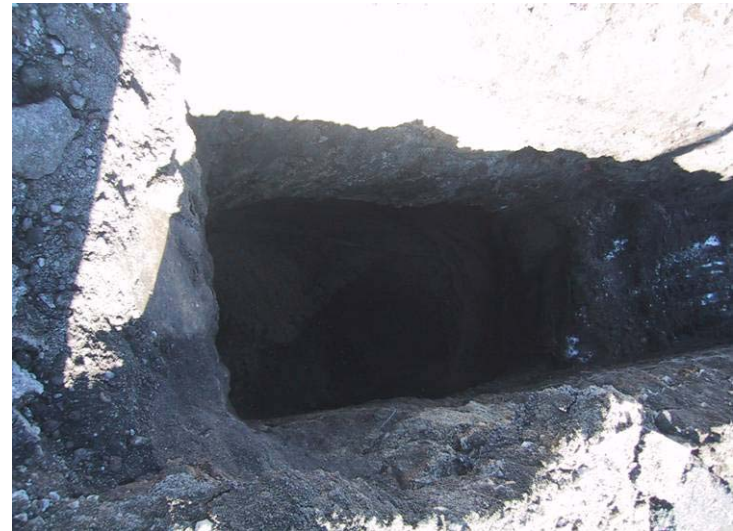
Photograph 12: Concrete slab at 5 to 7.5 feet bgs in TP-21, located at southern edge of former 3 million ft<sup>3</sup> gas holder footprint.

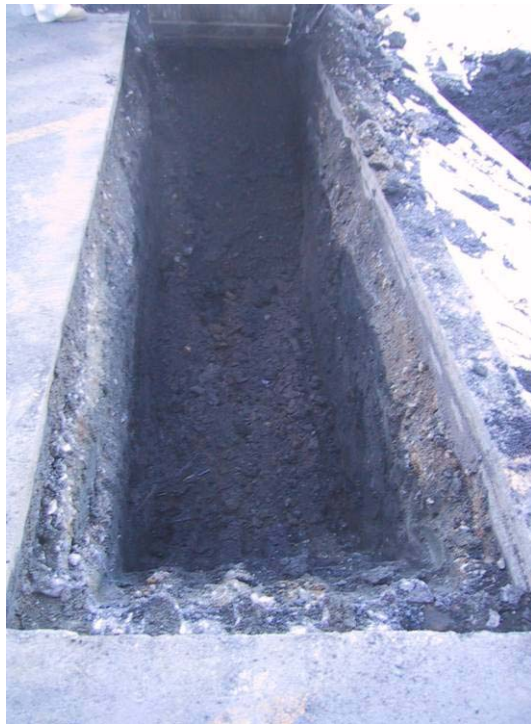
Photograph 13: Reddish-brown wood chips at 2.5 to 4.5 in TP-22, located adjacent to Mande's building.

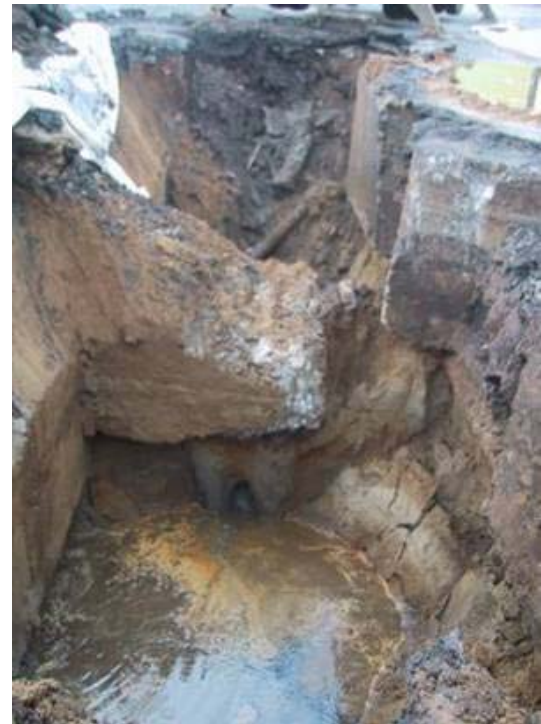
Photograph 14: Concrete and brick walls in TP-23, located within footprint of former generator house.

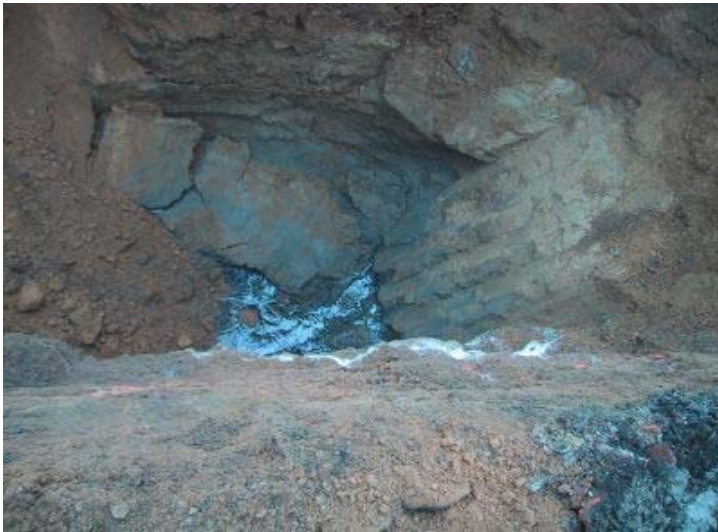
Photograph 15: NAPL at 8 to 10 feet bgs in TP-24, located within footprint of former generator house and adjacent to former underground brick tar tank.

was observed seeping into the excavation from the southern wall of TP-24 at 8 to 10 feet bgs.

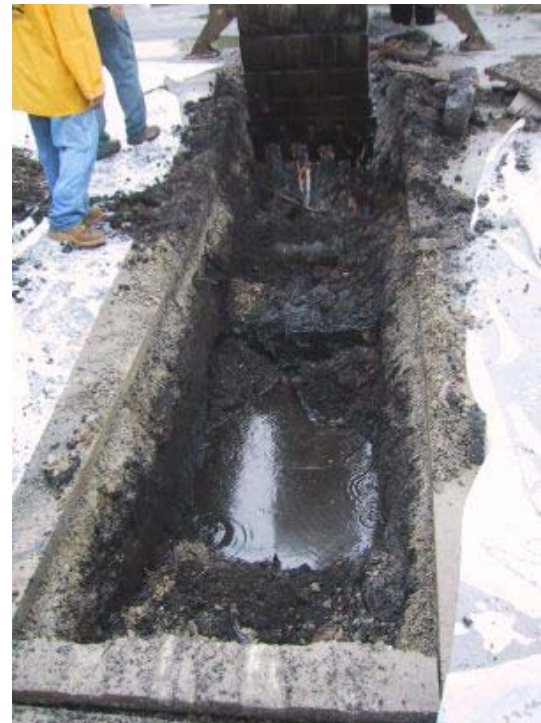
Photograph 16: Black-stained material and NAPL on groundwater at 1 to 4 feet bgs in TP-25, located within footprint of former underground brick tar tank.

- Test pit TP-25 was excavated within the footprint of the former underground brick tar tank, to the west of TP-7. A 12-inch metal pipe set in concrete was aligned east to west through the test pit at approximately 4 feet bgs. The concrete and brick chamber observed in TP-7 was not encountered in TP-25. TP-25 was advanced to 6 feet bgs where the elevated PID readings and the presence of NAPL at the water table made further excavation unsafe.

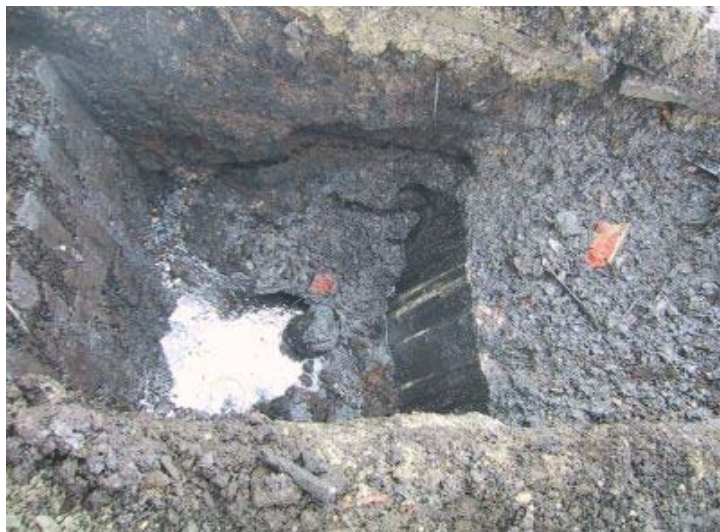
Photograph 17: Sheen on groundwater at 4 feet bgs in TP-25, located within footprint of former underground brick tar tank.

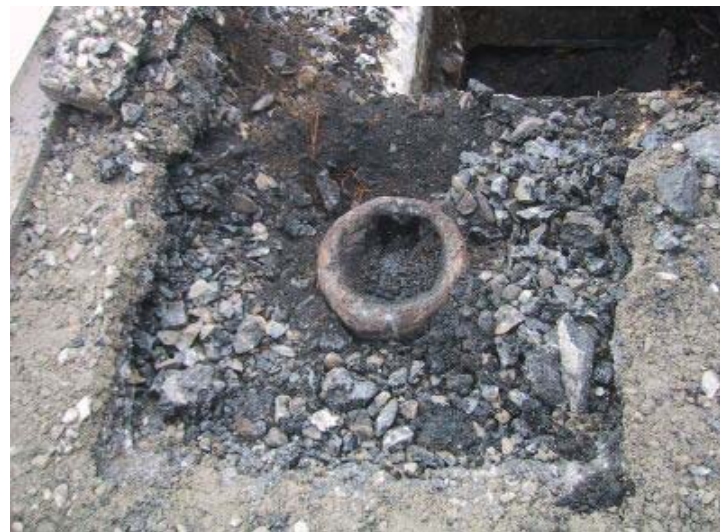
Photograph 18: Vertical pipe at approximately 0.5 feet bgs in TP-26, located within footprint of former pump house.

- A 12-inch vertical pipe, two steel beams, and four concrete partitions were present in test pit TP-26, excavated in the area of the former pump house. The structures were associated with elements of the pump house located in the central-western portion of the Site, near Eastchester Creek. A sheen was observed on soil and water within the pump house structure.

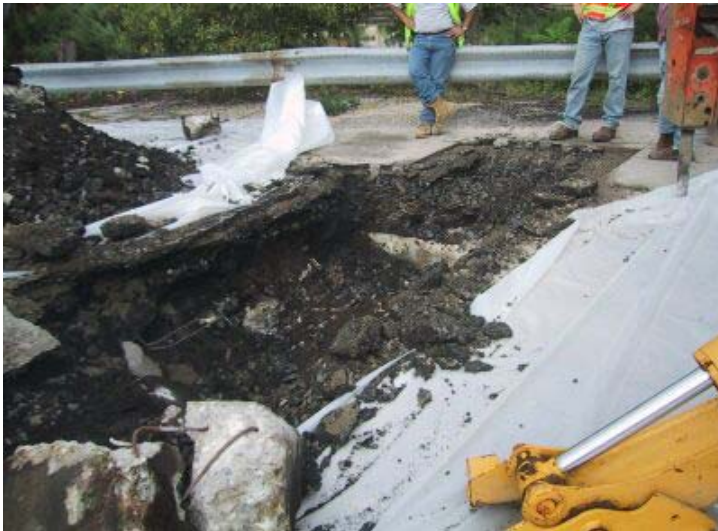
Photograph 19: Concrete partition at western end of TP-26, located within footprint of former pump house.

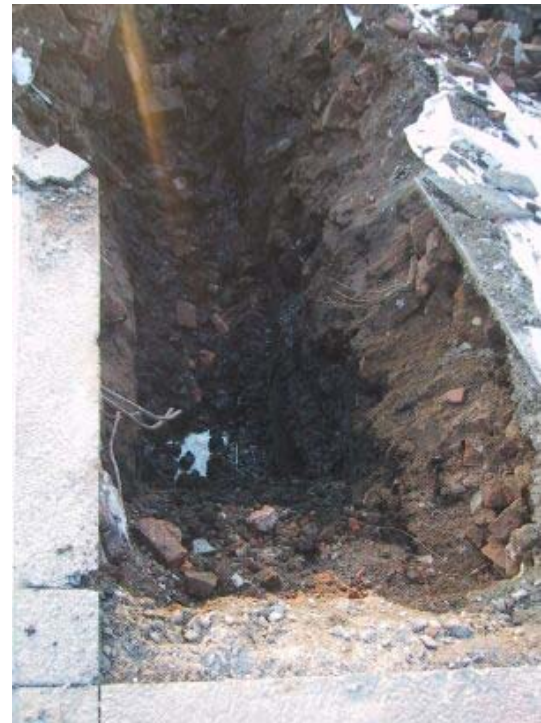
Photograph 20: NAPL and groundwater at 5 feet bgs in TP-29, located within footprint of former 100,000 gallon ammonia tank.

- Numerous bricks observed throughout test pit TP-29 were believed to be associated with remnants of the former 100,000-gallon ammonia tank located in the southwestern portion of the Site. An intact foundation was not identified during excavation in this area. NAPL saturated soil was observed at the water table in TP-29.

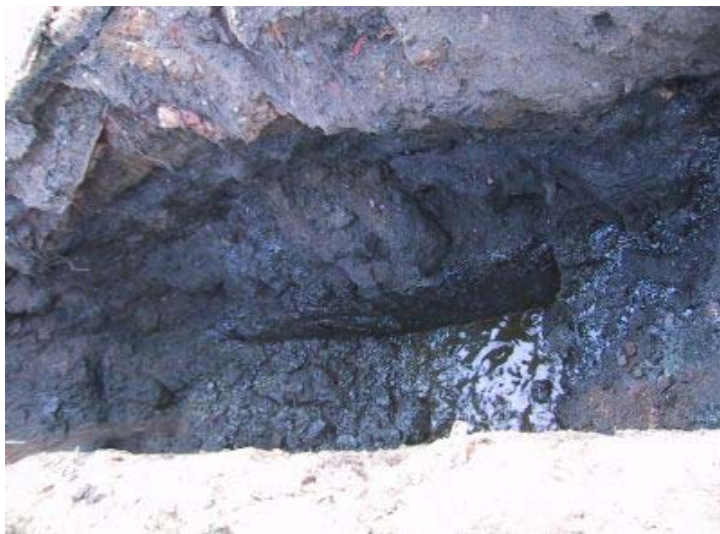
Photograph 21: Groundwater with sheen at 4 feet bgs in TP-31, located in southwestern portion of site, adjacent to Eastchester Creek.

- Brick was encountered at 5 feet bgs in TP-31. This brick wall or foundation did not appear to coincide with the location of any structures indicated on historic maps or aerial photos. A sheen was observed on soil and water in test pit TP-31.

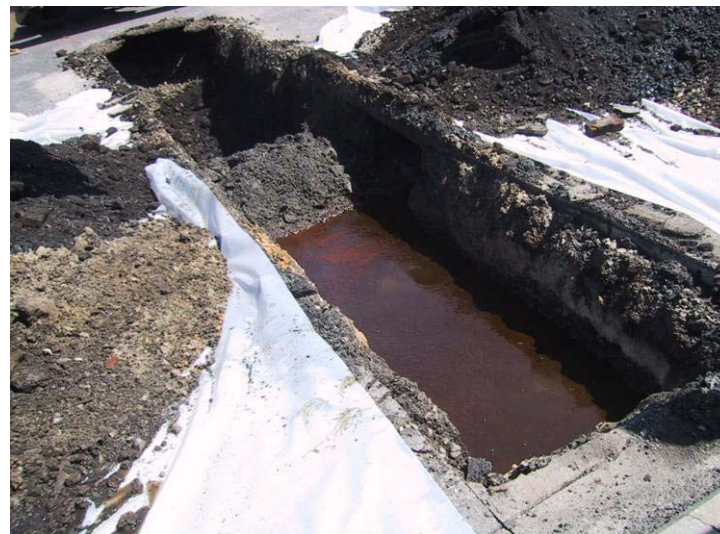
Photograph 22: Groundwater and NAPL at 2 feet bgs in TP-32, located in vicinity of former brick storage area.

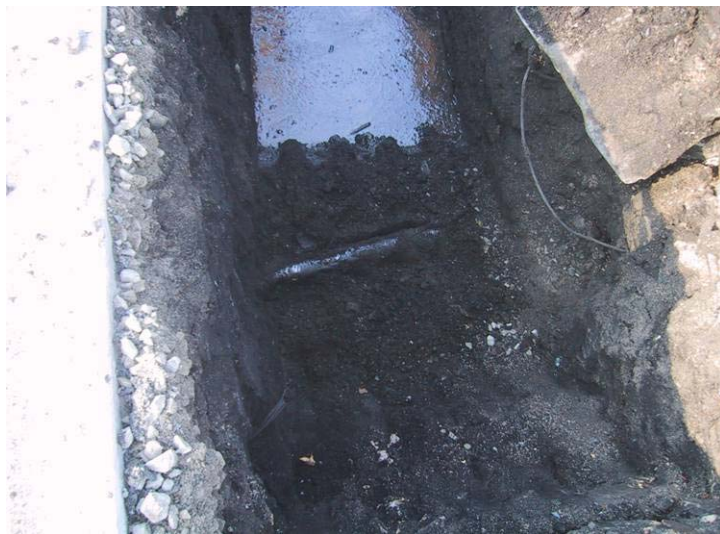
Photograph 23: Metal pipe and groundwater with sheen at 4 feet bgs in TP-33, located north of TP-32.

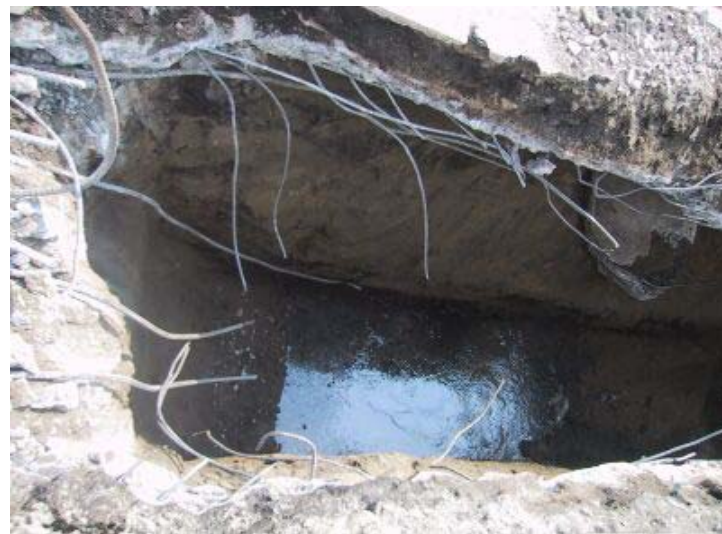
Photograph 24: Concrete pad with rebar and groundwater with sheen at 6 feet bgs in TP-34, located within footprint of former liquid petroleum process building.

- A 4-inch concrete and rebar pad was located just below the ground surface and two concrete walls were uncovered at three feet below grade in test pit TP-34. A sheen was observed on groundwater within the structure. These structures were associated with the liquid petroleum process building foundation.

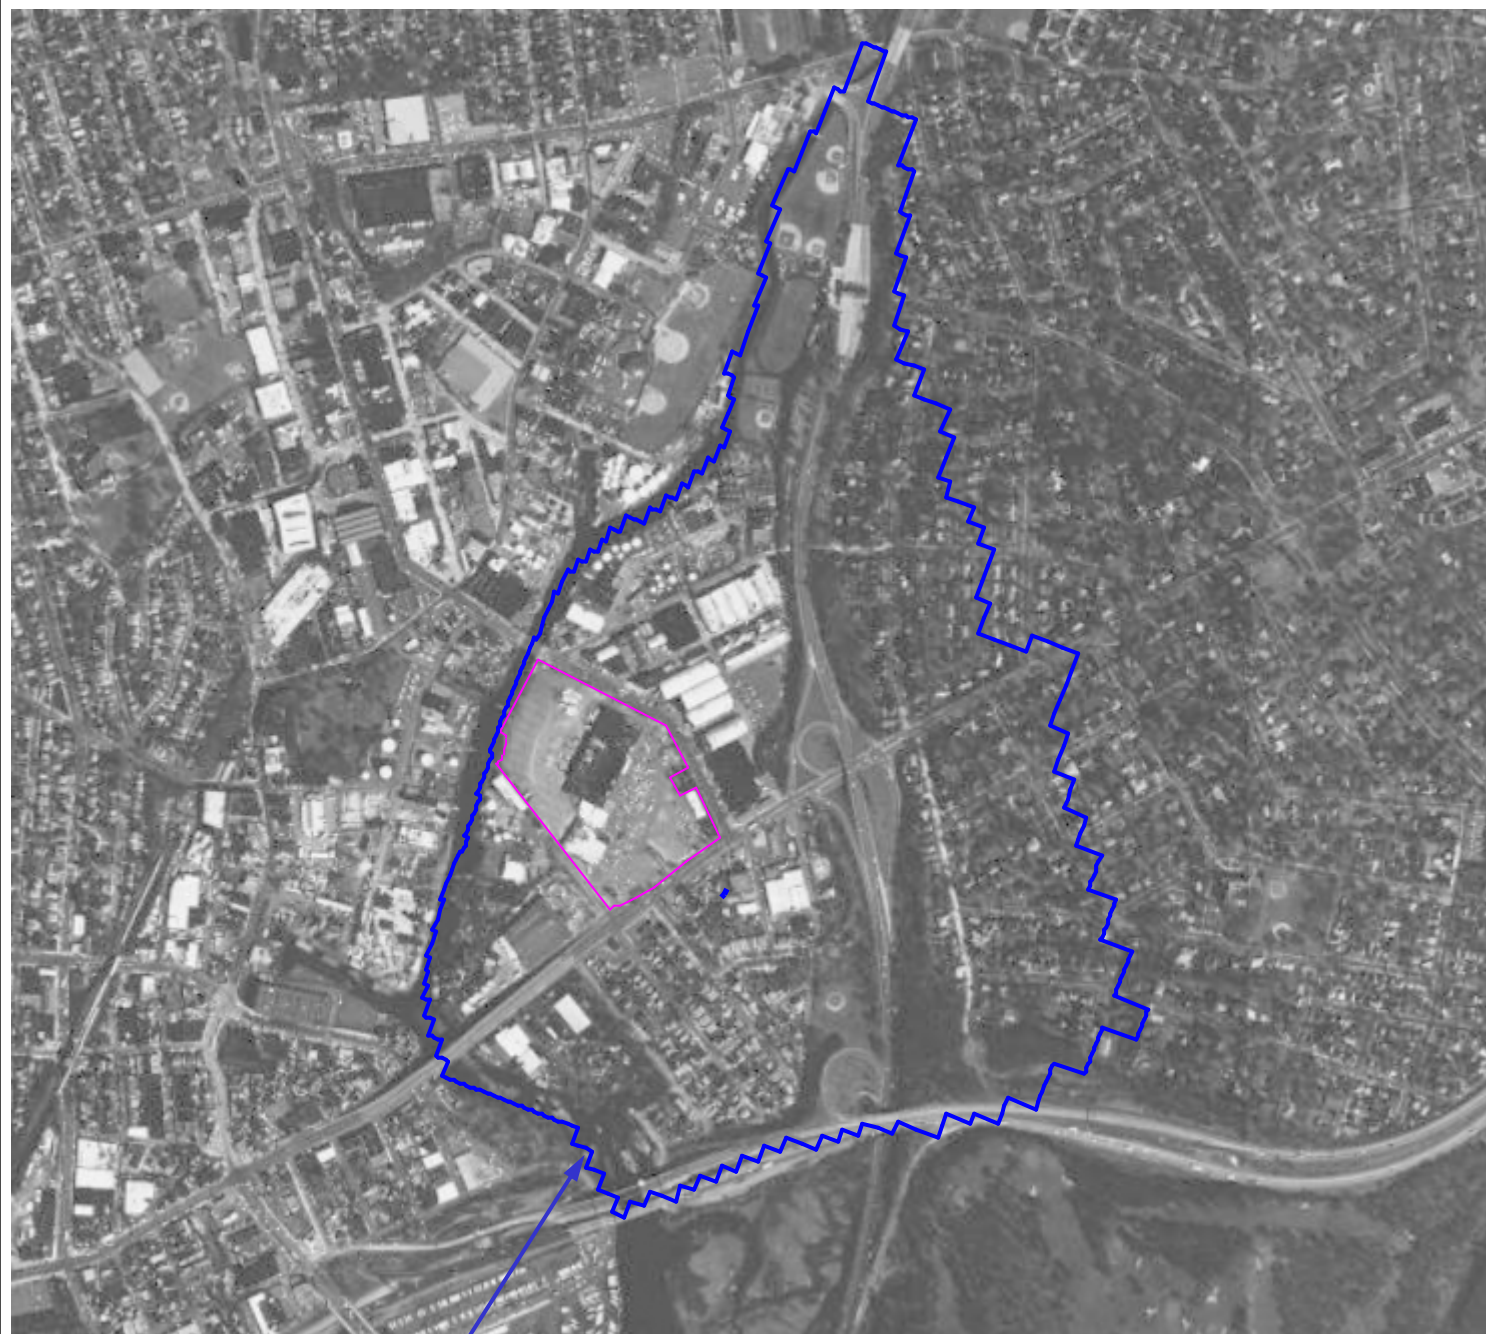
MODFLOW Model: F:\PROJECT\4933001\Pelham Model\Simulations\FULL\_WALL03.mfs (GMS: FULL\_WALL.gpr)  
LOCATION: F:\PROJECT\4933001\Pelham Model\Results\HC Model Results.PPT

**MODEL DOMAIN**

**SITE AREA/ PROPERTY LINE**

As shown in Figure I-1 the grid was constructed in a northeastern-southwestern orientation generally parallel to the section of Eastchester Creek adjacent to the site, which is generally consistent with regional flow conditions. Grid cells in the vicinity of the site are 20-feet by 20-feet in size. Outside of the site area, the cells increase in size by a factor of 1.1 to a maximum size of 200-feet by 200-feet. The refined grid in the vicinity

A two-well cluster was necessary for hydraulic control near the southern end of the hydraulic barrier wall with wells screened above and below the peat layer. The simulation indicated that hydraulic control at the northern property boundary near the barrier wall was better facilitated by pumping on the existing RW-1 instead of extending the proposed barrier wall into the site.
