**Periodic Review Report**

25 Melville Park Road  
Melville, New York  
NYSDEC Site No. V00128

25 Melville Park Road Site  
Melville, New York  
NYSDEC Site No. V00128

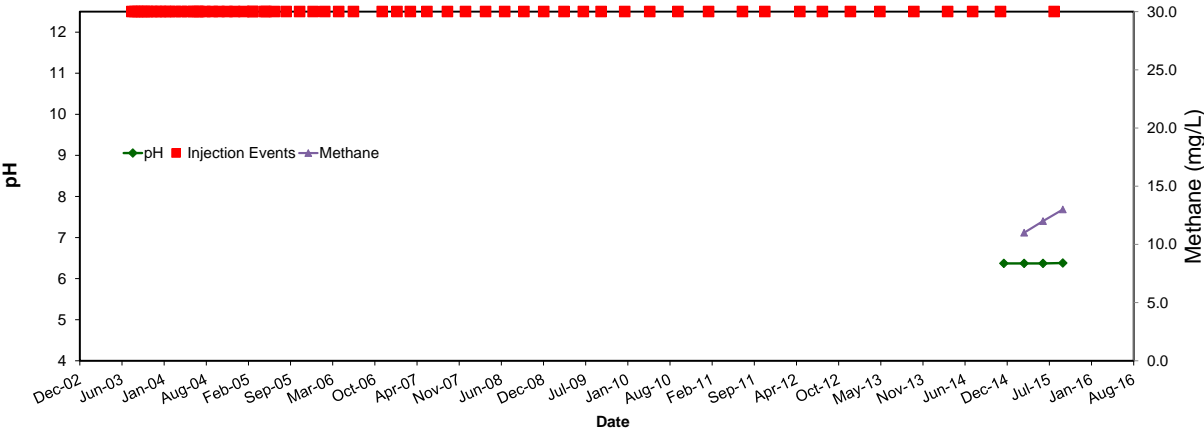
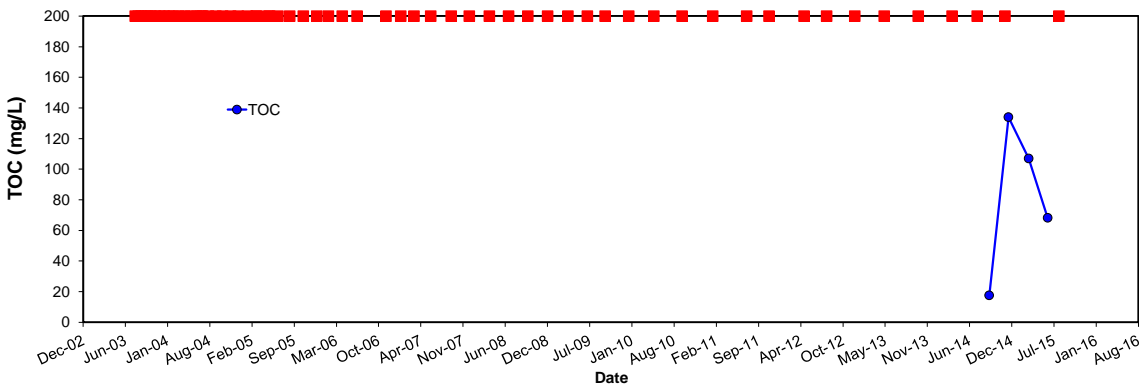
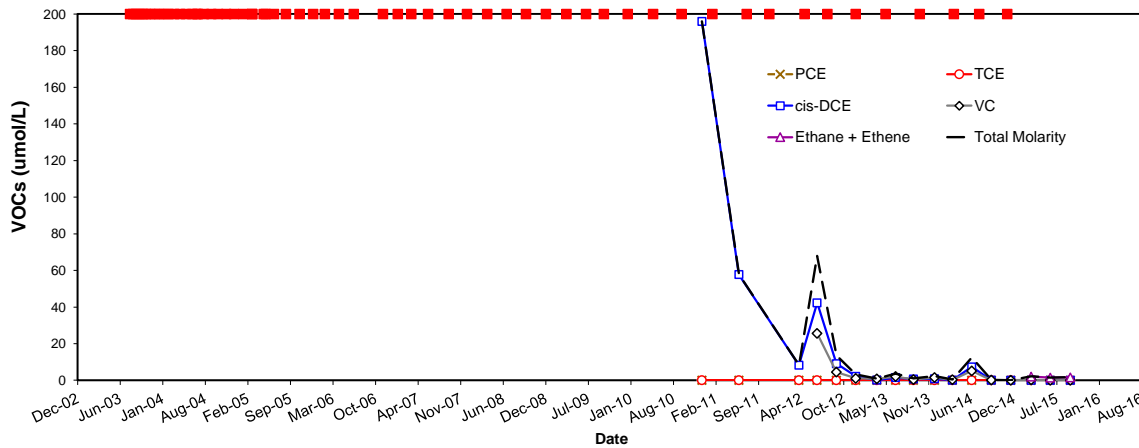
Figure D-1. Degradation Trends for Shallow Zone Monitoring Well MW-28M

present and active within the subsurface and confirms that COCs are undergoing complete reductive dechlorination through a biologically mediated pathway. Ethane and ethene detections were widespread during monitoring activities conducted during this reporting period. These data corroborate TOC data and indicate that complete reductive dechlorination is occurring within the IRZs. A summary of the ethene and ethane analytical data collected during the reporting period is provided in Table 3. Trend plots that include the concentration of ethene and ethane versus time for key monitoring wells (MW-28M and MW-31 in the shallow zone and IW-18, MW-23 and MW-34 in the intermediate zone) are provided in Appendix D.
