# **VOLUNTARY CLEANUP PROGRAM FINAL REPORT**

**SITE NO. V-00150-7**

**VOLUNTARY CLEANUP  
AGREEMENT NO. A7-0466-0702**

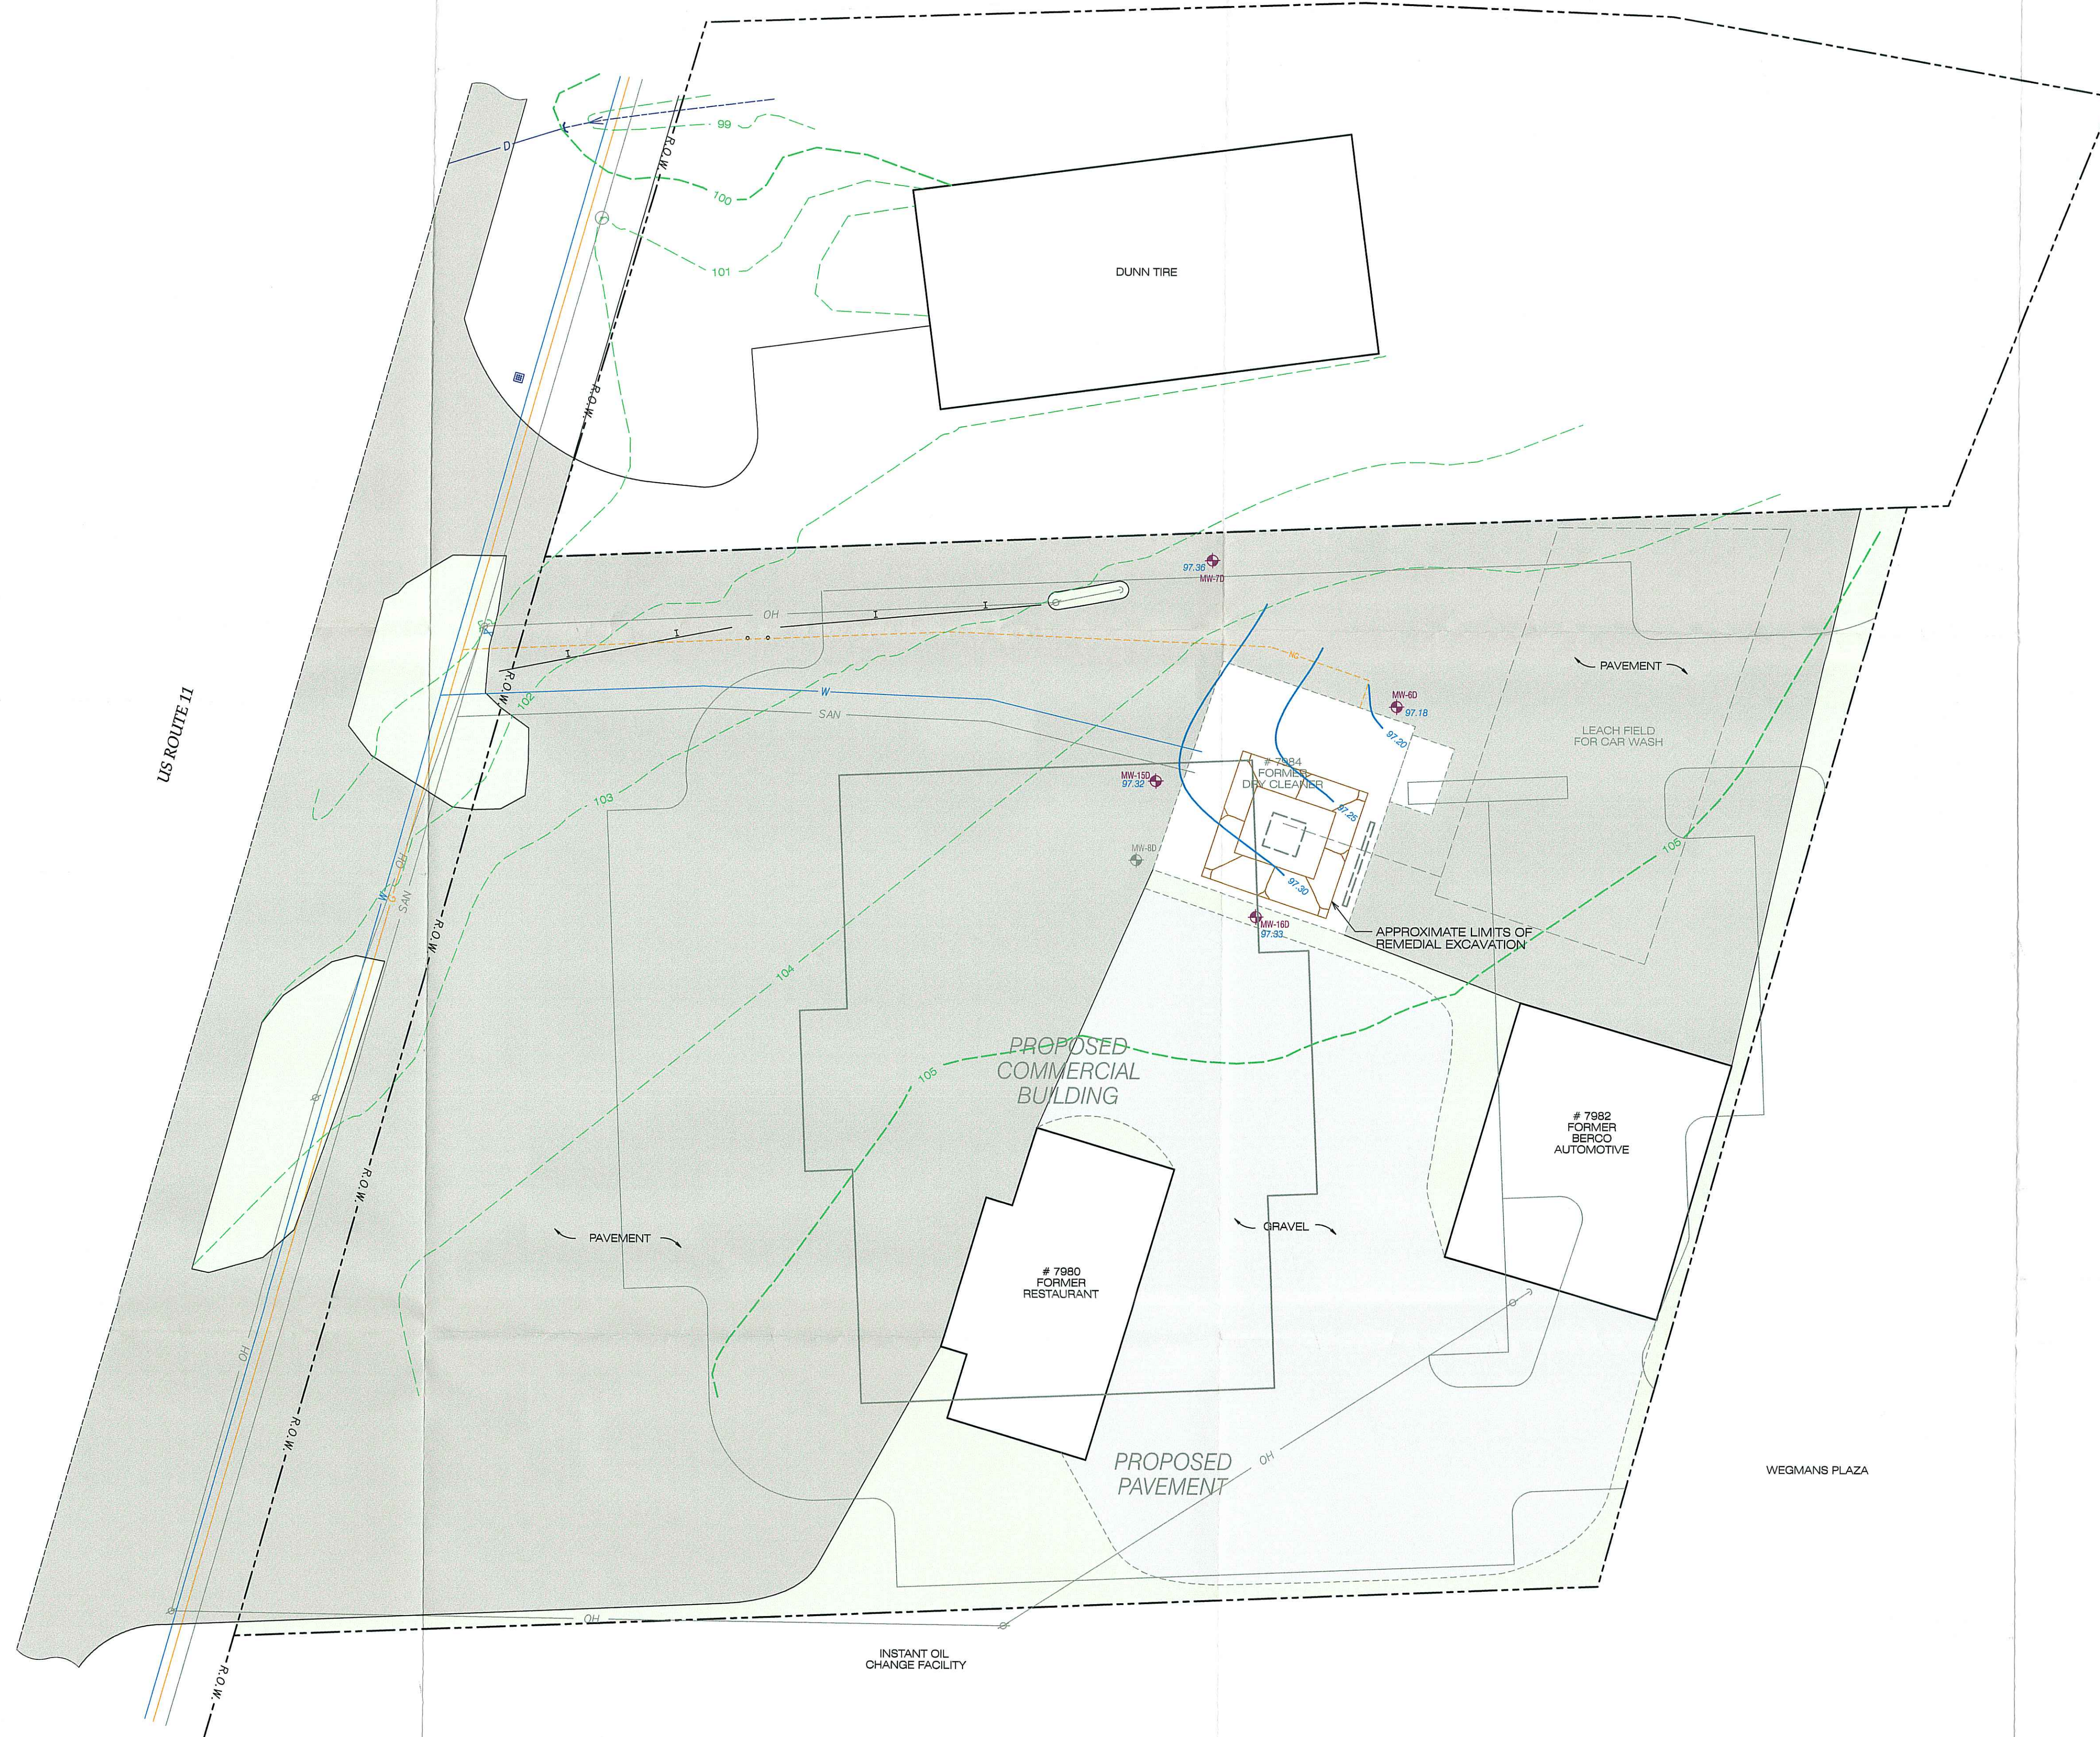
#### Existing

- Deep Monitoring Well Location
- Injection Well
- Injection Trench Location
- Overhead Electric Line
- Water Service Line
- Natural Gas Service
- Deep Groundwater Contour (Based on 07-18-06 Data)
- Groundwater Elevation (Based on 07-18-06 Data)

Flow direction for the deep groundwater was based only on deep wells completed into the same stratigraphic horizon, therefore excluding use of groundwater measurements in MW-8D. Flow direction based on the November 2005 measurement in three deep wells was found to be to the south-southeast in March 2006 and to the northeast in July 2006. In terms of the deep groundwater flow direction from the former sump area, in November 2005 MW-16D may be characterized as peripherally downgradient, while in July 2006 MW-6D was located directly downgradient.
