FINAL SITE REMEDIATION REPORT

2614-2620 UNIVERSITY AVENUE
BRONX, NEW YORK

Prepared for:
The Jewish Home and Hospital
New York, New York

Project No.: JHH0201

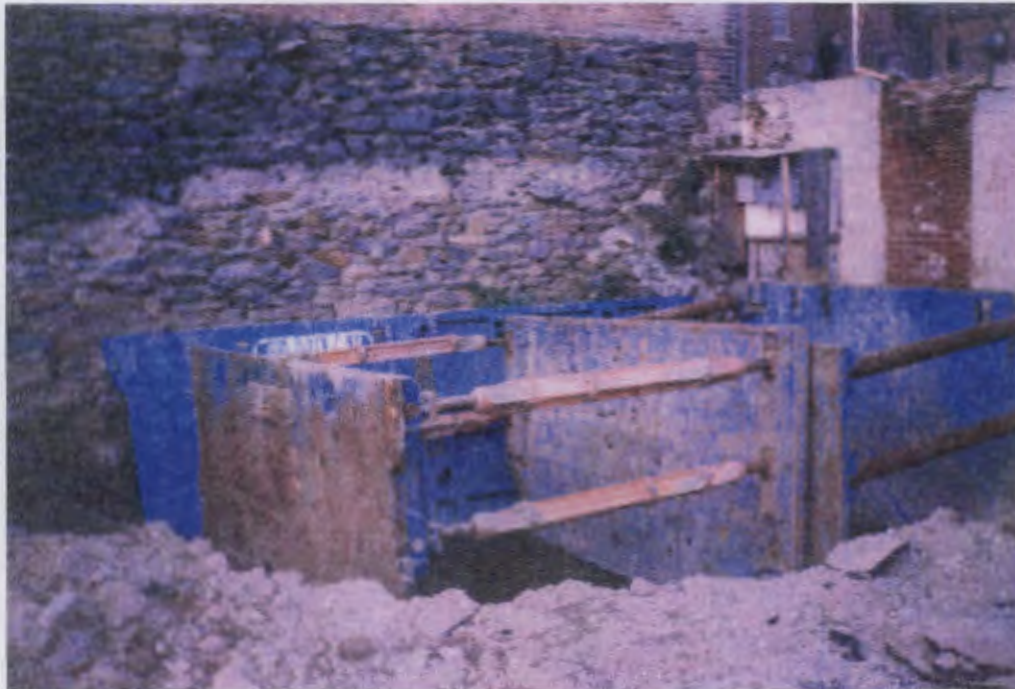
Figure 1 – Excavation of the southwest corner of the site along the Orchard Mews building

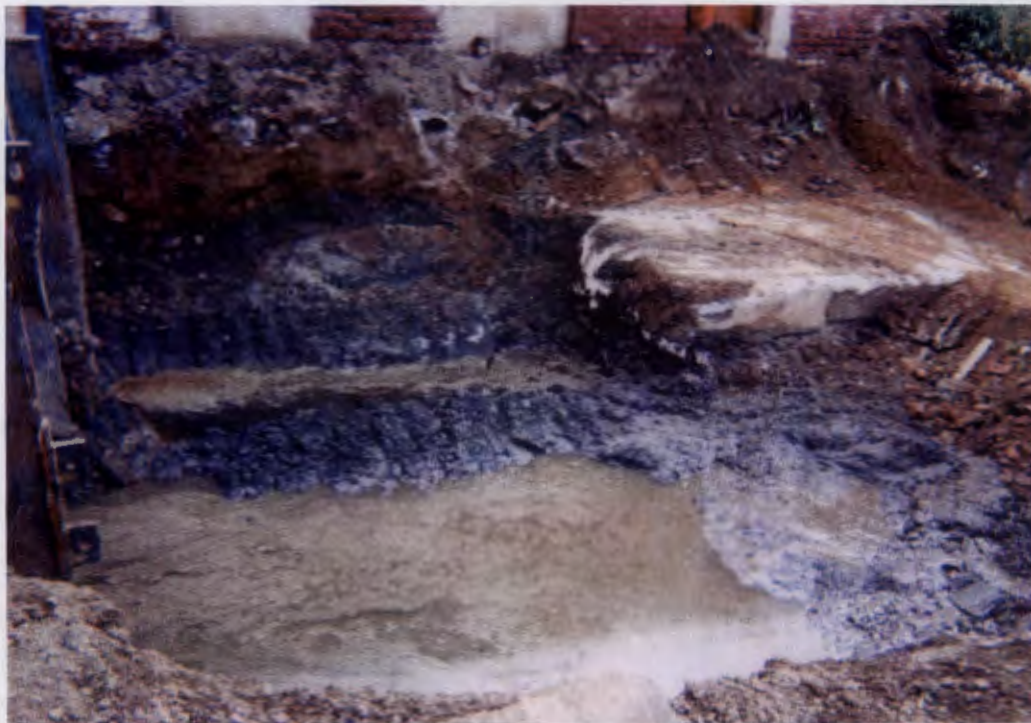
Figure 2 – Soil excavated to bedrock in western portion of the excavation. A concrete encased 550 gallon tank was encountered.

Historic site information and the presence of fill ports indicated that there were three 550-gallon gasoline USTs located in the western portion of the property. The tanks were reportedly abandoned in place in 1994. During the October 2000 soil excavation only two tanks were encountered in one concrete vault. However, the third tank was discovered in its own concrete vault during the soil excavation work. The tank was discovered closer to the University Avenue sidewalk than the other two. This area was not accessible during the October 2000 removal efforts due to the presence of a rubble berm, installed to support the building walls and adjacent sidewalk following the building demolition. The tank had been abandoned, identical to the two USTs previously removed in 2000. Brookside removed the top of the vault to allow access and confirmed that the tank was filled with a mixture of sand and water. Water in the tank (with a slight petroleum odor) was sampled and pumped into a tank truck for disposal. The sample was submitted to Chemtech Laboratories, Mountainside, New Jersey for petroleum fingerprint analysis by EPA Method 8015 to confirm the tank contents. Analytical results indicated that the liquid contained weathered gasoline constituents.

The tank was removed from the excavation and appeared to be in good condition with no evidence of holes and/or corrosion. Brookside cut the tank open and removed the sand which was stored in the contaminated soil stockpile pending proper disposal. Water in the excavation was pumped into a tank truck. After the tank was cleaned it was loaded onto a truck for off-site disposal.

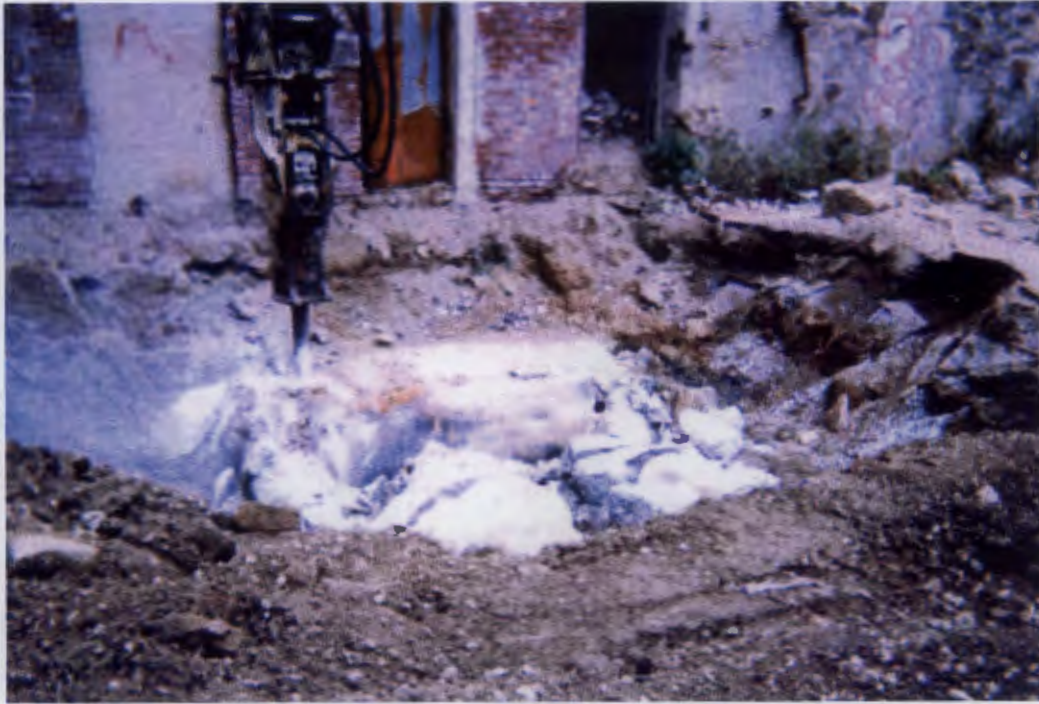
Figure 3 – Concrete vault around the tank was removed to access the tank.

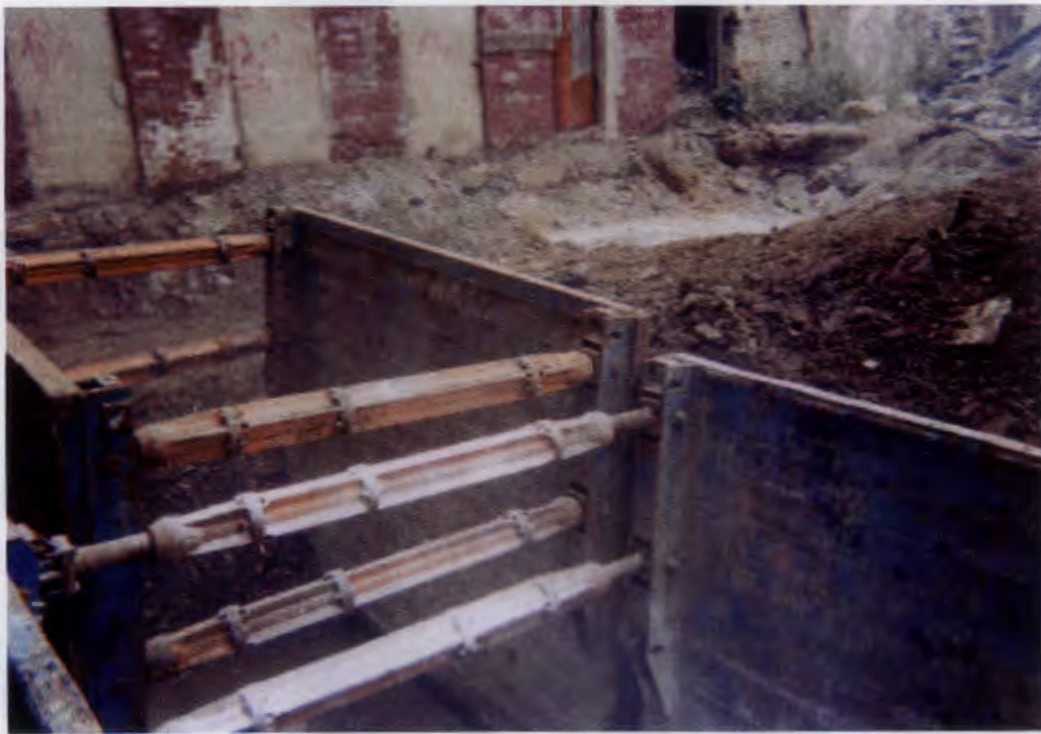
Figure 4 – Removal of soils along the south property line. Photo taken following the backfilling of the western portion of the excavation.

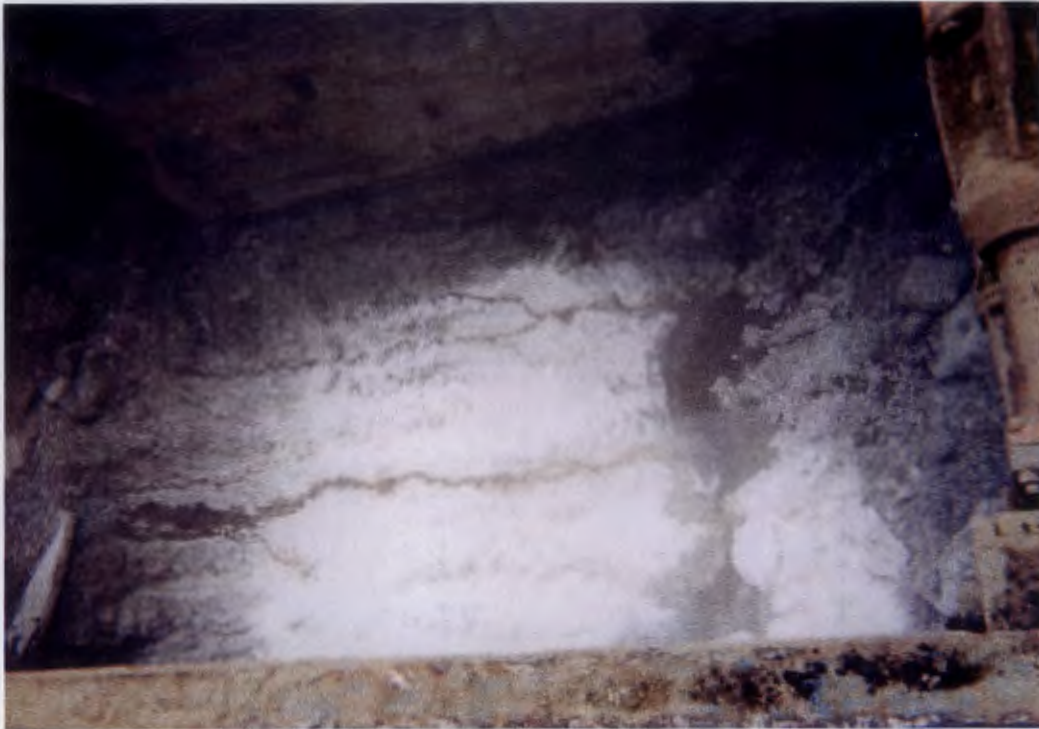
Figure 5 – ORC application within the excavation shown on Figure 3.

Because of the benefits of using oxygen releasing compounds to enhance the remediation of
petroleum constituents, this technology was incorporated into the proposed remedial design.
Following excavation of each soil zone, ORC was spread over the floor of the excavation to address
dissolved contamination and accelerate groundwater remediation in the vicinity of PS-11 and PS-12.
Consistent with previous investigations, groundwater was not encountered above bedrock in some
areas of the excavation. The manufacturer (Regenesys) provided software that incorporated
excavation dimensions and the SSI groundwater analytical data to calculate the amount of ORC to
be used. Approximately 1,100 pounds of ORC were applied directly to groundwater, providing an

ORC application thickness of one-quarter inch in each of the excavation zones that did contain groundwater.

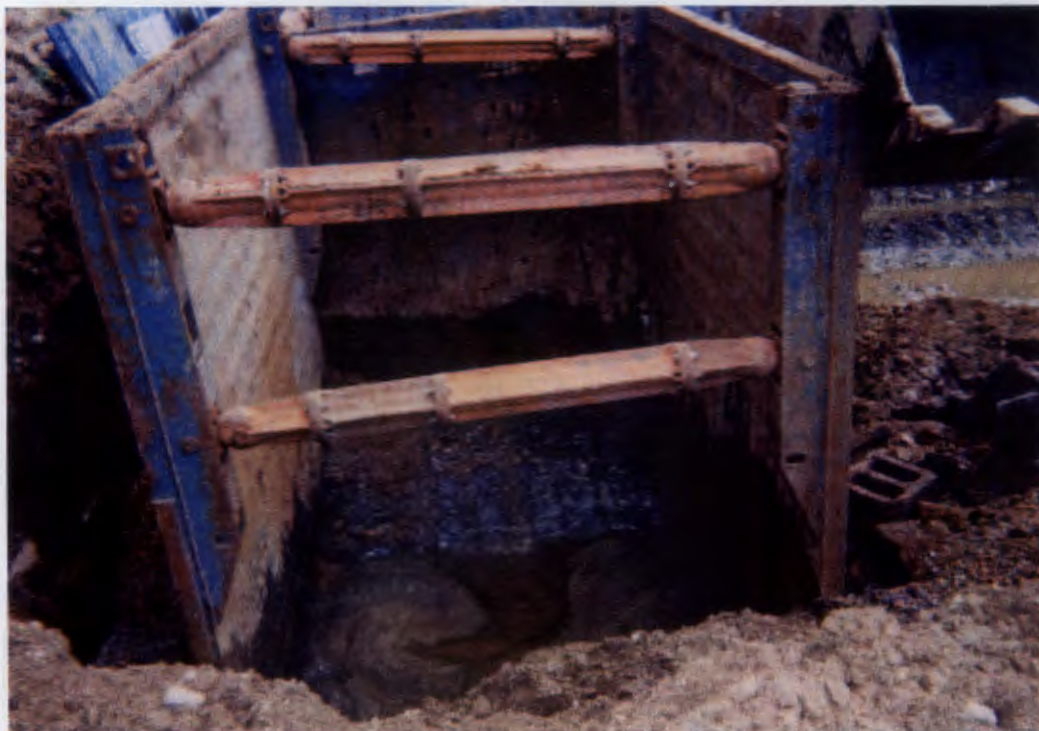
Figure 6 – Excavation to bedrock along the south property line.

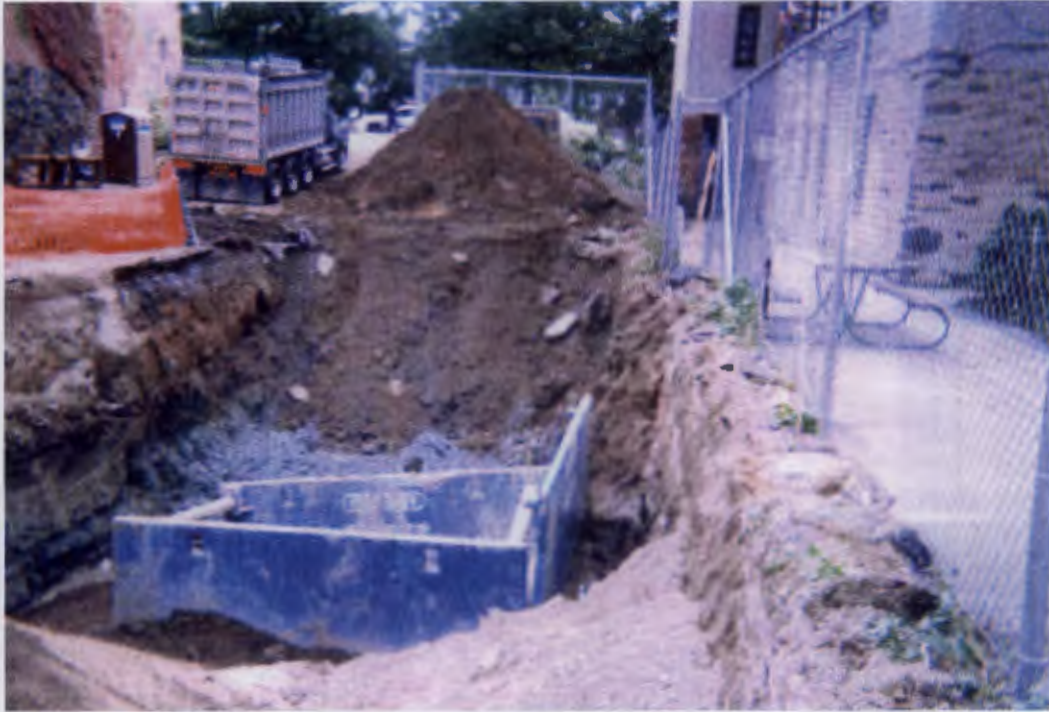
Figure 7 – Excavation along the south property line. Impacted soil was noted at approximately eight feet below grade.

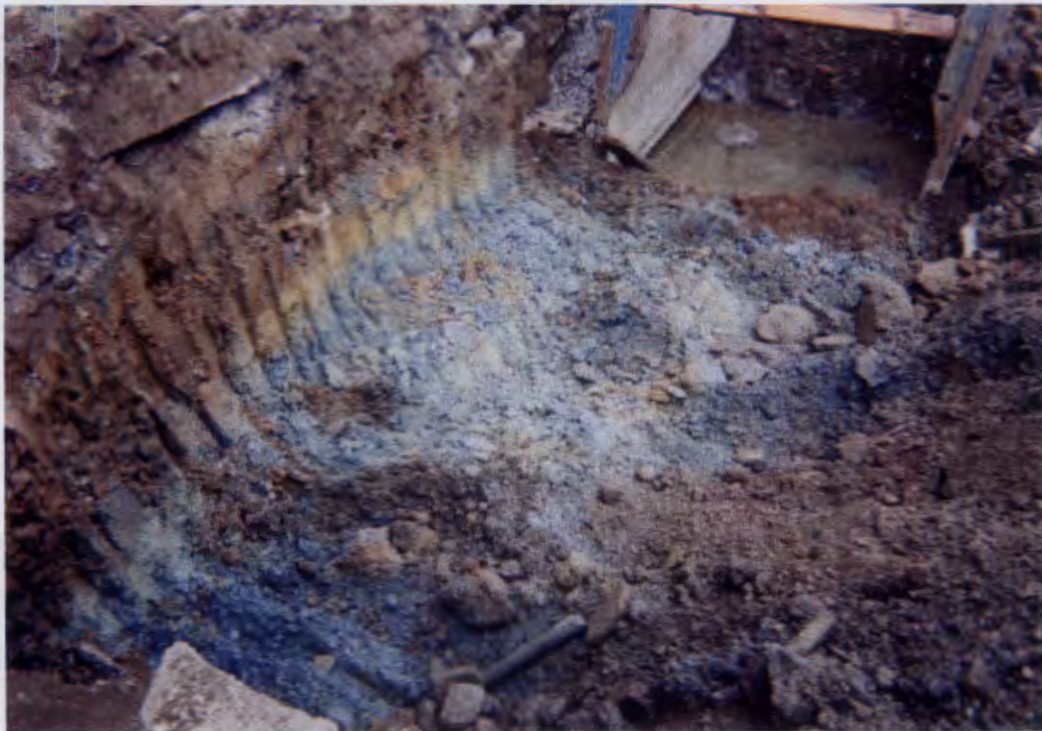
Figure 8 – Impacted soils encountered in the central portion of the excavation.

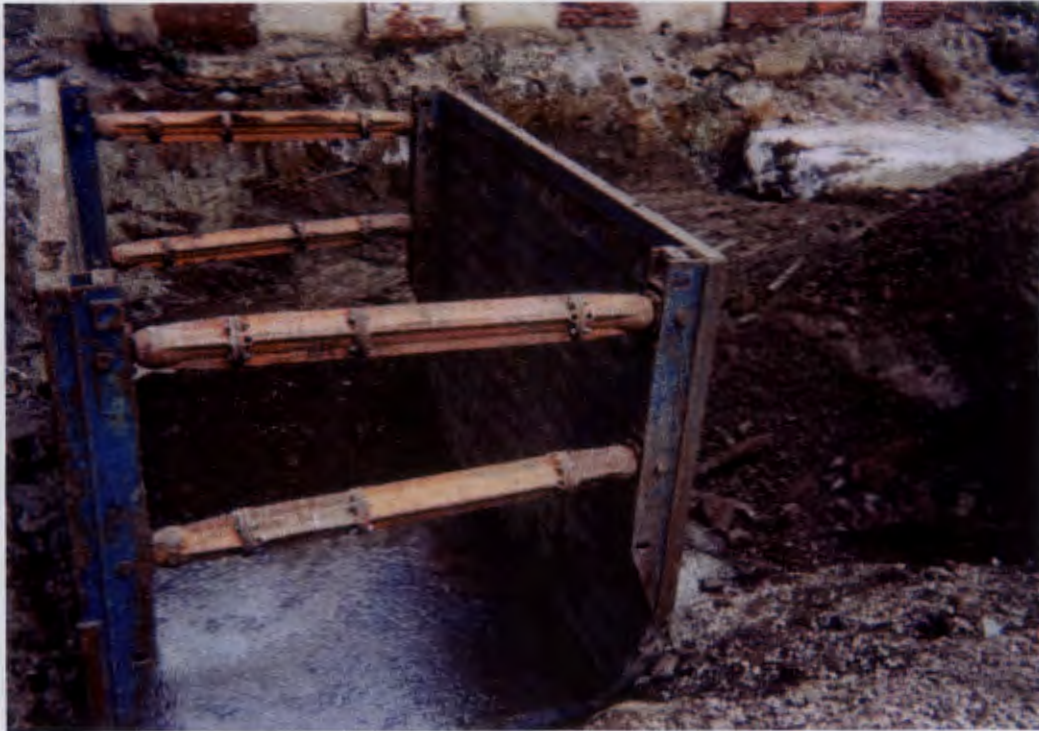
Figure 9 – Overnight groundwater would seep into the open excavation.

Groundwater beneath the site occurs at a depth of approximately six feet below grade in the tight silt and clay. Because the proposed excavation extended to bedrock and below groundwater in most areas, dewatering of the excavation was necessary to facilitate the excavation of deep soils. Because a shoring box system was installed close to bedrock around the perimeter of each of the excavation zones, groundwater infiltration to the excavation was minimized. Groundwater that was present or

infiltrated the excavation area was removed from the excavation by pumping it directly into a tank truck for transportation to an appropriate off-site disposal facility. This removal of groundwater – which may be contaminated – is expected to accelerate cleanup of the site. A total of 31,468 gallons of groundwater were removed during the course of the excavation work. The groundwater was transported from the site by Terrace Transportation for disposal as petroleum contaminated water at the Clean Water of New York, Inc. Facility in Staten Island, New York (EPA ID. No. NYR000080549). Copies of the liquid waste manifests are included in Appendix B. No analyses of this water were conducted by Brookside or PWGC.

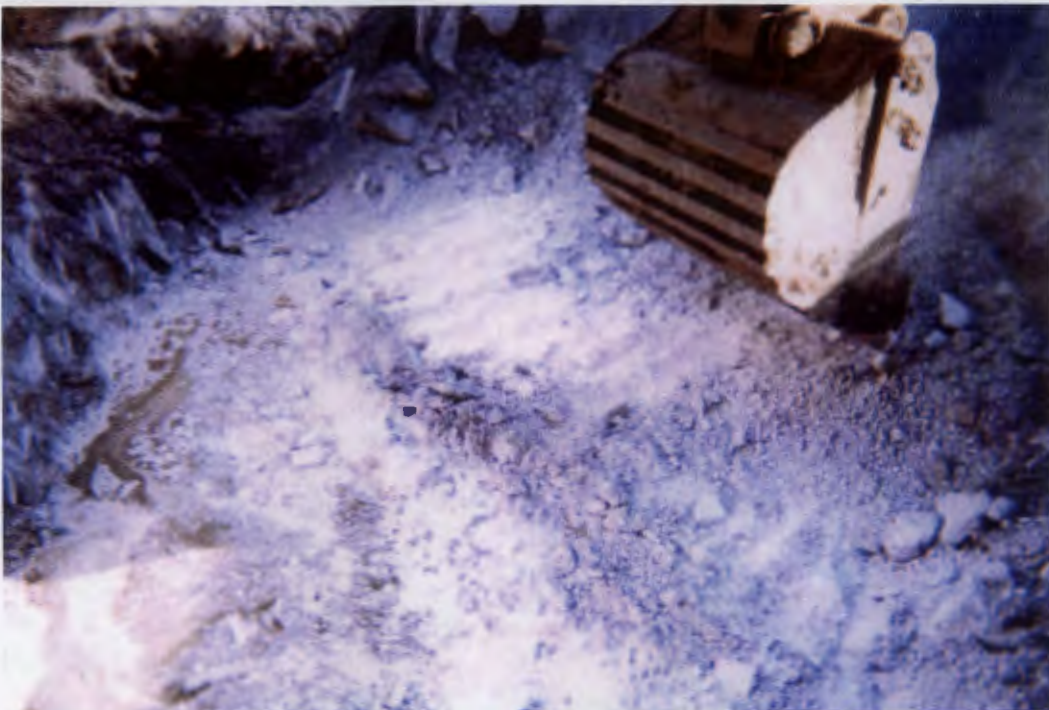
Figure 10 – ORC application within the excavation.

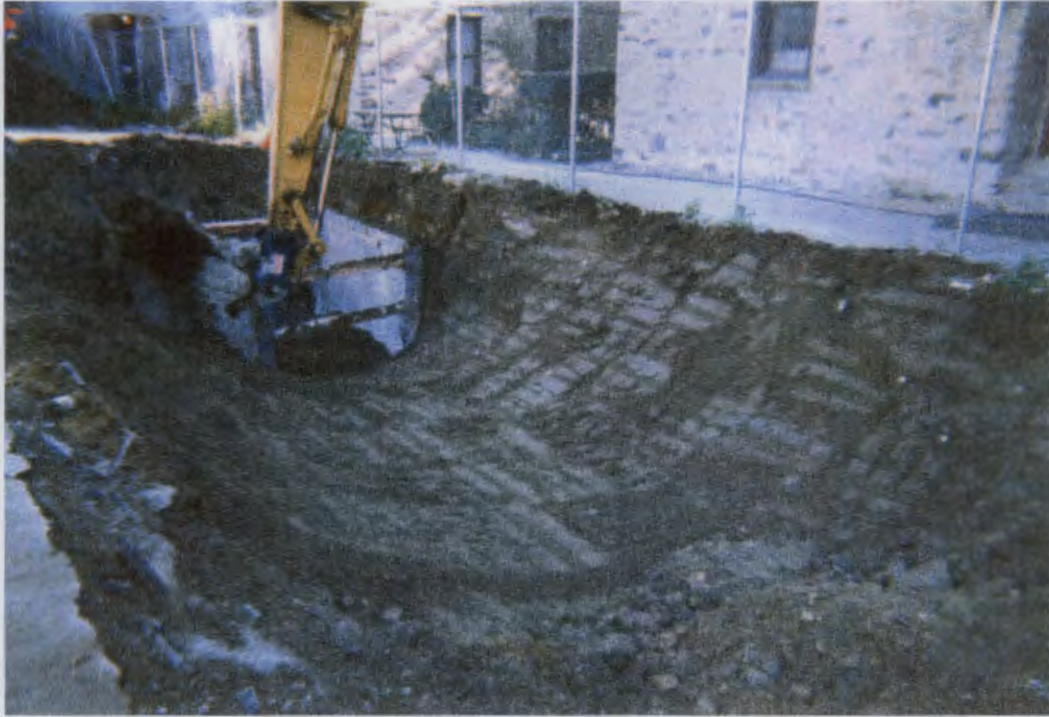
Figure 11 – View of the eastern excavation area with the central portion partially backfilled.

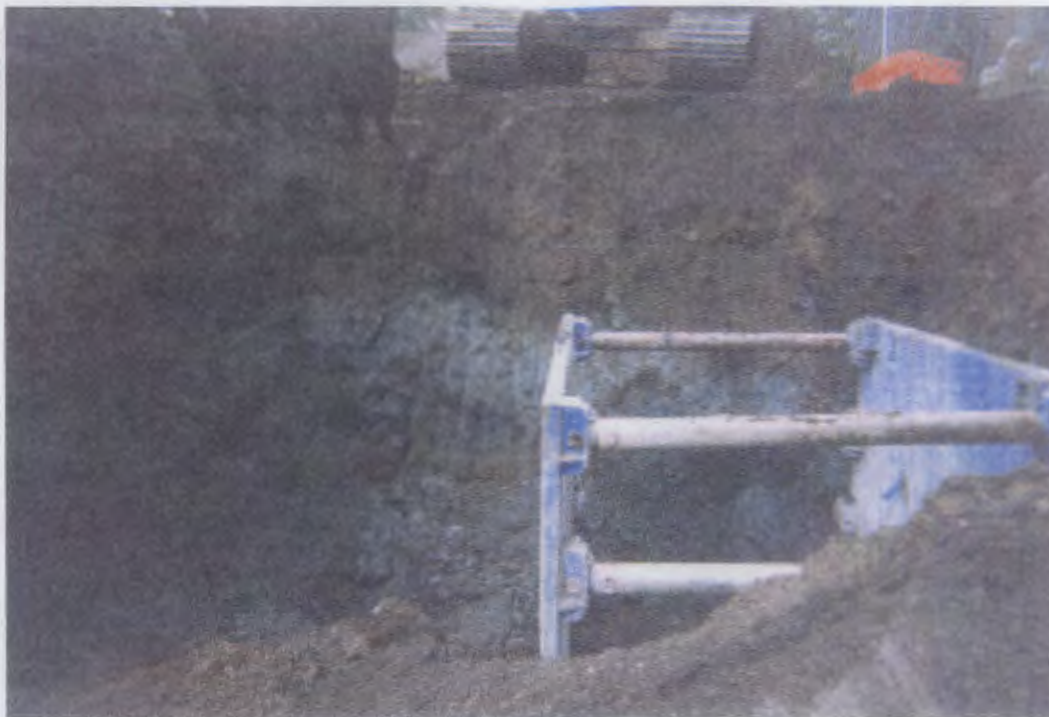
Figure 12 – View of the intended eastern end of the excavation prior to extending the excavation further eastward.

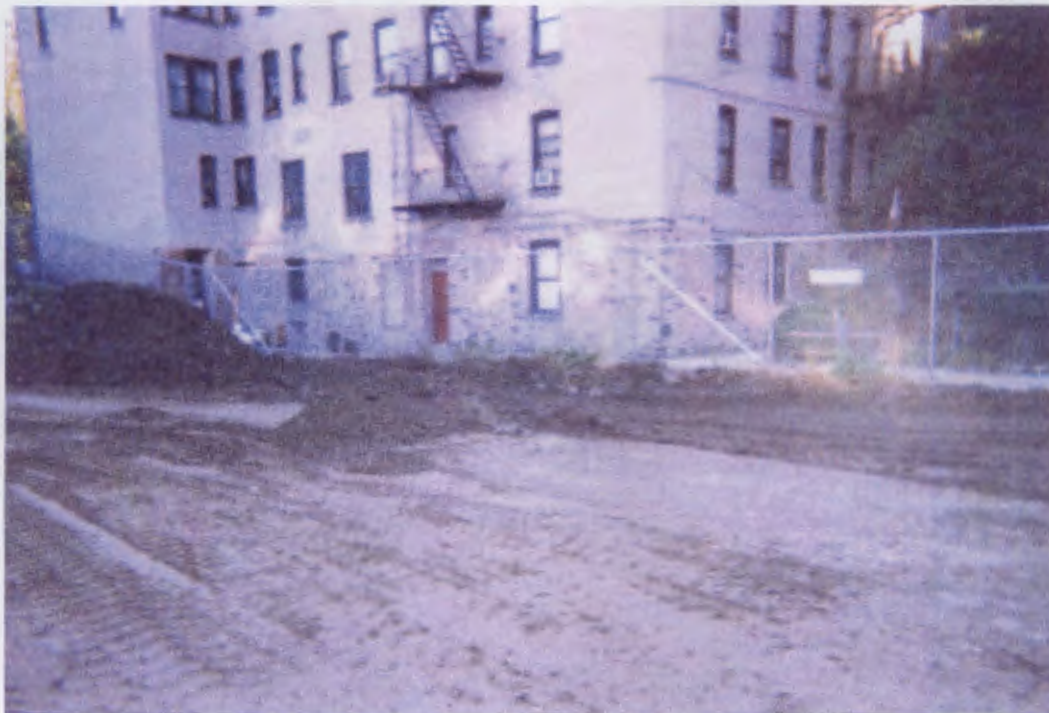
Figure 13 – Eastern portion of the excavation after it was backfilled.

Following collection of the endpoint samples, each excavation zone was backfilled with approved fill material that was tested by Brookside using Environmental Testing Laboratories (ETL) of Farmingdale, New York (NYSDOH Cert #10969). Testing requirements included TCLP VOCs Method 8260, SVOCs Method 8270C, and herbicides/pesticides by Methods 8151 and 8081 and there were no detections of any compounds. TCLP metals were not detected except for barium and silver at low concentrations. Other waste characterization analyses were run and all analytical results are given in Appendix C.

Backfill was compacted to a depth of six inches below the top of the surrounding pavement. Fill material analytical results and fill receipts are included in Appendix C.

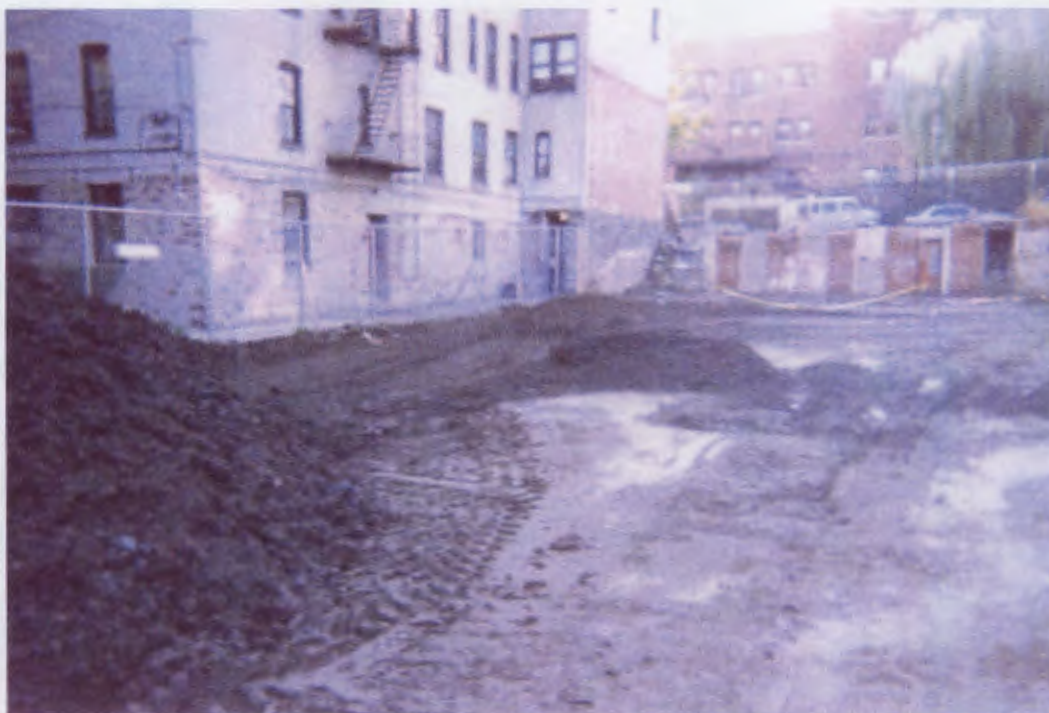
Figure 14 – Central portion of the site backfilled.

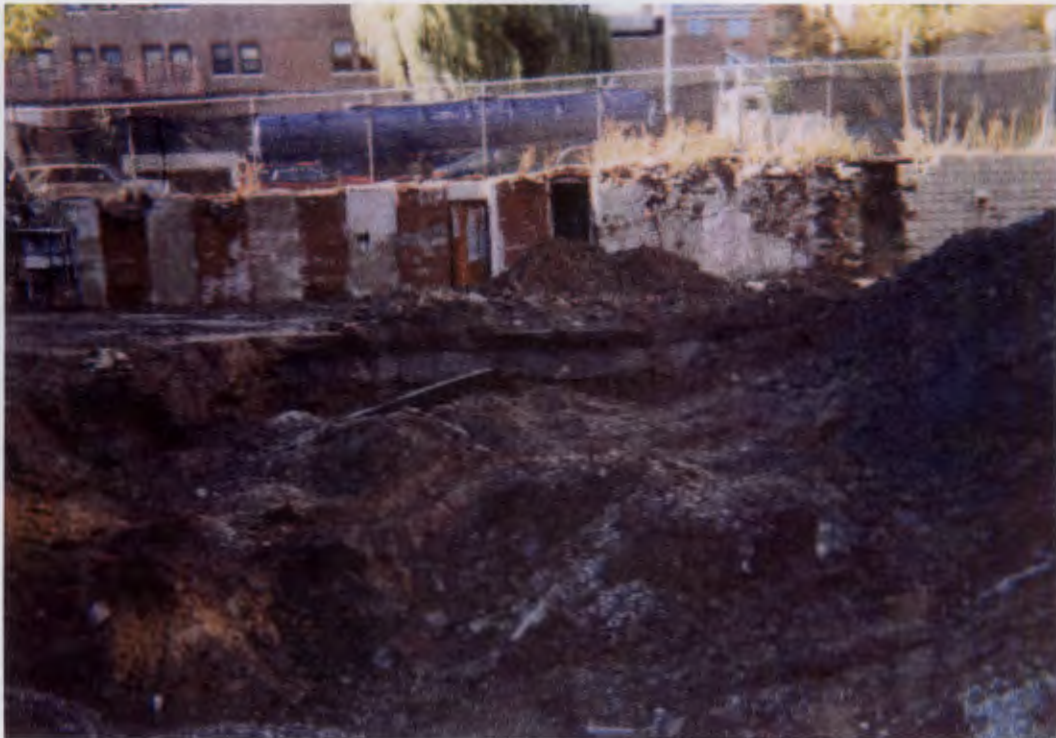
Figure 15 – Excavation was extended to the north to remove impacted soils.

The proposed excavation as shown in the Supplemental RAWP was completed as planned. Approximately 1,000 tons of affected soil was removed with an additional 180 tons from the tank excavation to the west. However, petroleum-stained soil was noted on *parts* of the eastern and northern walls of the excavation. PWGC had Brookside excavate test pits to determine the extent of the affected soil in both directions. Based on these data, the JHH made the decision to remove approximately 340 additional tons of affected soil to the east and north. The total amount of soil removed was 1519.24 tons. The locations of endpoint samples and the horizontal extent of the excavation area are shown on Figure 2.

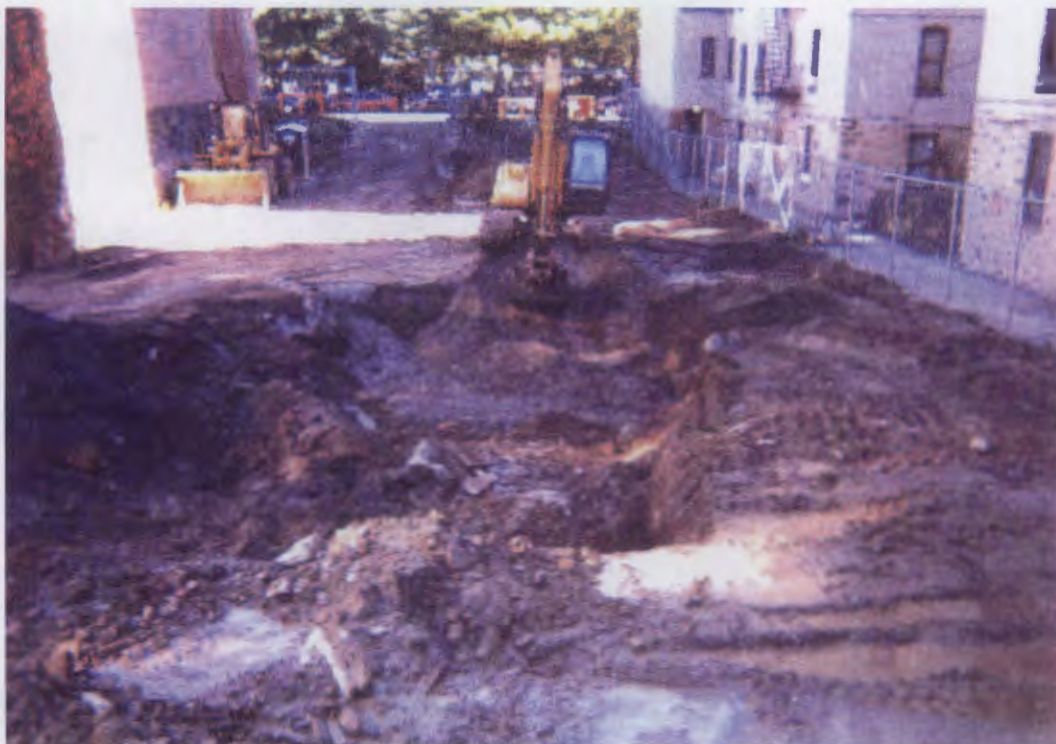
Figure 16 – View of the additional excavation to the north.

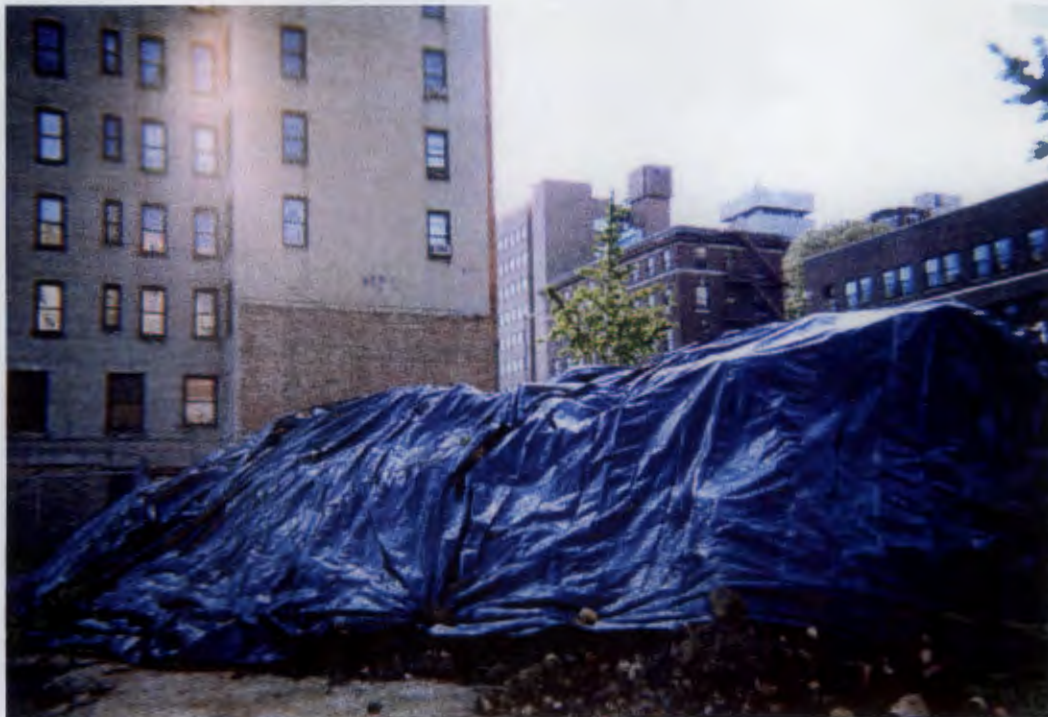
Figure 17 – During the excavation phase, the stockpile was covered each night.

Excavated contaminated soils were stockpiled on site (on top of and covered with polyethylene sheeting) pending receipt of disposal analysis and disposal facility approval, and then transported off-site for proper disposal. Brookside Environmental was responsible for collecting and analyzing excavated soils, as necessary to obtain approval from the selected disposal facility.

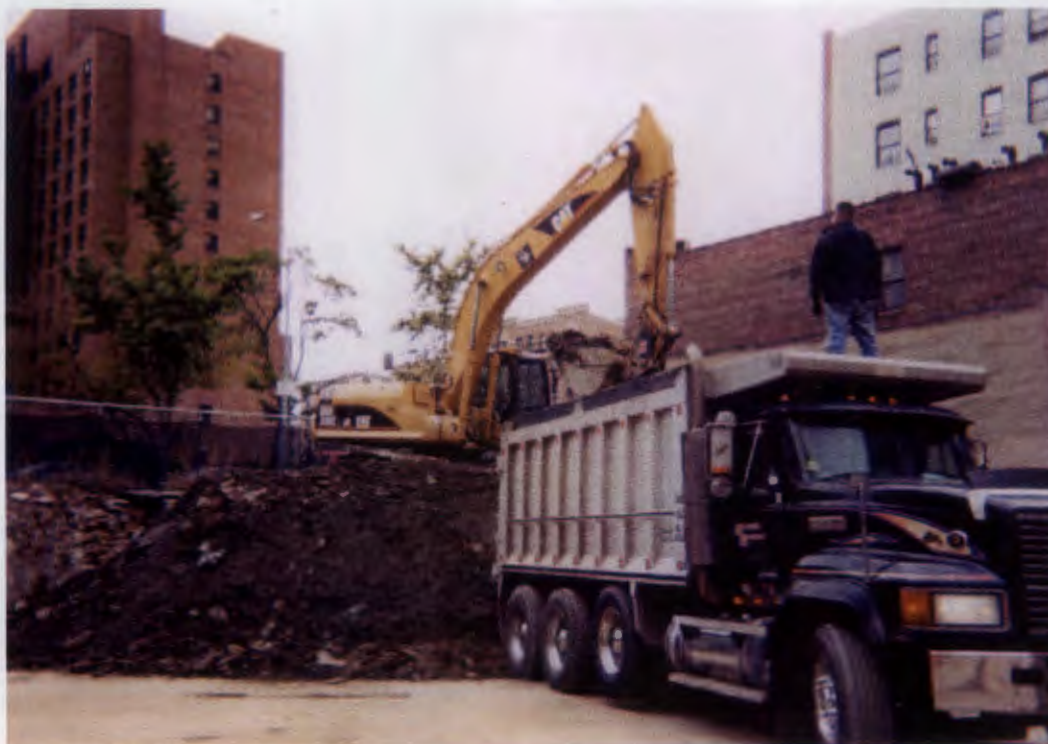
Figure 18 – Soil was loaded out by dump truck for disposal.

through November 4, 2003, Brookside loaded the stockpiled soils into trucks for transport to the disposal facility. Seventy truck loads of soil were transported by Middlesex Materials to the Mount Hope Recycling facility (EPA ID. No. NJD101241537) in Wharton, New Jersey for recycling/disposal. Copies of the waste disposal analytical data and the non-hazardous waste manifests are included in Appendix B.

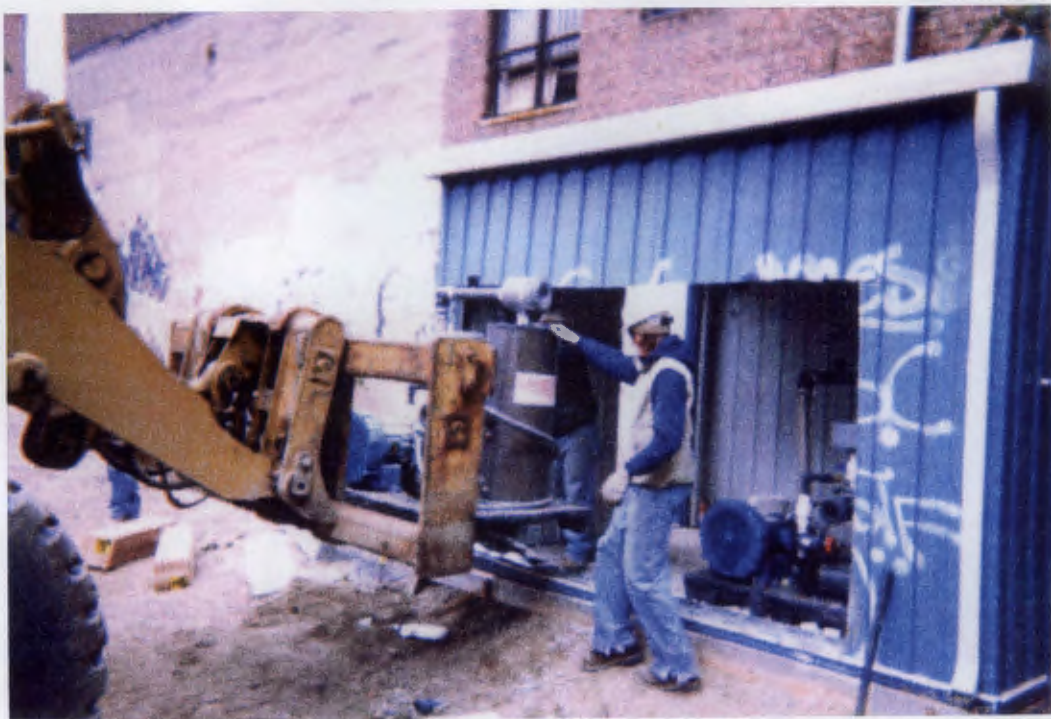
Figure 19 – The SVE system was dismantled and removed from the site.

Work under the 2003 SRAWP began on October 15 and was completed on November 4, 2003. During the excavation work the SVE system was shut off, decommissioned and completely dismantled. Brookside also removed the SVE equipment and the equipment shed from the site.
