Subject: 2023 Periodic Review Report
Former Champion Products Facility
200 North Main Street
Perry, New York 14530
NYSDEC Site No. V00189

1.0 EXECUTIVE SUMMARY

FIGURE 1 - SITE LOCATION MAP
 FORMER CHAMPION PRODUCTS FACILITY
 200 NORTH MAIN STREET
 PERRY, NEW YORK

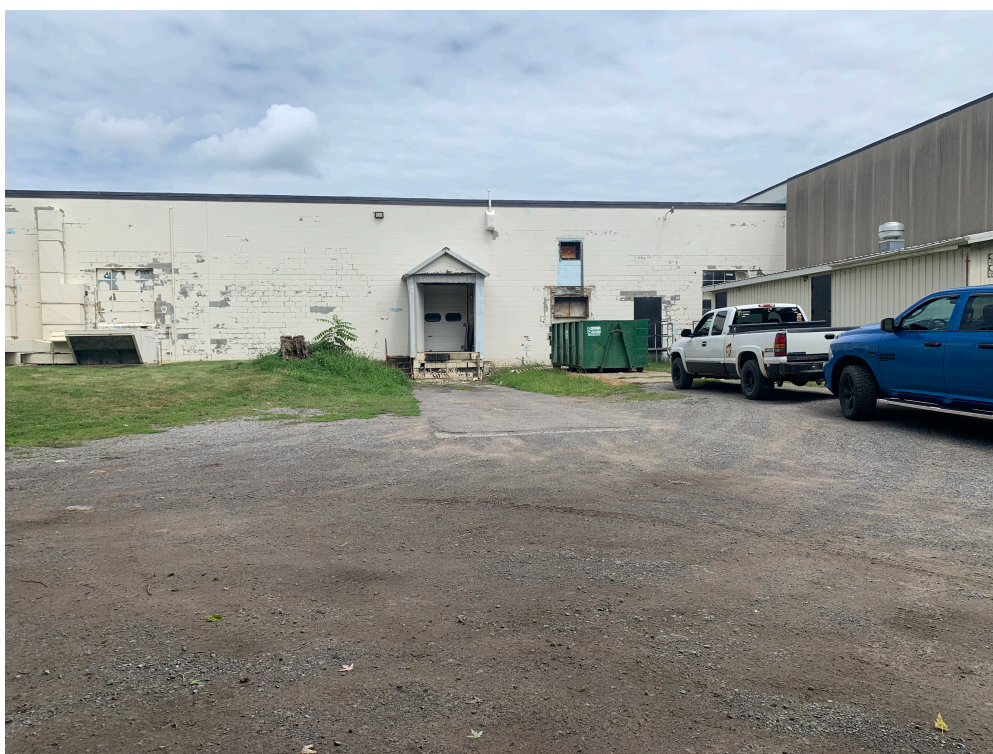
Former Empty Drum Storage Area	
Soil Cover Condition	Good
Erosion (Y/N)	No
Cover Breaches (Y/N)	No
Repairs Required (Y/N)	No

Photo 1 – View
looking north at
soil cover system
area

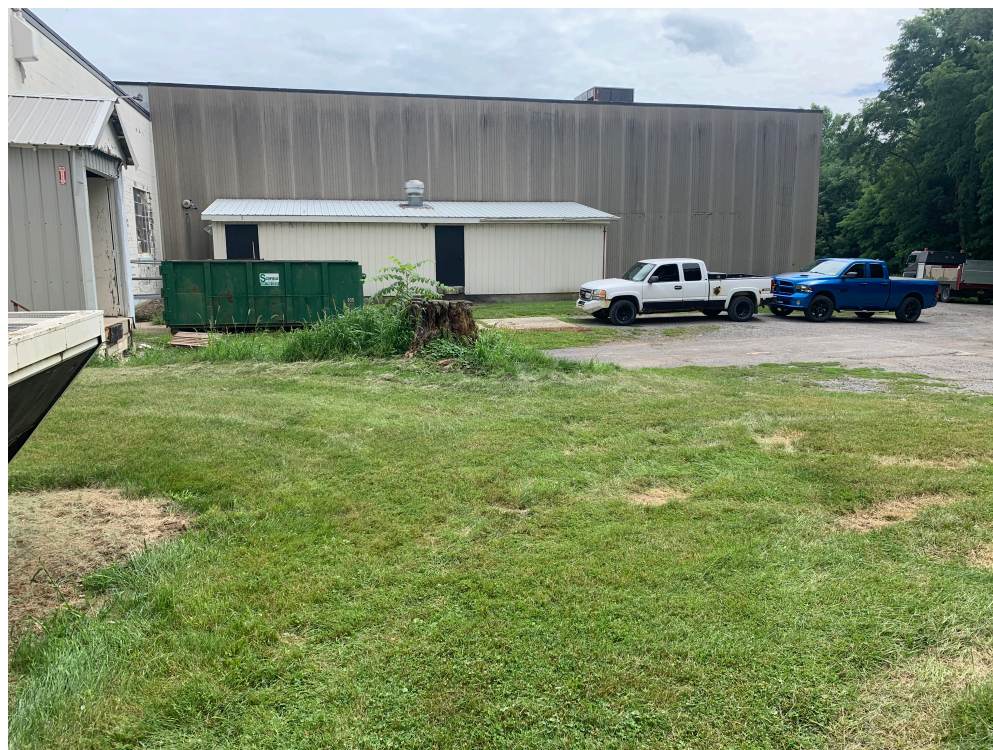
Photo 2 – View
looking east at
cover soil system
area

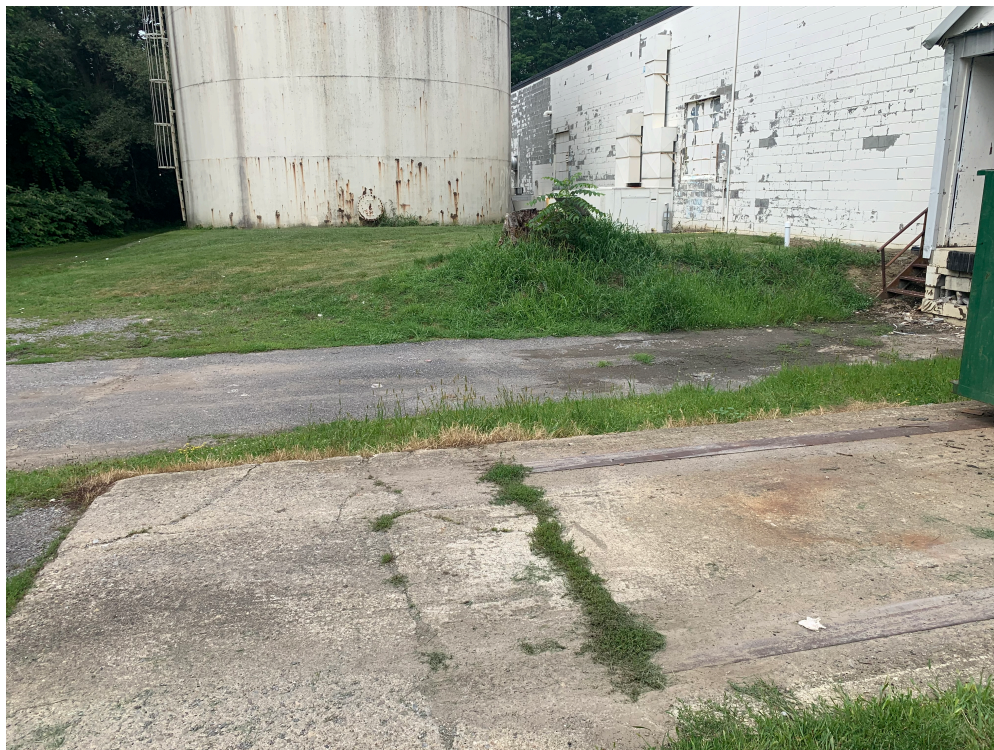
Photo 3 –
View looking
west at cover
soil system area

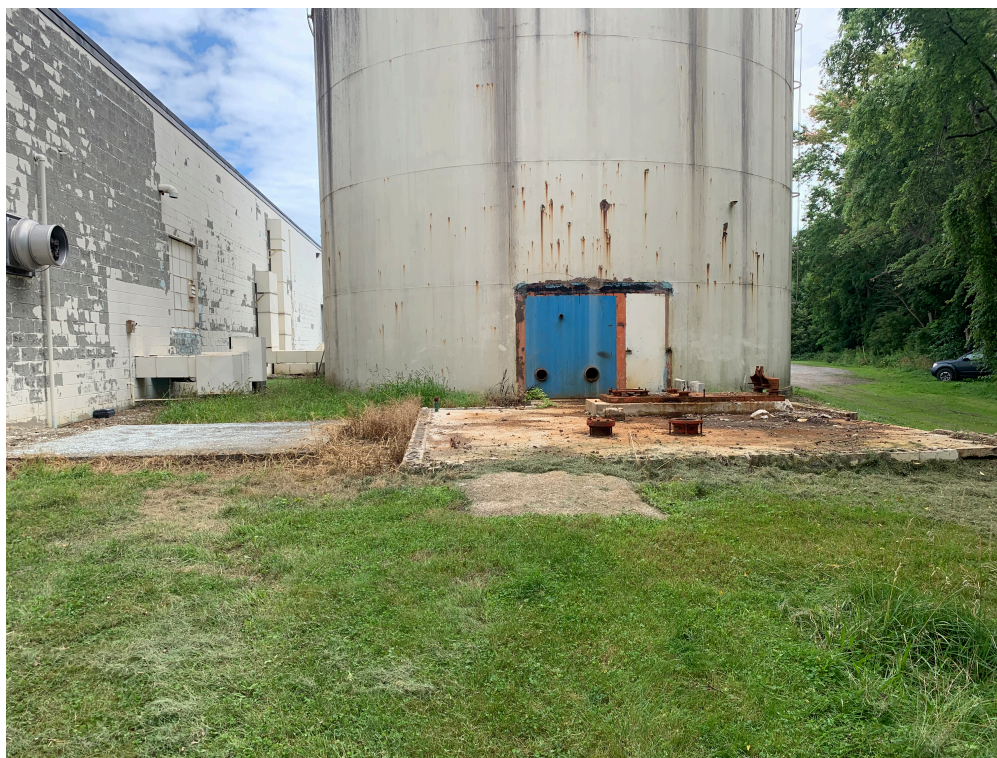
• Area west of soil cover system to be demo (two concrete slabs) and restored
to vegetation to mow.

Photo 4 – View
looking east at
concrete slabs to
be removed and
restored to
vegetation.
