AECOM
2 Technology Park Drive
Westford, MA 01886-3140

November 8, 2011

**RE: 2011 Periodic Review Report
Mineral Springs Road Former Manufactured Gas Plant Site**

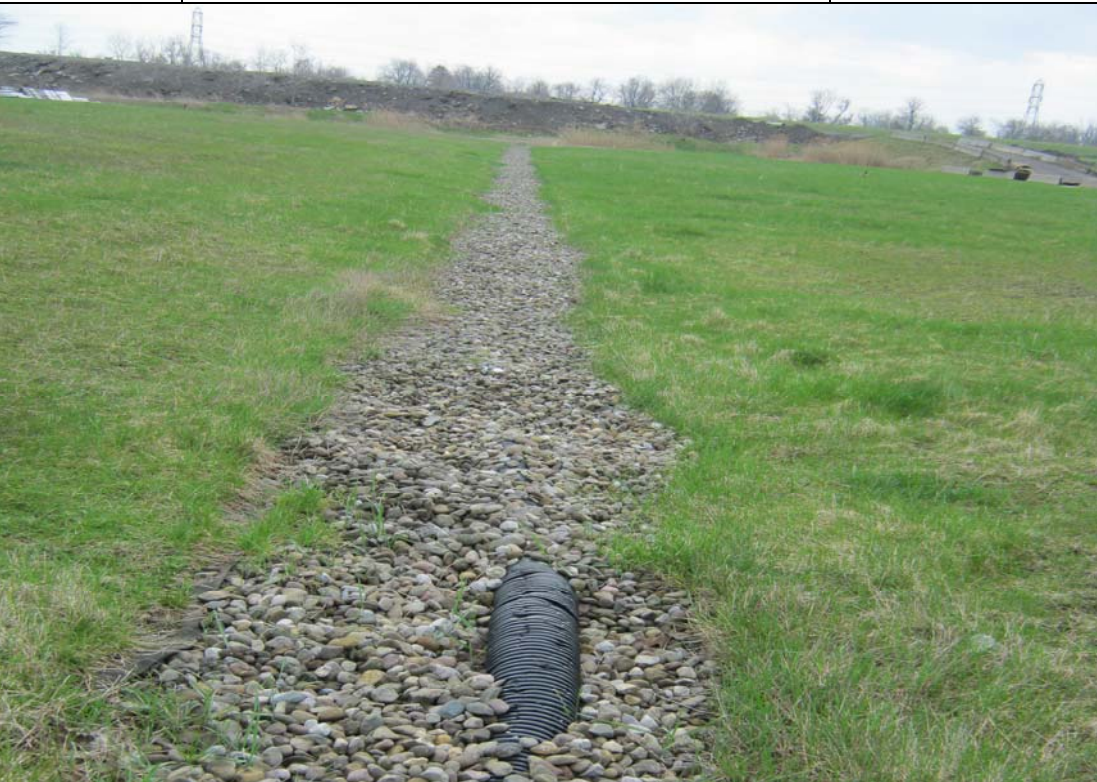
Client Name: National Fuel Gas Distribution Corp.		Site Location: 365 Mineral Springs Road, Buffalo, New York	Project No. 60137322
Photo No. <div style="text-align: center; font-size: 1.2em; font-weight: bold;">1</div>	Date: 4/26/11

Direction Photo Taken: From the West			
Description: Eastern Swale HDPE Cap – Drainage pipe observed in gravel-filled ditch.

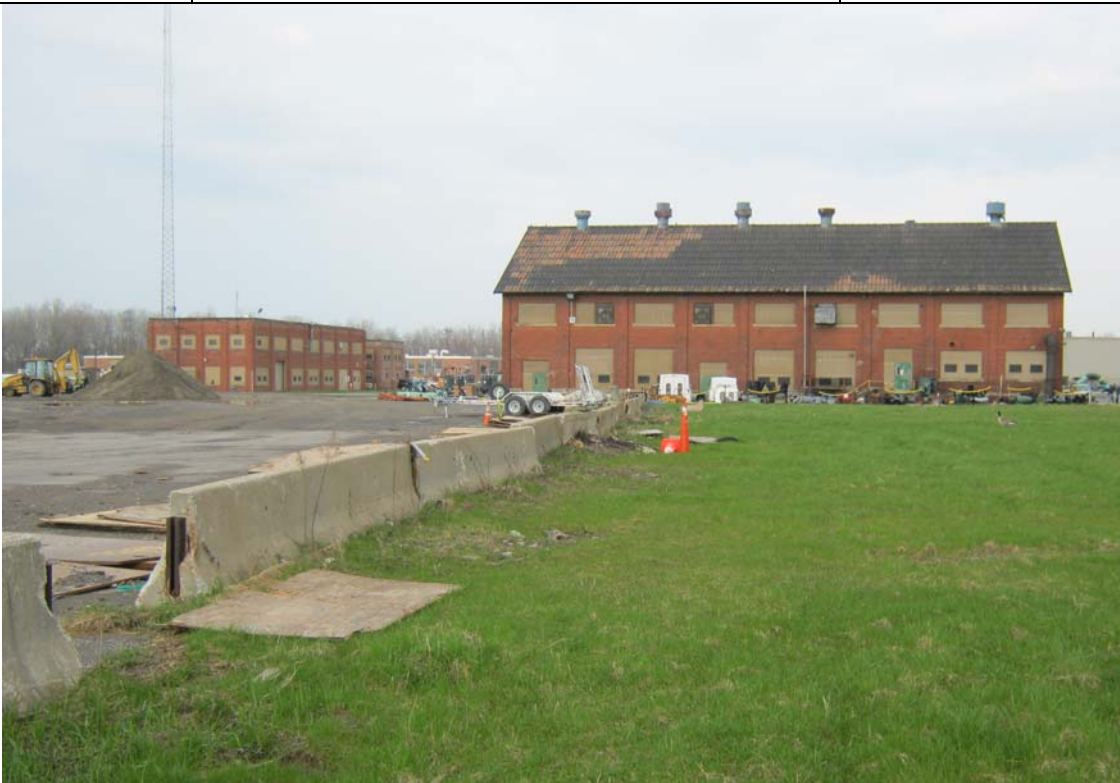
Client Name: National Fuel Gas Distribution Corp.		Site Location: 365 Mineral Springs Road, Buffalo, New York		Project No. 60137322	
Photo No. <div style="text-align: center; font-size: 1.2em; font-weight: bold;">3</div>	Date: 4/26/11

The ESHC has been mowed periodically. No plastic or geofabric, animal burrows, or blue-stained surface soil were visible. Debris, plywood, and piles of soil were observed on both the northern and southern sides of the cap. These had been removed by the time of the re-inspection. Corrugated HDPE pipe placed in a gravel filled ditch which drains the cap to the EDD was visible on the surface of the gravel. The pipe had been reinstalled by the time of the re-inspection. Chain fence at the west side of cap had been knocked down. It was fixed by the time of the re-inspection.

Direction Photo Taken: From the East					
Description: Eastern Swale HDPE Cap – Debris and soil on edge of cap.

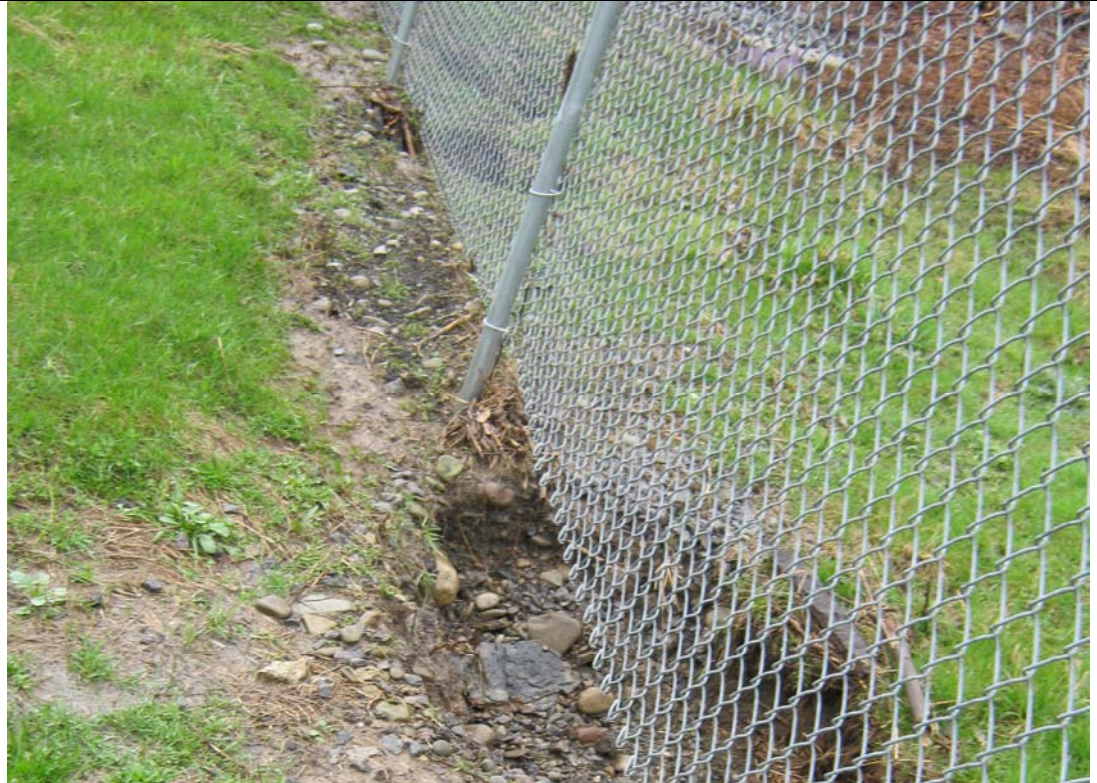
The clay cap southeast of Building 14 has been mowed periodically to prevent tree growth. No blue stained soils were observed during the inspection. Several large holes were observed along the fence line south of the cap, near the culvert in a different location than the hole identified and repaired last year. Following the April inspection NFG filled the holes with gravel. Sink holes observed this year and in the past near the fence line result from infiltration of soil into the storm water culvert located south of the site. The culvert is not located on NFG property. A review of the as-built drawing from cap construction shows that the cap in that location includes a clay cutoff wall constructed as part of the clay cap. The drawing shows that the holes observed have not impacted the cutoff wall and have not reduced the effectiveness of the cap.

Clay Cap – Sink holes
