**RE: 2013 Periodic Review Report
Mineral Springs Road Former Manufactured Gas Plant Site**

2013 Periodic Review Report
Mineral Springs Road Former Manufactured Gas Plant Site

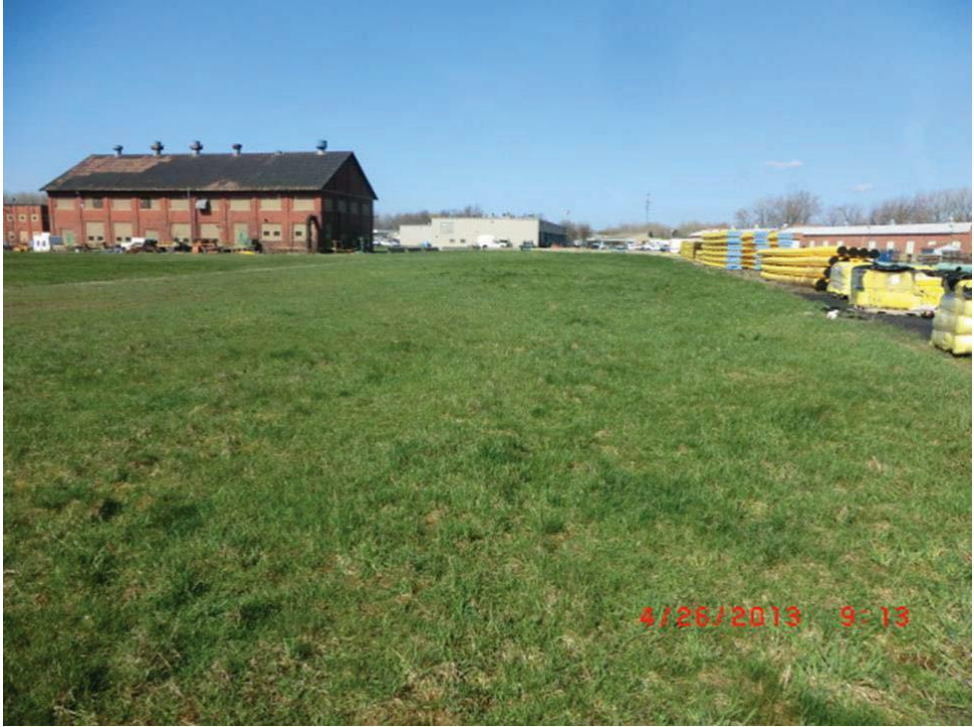
Client Name: National Fuel Gas Distribution Corp.		Site Location: 365 Mineral Springs Road, Buffalo, New York	Project No. 60250836
Photo No. 1	Date: 4/26/13

Direction Photo Taken: Looking West			
Description: Eastern Swale HDPE Cap. No issues identified.

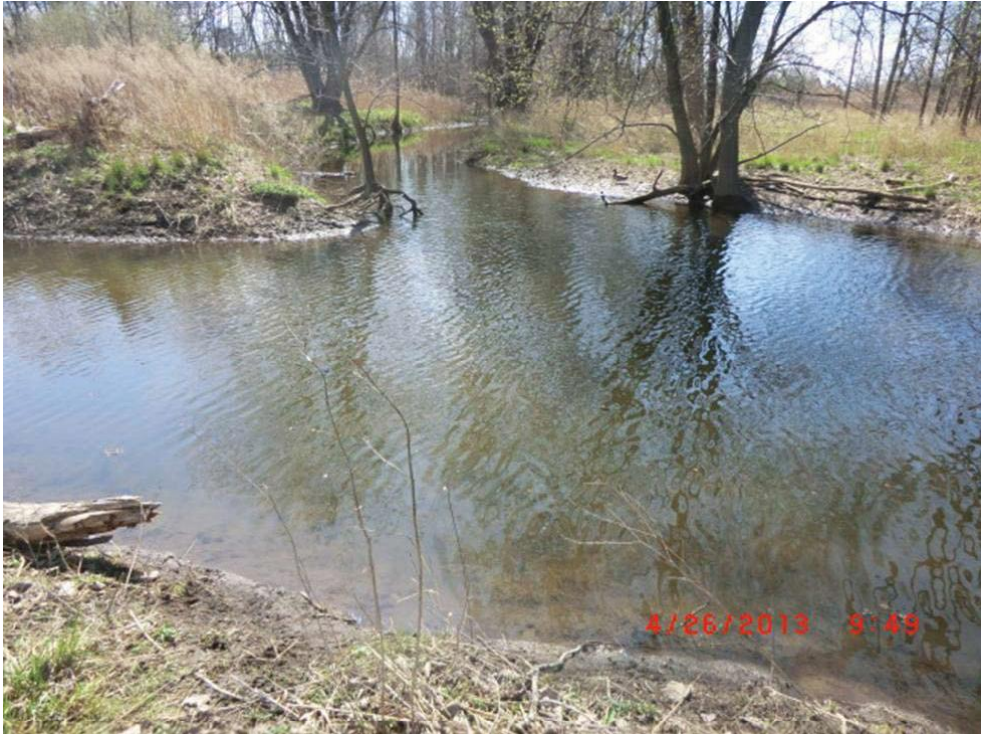
Client Name: National Fuel Gas Distribution Corp.		Site Location: 365 Mineral Springs Road, Buffalo, New York	Project No. 60250836
Photo No. 3	Date: 4/26/13

Direction Photo Taken: Looking Southeast.			
Description: Junction between Eastern Drainage Ditch and Class 2 Stream. No issues identified.

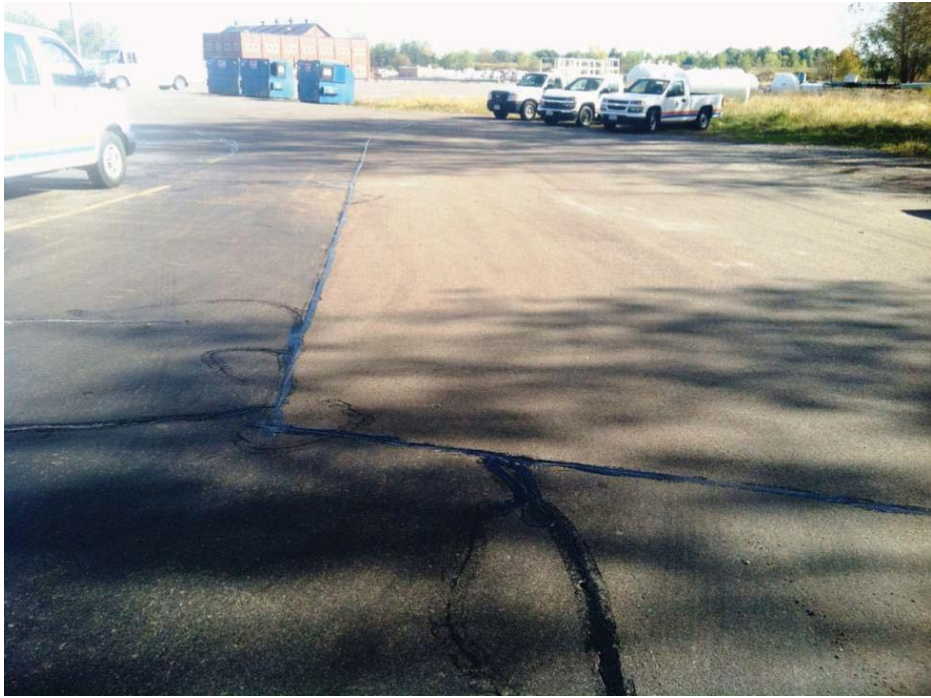
Photo No. <div style="text-align: center; font-size: 1.2em; font-weight: bold;">6</div>	Date: 10/3/13

On the Building 3 South Asphalt Cap (B3SAC), the seals on previously repaired cracks appeared to be disturbed, and the joints between the new and old asphalt are not sealed. On the Eastern Swale North Asphalt Cap (ESNAC), minor cracks which were previously repaired have reopened. Since the site inspection, the cracks and seals have all been repaired.

Direction Photo Taken: Facing Northeast			
Description: Building 3 South Asphalt Cap. Note repaired and sealed area.

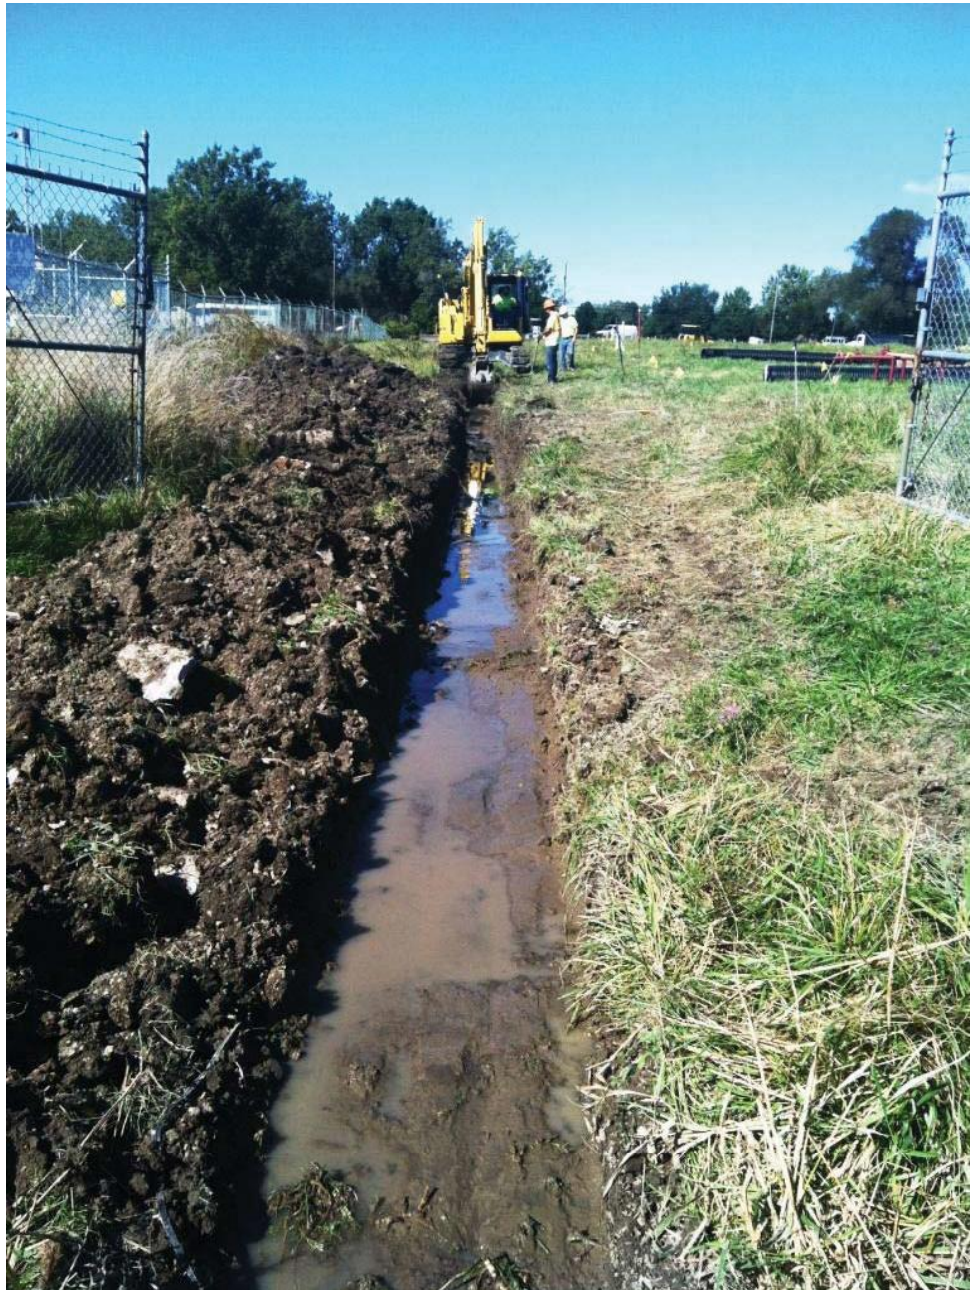
CNG Expansion Trench
Excavation. No Issues
Identified
