October 13, 2015

**RE: 2015 Periodic Review Report
Mineral Springs Road Former Manufactured Gas Plant Site**

To	Brad Walker	Page	1
CC			
Subject	Summary Report for Clay Cut-off Wall and Clay Cap Direct-push Technology Investigation Related to the Norfolk Southern Sewer Failure		
From	Tamara Raby		
Date	October 7, 2015

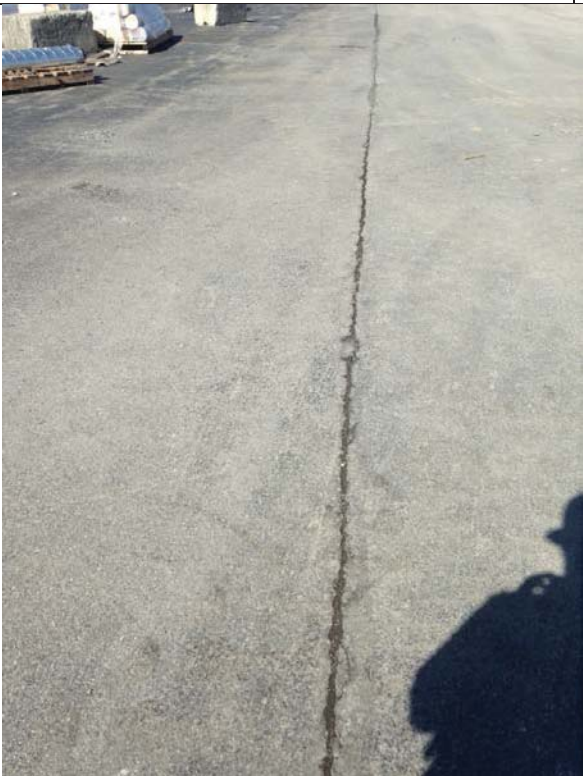
Client Name: National Fuel Gas Distribution Corp.		Site Location: 365 Mineral Springs Road, Buffalo, New York		Project No. 60137322	
Photo No. <div style="text-align: center; font-size: 1.2em;">1</div>	Date: 4/28/15

Direction Photo Taken:					
Description: Longitudinal crack in Eastern Swale North Asphalt Cap (ESNAC).

All caps except for Building 3 South Asphalt Cap (B3SAC) and B10AC were observed to be intact with no significant cracking. On the Eastern Swale North Asphalt Cap (ESNAC), minor cracks which were previously repaired had reopened, but since the site inspection, have been repaired.

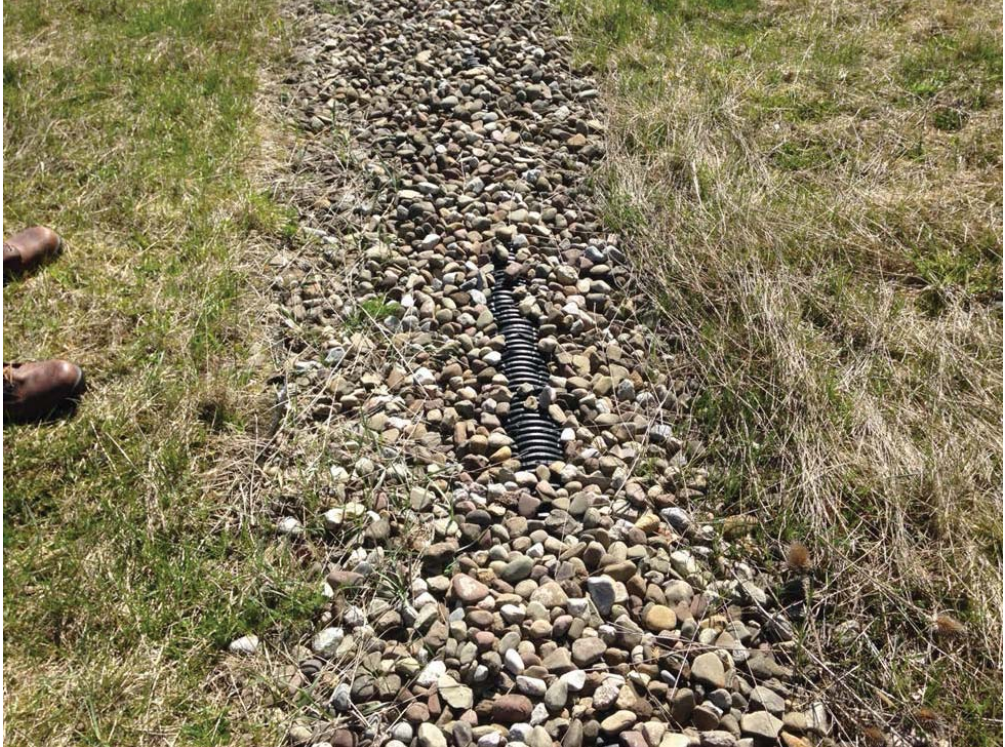
Client Name: National Fuel Gas Distribution Corp.		Site Location: 365 Mineral Springs Road, Buffalo, New York	Project No. 60137322
Photo No. 3	Date: 4/28/15

Direction Photo Taken:			
Description: Minor exposure of corrugated drain pipe within French drain of ESHC

The ESHC has been mowed periodically. No plastic or geotextile, rutting, or blue-stained surface soil were visible within the limits of the cap, except that the corrugated HDPE pipe that runs in a french drain on the surface of the cap was exposed in one location. A possible animal burrow was observed next to the drain pipe near the midpoint of the cap. This hole has been filled since the inspection.

Animal burrow observed. Corrugated drainage
pipe exposed in french drain.

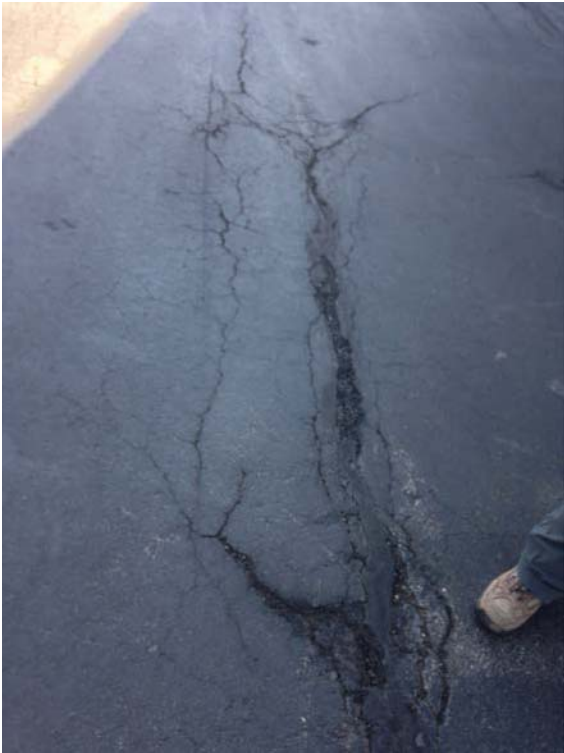
Photo No. 4	Date: 4/28/15

Direction Photo Taken:		
Description: Cracks in Building 10 Asphalt Cap (B10AC)

The surface of B10AC showed cracking. The surface of B3SAC showed significant disturbance to the surface including areas of broken asphalt, the seals on previously repaired cracks appeared to be disturbed, and the joints between the new and old asphalt are not sealed. These areas have since been repaired and sealed since the inspection.

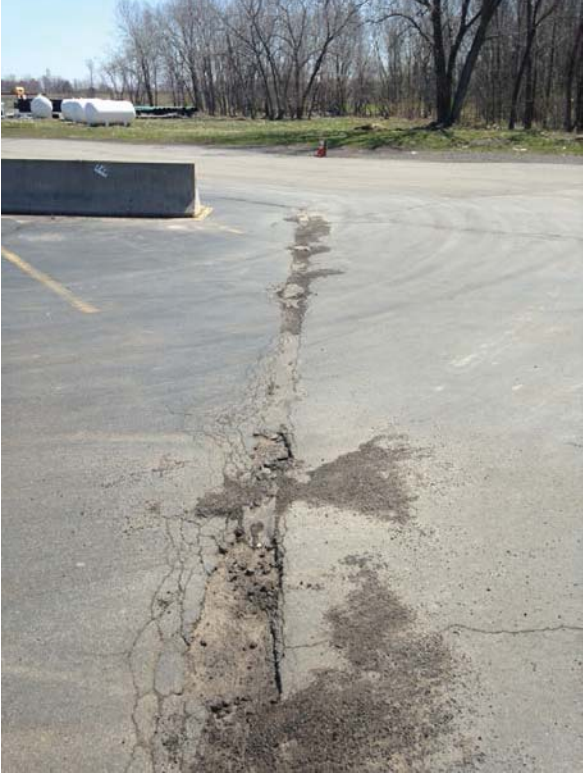
Client Name: National Fuel Gas Distribution Corp.		Site Location: 365 Mineral Springs Road, Buffalo, New York	Project No. 60137322
Photo No. 7	Date: 4/28/15

Direction Photo Taken:			
Description: Pothole/cracks in Building 3 South Asphalt Cap (B3SAC)
