**Subject: Site Management Periodic Review Report and IC/EC Certification  
Submittal  
Mineral Springs Road MGP Site (NYSDEC Site #V00195)**

## Site Management Periodic Review Report and IC/EC Certification (2018)

NFG - Mineral Springs MGP - Site No. V00195  
West Seneca, New York

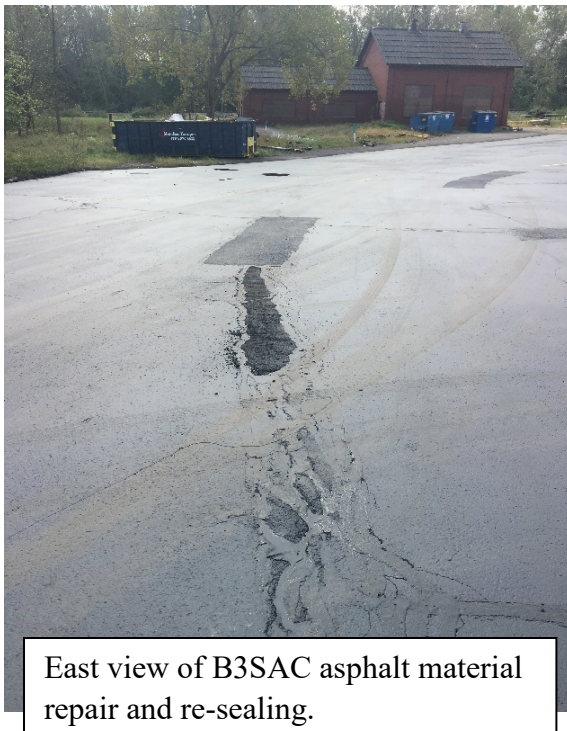
Building 3 South Asphalt Cap (B3SAC): No blue stained soil or edge erosion was observed. Surface cracks and minor asphalt repairs and sealing are required for 2018 maintenance.

East view of B3SAC asphalt material repair and re-sealing.

B3SAC repairs, which include asphalt material patching and re-sealing, were performed in 2018 under the direction of NFG (photos below).

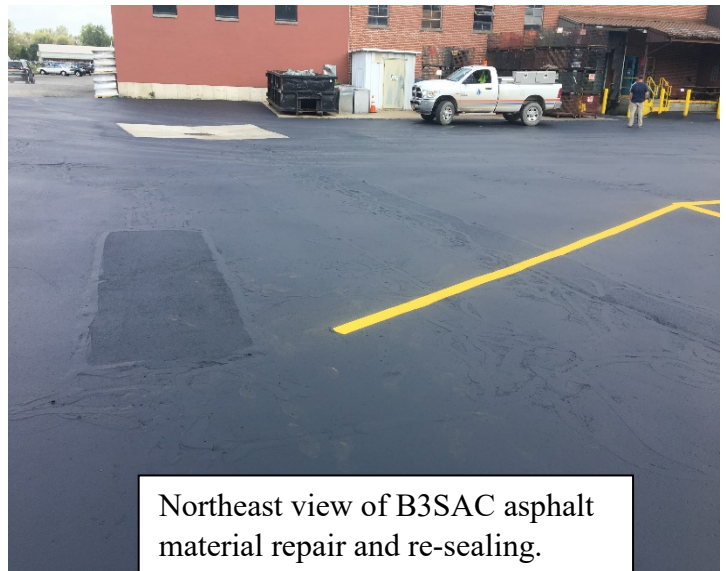
Northeast view of B3SAC asphalt material repair and re-sealing.

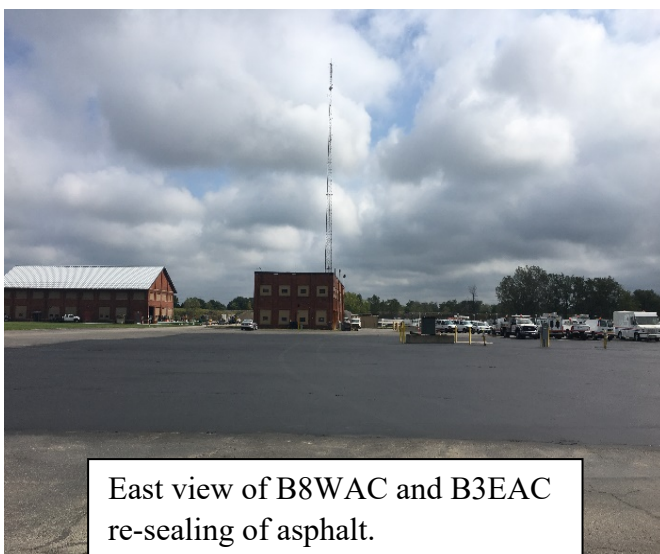
Building 8 West Asphalt Cap (B8WAC): No blue stained soil or edge erosion was observed. Cap repairs which include asphalt material repairs and re-sealing were performed in 2018 under the direction of NFG (photos below).

East view of B8WAC and B3EAC re-sealing of asphalt.

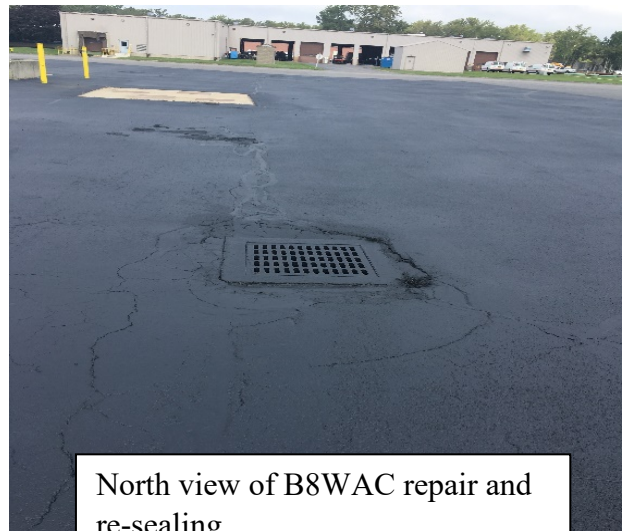
North view of B8WAC repair and re-sealing.

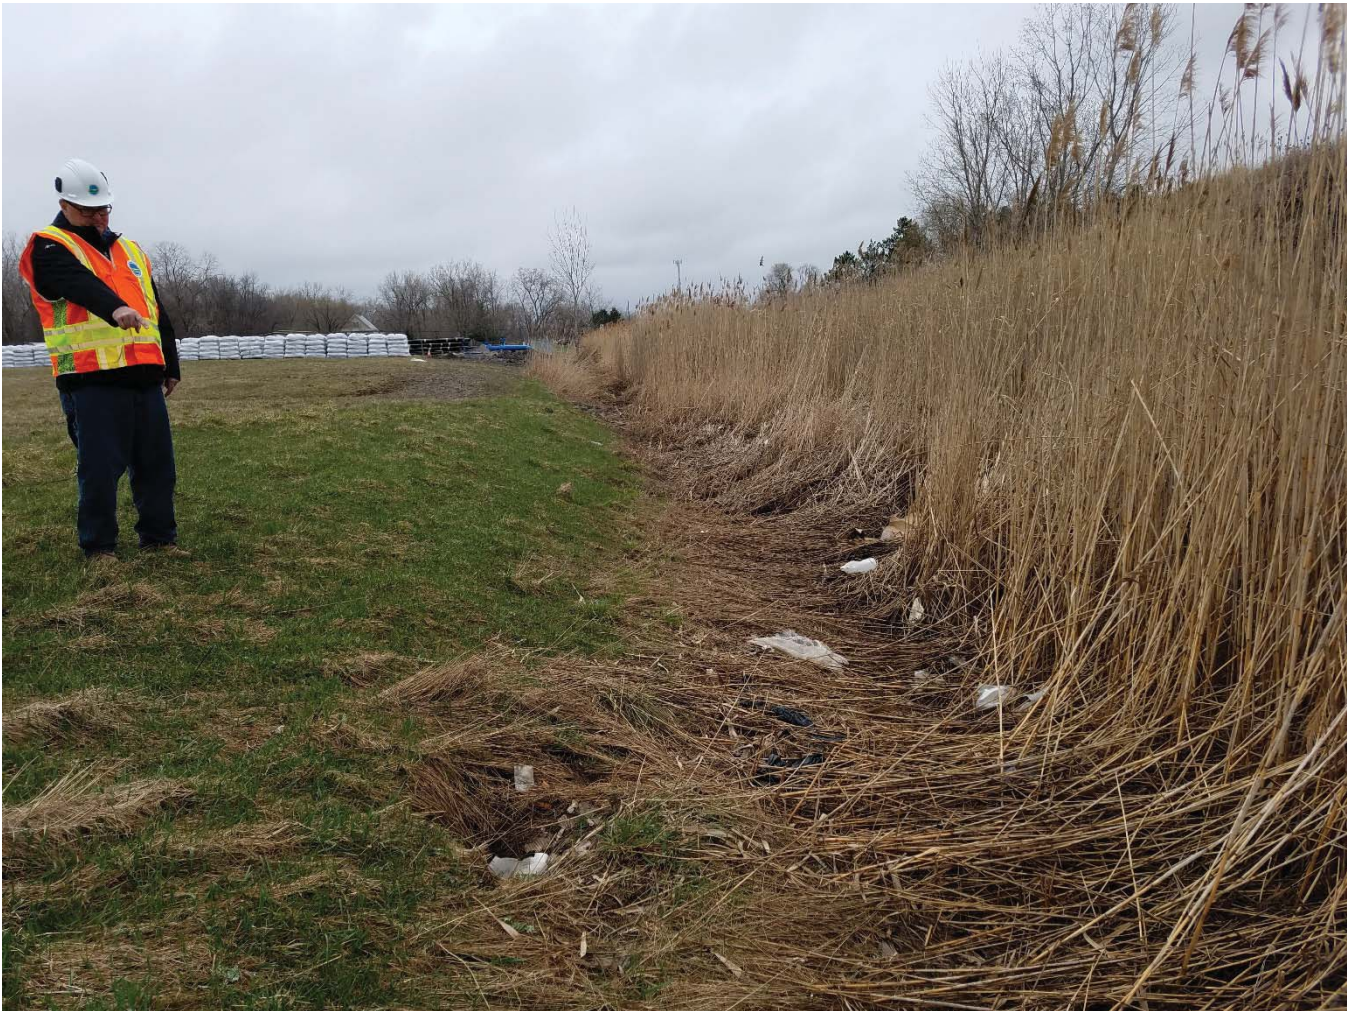
**Eastern Drainage Ditch (EDDCC):** No blue stained soil or bank erosion was observed. An animal burrow was observed (Photo 1). The capped areas were free of trees and no hydrocarbon sheens were observed. Litter, including plastic sheeting and packing material was observed throughout the area.

**Photo 1. View looking east, north of Class D stream. Animal burrow in east drainage ditch clay cap area.**

Various cap maintenance activities occurred in 2018. The Eastern Swale HDPE Cap and Clay Cap were mowed in September 2018. A trapping contractor was hired to trap a groundhog assumed to have created the burrow in the Eastern Drainage Ditch Clay Cap. The contractor did not capture the groundhog and no evidence of recent activity was observed in September 2018 as the burrow had naturally filled in. Asphalt cap repairs and resealing were conducted in September 2018 at the B3SAC and B8AC asphalt caps in the areas of Building 3 and former Building 8.

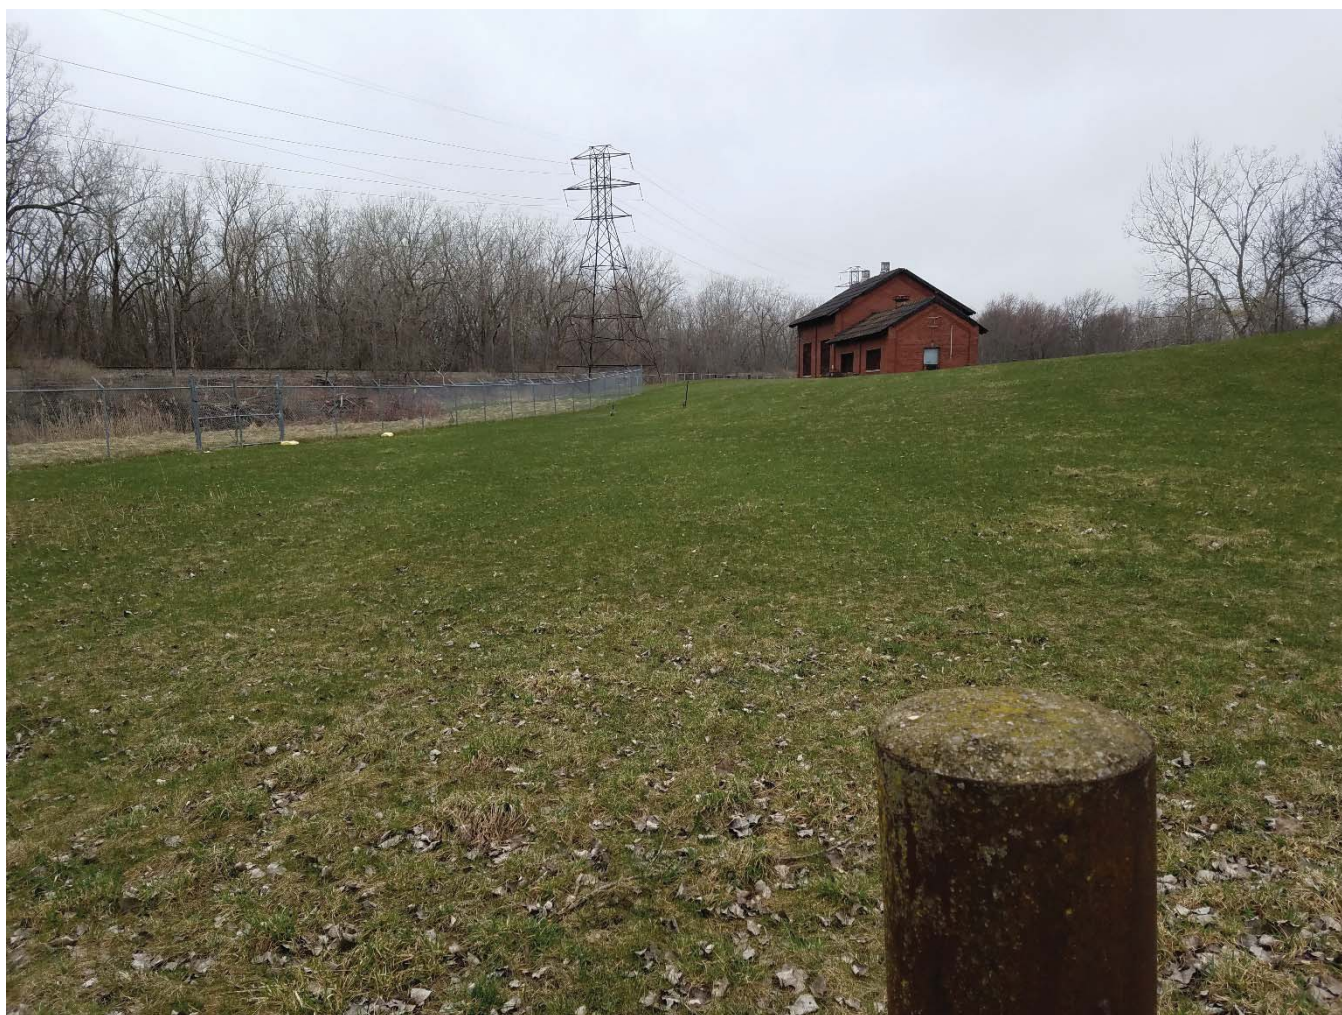
**Clay Cap South of Building 14 (B14CC):** No blue stained soil or erosion was observed. No animal burrows were observed. The vegetative cover was intact and free of trees and no hydrocarbon sheens were observed (Photo 2).

**Photo 2. View looking west across clay cap in the area of Building 14.**

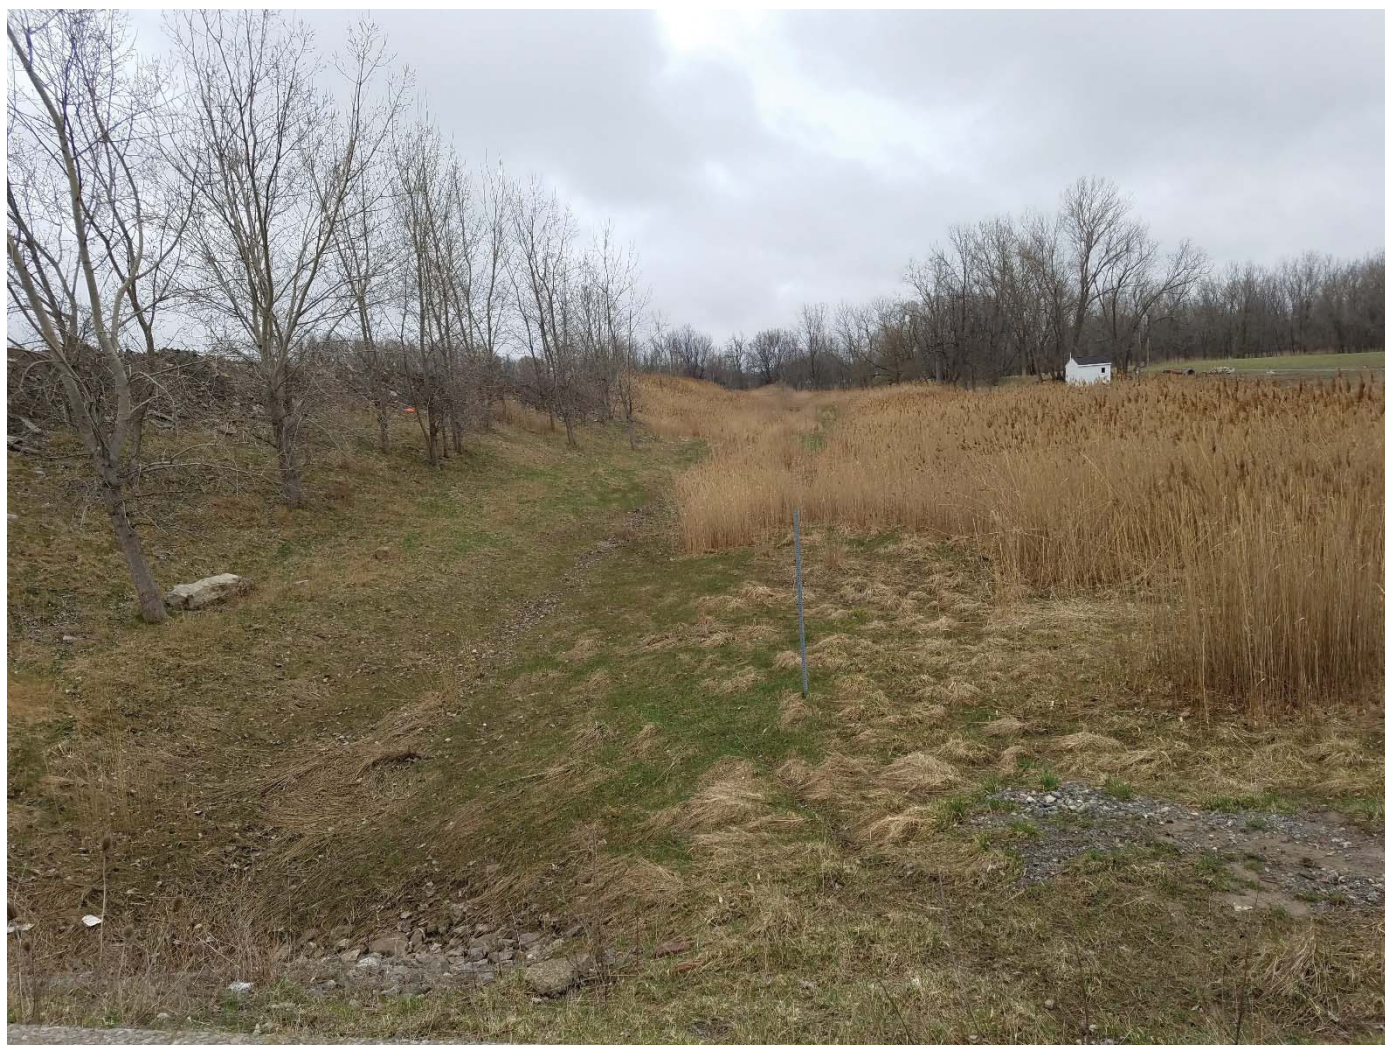
**Eastern Drainage Ditch (EDDHC):** No blue stained soil or bank erosion was observed. No animal burrows were observed. The HDPE area was free of trees and no hydrocarbon sheens were observed. Litter, including plastic sheeting and packing material was observed throughout the area (Photo 3).

**Photo 3. South view of East Drainage Ditch HDPE Cap area.**

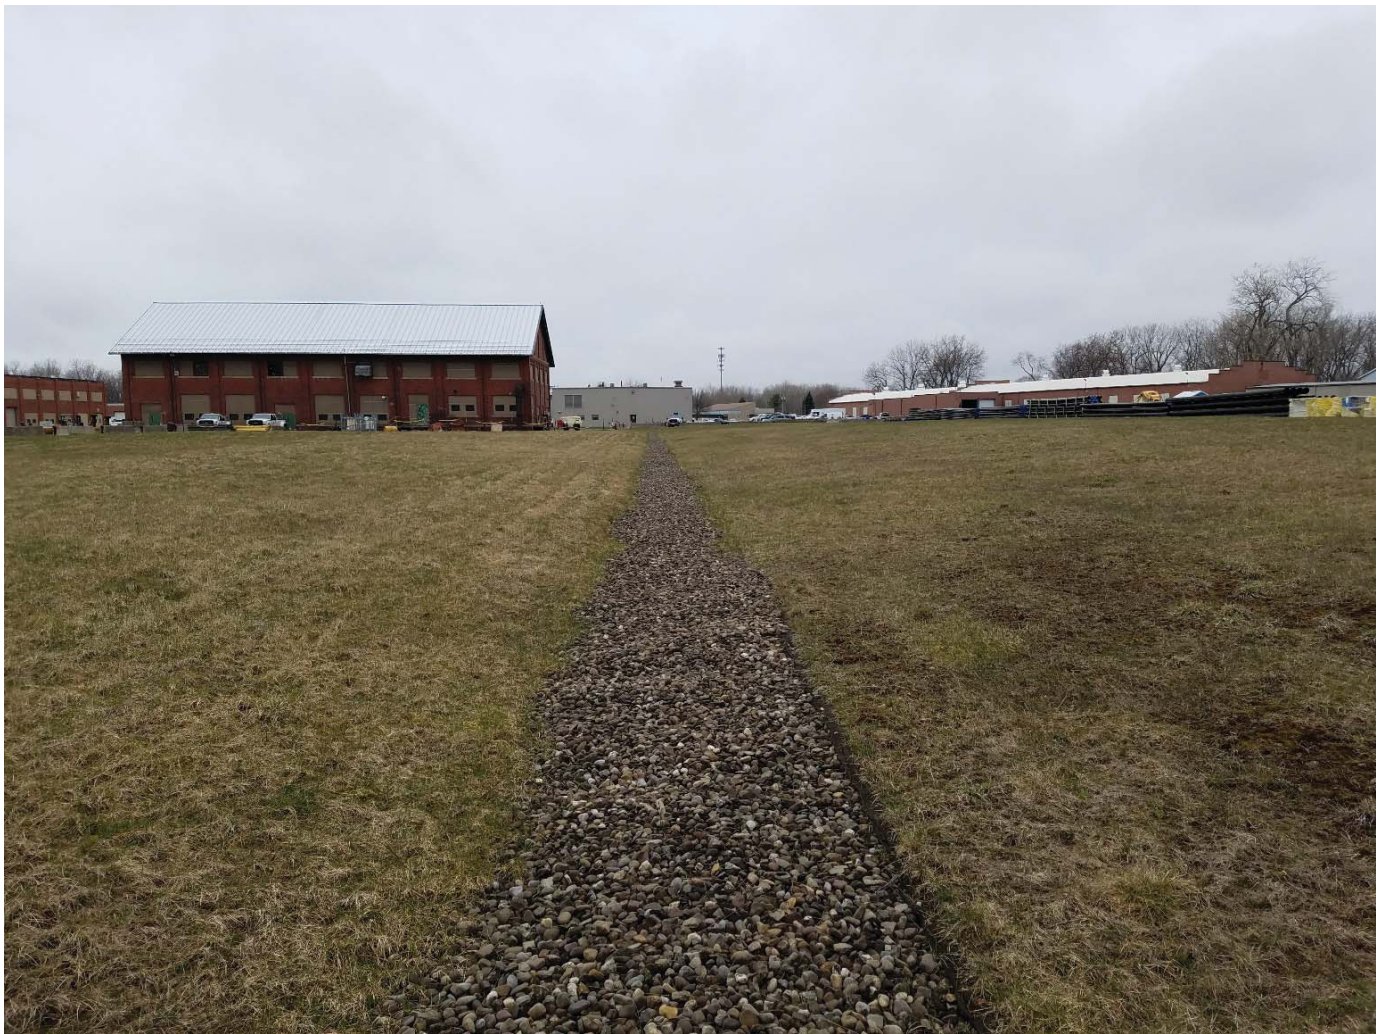
**HDPE Cap in Eastern Swale (ESHC):** No blue stained soil or edge erosion was observed. No animal burrows were observed. The vegetative cover was intact and free of trees. The capped areas were free of trees and no hydrocarbon sheens were observed (Photo 4).

**Photo 4. View looking west at French drain in Eastern Swale HDPE Cap (ESHC)**

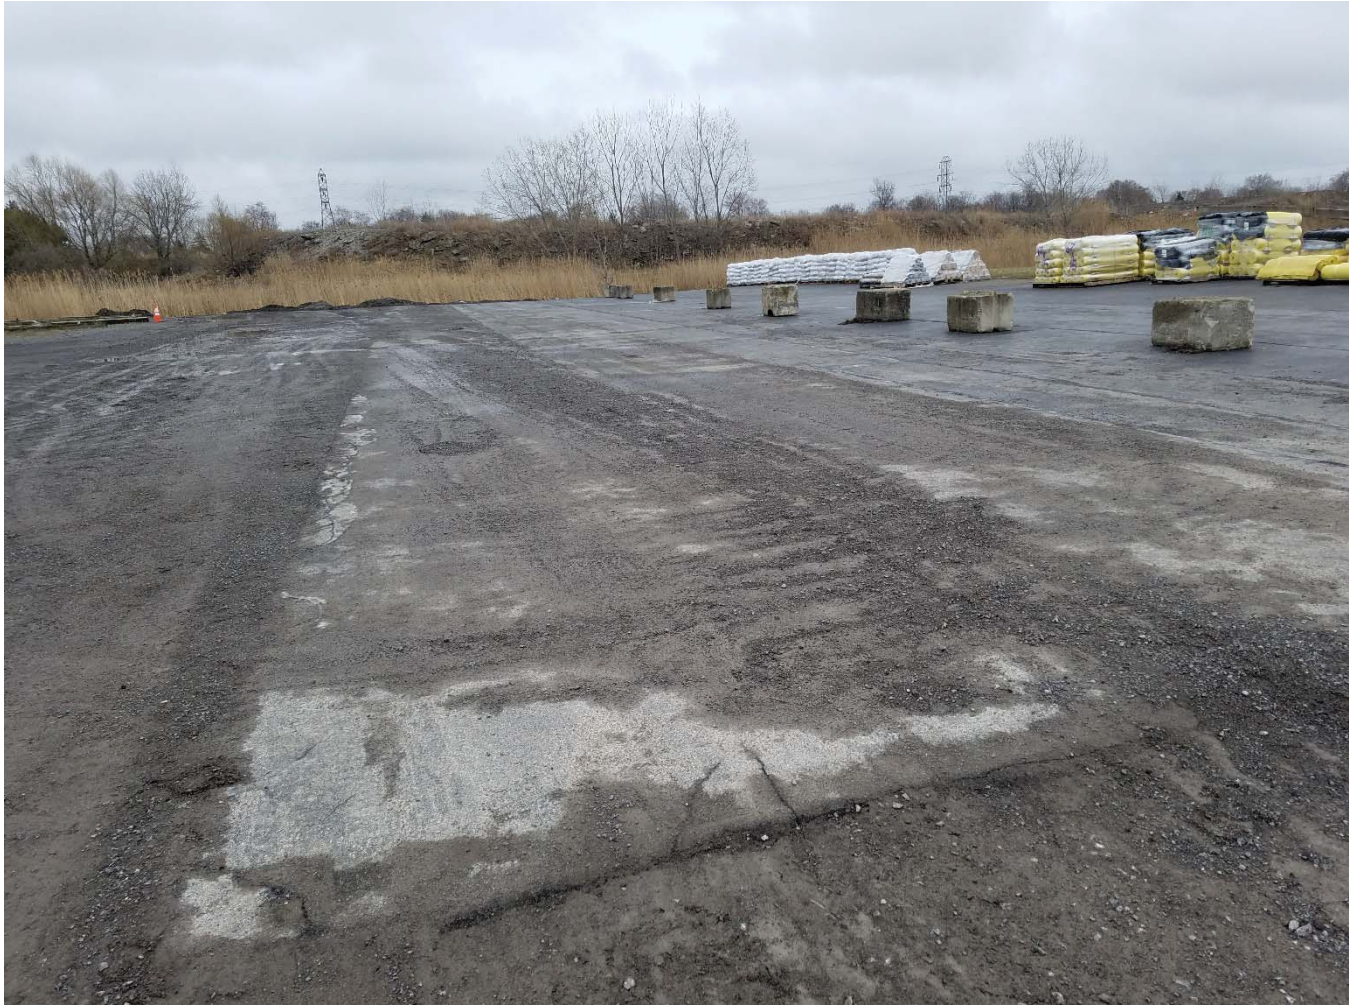
**Asphalt Cap North of Eastern Swale (ESNAC):** No blue stained soil or edge erosion was observed. Surface cracks in the sealant were abundant, but none appeared open through the asphalt wearing course layer (Photo 5).

**Photo 5. East view at Eastern Swale North Asphalt Cap (ESNAC).**

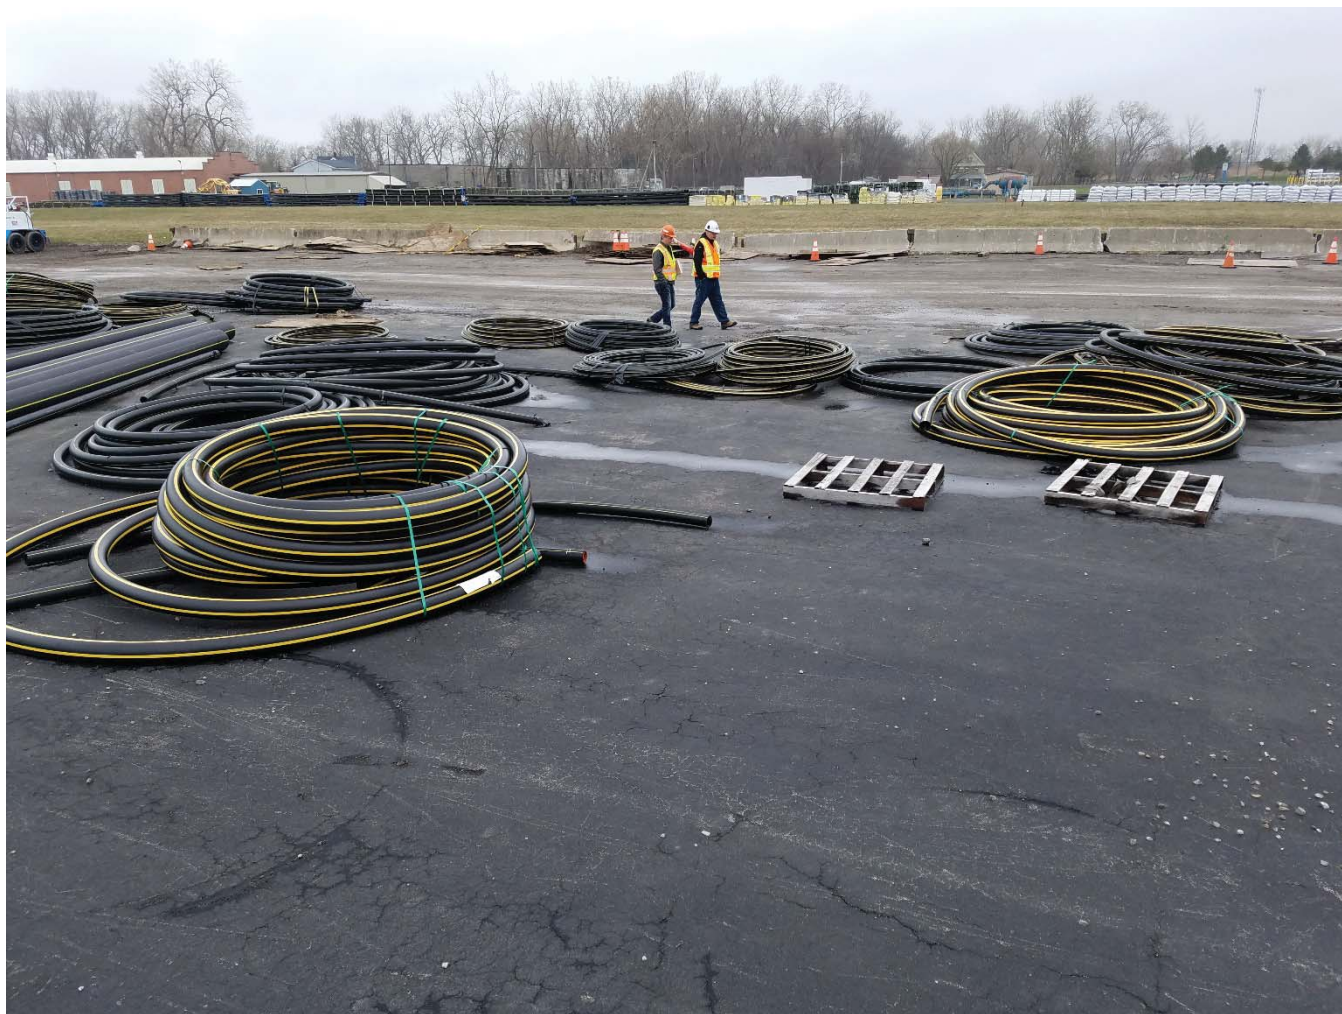
**Asphalt Cap South of Eastern Swale (ESSAC):** No blue stained soil or edge erosion was observed. Surface cracks in the sealant were abundant, but none appeared open through the asphalt wearing course layer (Photo 6).

**Photo 6. North west view at Eastern Swale South Asphalt Cap (ESSAC).**

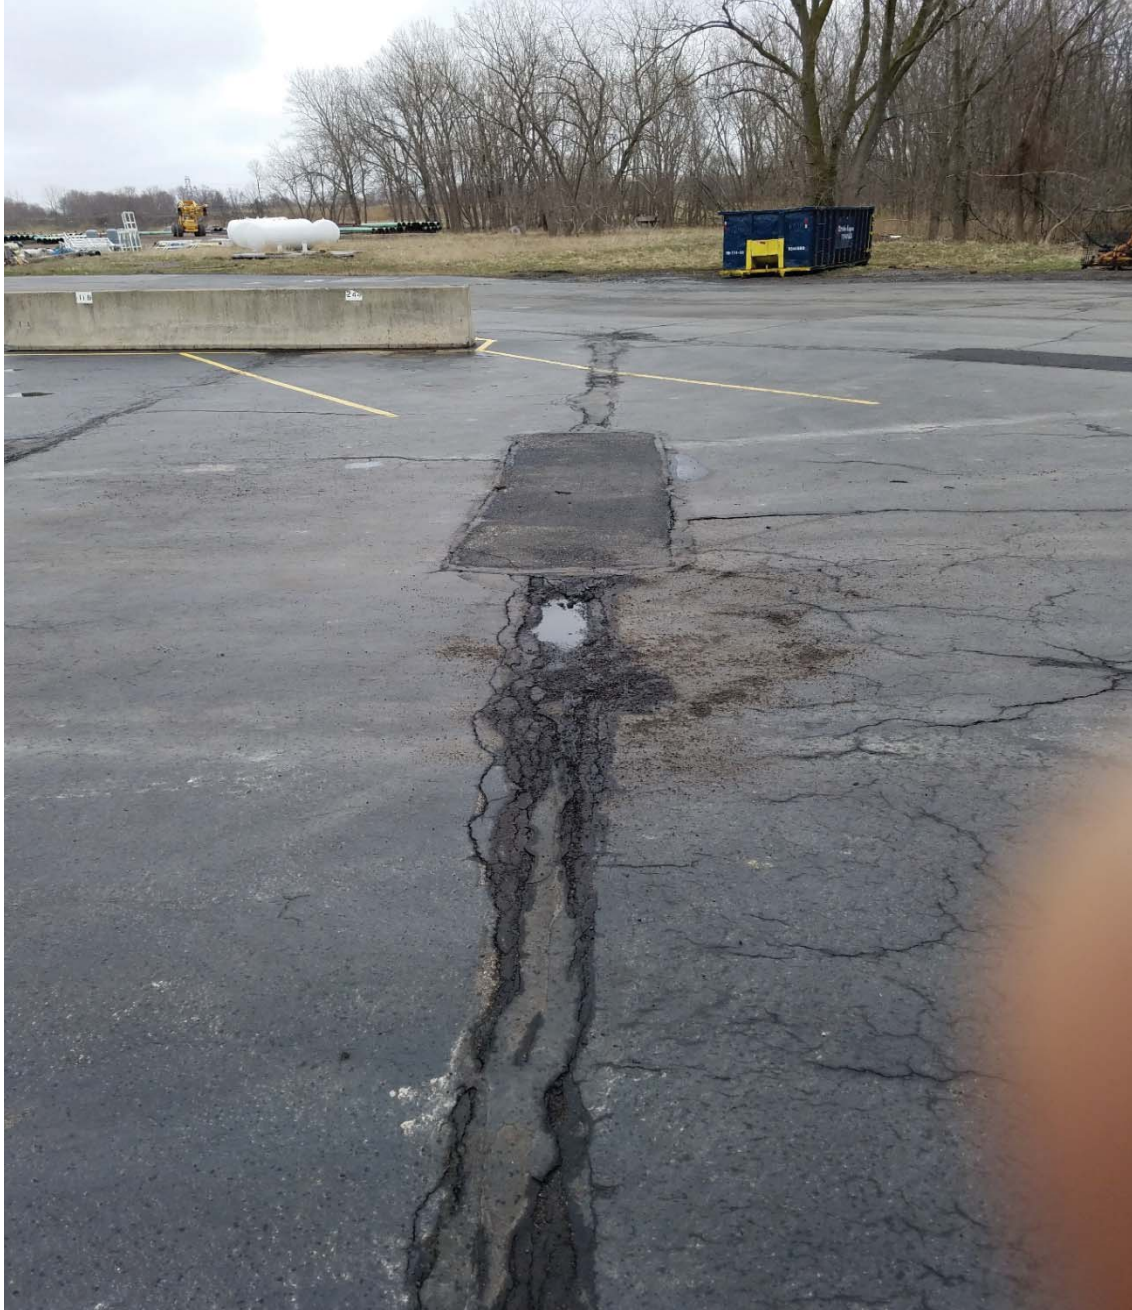
**Building 3 South Asphalt Cap (B3SAC):** No blue stained soil or edge erosion was observed. Surface cracks in the sealant were abundant, and some were open into the asphalt wearing course layer (Photo 7). Some resealing or asphalt maintenance should be planned for before these cracks become deteriorated. Seams with concrete structures and catch basins should be resealed where gaps have developed.

**Photo 7. East view of Building 3 South Asphalt Cap (B3SAC). Surface cracks in sealant and some open to asphalt wearing course layer.**

The B3SAC area exhibits abundant surface cracking in the sealant and some were open into the asphalt wearing course layer. Resealing or asphalt maintenance should be performed before cracks become deteriorated. Seams with concrete structures and catch basins should be resealed where gaps have developed. The asphalt surrounding the storm water catch basin area at B8WAC requires repair.

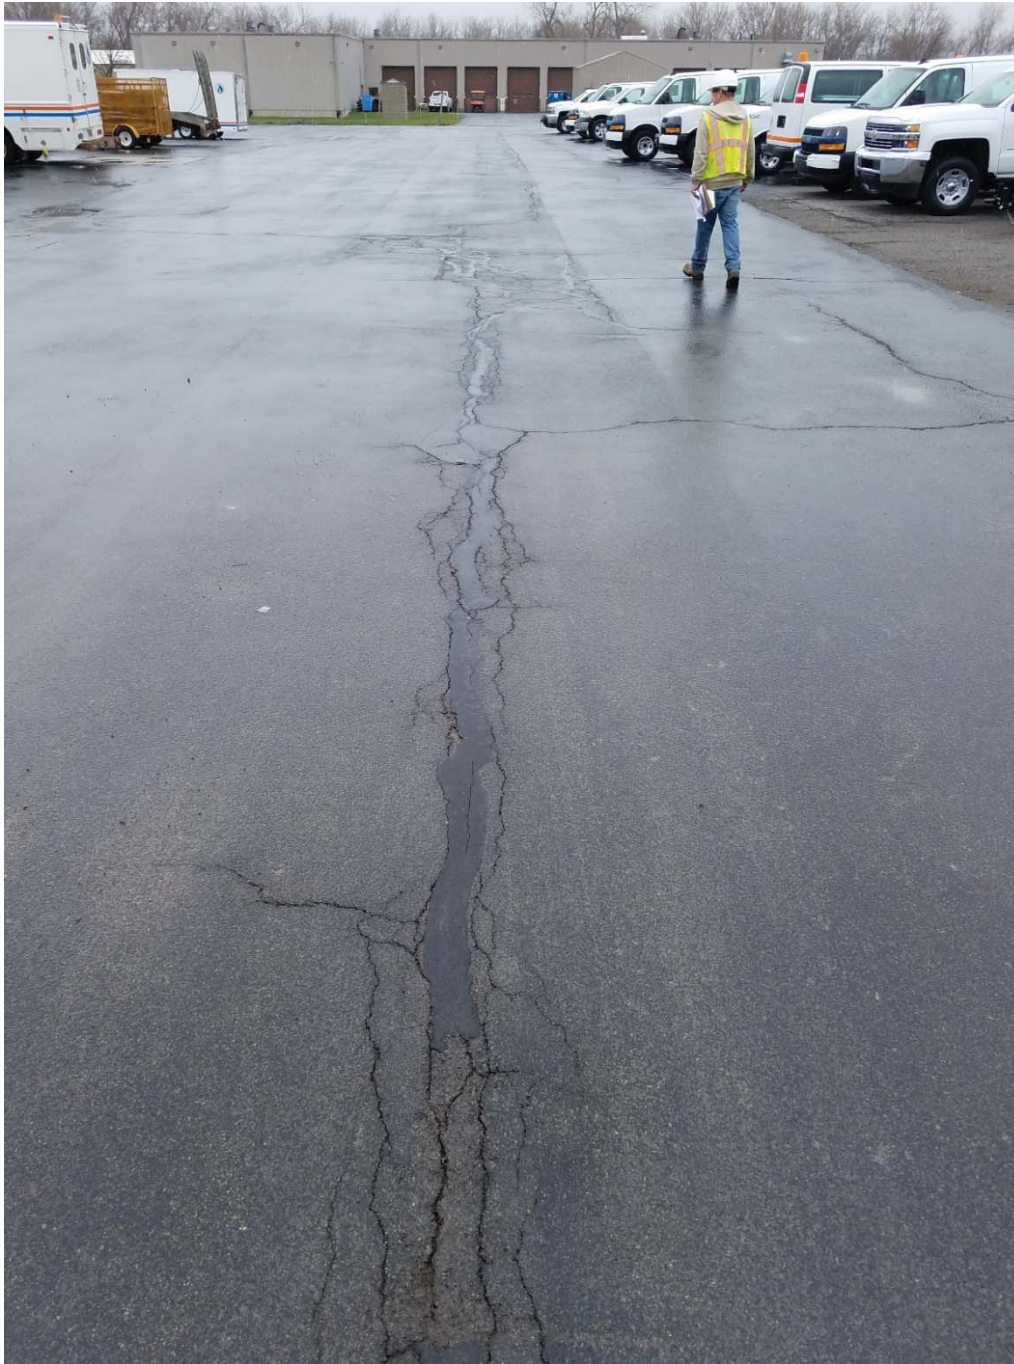
**Building 3 East Asphalt Cap (B3EAC):** No blue stained soil or edge erosion was observed. Surface cracks in the sealant were abundant, but none appeared open through the asphalt wearing course layer (Photo 8).

**Photo 8. North view of Bldg. 3 East Asphalt Cap (B3EAC) with surface cracks and prior sealing.**

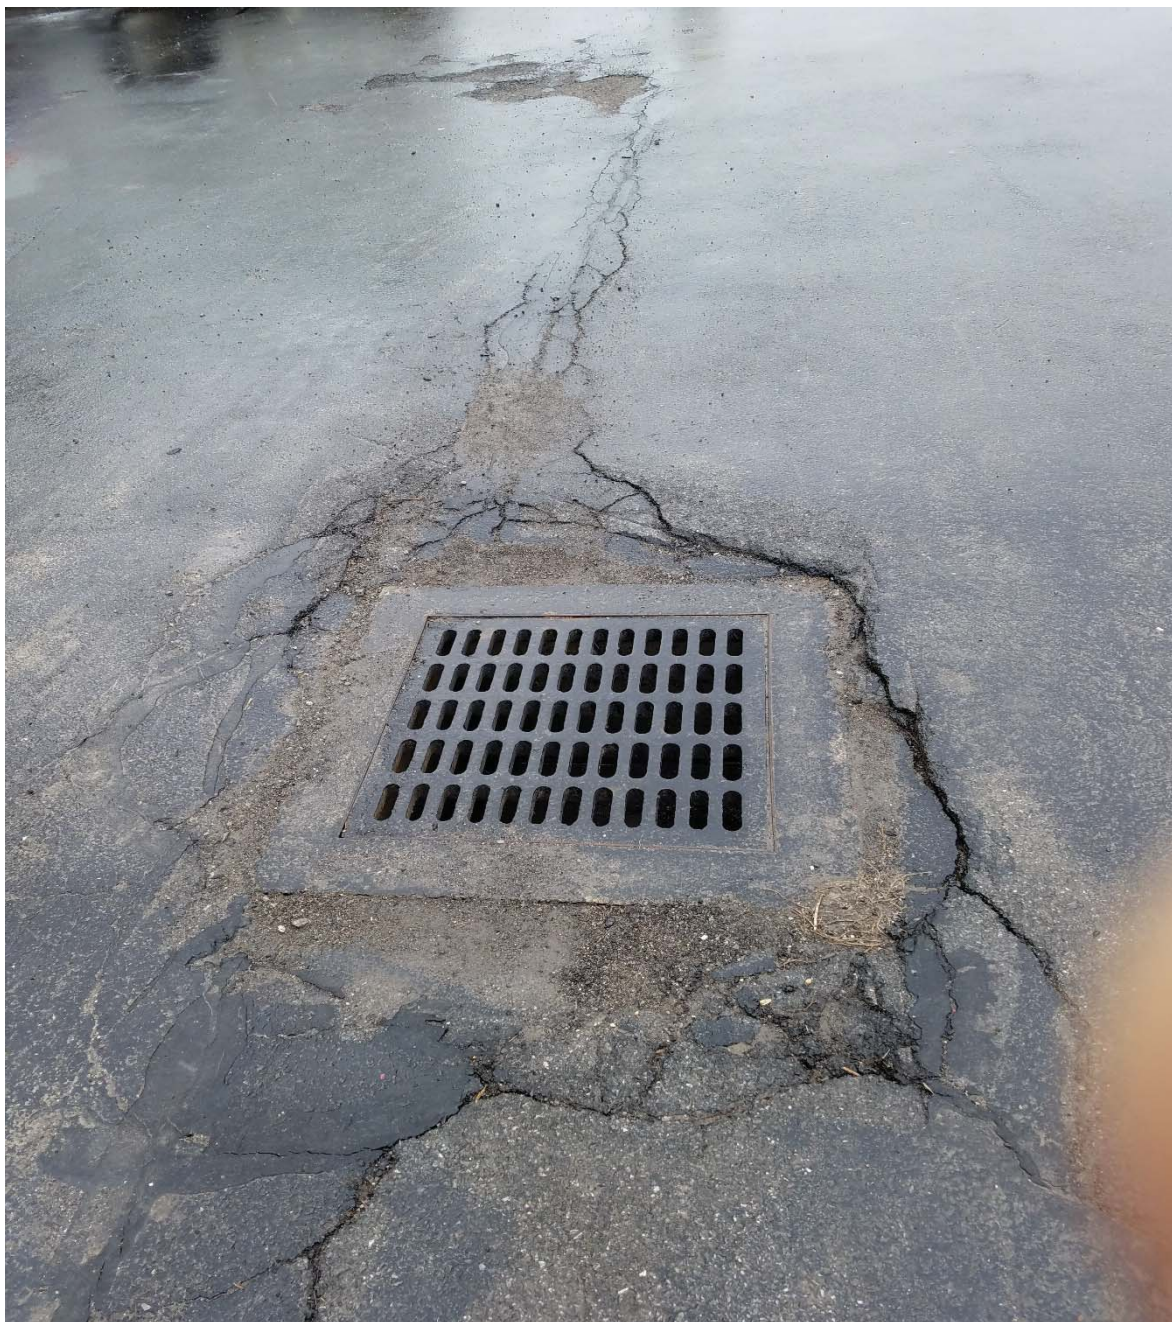
**Building 8 West Asphalt Cap (B8WAC):** No blue stained soil or edge erosion was observed. Surface cracks in the sealant were abundant, but none appeared open through the asphalt wearing course layer except near a catch basin as shown on Photo 9.

**Photo 9. Building 8 West Asphalt Cap (B8WAC) cracking at storm sewer catch basin.**
